FACILITIES NEEDS ASSESSMENT

MISSION PARK

PREPARED BY BELLI ARCHITECTURAL GROUP

2022

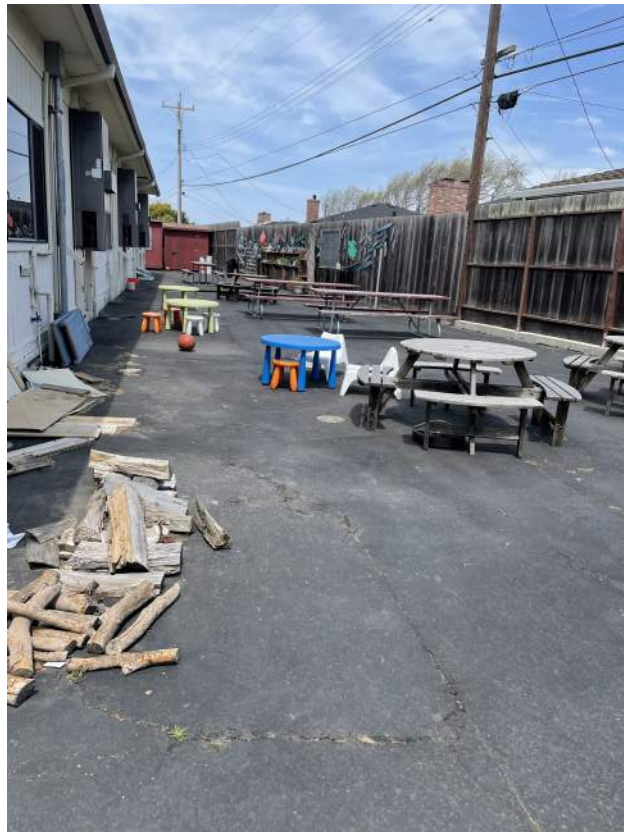
Image 2.1.2 Alley behind classrooms. Taken on 04/27/2022 by Belli Architectural Group.

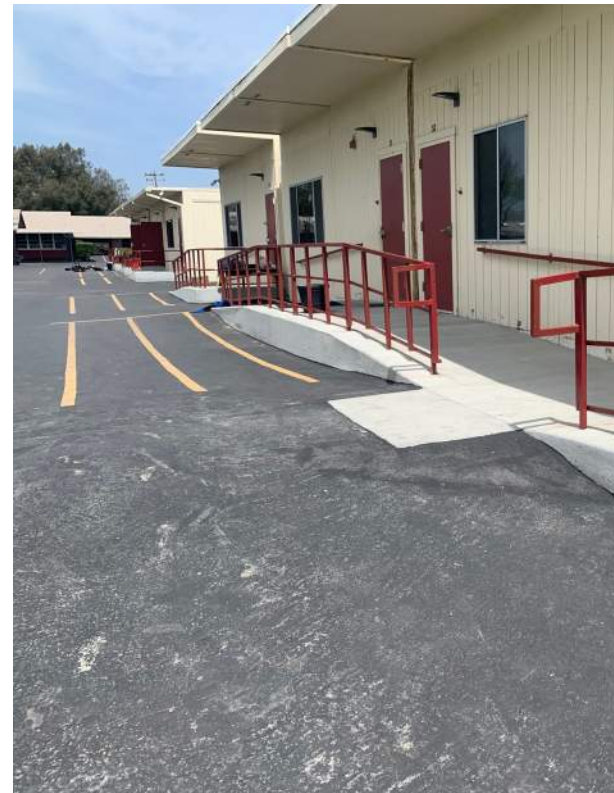
Image 2.1.2 Steep changes in asphalt elevation. Taken on 04/27/2022 by Belli Architectural Group.

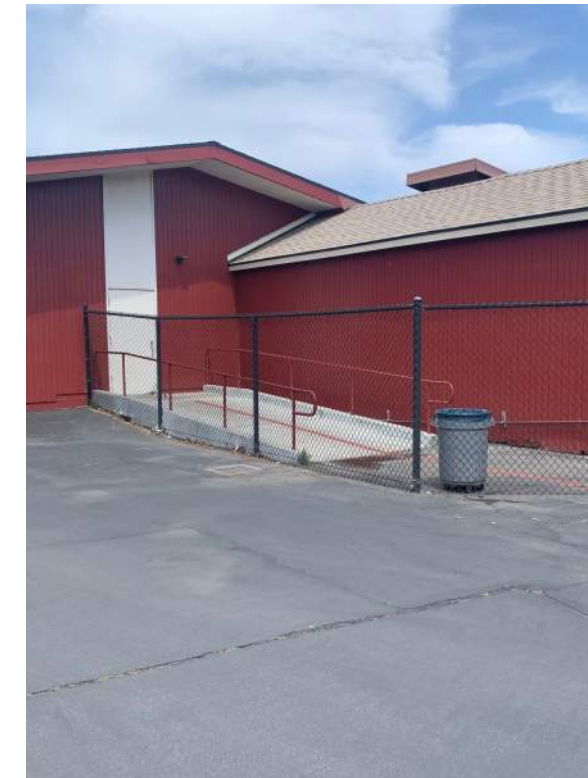
Image 2.1.5 MPR accessible entry at back of building. Taken on 04/27/2022 by Belli Architectural Group.

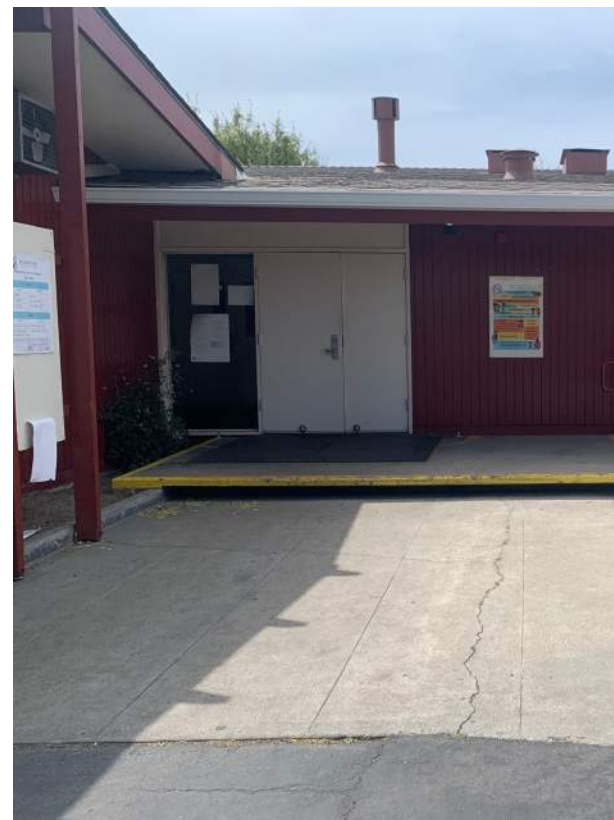
Image 2.1.3 Cracks in walkways. Taken on 04/27/2022 by Belli Architectural Group.

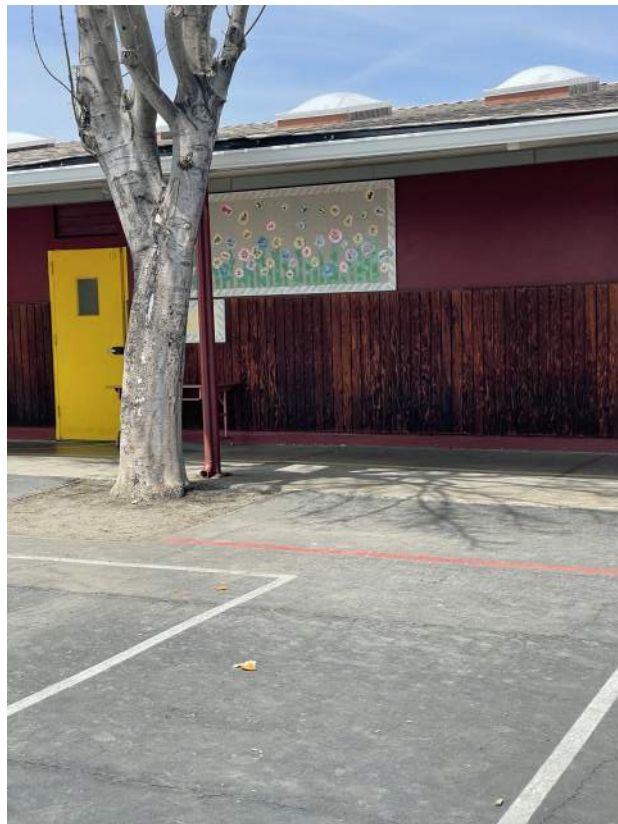
Image 2.2.1 Sagging roof at permanent building. Taken on 04/27/2022 by Belli Architectural Group.

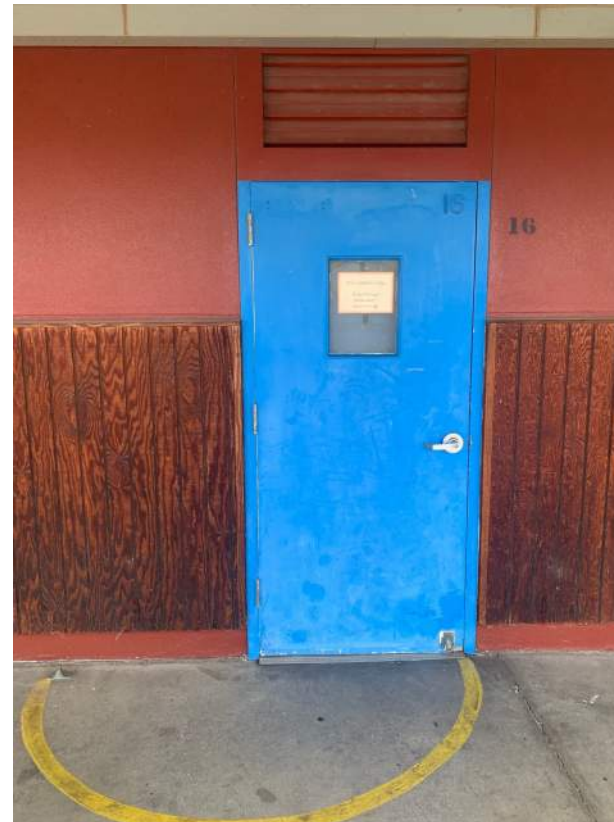
Image 2.2.2 Exterior paint. Taken on 04/27/2022 by Belli Architectural Group.

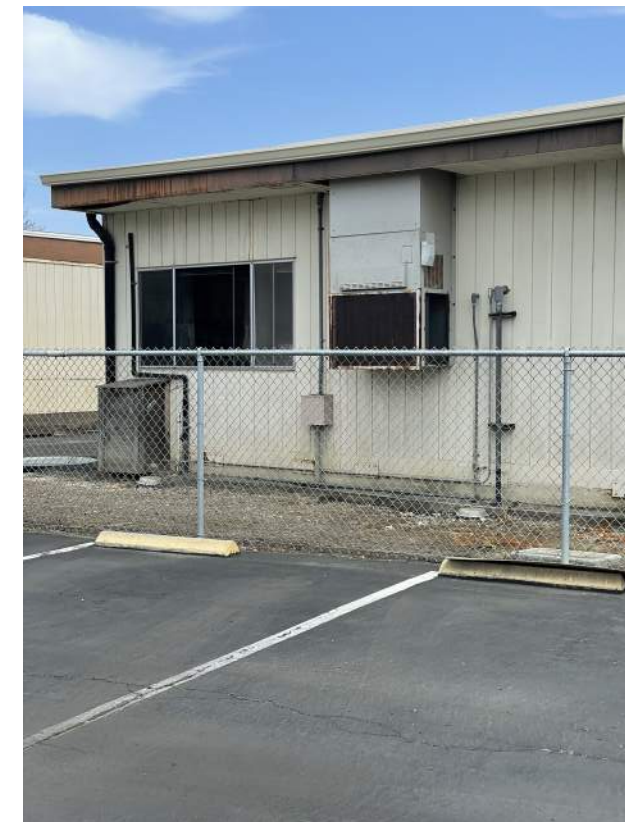
Image 2.2.2 Rust and dry rot at relocatable building. Taken on 04/27/2022 by Belli Architectural Group.

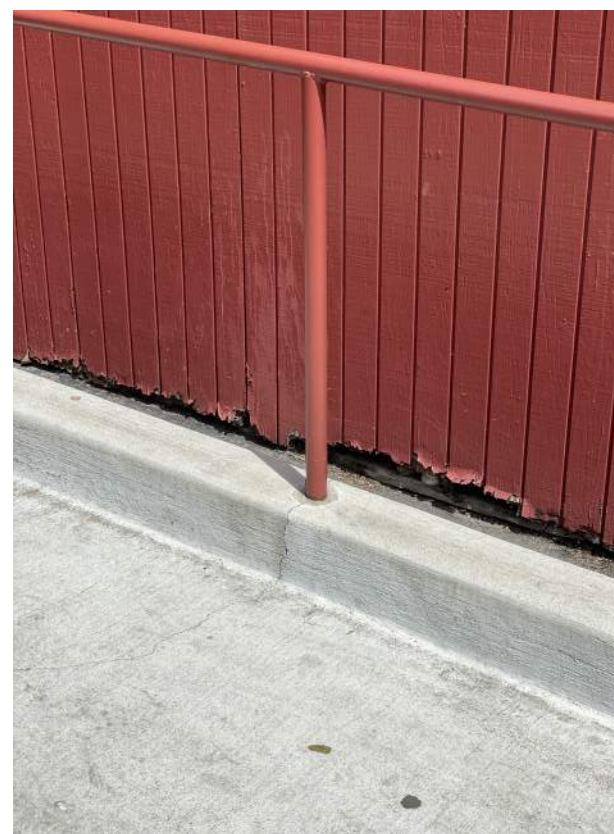
Image 2.2.3 Exterior dry rot. Taken on 04/27/2022 by Belli Architectural Group.

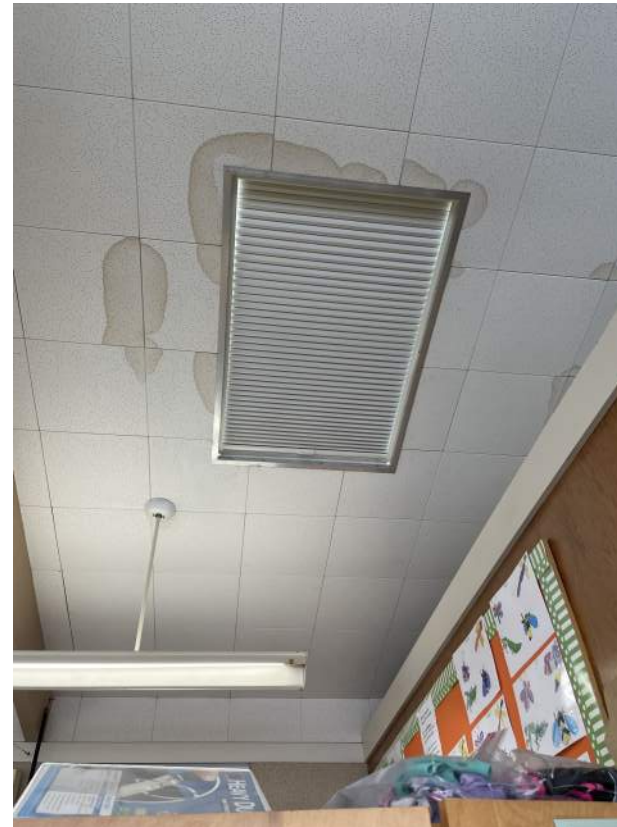
Image 2.3.1 Damaged ceiling panels. Taken on 04/27/2022 by Belli Architectural Group.

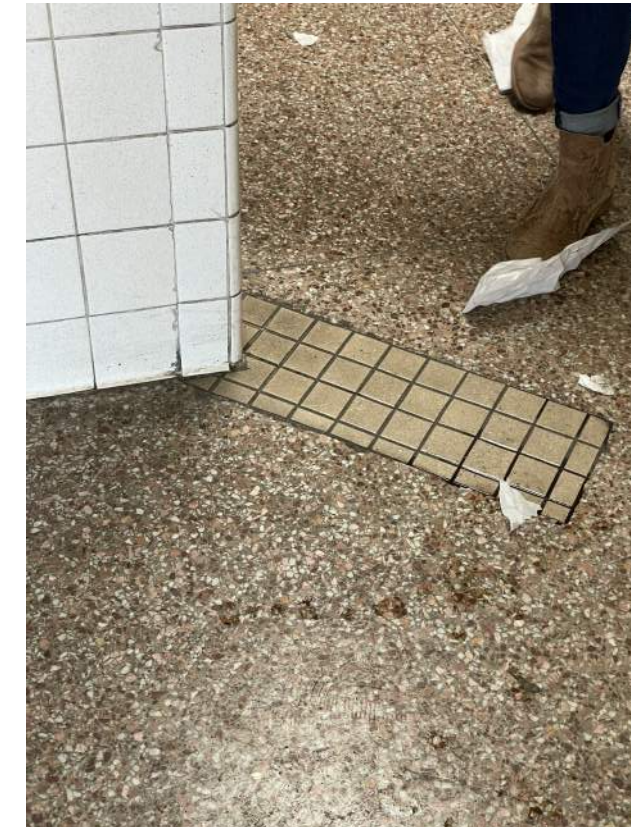
Image 2.3.3 Patched restroom floor. Taken on 04/27/2022 by Belli Architectural Group.

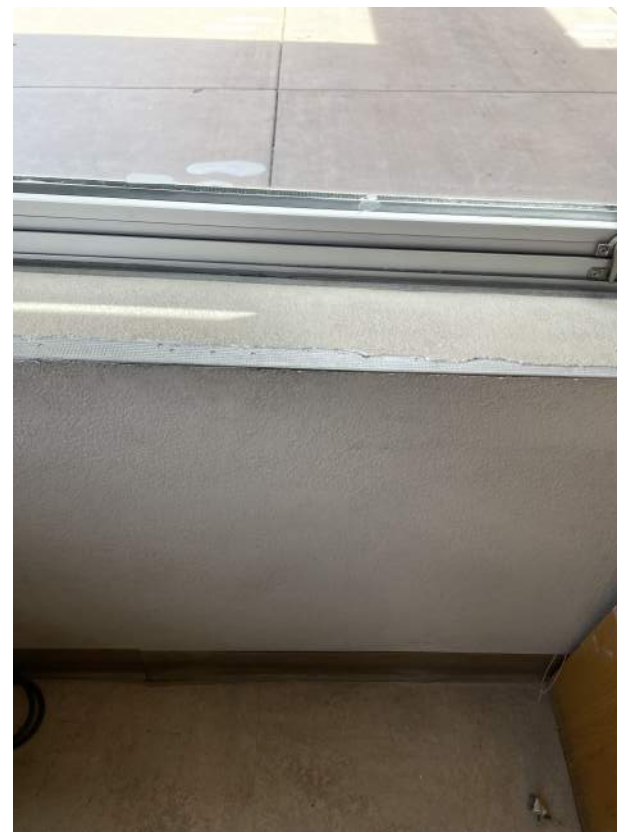
Image 2.3.2 Peeling plaster. Taken on 04/27/2022 by Belli Architectural Group.

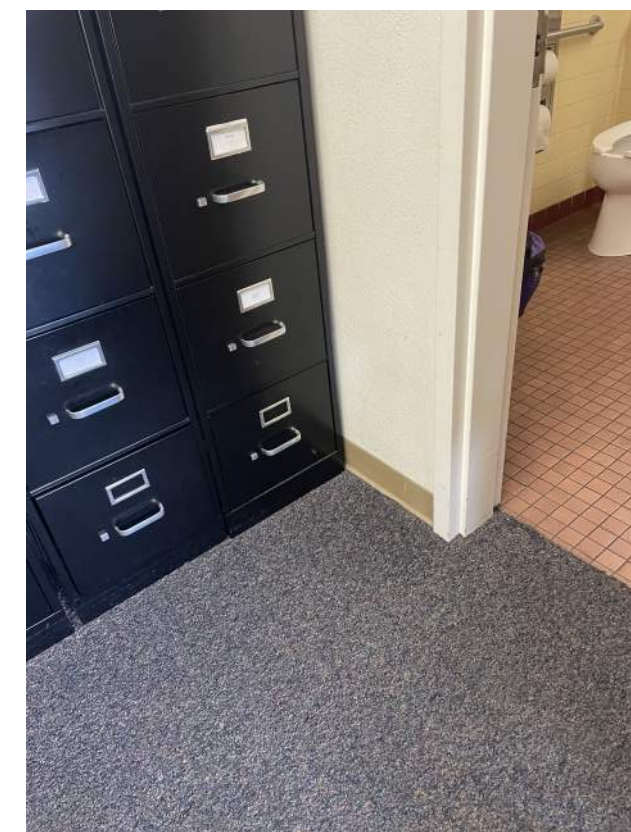
Image 2.3.4 Missing threshold. Taken on 04/27/2022 by Belli Architectural Group.

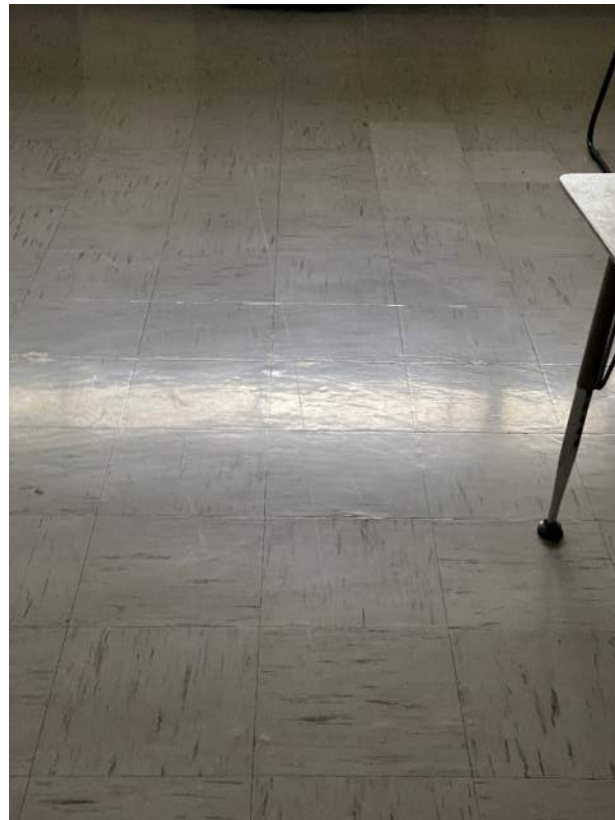
Image 2.3.5 Old VCT floor. Taken on 04/27/2022 by Belli Architectural Group.

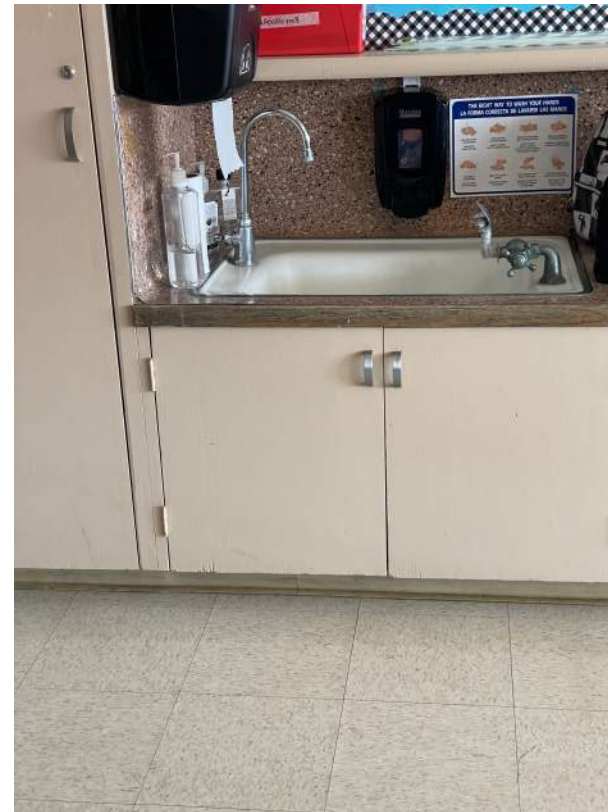
Image 2.3.7 Non-accessible classroom sink. Taken on 04/27/2022 by Belli Architectural Group.

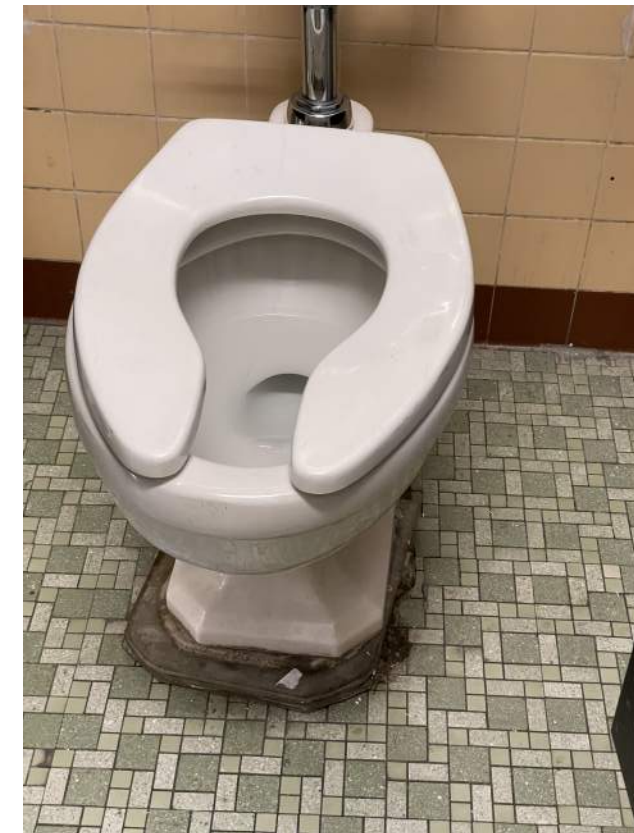
Image 2.3.9 Incorrectly installed water closet. Taken on 04/27/2022 by Belli Architectural Group.

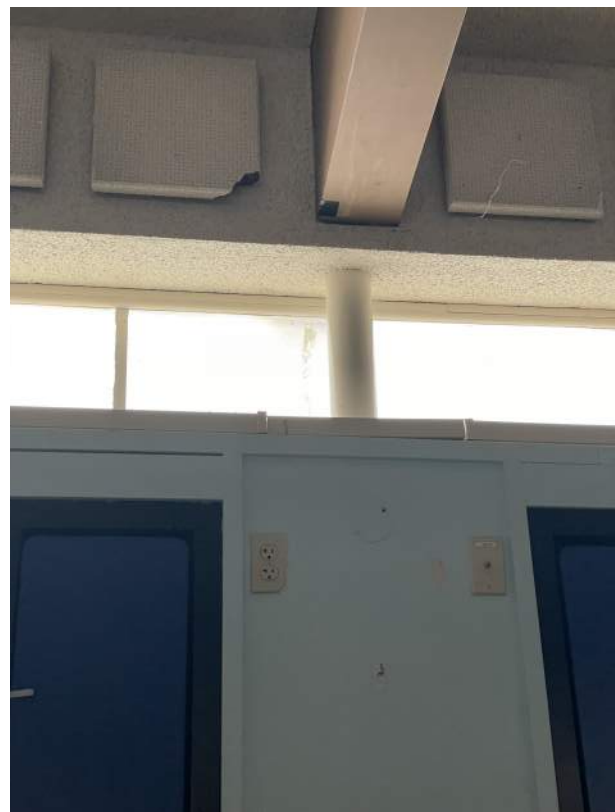
Image 2.3.6 Broken acoustic panel. Taken on 04/27/2022 by Belli Architectural Group.

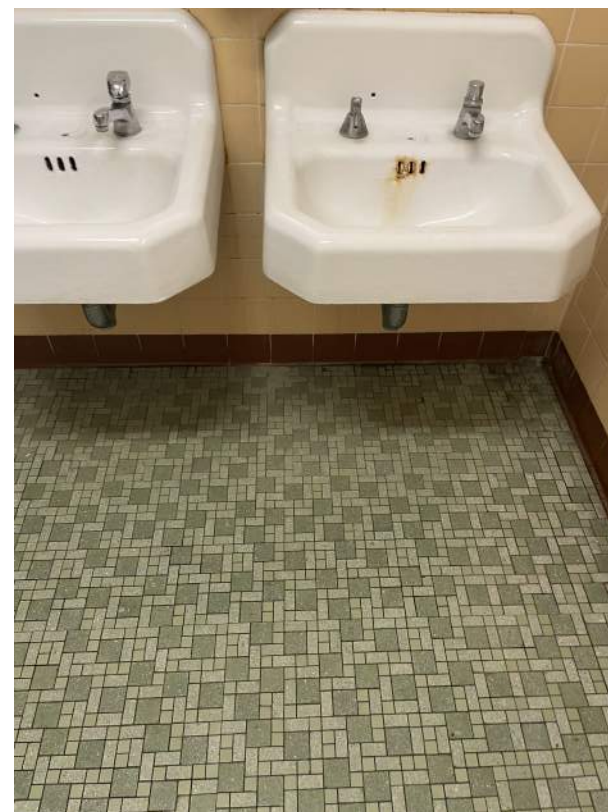
Image 2.3.8 Rust at plumbing fixtures. Taken on 04/27/2022 by Belli Architectural Group.

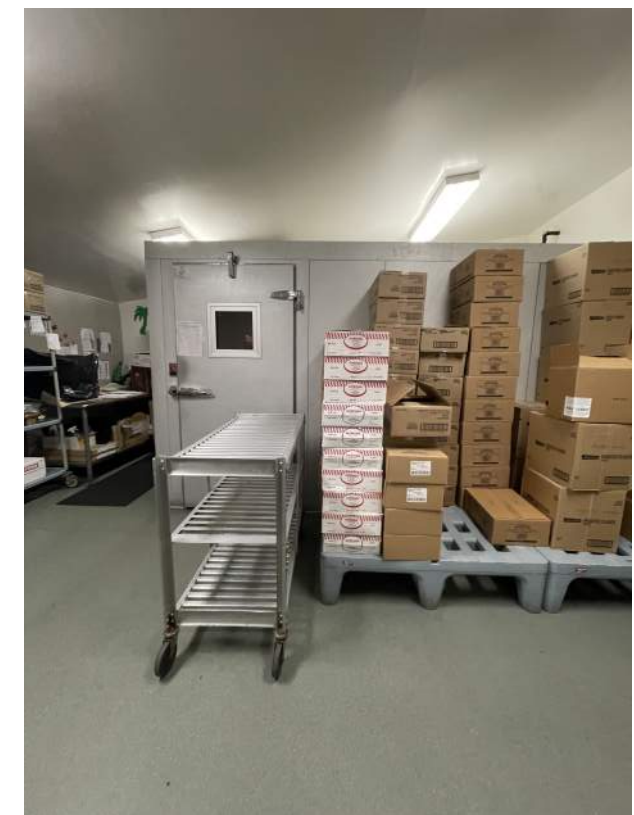
- Refrigeration equipment has been installed inside the Multi-Purpose building. The space where this is installed has not been designed to accommodate such equipment.
- Flooring surfaces are adequate and in good conditions.
- Cooking equipment and surfaces are adequate, made of stainless steel.
- The rooms contain mechanical ventilation plus Ansul exhaust hood.
- There is not an “allergy free” meal preparation area.
- Additional storage and food preparation areas needed.

Image 2.3.10 Kinchen refrigeration. Taken on 06/29/2022 by Belli Architectural Group.

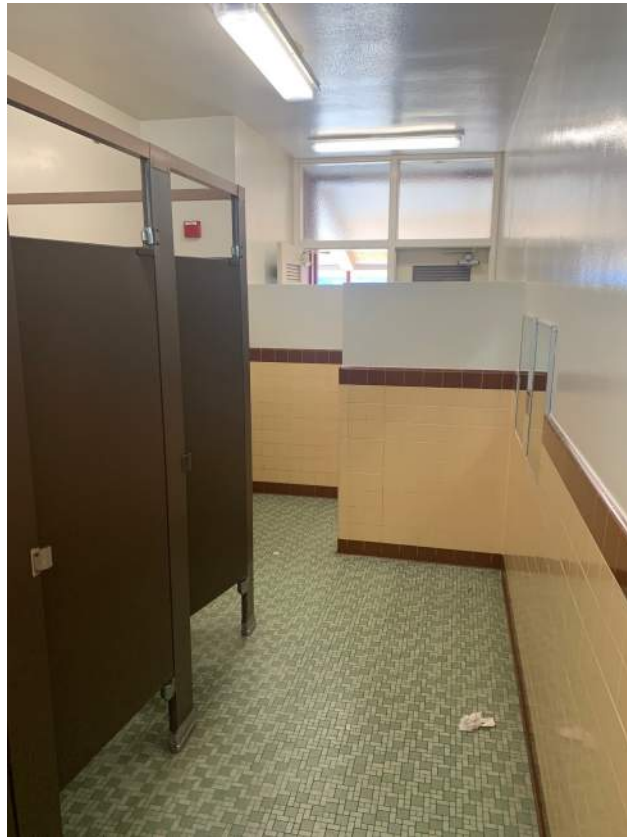
Image 2.4.1 Non-accessible restrooms. Taken on 04/27/2022 by Belli Architectural Group.

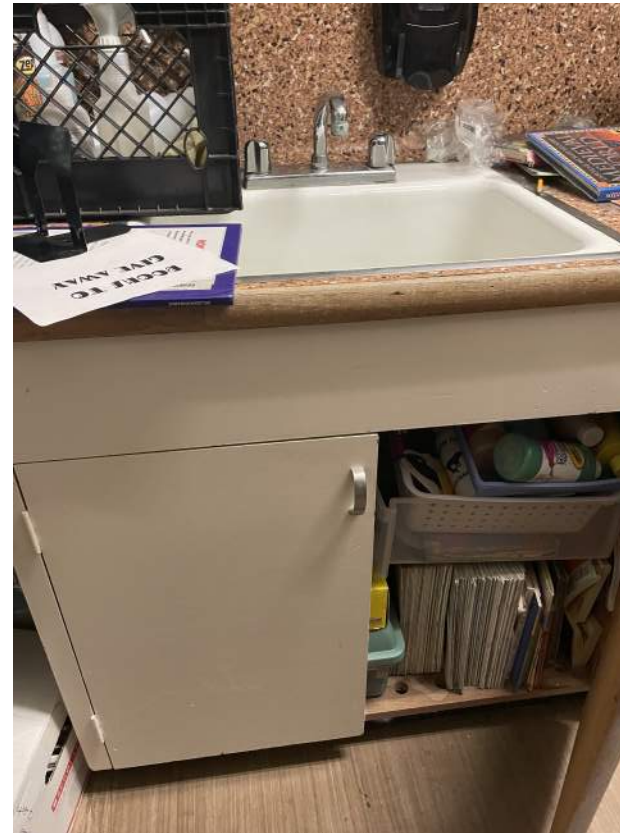
Image 2.4.1 Non-accessible sinks. Taken on 04/27/2022 by Belli Architectural Group.

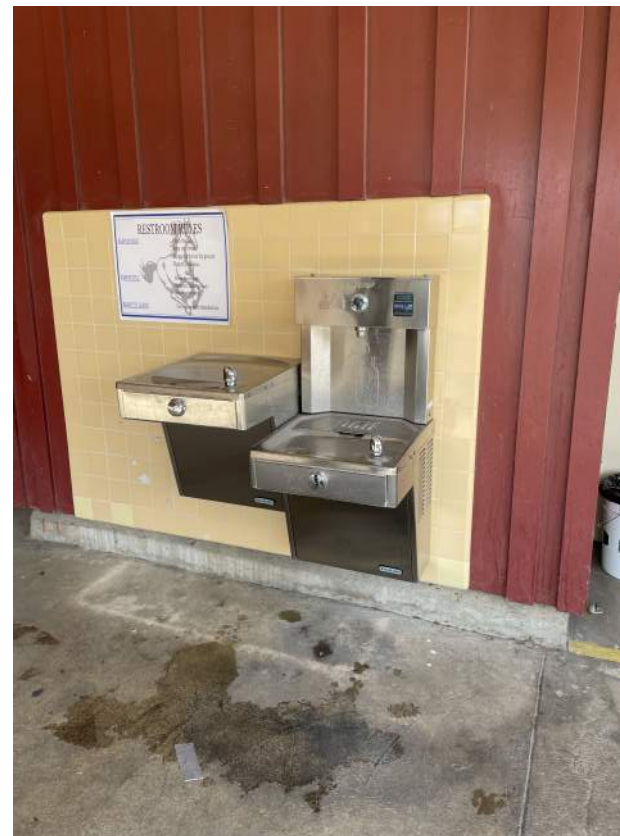
Image 2.4.1 Drinking fountains missing cane detection rails. Taken on 04/27/2022 by Belli Architectural Group.

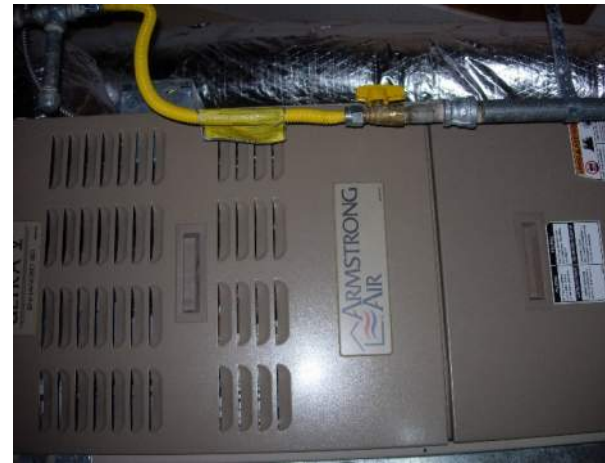
It appears as if this area has been remodeled since 2003. The heating system for this area consist of two (2) Armstrong gas-fired horizontal furnaces located in the attic. These furnaces appear to be from the 2003 modernization and are in fair condition and operating. These heating units are 20 years old and should be replaced.

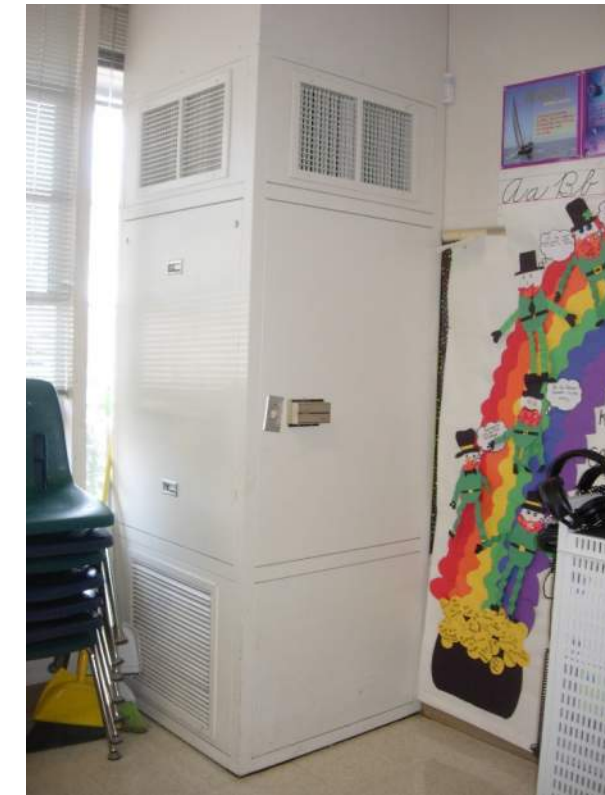
The heating system for these classrooms consist of Armstrong up-flow furnaces located inside a TEAM Mfg. metal enclosure. These were installed during the 2003 modernization. The heating system appeared to be in good condition and operating. The furnaces inside these enclosures are 20 years old and should be replaced. Thermostats are non-programmable and operate from a 0 to 6 hour no-hold timer.

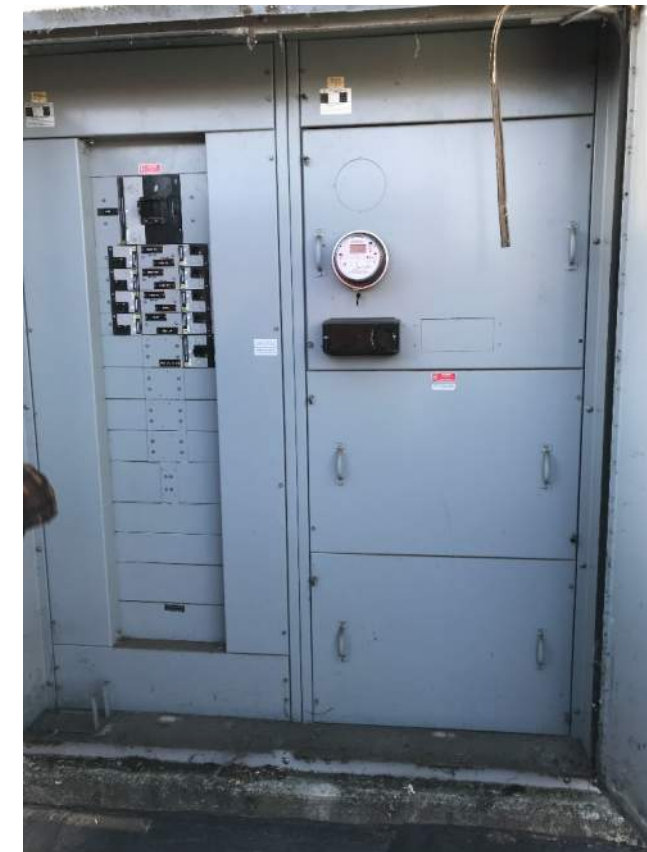
MSB2.

There are (3) existing main “metered” electrical service switchboards (MSB1, MSB2 and MSB3). MSB1 is a 400 amp, 120/208 volt, 3 phase, NEMA 1, Square D, service located in the Administration building. MSB1 has a connection for the existing Solar PV system. The Solar PV is connected ahead of the main breaker at MSB1. MSB1 serves the Administration and Multi-Purpose building. MSB1 expected life; 10 to 15 yrs. MSB2 is an 800 amp, 120/208V, 3-phase, NEMA 3R, Square D, service located on the east side of campus, outside of a modular building. MSB2 feeds the permanent classroom buildings as well as the modular buildings located on the east side of campus. MSB3 expected life; 15 to 20 yrs. MSB3 is a 400 amp, 120/208V, 3-phase, NEMA 3R, Square D, service located on the west side of campus near the parking lot. MSB3 mainly serves the modular classrooms clustered on the west side of campus. MSB3 expected life; 15 to 20 yrs. The electrical services are used primarily for lighting and heating equipment, with minimal plug loads. A few of the electrical distribution system panels that are located around the site and are original to the main campus buildings when the school was built are old and manufactured by a company that no longer exists. The reliability of the system’s breakers to function correctly when necessary cannot be relied upon. It is recommended to replace the oldest panels within the classroom wings of the main campus building. Where the District plans to add HVAC to the site, the switchboards that are serving those locations may require an upgrade based on what type of system is recommended for HVAC upgrades. See attached photos MSB1, MSB2 and MSB3.

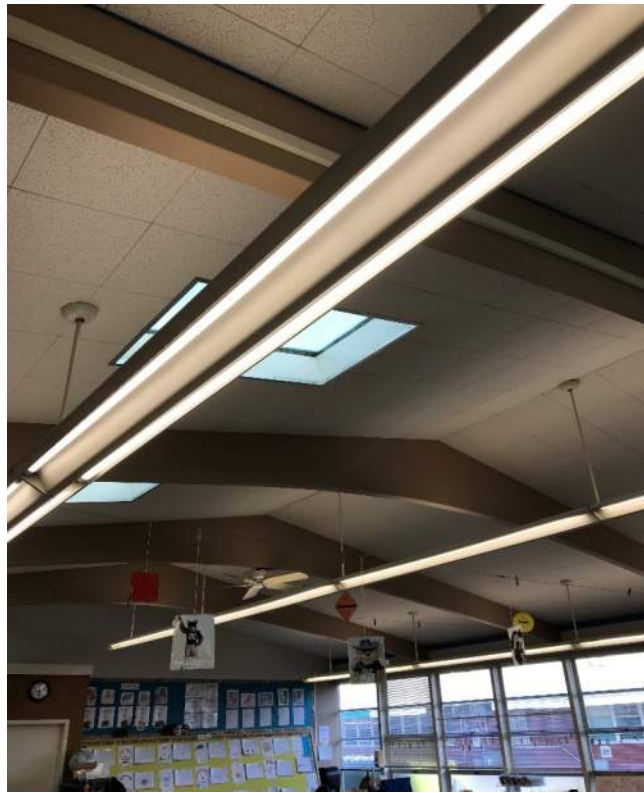
Interior Lighting is primarily LED T8 lamps. Several closets and utility rooms still have old fluorescent lights. Most, if not all classrooms fluorescent lights were retrofitted with LED T8 lamps manufactured by eTech LED. The District Staff stated that these LED lamps are made in China and are no longer available. The lighting lenses/diffusers throughout the school campus are old and although there was no mention of complete failure, some light fixture housing seemed original to the spaces. Hence, the old diffusers would not provide the adequate lighting distribution. There were also several light fixtures in the classrooms that don’t work. It appears that all classrooms and large areas have energy code compliant controls such as wired and wireless occupancy sensors. Emergency lighting was not apparent at any classrooms, restrooms, or exterior landings. However, in multi-use spaces and hallways, bug-eye type stand-alone emergency light fixtures were installed. Multi-level switching/dimming necessary for energy conservation is almost non-existent. Expected life; Unknown. It is recommended to retrofit or replace campus wide lighting system with new LED technology in the near future. This would be a good opportunity for reduction in energy use from more efficient lighting fixtures, improved classroom lighting, smart lighting controls, daylight harvesting and would also reduce maintenance costs. See attached photo LTG1.

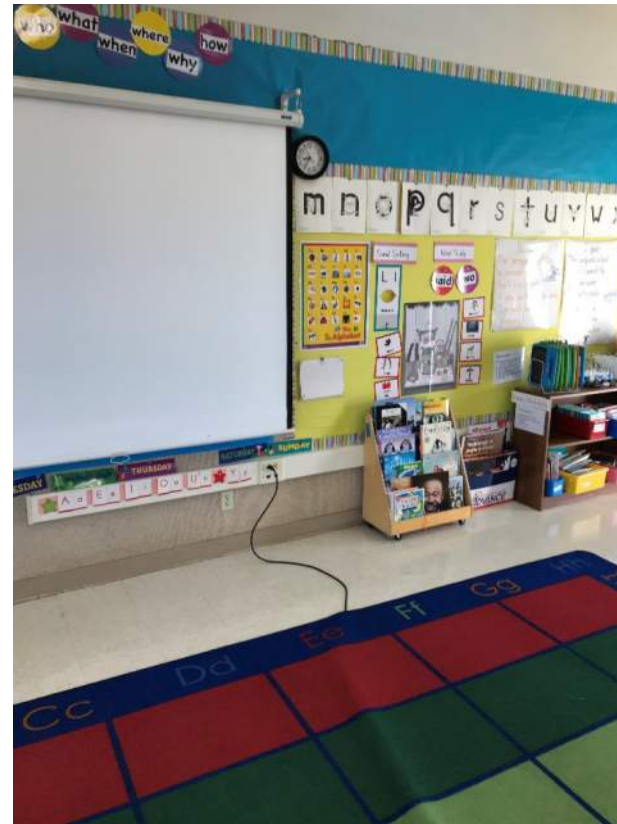
Most of the classrooms have ceiling mounted projectors with associated AV controls located near the teacher’s station. There are no ongoing problems. However, where projectors were installed on accessible ceilings (TBAR), the associated receptacles were installed above the ceiling with the cord passing through the T-BAR up to the receptacle. Current code does not allow this installation. Where classroom renovations occur, it is required to mount the receptacles exposed on the ceiling. Additionally, most of the teacher’s stations are centralized in the classrooms, which lead the power cord to be extended from the outlet to the teacher’s station. This is a trip hazard and should be avoided for the children’s safety. It is recommended to relocate the teacher’s station near the electrical outlet or provide an ADA complaint floor raceway. See attached photo PROJECTOR1 and CABLE1.
