# FACILITIES NEEDS ASSESSMENT

MONTEREY PARK

PREPARED BY BELLI ARCHITECTURAL GROUP

2022

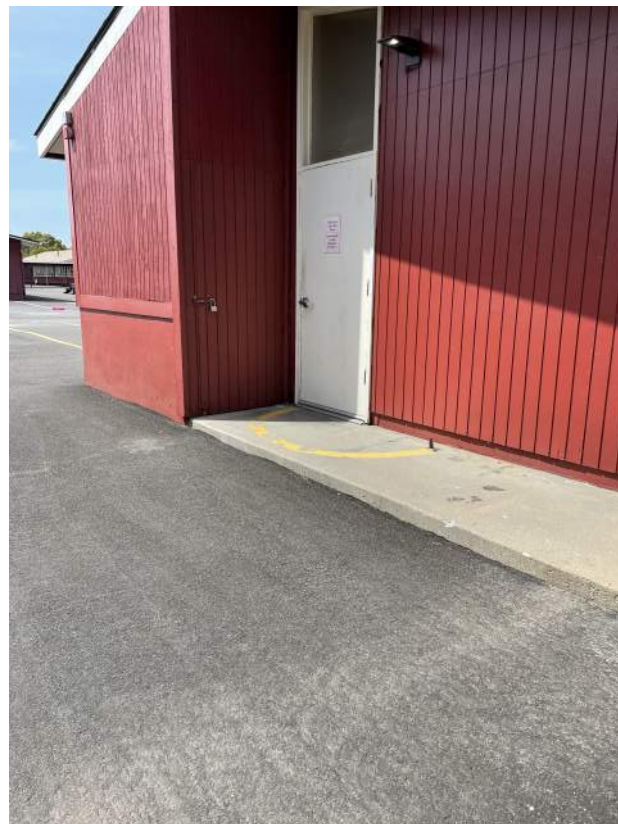
- One door at MPR did not have proper ADA clearance nor accessible approach.

Image 2.1.1 Non-ADA compliant door landing. Taken on 04/27/2022 by Belli Architectural Group.

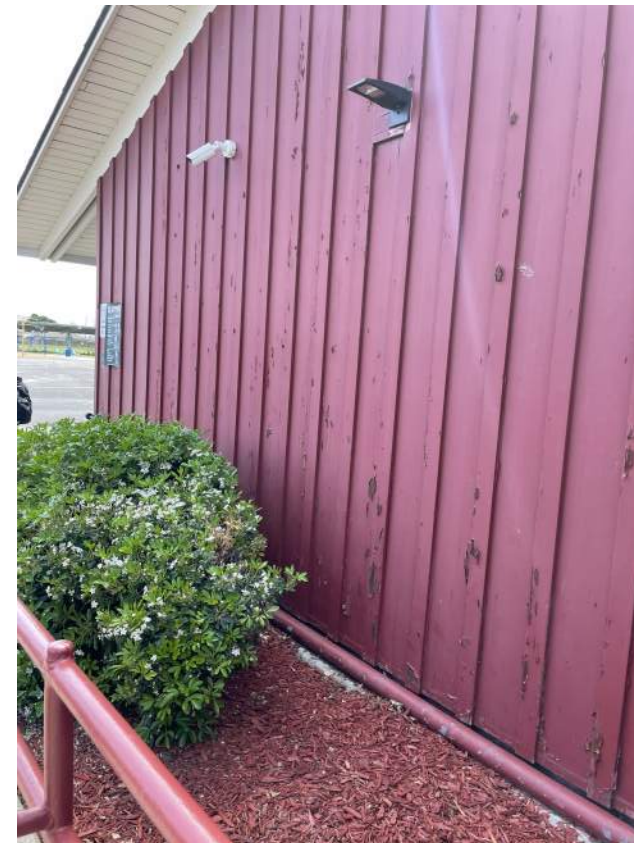
Image 2.2.1 Exterior paint peeling. Taken on 04/27/2022 by Belli Architectural Group.

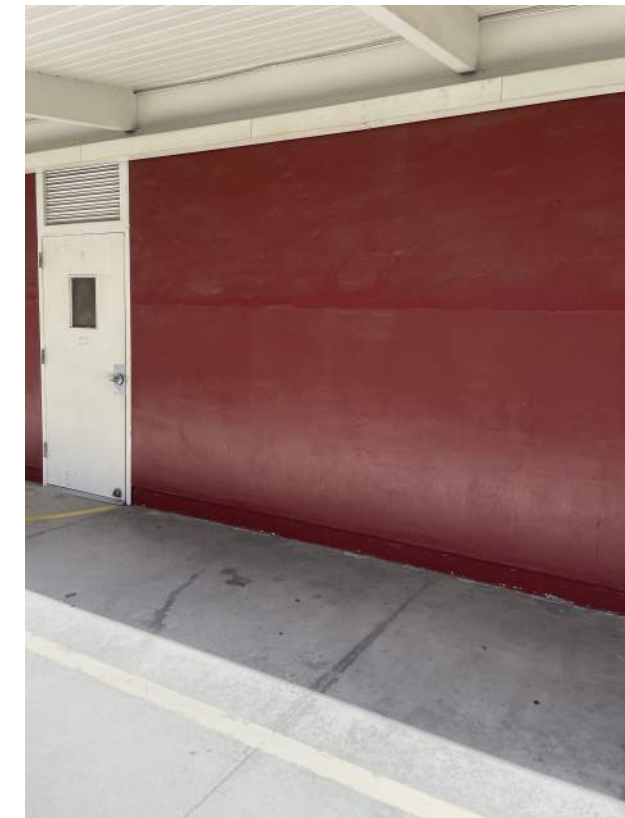
Image 2.2.2 Uneven exterior finishes. Taken on 04/27/2022 by Belli Architectural Group.

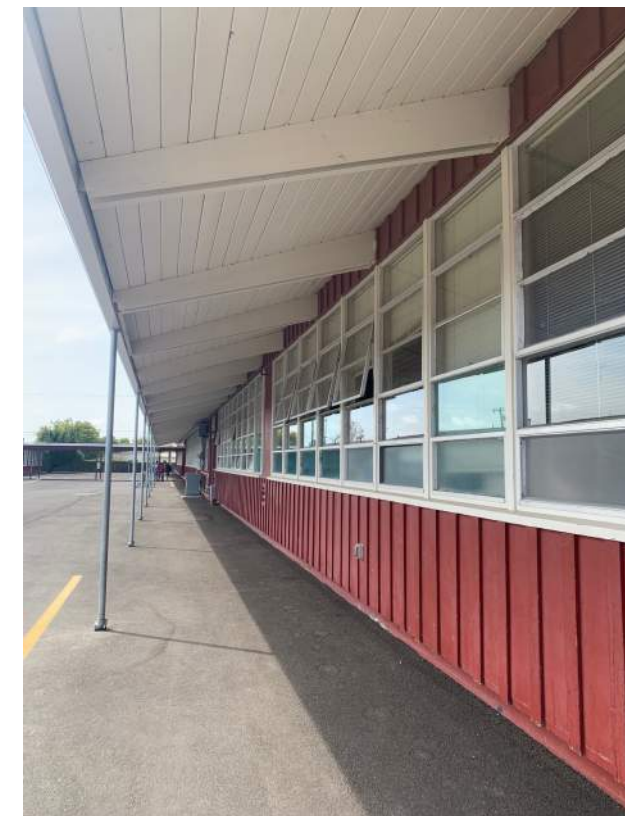
Image 2.2.3 Old, original windows. Taken on 04/27/2022 by Belli Architectural Group.

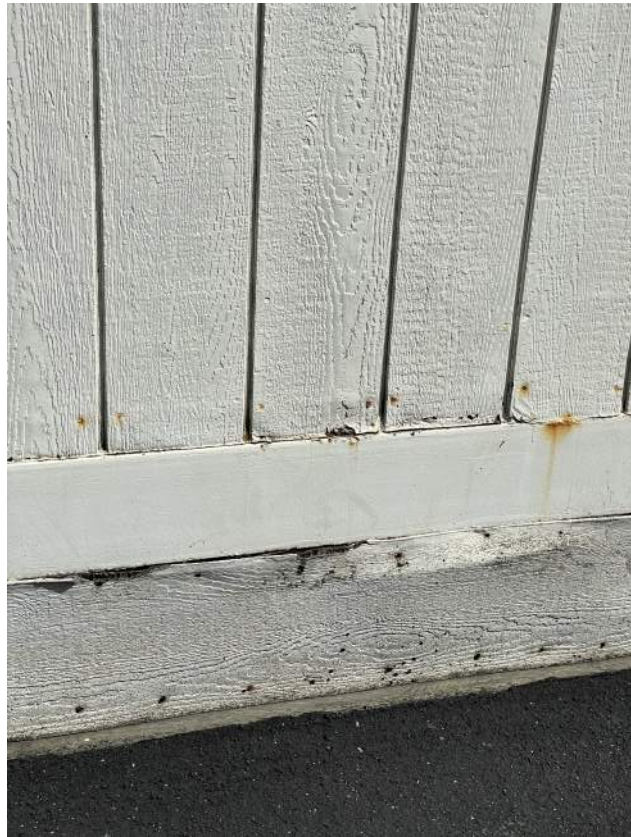
Image 2.2.5 Rust present at relocatable classrooms. Taken on 04/27/2022 by Belli Architectural Group.

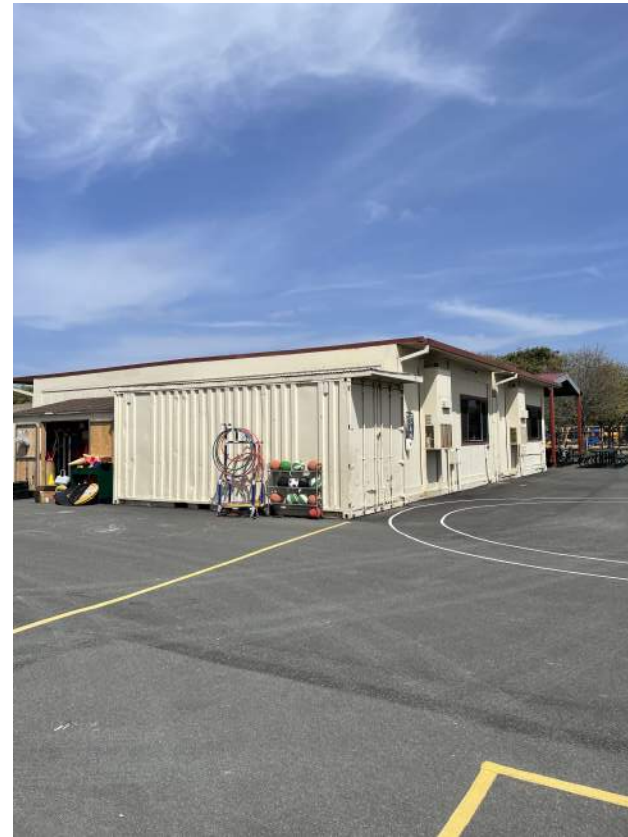
Image 2.2.7 Storage container next to classroom. Taken on 04/27/2022 by Belli Architectural Group.

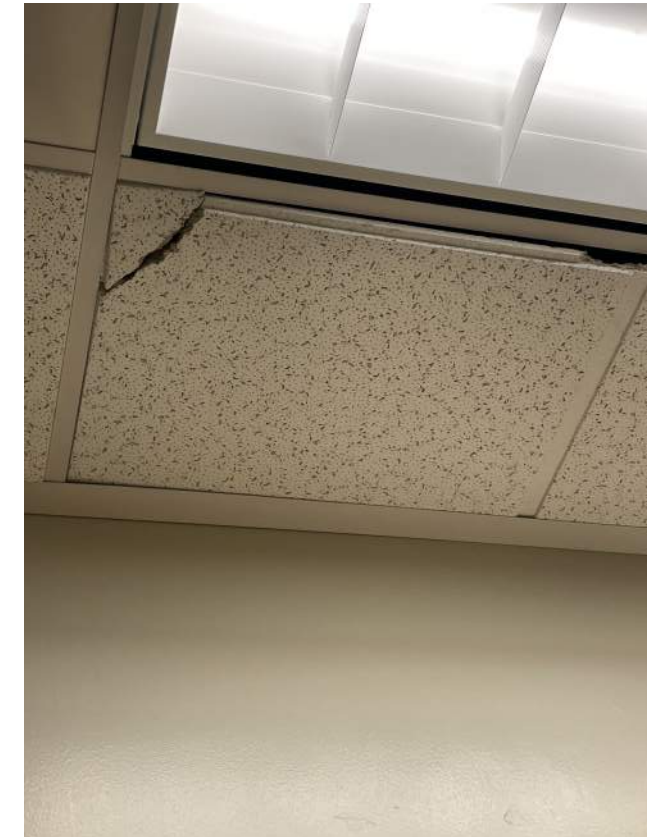
Image 2.3.1 Broken ceiling panels. Taken on 04/27/2022 by Belli Architectural Group.

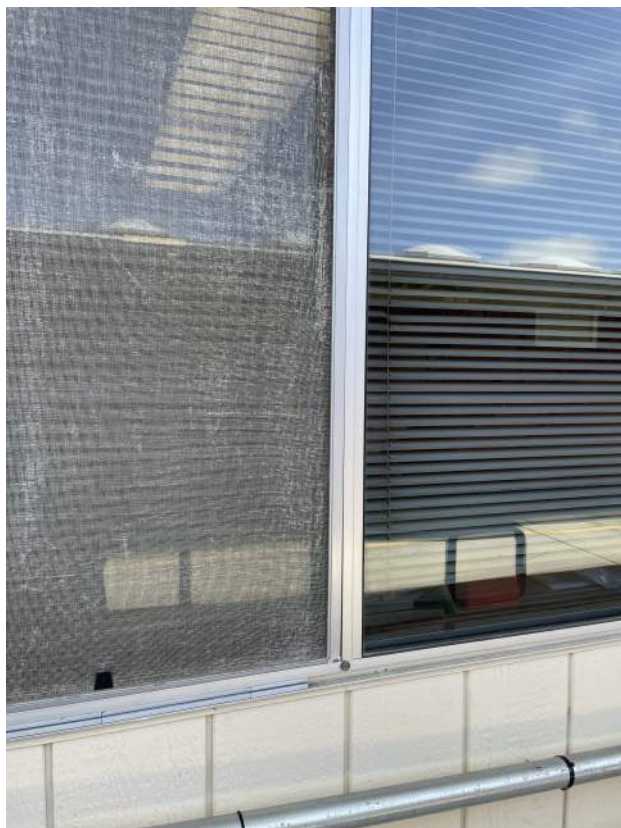
Image 2.2.6 Broken window screen. Taken on 04/27/2022 by Belli Architectural Group.

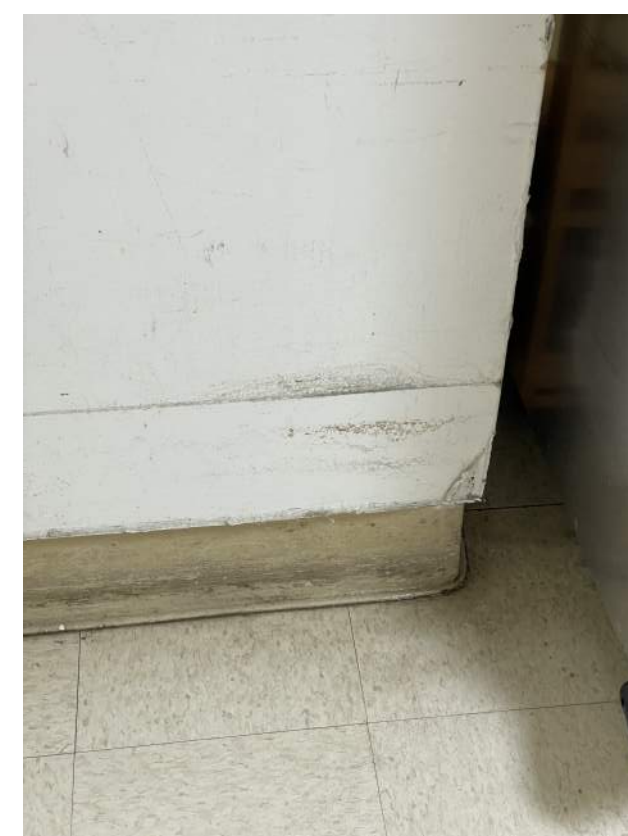
Image 2.3.2 Existing VCT flooring and worn rubber base. Taken on 04/27/2022 by Belli Architectural Group.

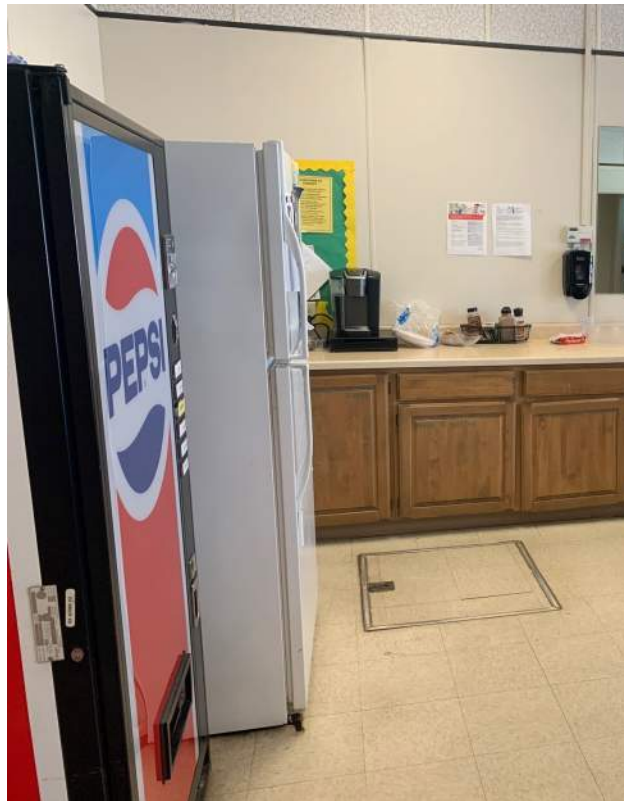
Image 2.3.3 Patched sheet vinyl flooring at under-floor access panel. Taken on 04/27/2022 by Belli Architectural Group.

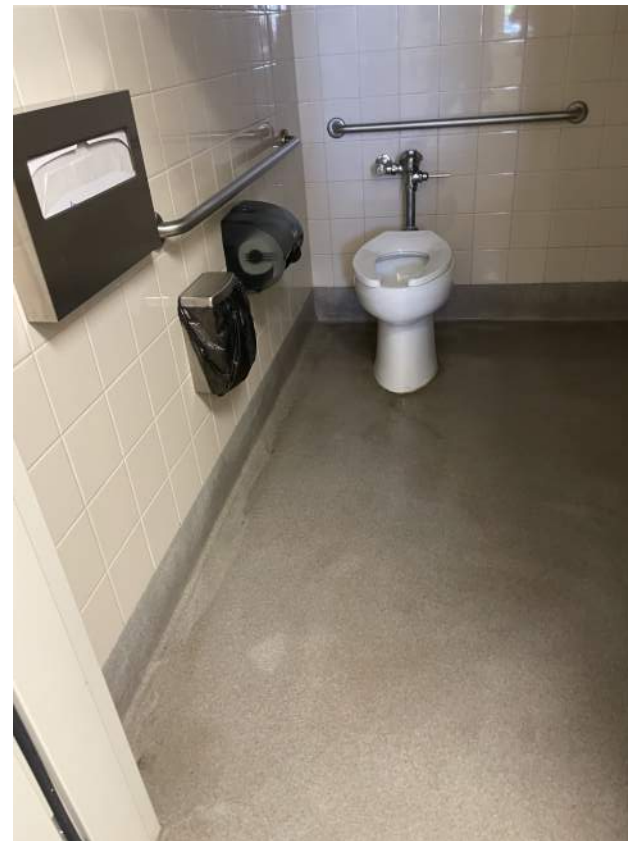
Image 2.3.5 Corrosion in epoxy restroom floor. Taken on 04/27/2022 by Belli Architectural Group.

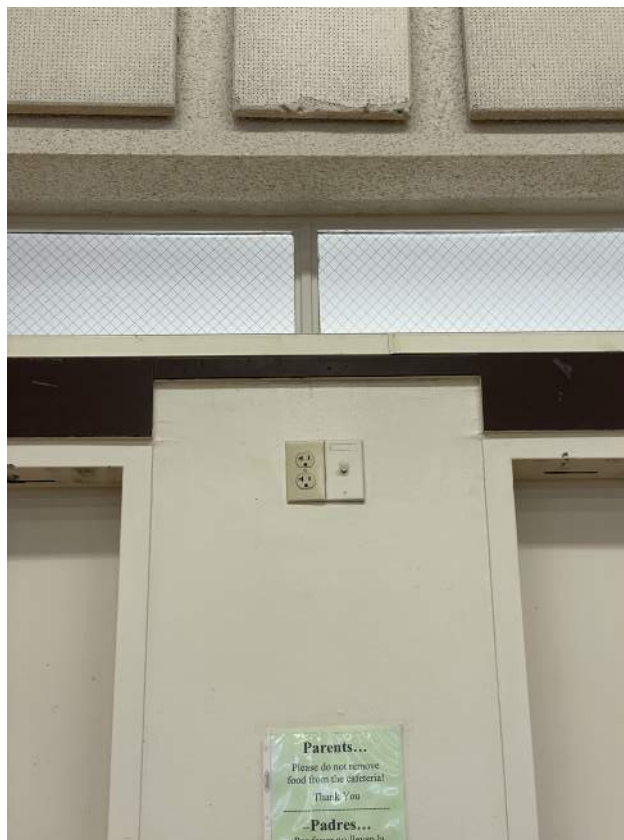
Image 2.3.4 Broken acoustic panel at MPR. Taken on 04/27/2022 by Belli Architectural Group.

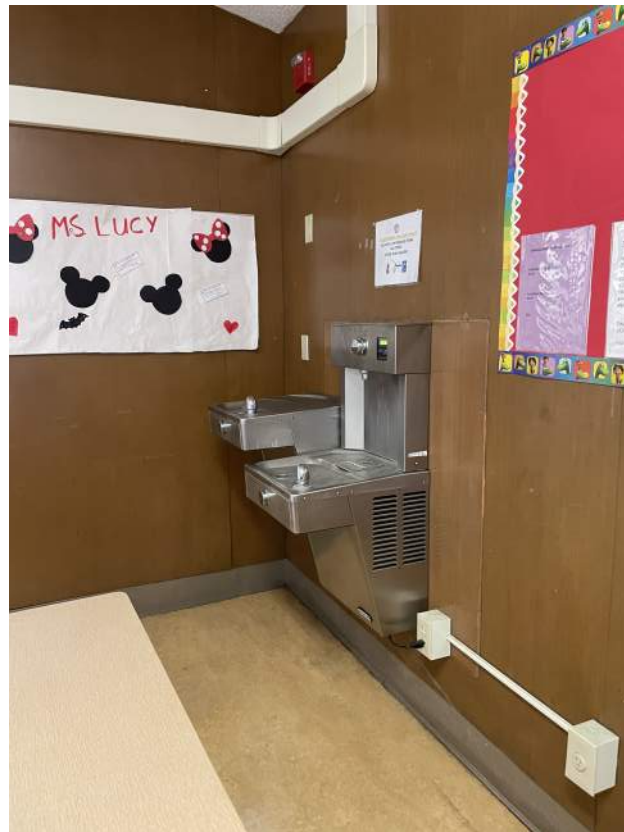
Image 2.4.1 Missing cane detection rails. Taken on 04/27/2022 by Belli Architectural Group.

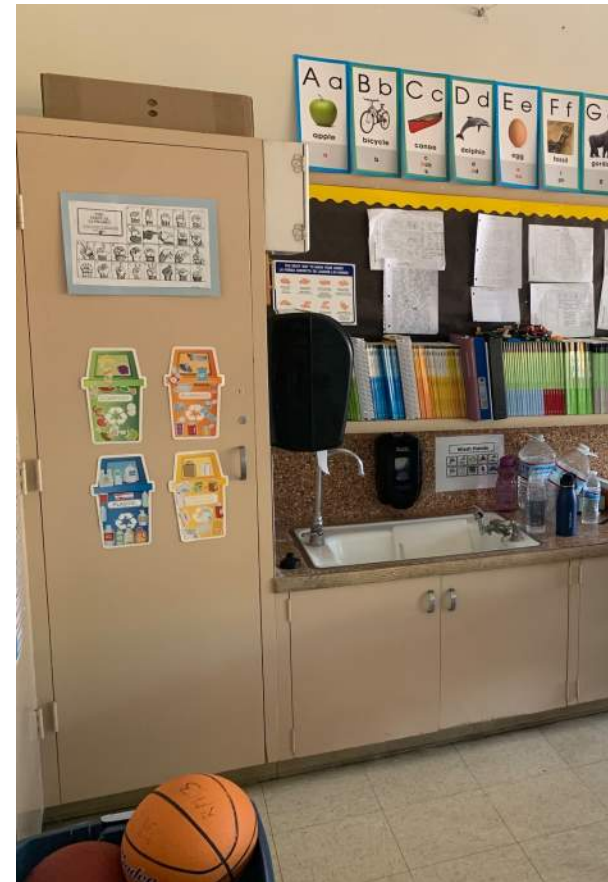
Image 2.4.2 Non-accessible sink. Taken on 04/27/2022 by Belli Architectural Group.

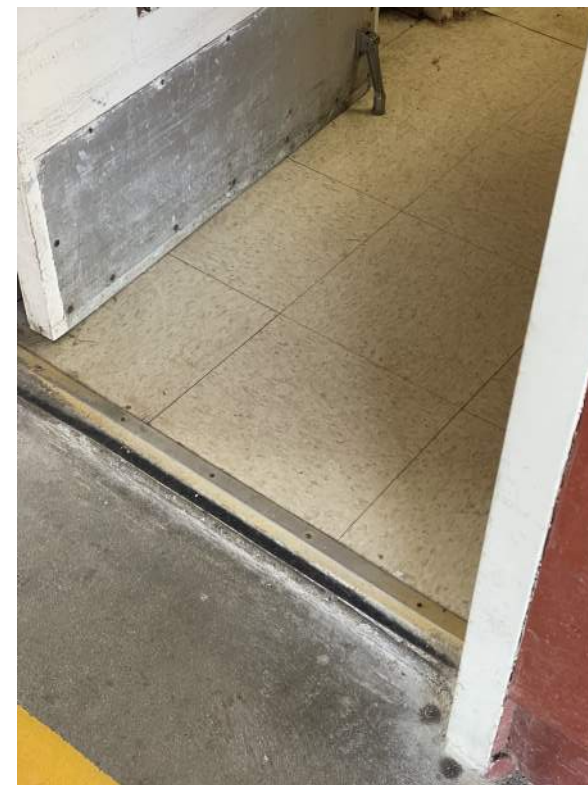
Image 2.4.3 Non-compliant threshold. Taken on 04/27/2022 by Belli Architectural Group.

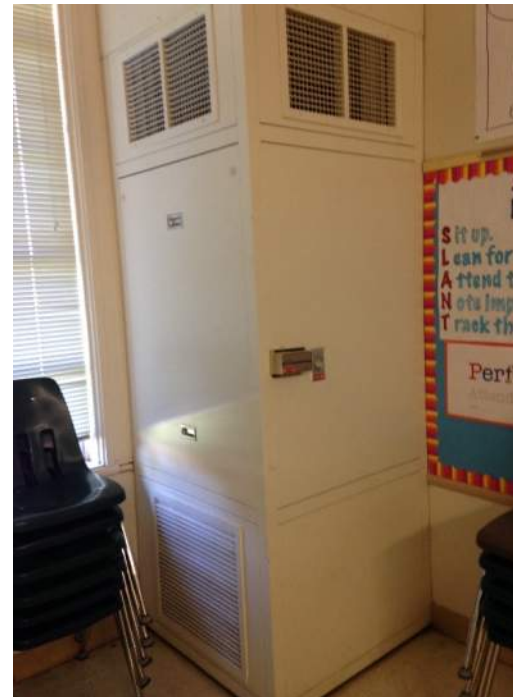
The heating system for these classrooms consist of Armstrong up-flow furnaces located inside a TEAM Mfg. metal enclosure. These were installed during the 2003 modernization. These heating systems appeared to be in fair condition and operating. The furnaces inside these enclosures are 20 years old and should be replaced. Thermostat are non-programmable and operate from a 0 to 6 hour no-hold timer.

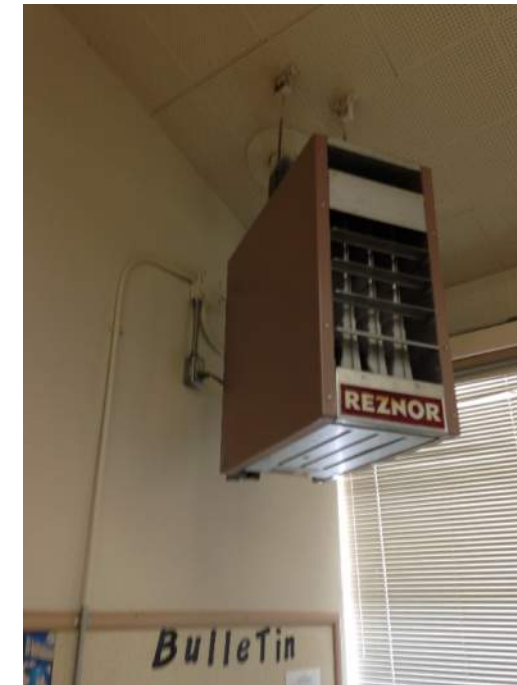
The heating system for this classroom was a suspended Reznor gas-fired unit heater. This heater should be replaced with a TEAM Mfg. enclosure and an up-flow gas-fired furnace with an outside air inlet as installed in all of the other classrooms noted above. A unit heater does not provide the code required ventilation.

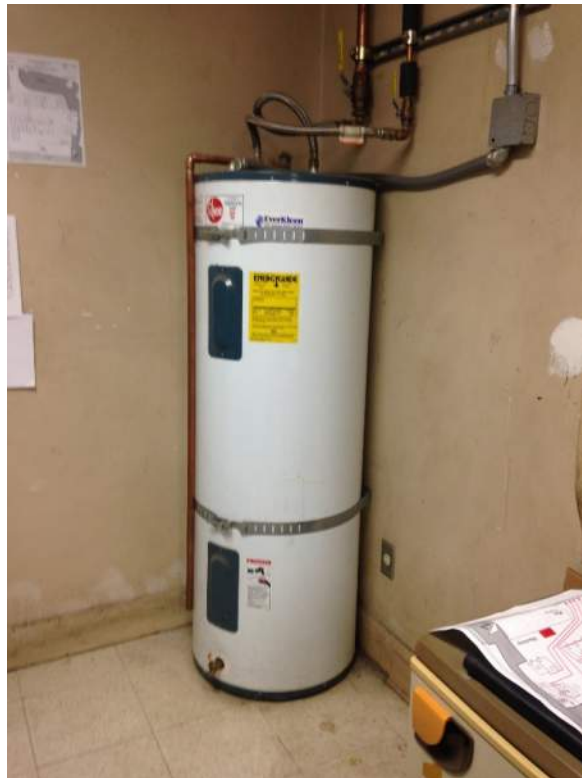
An electric tank type water heater located in the food service area has the required DSA approved seismic bracing. This water appears to be undersized for the food service equipment it serves.

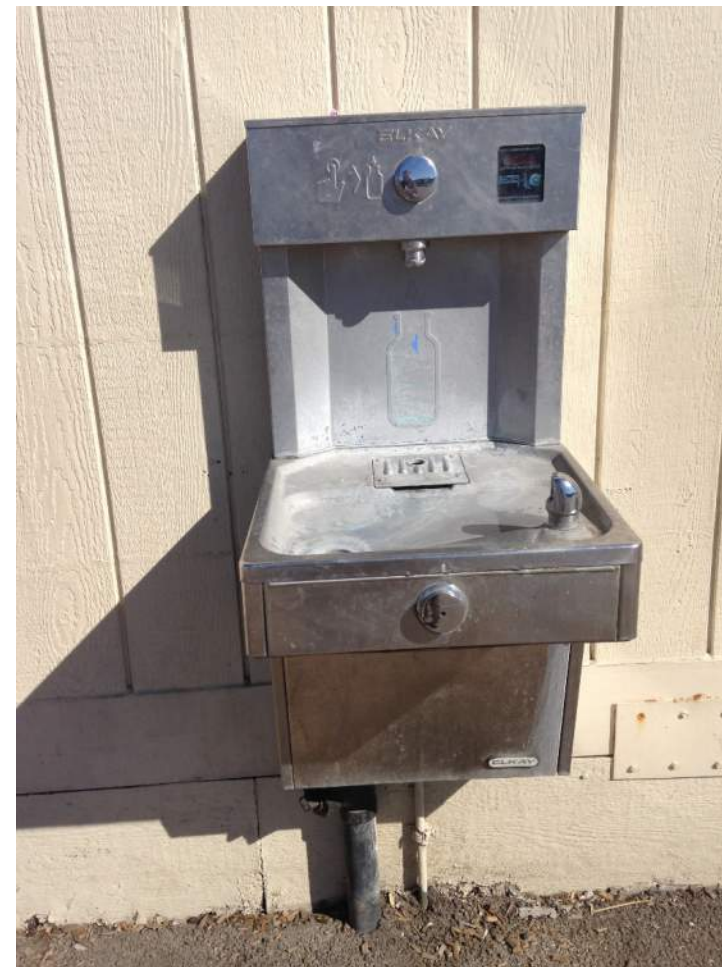
A bottle filler near Classroom 24 in need of replacement.

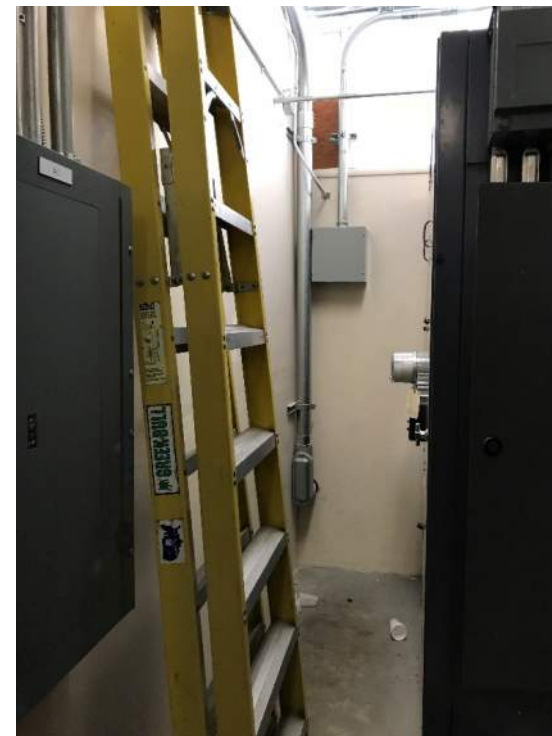
There are (2) existing main “metered” electrical service switchboards (MSB1 and MSB2). MSB1 is a 600 amp, 120/208 volt, 3 phase, NEMA 1, Square D, service located in the Administration building. MSB1 has a connection for the existing Solar PV system. The Solar PV is connected ahead of the main breaker at MSB1. MSB1 serves the Administration and Multi-Purpose building. MSB1 expected life; 10 to 15 yrs. MSB2 is an 800 amp, 120/240V, single-phase, NEMA 3R, Square D, service located on the south side of campus, outside of a modular building. The Solar PV is also connected at this switchboard. MSB2 feeds the modular classrooms located on the south and southwest of campus. MSB2 expected life; 15 to 20 yrs. The electrical services are used primarily for lighting and heating equipment, with minimal plug loads. A few of the electrical distribution system panels that are located around the site and are original to the main campus buildings when the school was built are old and manufactured by a company that no longer exists. The reliability of the system’s breakers to function correctly when necessary cannot be relied upon. It is recommended to replace the oldest panels within the classroom wings of the main campus building. Where the District plans to add HVAC to the site, the switchboards that are serving those locations may require an upgrade based on what type of system is recommended for HVAC upgrades. See attached photos MSB1 and MSB2.

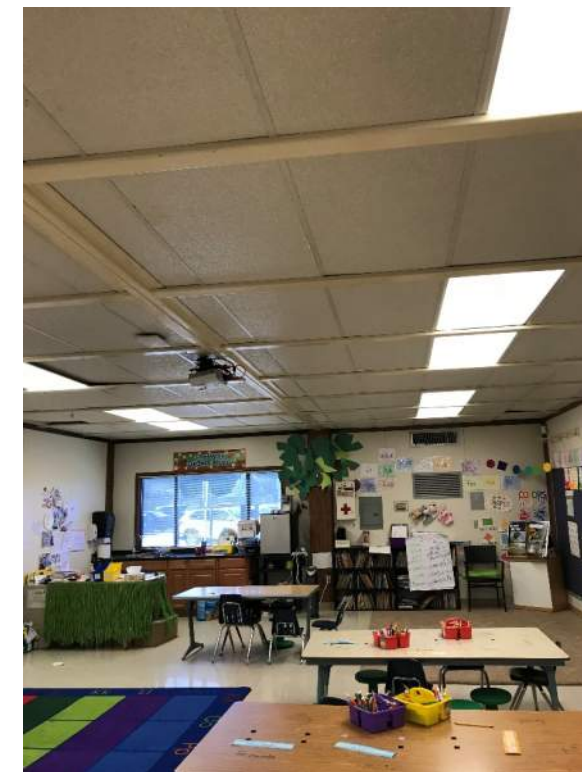
Interior Lighting is primarily LED T8 lamps in all modular buildings. The permanent buildings including the Multi-Purpose building still have old fluorescent lights. Most, if not all classrooms fluorescent lights were retrofitted with LED T8 lamps manufactured by eTech LED. The District Staff stated that these LED lamps are made in China and are no longer available. The lighting lenses/diffusers throughout the school campus are old and although there was no mention of complete failure, some light fixture housing seemed original to the spaces. Hence, the old diffusers would not provide the adequate lighting distribution. There were also several light fixtures in the classrooms that don’t work. It appears that all classrooms and large areas have energy code compliant controls such as wired and wireless occupancy sensors. Emergency lighting was not apparent at any classrooms, restrooms, or exterior landings. However, in multi-use spaces and hallways, bug-eye type stand-alone emergency light fixtures were installed. Multi-level switching/dimming necessary for energy conservation is almost non-existent. Expected life; Unknown. It is recommended to retrofit or replace campus wide lighting system with new LED technology in the near future. This would be a good opportunity for reduction in energy use from more efficient lighting fixtures, improved classroom lighting, smart lighting controls, daylight harvesting and would also reduce maintenance costs. See attached photo LTG1.

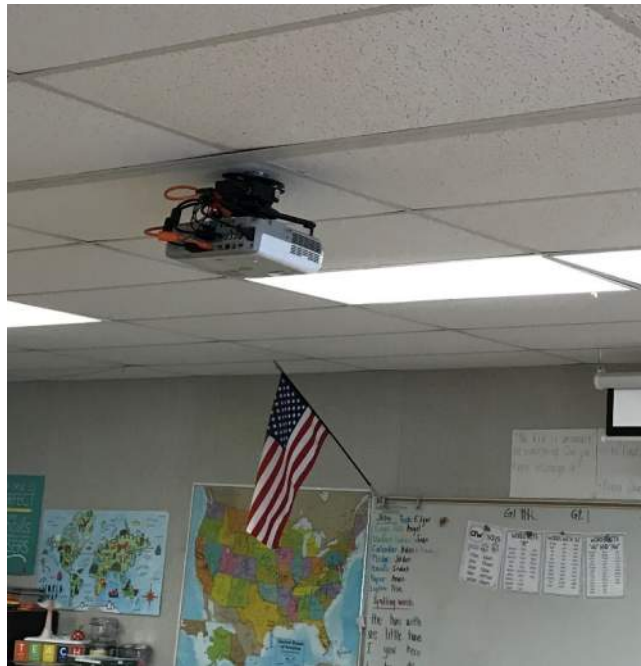
PROJECTOR.

Most of the classrooms have ceiling mounted projectors with associated AV controls located near the teacher’s station. There are no ongoing problems. However, where projectors were installed on accessible ceilings (TBAR), the associated receptacles were installed above the ceiling with cord passing through the T-BAR up to the receptacle. Current code does not allow this installation. Where classroom renovations occur, it is required to mount the receptacles exposed on the ceiling. See attached photo PROJECTOR1.
