FACILITIES NEEDS ASSESSMENT

PREPARED BY BELLI ARCHITECTURAL GROUP

1. CAMPUS INFORMATION: Natividad

Address: 1465 Modoc Ave., Salinas, CA 93906
 Year Built: 1958
 Current Principal: Jose Fausto
 Current Enrollment: 659 students

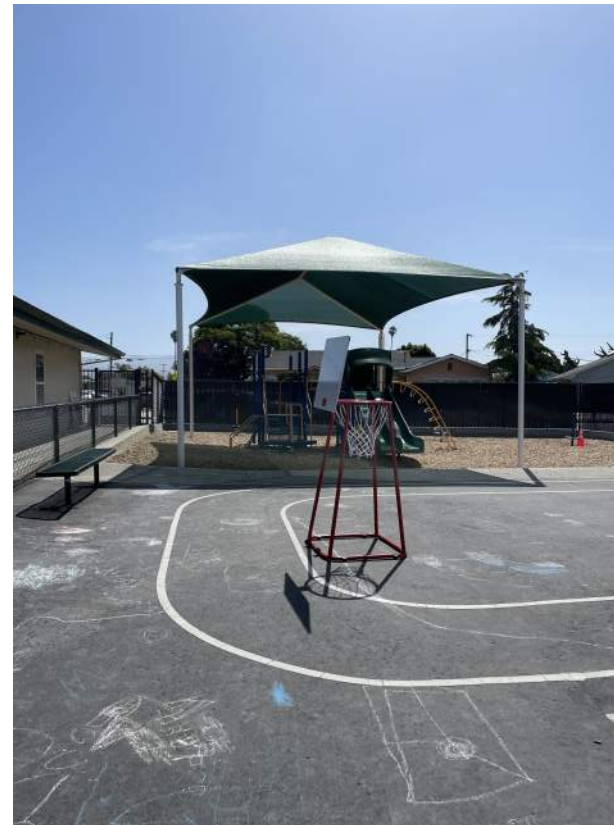
Image 2.1.2 Kindergarten playground. Taken on 05/02/2022 by Belli Architectural Group.

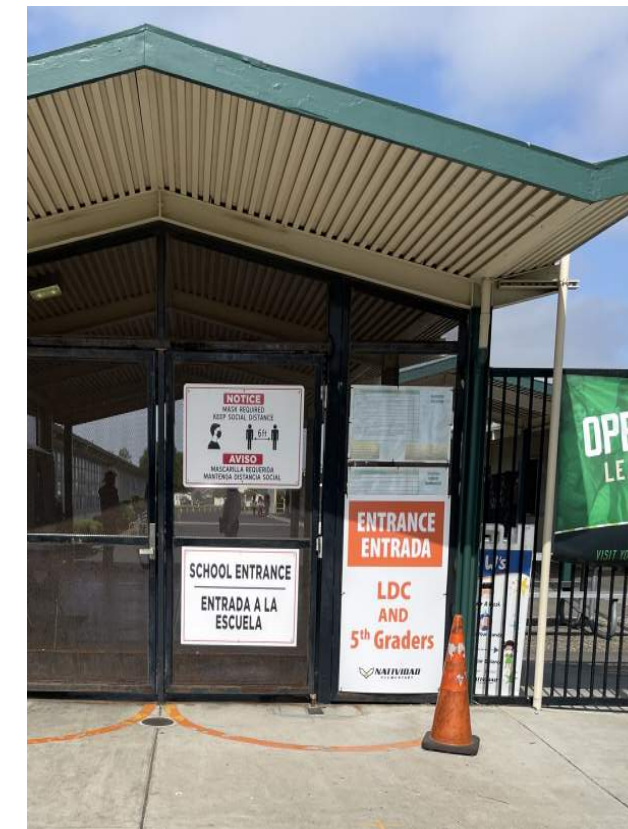
Image 2.1.4 Rust present at entrance gate. Taken on 05/02/2022 by Belli Architectural Group.

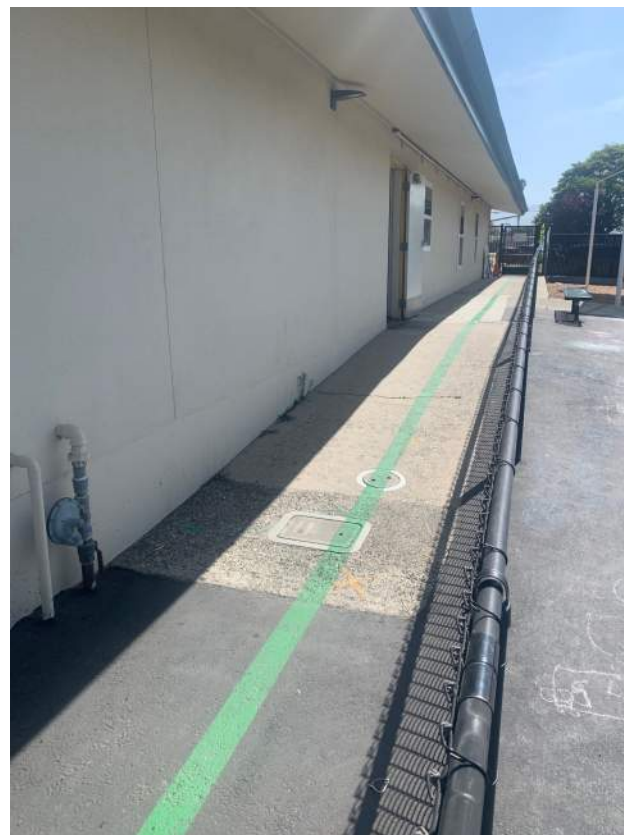
Image 2.1.1 Damaged walkways. Taken on 05/02/2022 by Belli Architectural Group.

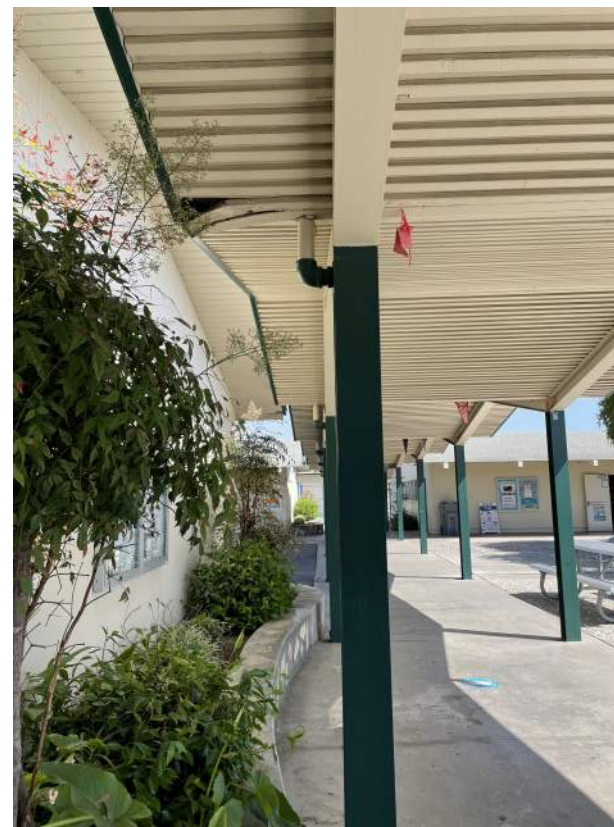
Image 2.1.3 Corridor roofing. Taken on 05/02/2022 by Belli Architectural Group.

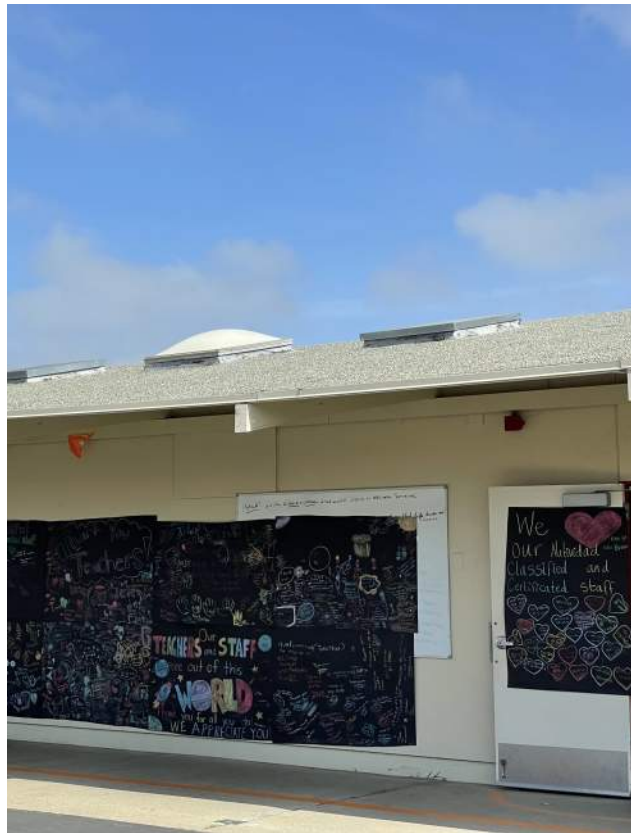
- Aging roofs in need of replacement.
- Original windows in need of replacement.
- Non-ADA compliant threshold in select locations.

Image 2.2.1 Permanent building roof. Taken on 05/02/2022 by Belli Architectural Group.

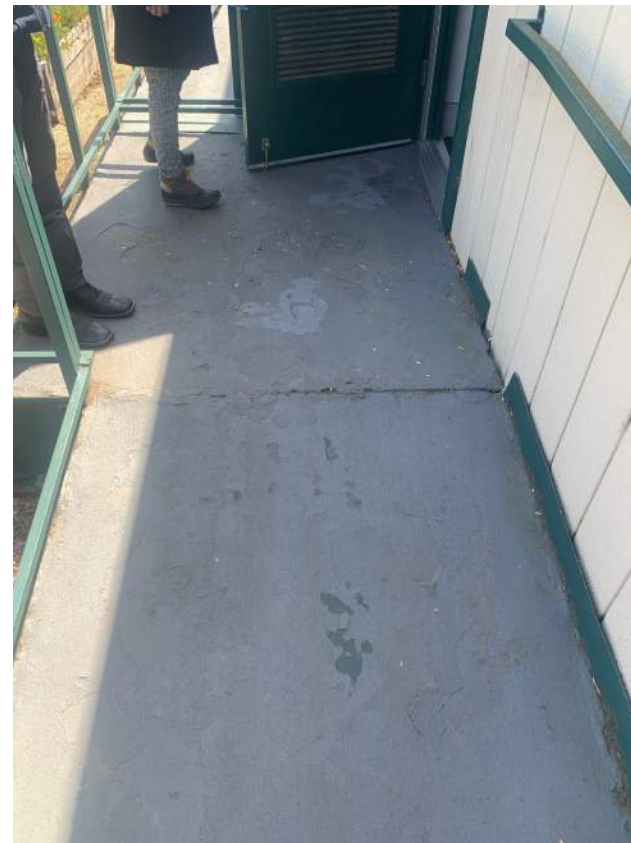
- Access ramps and steel elements present rust and rot.

Image 2.2.3 Relocatable restrooms ramps. Taken on 05/02/2022 by Belli Architectural Group.

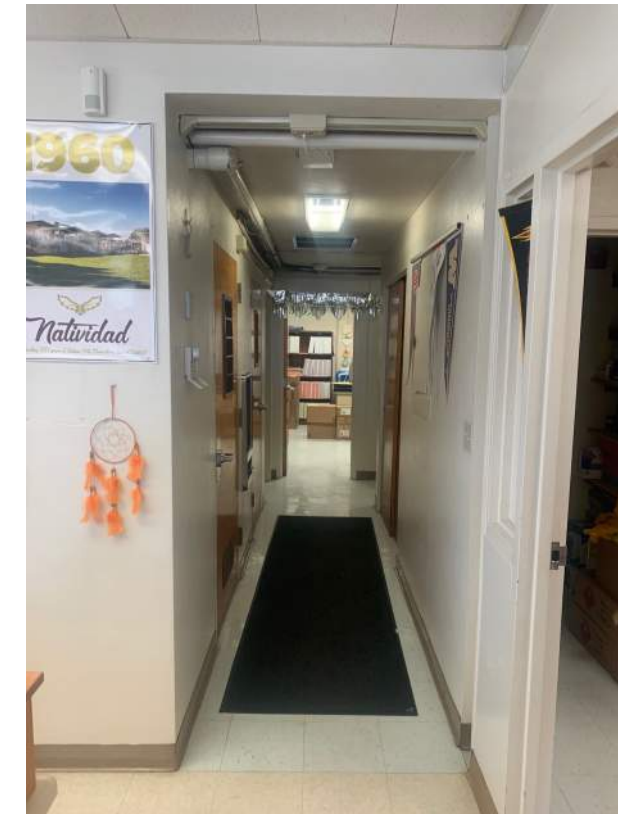
Image 2.3.1 Administrative office. Taken on 05/02/2022 by Belli Architectural Group.

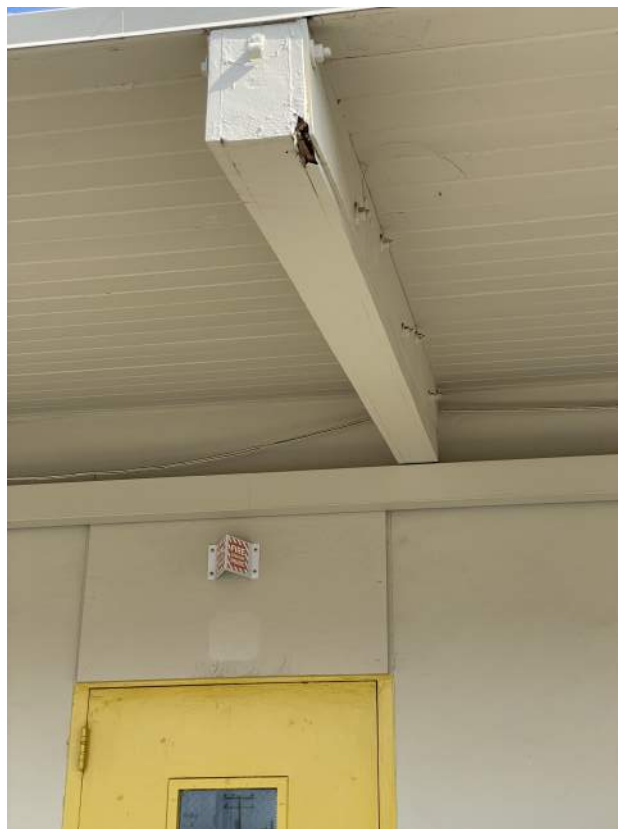
Image 2.2.2 Dry rot at eave condition. Taken on 05/02/2022 by Belli Architectural Group.

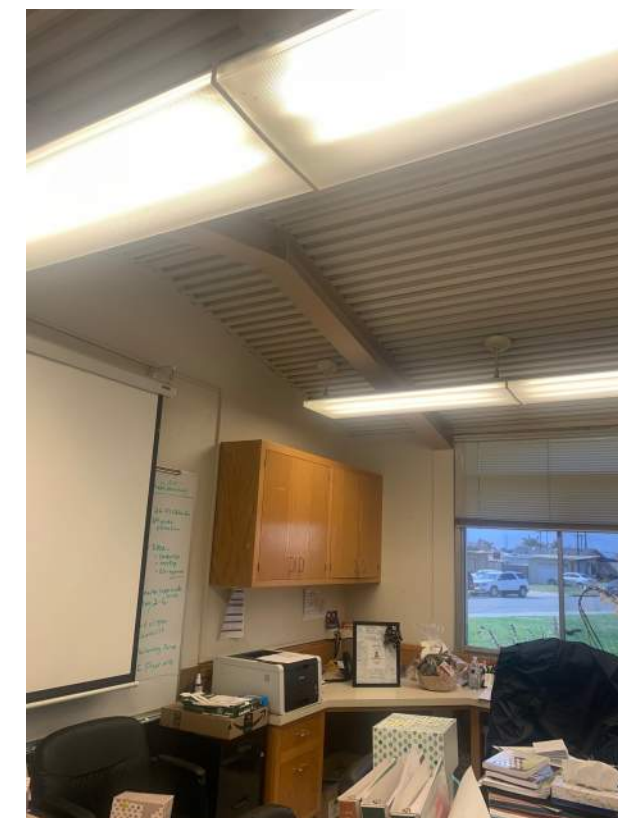
Image 2.3.2 Administrative office. Taken on 05/02/2022 by Belli Architectural Group.

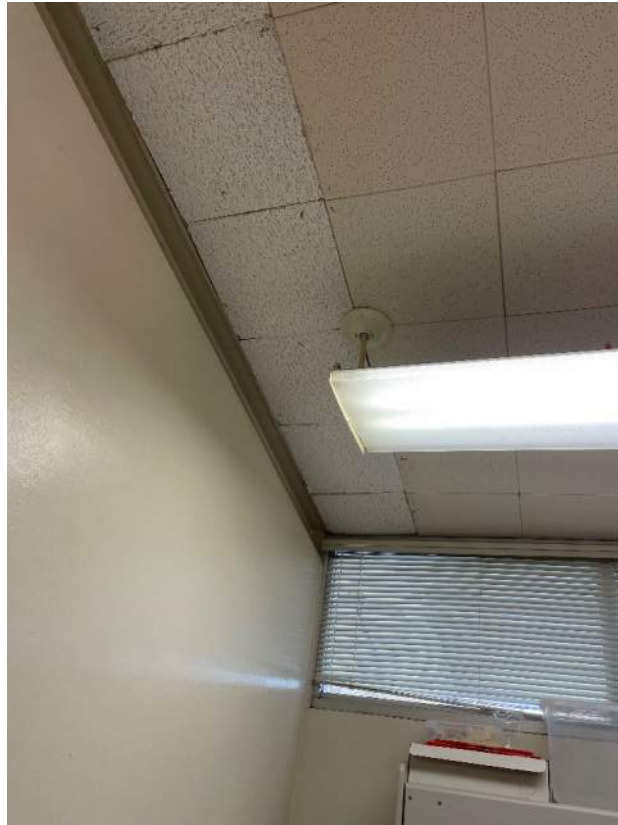
Image 2.3.3 Ceiling panels. Taken on 05/02/2022 by Belli Architectural Group.

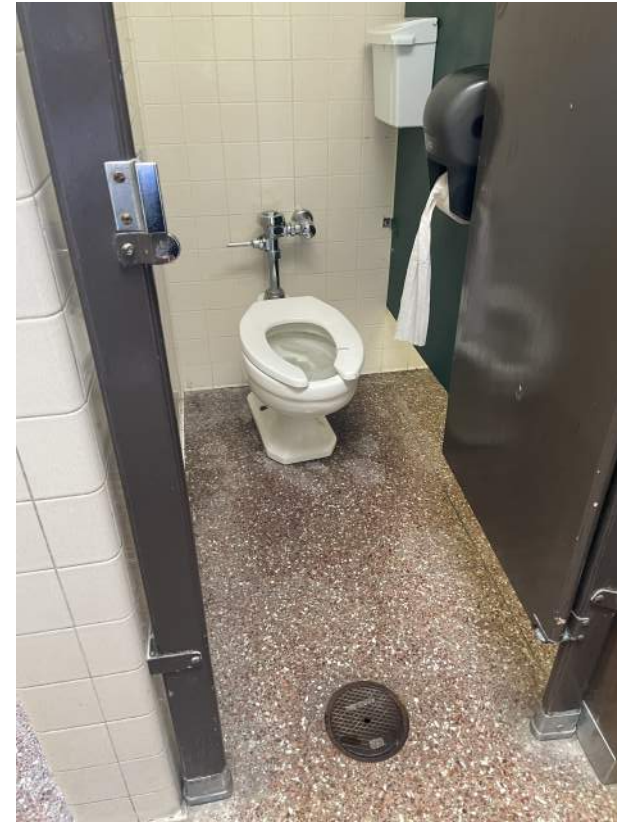
Image 2.3.5 Student restroom. Taken on 05/02/2022 by Belli Architectural Group.

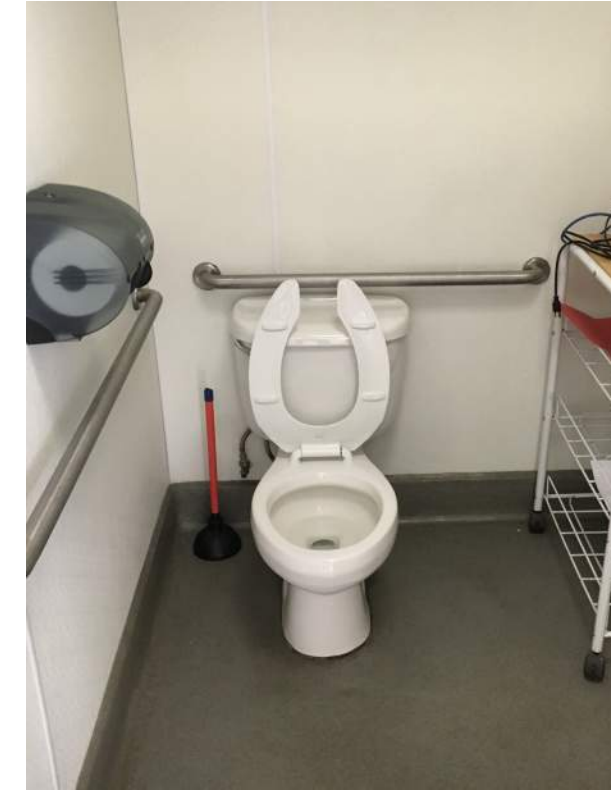
Image 2.3.7 Preschool restrooms. Taken on 05/02/2022 by Belli Architectural Group.

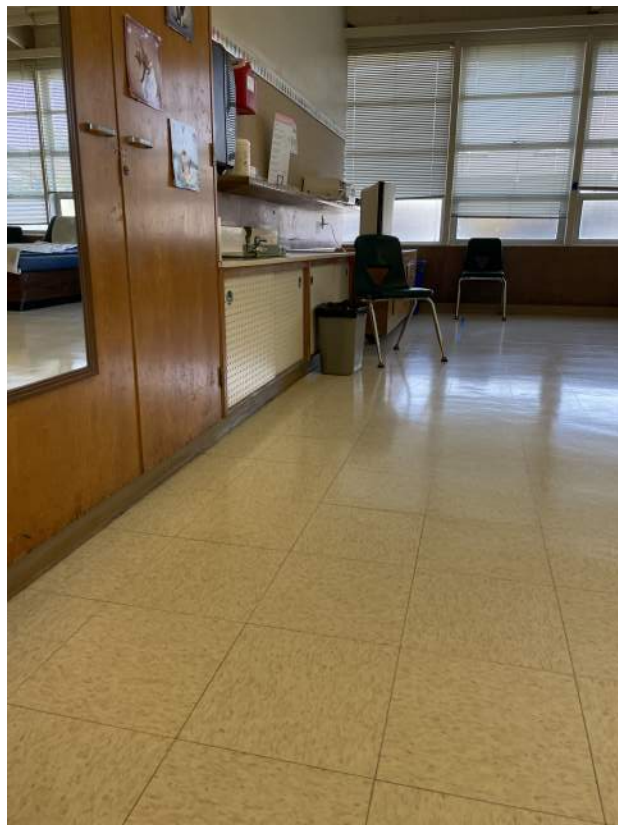
Image 2.3.4 VCT flooring and existing casework. Taken on 05/02/2022 by Belli Architectural Group.

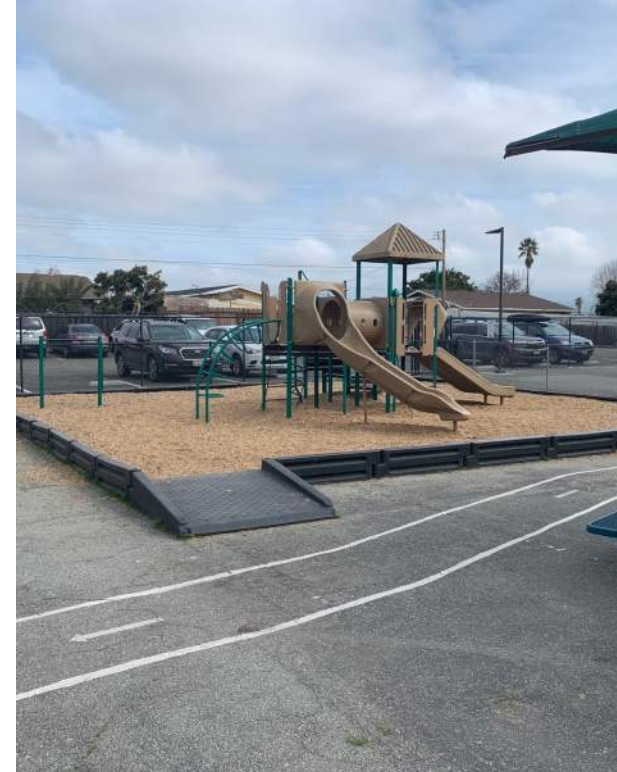
Image 2.3.6 Preschool. Taken on 05/02/2022 by Belli Architectural Group.

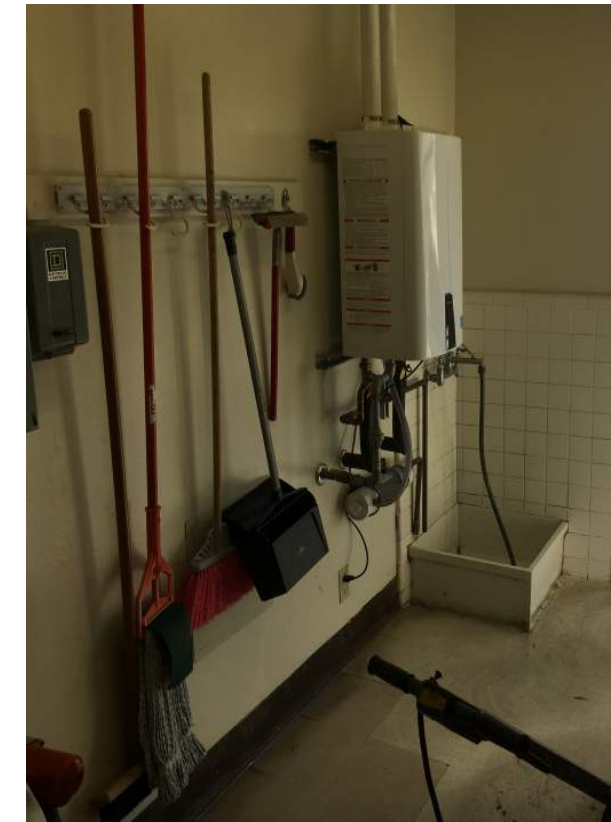
Image 2.3.8 Janitorial room. Taken on 05/02/2022 by Belli Architectural Group.

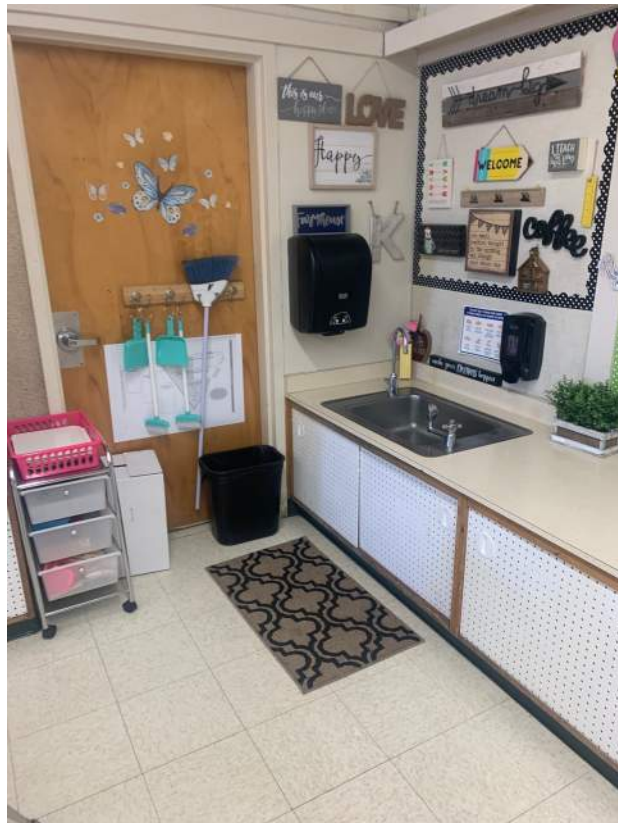
Image 2.4.1 Non-accessible classroom sink. Taken on 05/02/2022 by Belli Architectural Group.

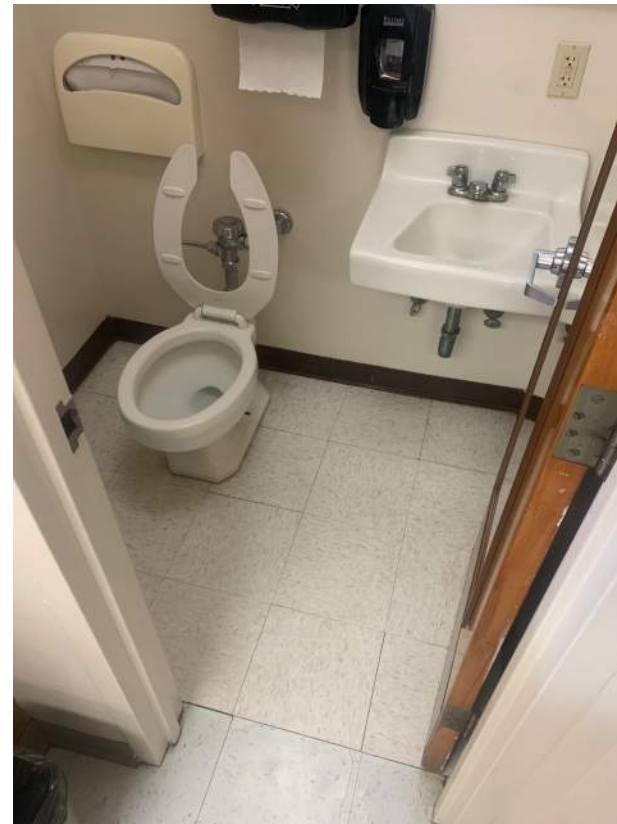
Image 2.4.2 Non-accessible staff restrooms. Taken on 05/02/2022 by Belli Architectural Group.

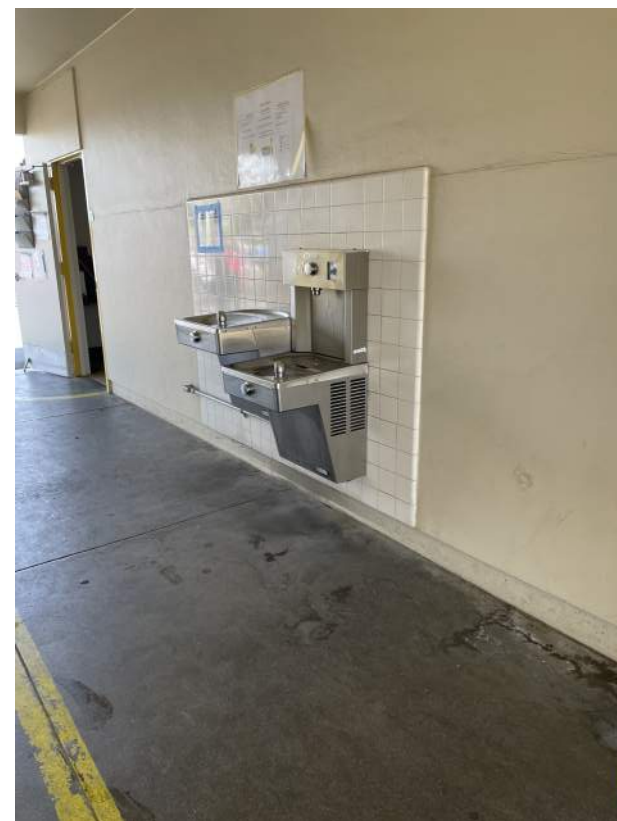
Image 2.4.3 Drinking fountain missing cane detection rails. Taken on 05/02/2022 by Belli Architectural Group.

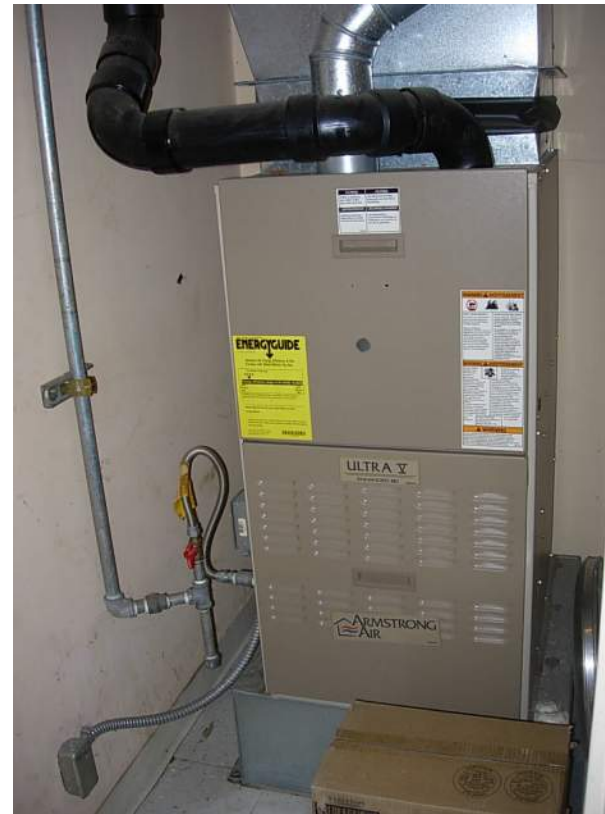
Administration Building:

The heating system for this building consisted of an Armstrong down-flow gas-fired furnace utilizing an under-slab supply air duct system with floor registers. The underfloor duct system appears to be original. The furnace was installed during the 2003 modernization. The heating system appeared to be in fair condition and operating. This furnace is 20 years old and should be replaced. The thermostat is non-programmable and operate from a 0 to 6 hour no-hold timer. Ceiling mounted exhaust fans throughout require replacing.

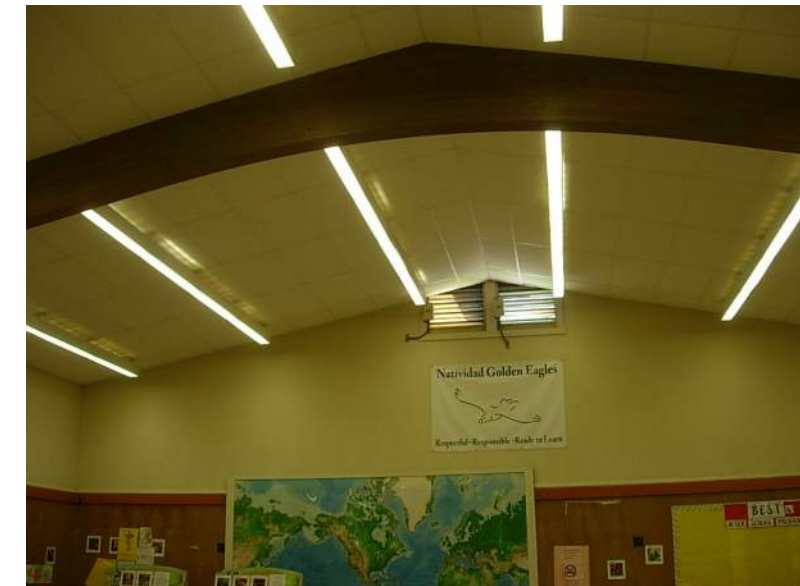
Multi-Purpose Building:

The heating system for this building consist of two gas-fired unit heaters with air handling units located on a mezzanine adjacent to the stage. One unit is original and one unit has had its heater section replaced. This equipment needs to be replaced. A motorized damper air relief vent located near the ceiling is frozen in the open position. These four (4) dampers and actuators need replacing.

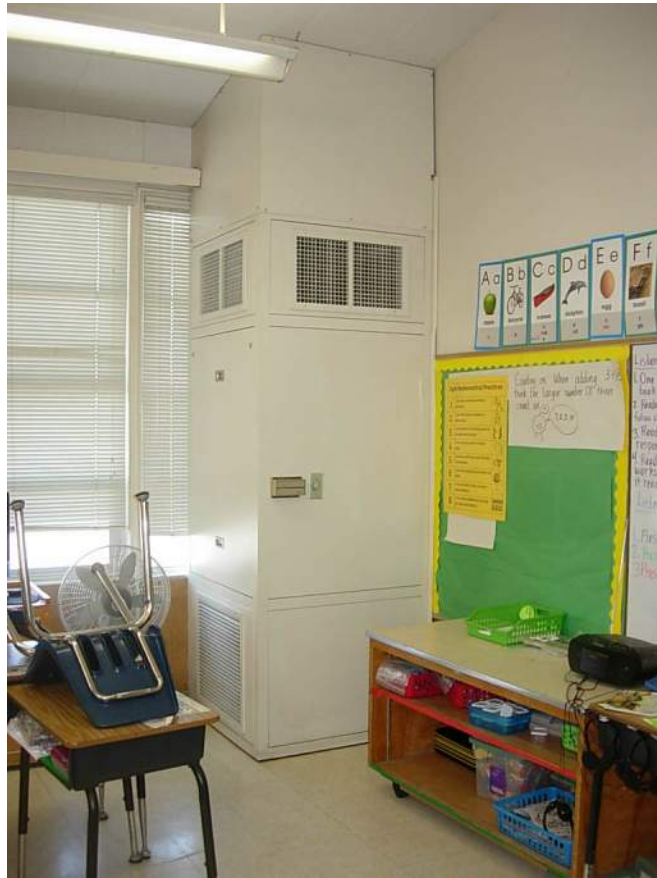
Classroom 1 thru 18 and 26:

The heating system for these classrooms consist of Armstrong up-flow furnaces located inside a TEAM Mfg. metal enclosure. These were installed during the 2003 modernization. The heating system appeared to be in fair condition and operating. These furnaces inside the enclosures are 20 years old and should be replaced. Thermostats are non-programmable and operate from a 0 to 6 hour no-hold timer.

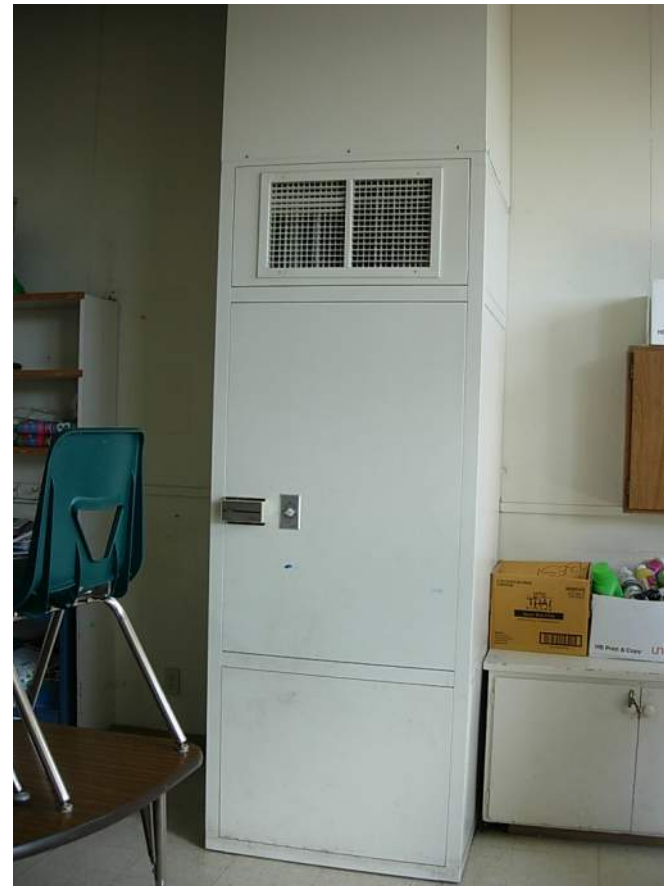
Classroom 21 thru 25:

The heating system for these classrooms consist of Armstrong up-flow furnaces located inside a TEAM Mfg. metal enclosure. These were installed during the 2003 modernization. The heating system appeared to be in fair condition and operating. These furnaces are 20 years old and should be replaced. Thermostats are non-programmable and operate from a 0 to 6 hour no-hold timer.

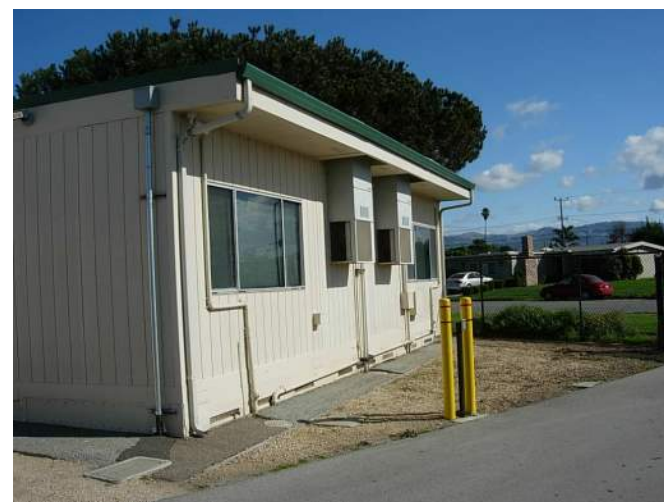
Classroom 27 thru 42:

These are portable classroom consisting of the exterior wall mounted “Bard” type heat pump units. The photo below is Classroom 37 and 38. All portables utilize this type of equipment. These units throughout the campus appear to be original and are operating. Units more than 20 years old should be replaced.

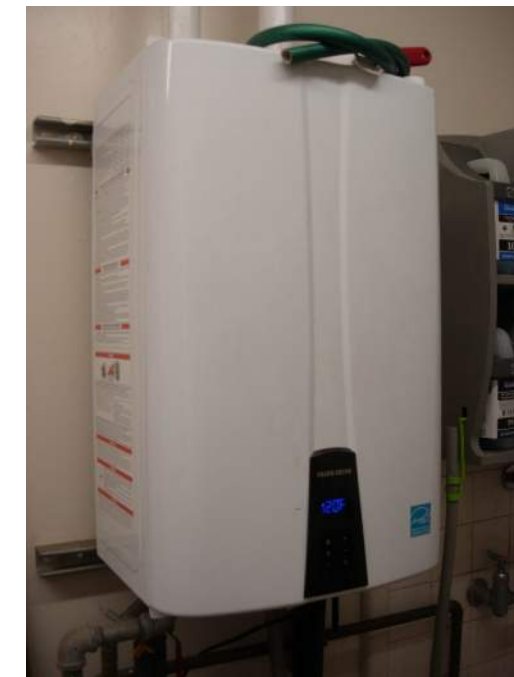
Multi-Purpose Building:

A recent kitchen improvement project replaced the kitchen sinks and added a new tank-less gas-fired water heater to serve the kitchen. A new bottle filling/drinking fountain was also installed. The Boys and Girls restroom were remodeled to meet ADA.

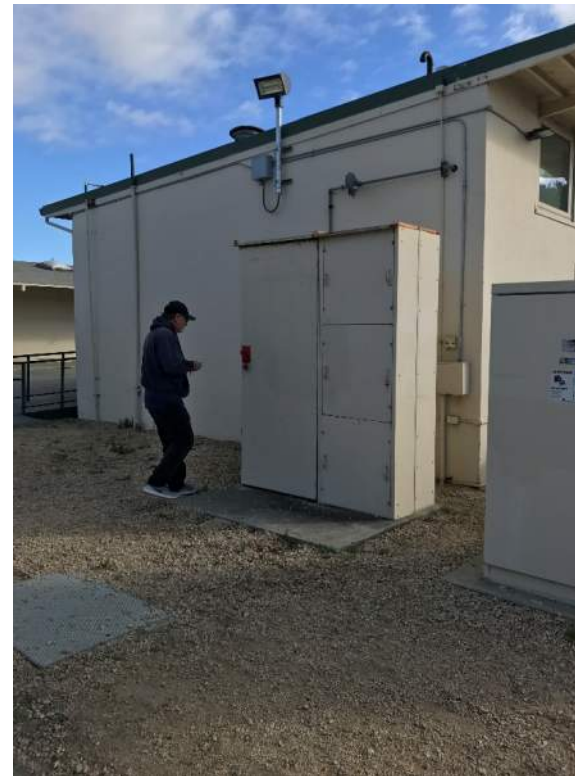
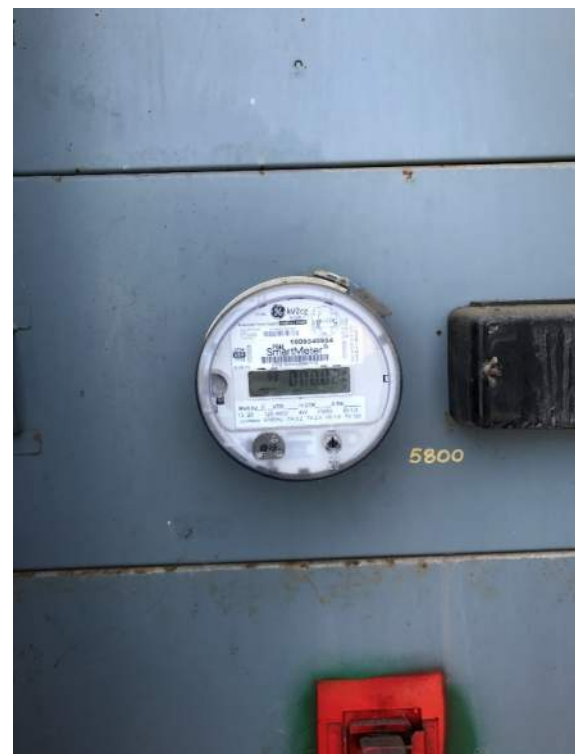
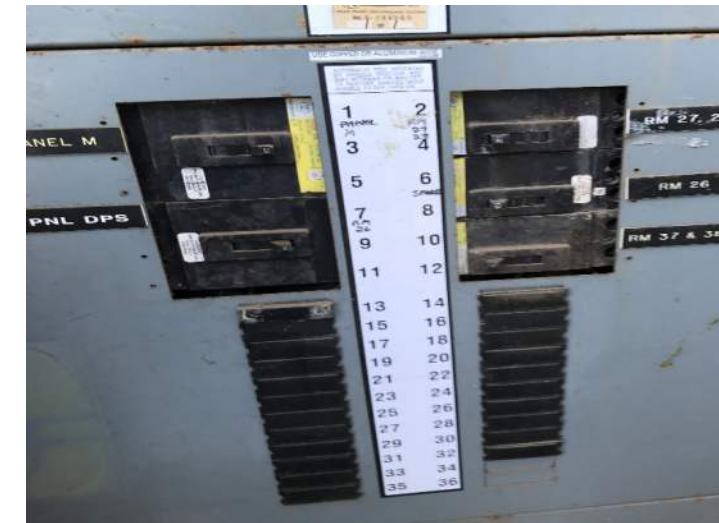
There are (3) existing main “metered” electrical service switchboards (MSB1, MSSB2 and MSB3). MSB1 is a 350 amp, 120/208 volt, 3 phase, NEMA 1 service located in the central wing between Classrooms #9 and #10 in a storage room. MSB1 has a connection for the existing Solar PV system on site and this Solar PV System is connected to MSB1 through a step-down voltage transformer (steps down 480V Solar PV system to 208V electrical distribution system) just outside the storage room where MSB1 is located. The Solar PV is then connected ahead of the main breaker at MSB1. MSB1 serves in large part, the center of campus: Wing #5, Wing #6, Wing #8, Wing #1 & Wing #2. MSB2 is a 600 amp, 120/208V, 3-phase, NEMA 3R service located on the south side of the campus adjacent to modular buildings Wing #4. MSB2 serves all of wing #4 and Wing #9 on the west side of the campus. MSB3 is a 600 amp, 120/240V, 1-phase, NEMA 3R service located on the north side of campus adjacent to Wing #3 near the parking lot. MSB3 serves the string of (4) portables at Wing #3. The electrical switchboards and campus wide electrical distribution system appears to be the original equipment installed when the school was built and the additional electrical services were added as buildings/modulars were added to the site. MSB1 expected life; minimal and should be replaced as upgrades/remodels to classroom buildings occur. MSB2 expected life; 5 yrs. MSB3 expected life; 5-10 yrs. The electrical services are used primarily for lighting and heating equipment, with minimal plug loads. Some of the electrical distribution system panels that are located around the site and are original to the buildings when the school was built, are old and manufactured by a company that no longer exists. The reliability of the system’s breakers to function correctly when necessary cannot be relied upon. It is recommended to retrofit the electrical switchboards and campus wide electrical service in the future. Where the District plans to add HVAC to the site, the switchboards that are serving those locations will require an upgrade. The service upgrade should be larger if the district has plans for additional buildings or renovations of the existing buildings with added loads for HVAC upgrades and added computer loads. See attached photos MSB1, MSB2 & MSB3.

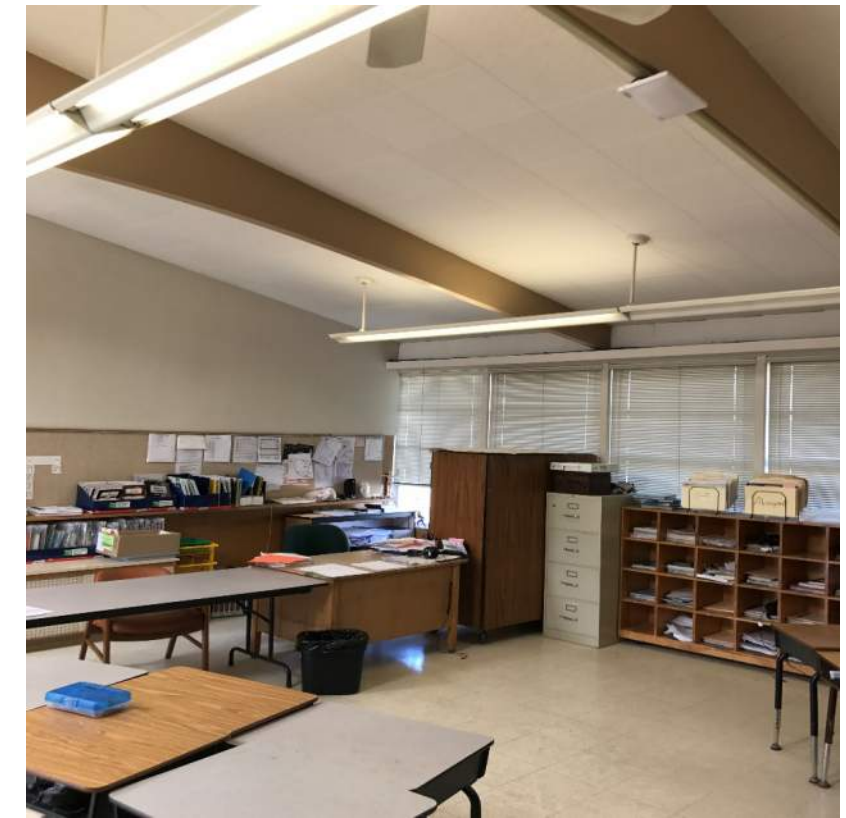
Interior Lighting is primarily fluorescent with T8 or T12 lamps at interior spaces. Most if not all the lighting throughout the school campus is old and although there was no mention of complete failure, some light fixtures seemed original to the spaces, so they are likely near their “end of life”, especially with regards to efficiency. Emergency lighting was not apparent at any classrooms, restrooms, exterior landings. However, in multi-use spaces, bug-eye type stand-alone emergency light fixtures were installed. Occupant sensors and multilevel switching necessary for energy conservation is almost non-existent. Expected life; Unknown. It is recommended to retrofit campus wide lighting system in the near future. This would be a good opportunity for reduction in energy use from more efficient lighting fixtures, improved classroom lighting, smart lighting controls and reduced maintenance. See attached photo LTG1.
