FACILITIES NEEDS ASSESSMENT

ROOSEVELT

PREPARED BY BELLI ARCHITECTURAL GROUP

2022

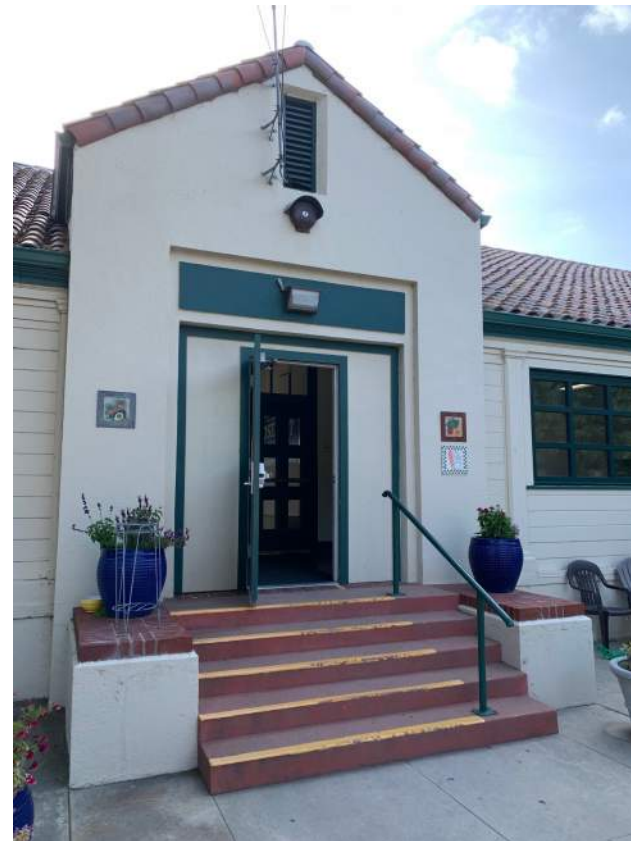
Image 2.1.2 No access ramp at courtyard. Taken on 04/27/2022 by Belli Architectural Group.

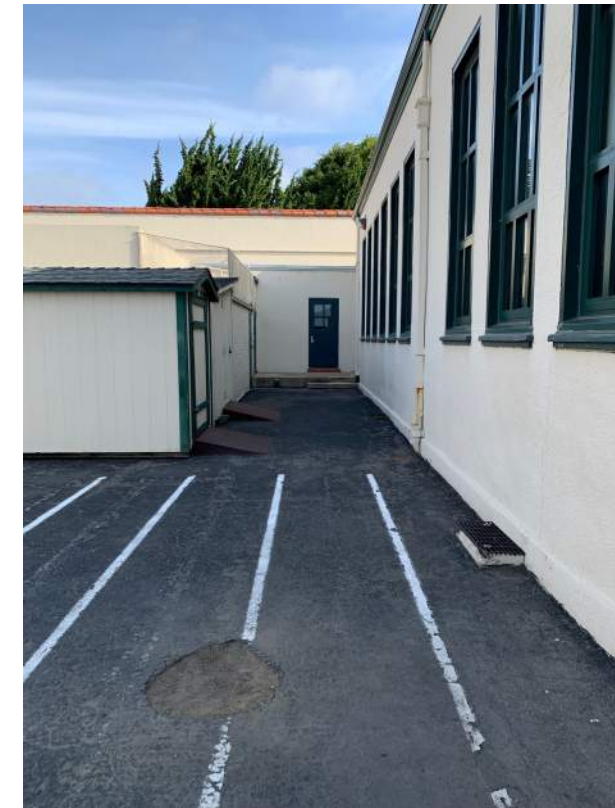
Image 2.1.4 Uneven asphalt surfaces. Taken on 04/27/2022 by Belli Architectural Group.

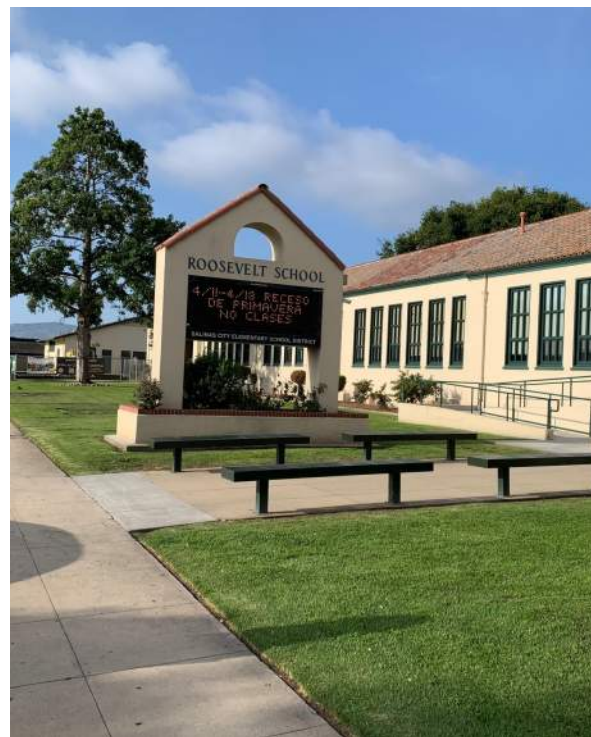
Image 2.1.1 No bus drop. Taken on 04/27/2022 by Belli Architectural Group.

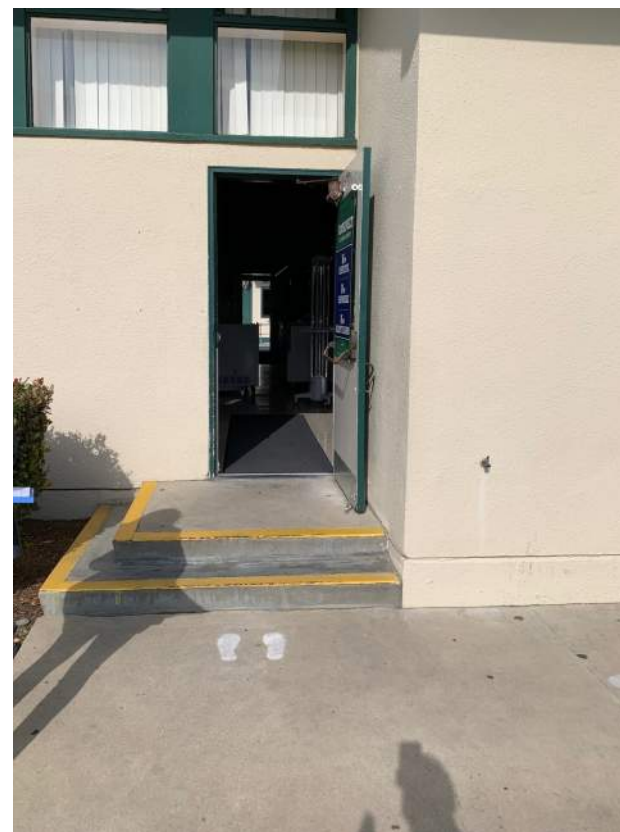
Image 2.1.3 Non-accessible entrance and unlocked door from MPR to street. Taken on 04/27/2022 by Belli Architectural Group.

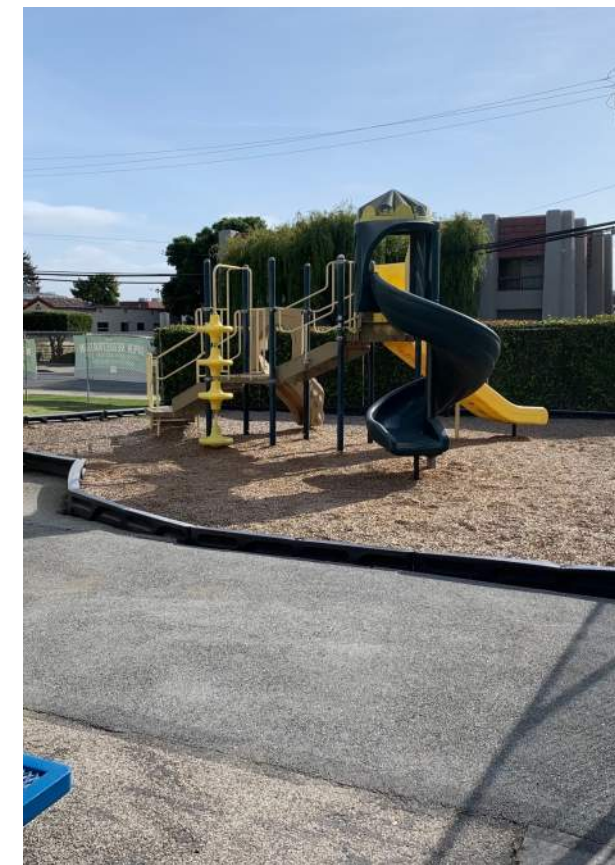
Image 2.1.5 Non-accessible Kindergarten playground. Taken on 04/27/2022 by Belli Architectural Group.

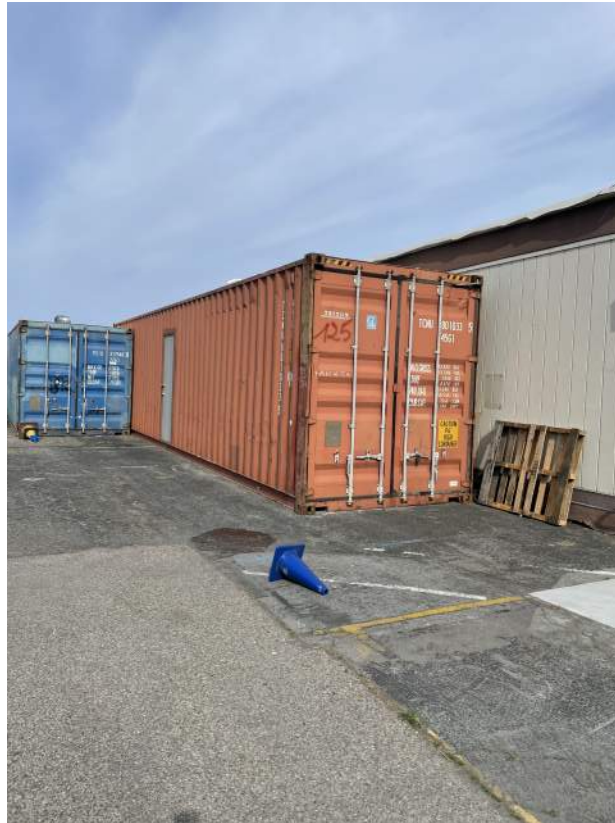
Image 2.1.6 Containers next to classrooms. Taken on 04/27/2022 by Belli Architectural Group.

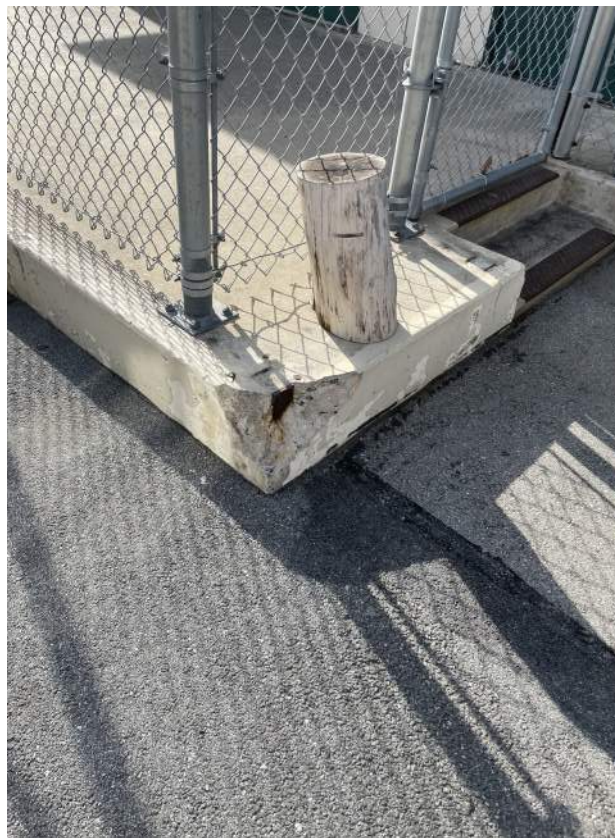
Image 2.1.6 Spalling at curb. Taken on 04/27/2022 by Belli Architectural Group.

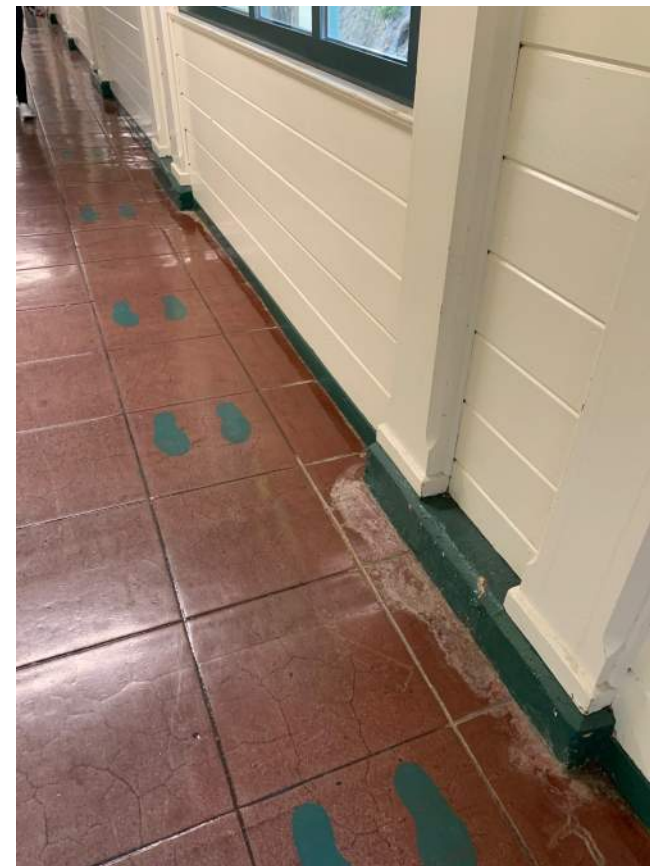
Image 2.2.1 Water intrusion in hallway. Taken on 04/27/2022 by Belli Architectural Group.

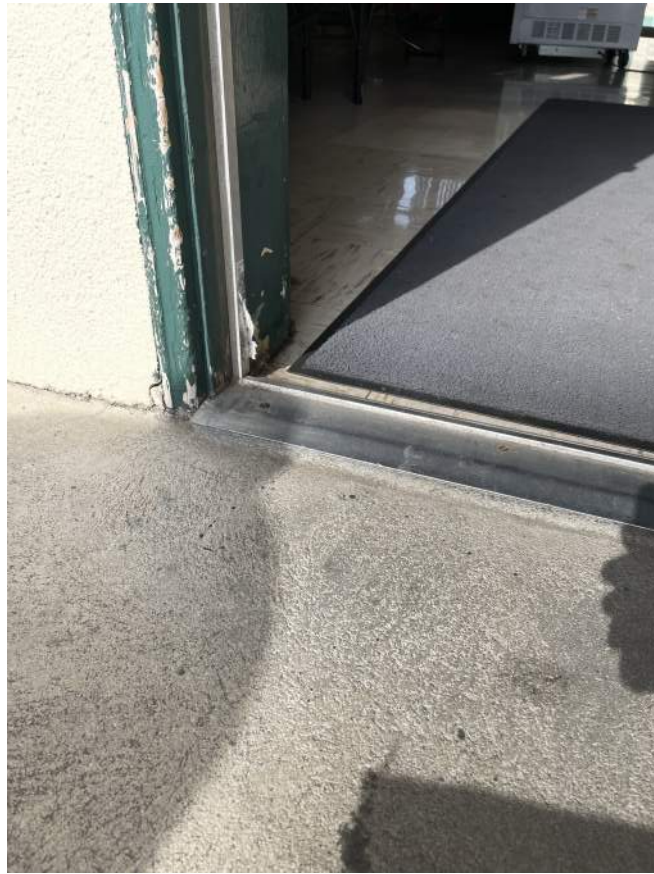
Image 2.2.4 Damaged door frames. Taken on 04/27/2022 by Belli Architectural Group.

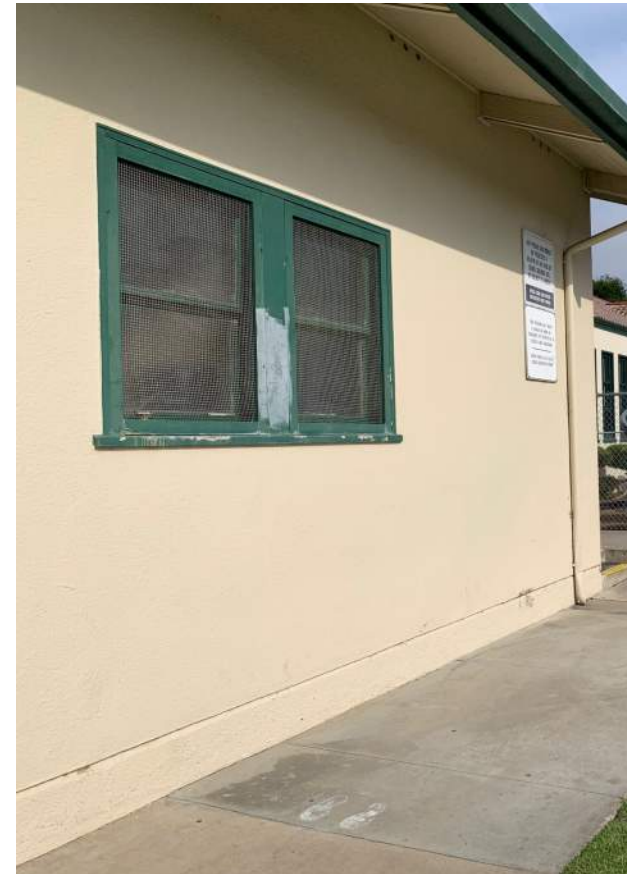
Image 2.2.5 Damaged windows. Taken on 04/27/2022 by Belli Architectural Group.

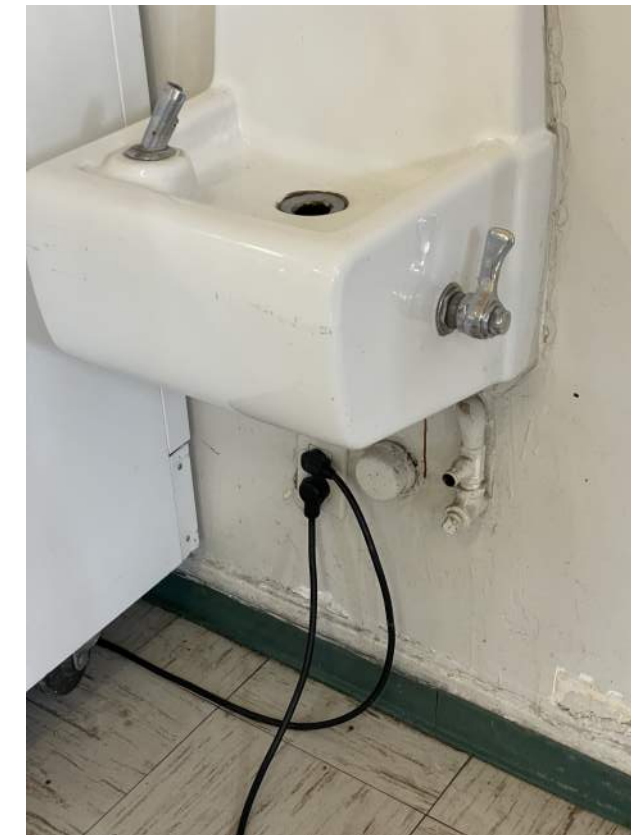
Image 2.3.3 Outlets under drinking fountain. Taken on 04/27/2022 by Belli Architectural Group.

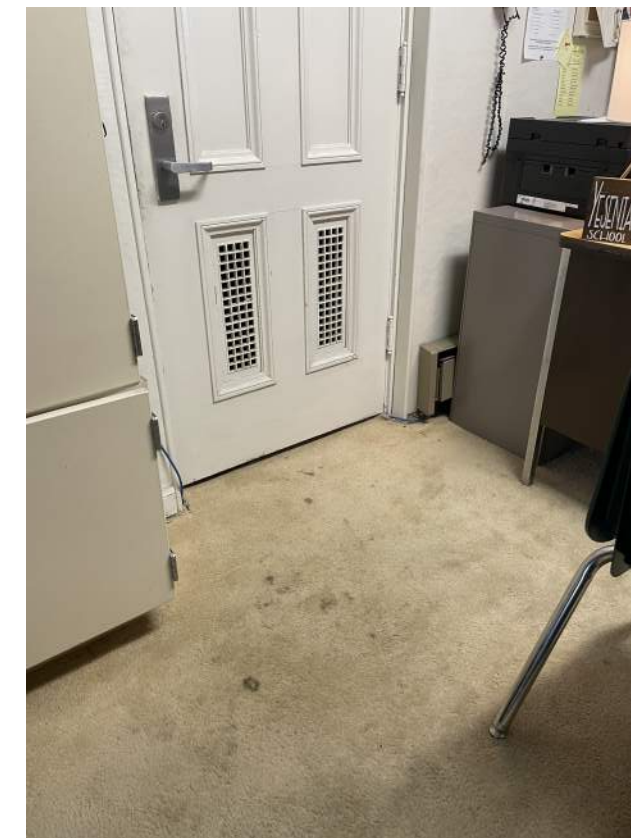
Image 2.3.4 Old carpet. Taken on 04/27/2022 by Belli Architectural Group.

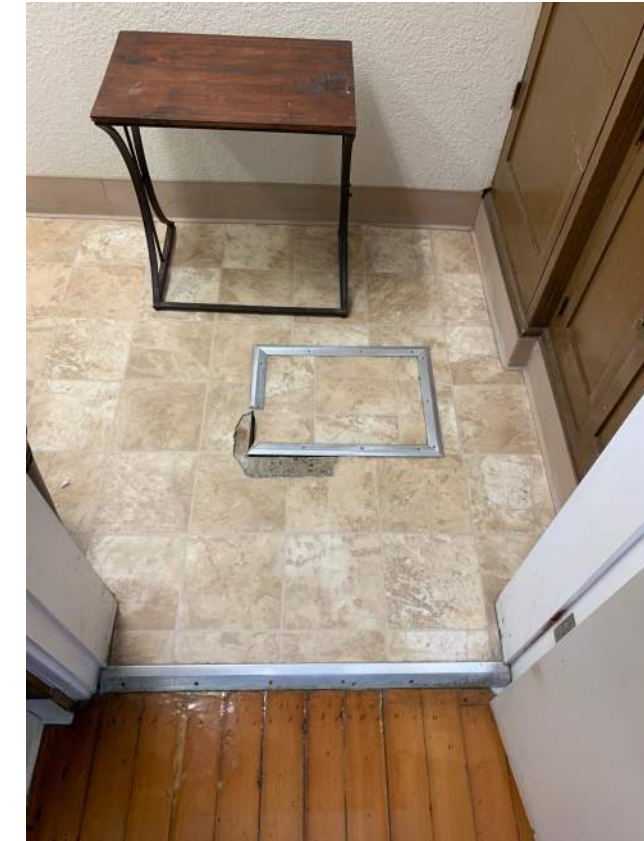
Image 2.3.9 Patched sheet vinyl flooring. Taken on 04/27/2022 by Belli Architectural Group.

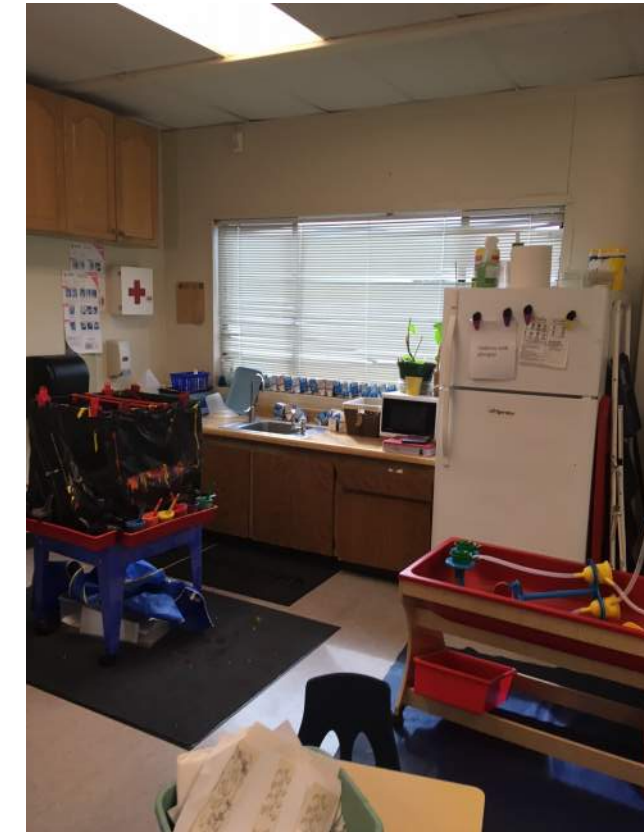
Image 2.3.10 Preschool. Non-compliant sink. Taken on 04/27/2022 by Belli Architectural Group.

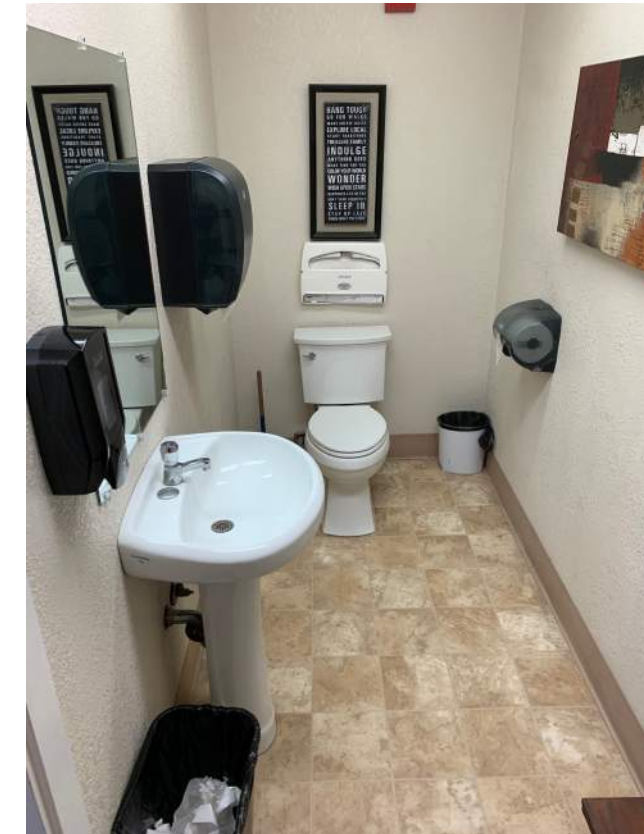
Image 2.4.4 Small, non-accessible single occupancy restroom. Taken on 04/27/2022 by Belli Architectural Group.

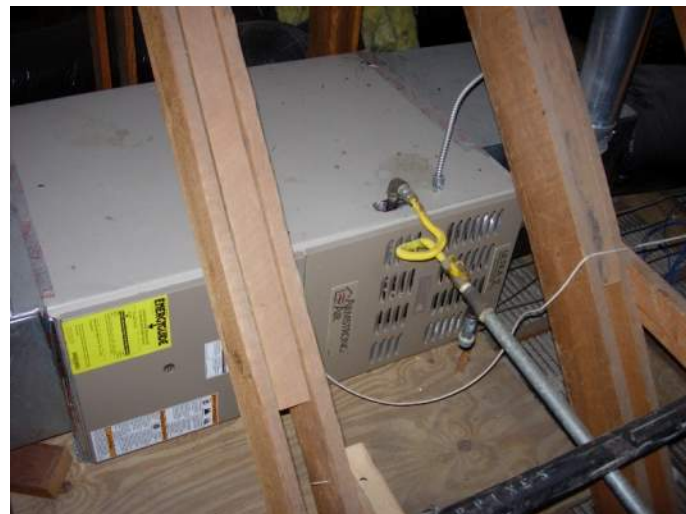
The heating system for the Administration and adjacent Teacher’s Lounge consist of a single (one) Armstrong horizontal gas-fired furnace located in the attic above. The furnace was installed during the 2003 modernization and appears to be fair condition and operating. These furnaces are 20 years old and should be replaced. The Boys and Girls Toilet Rooms adjacent to Room 1B do not have any exhaust fans. These rooms have screened openings in the ceiling to the attic. New exhaust fans should be installed here to ventilate these rooms.

The heating system for these two (2) rooms consist of a single (one) Armstrong horizontal gas-fired furnace located in the attic above. The furnace was installed during the 2003 modernization and appears to be fair condition and operating. See the photo above. These furnaces are 20 years old and should be replaced.

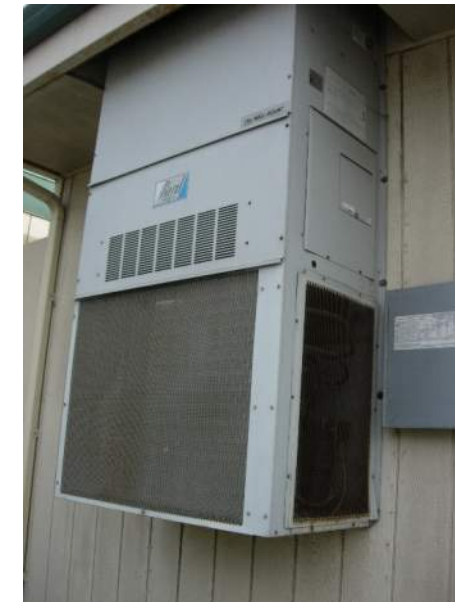
These are portable classroom consisting of the exterior wall mounted “Bard” type heat pump units. All portables utilize this type of equipment. These units throughout the campus appear to be from the 2002 modernization and are operating satisfactory. Older (20 years) units should be replaced with new units.

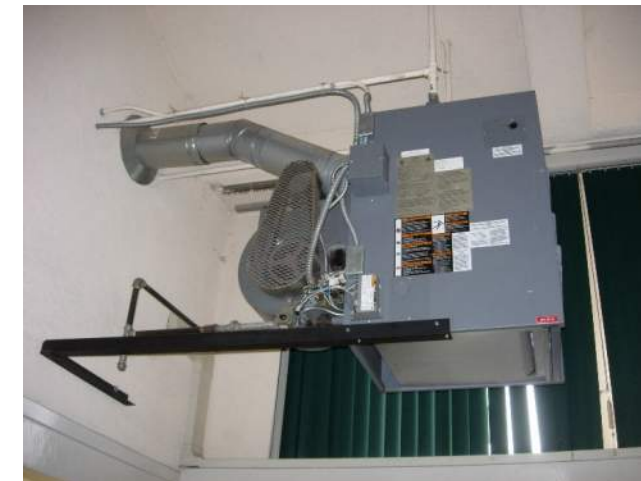
The heating system for the Multi-Purpose room is with two (2) suspended Sterling gas-fired unit heaters. These appear to be from the 2003 modernization and are in fair condition and operating. These heaters should be replaced.

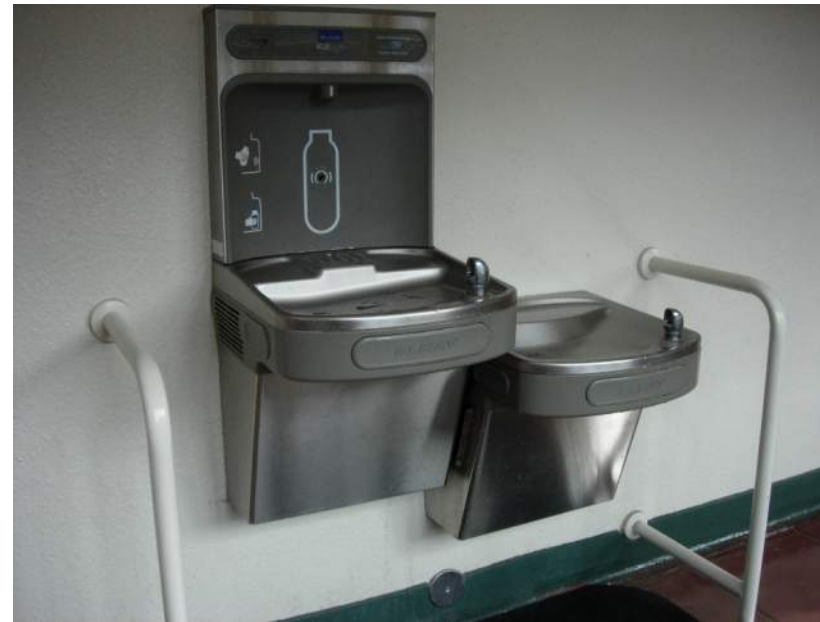
A 1940's era drinking fountain in the main building.

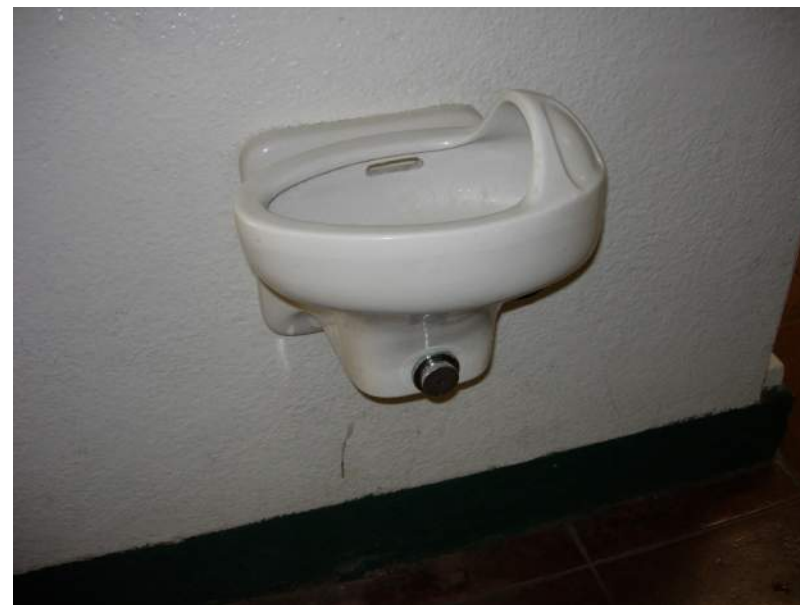
A typical wall mounted drinking fountain that does not meet ADA and should be replaced.

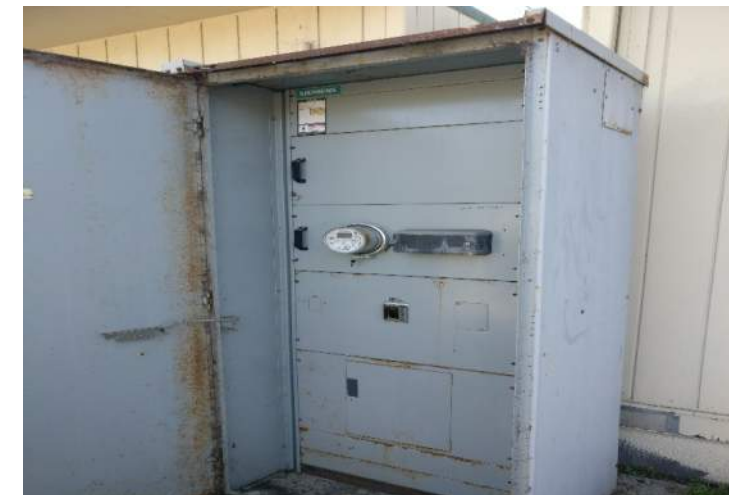
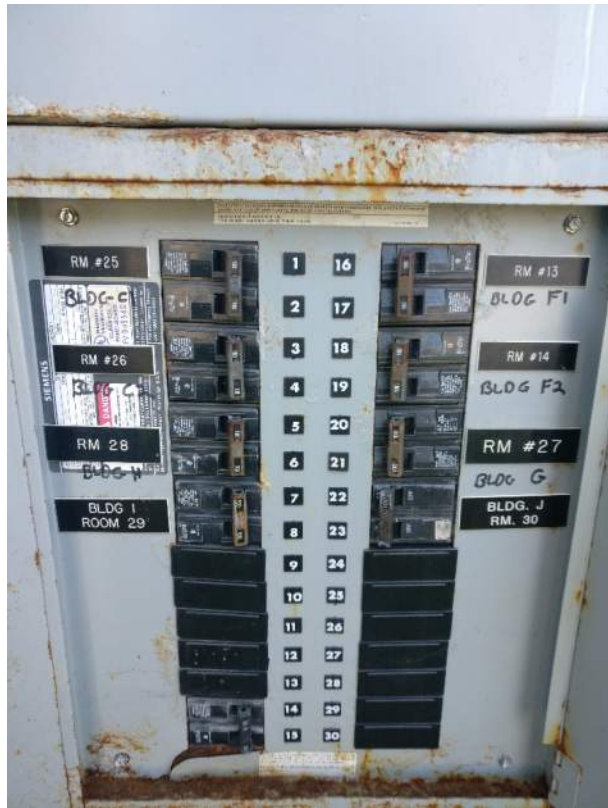
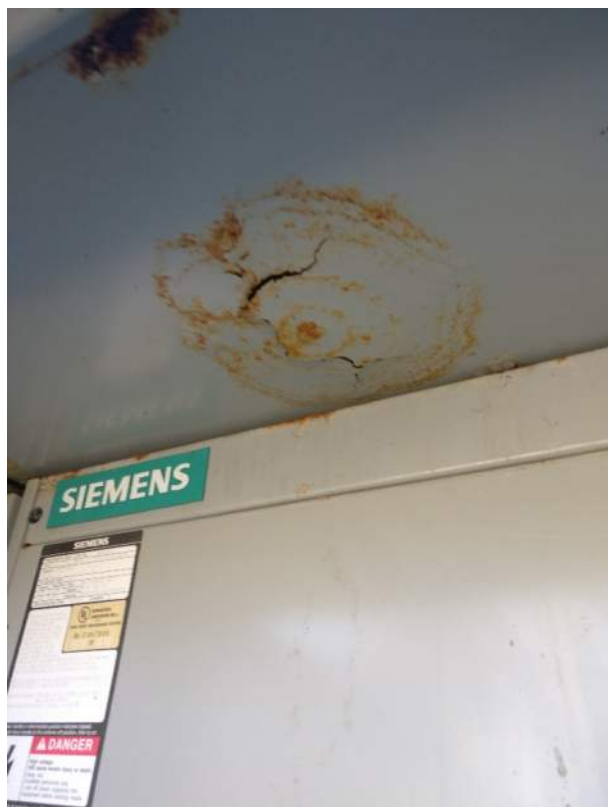
MSB3.

The school electrical infrastructure is in fair condition for existing needs except for MSB3 which will need repair/replacement in the near future.
