# FACILITIES NEEDS ASSESSMENT

SHERWOOD

PREPARED BY BELLI ARCHITECTURAL GROUP

2022

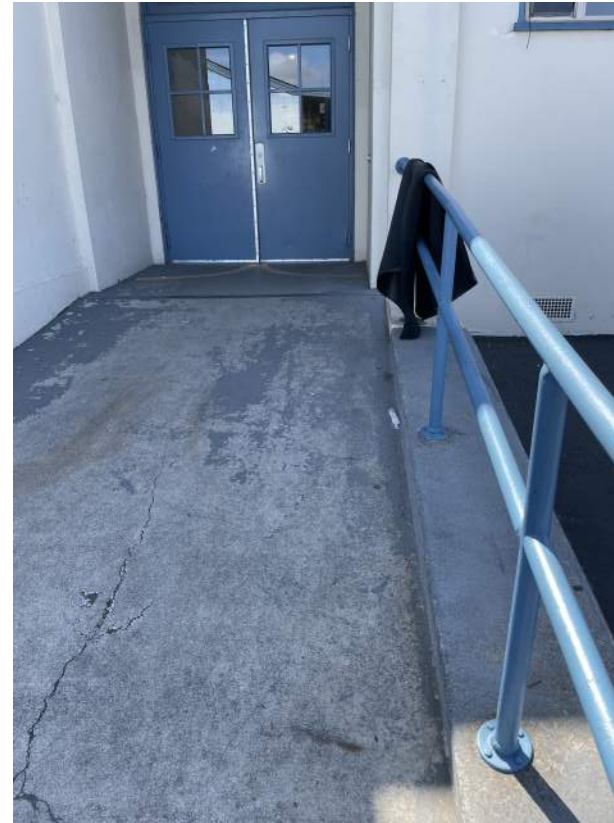
Image 2.1.3 Non-accessible ramps. Taken on 05/02/2022 by Belli Architectural Group.

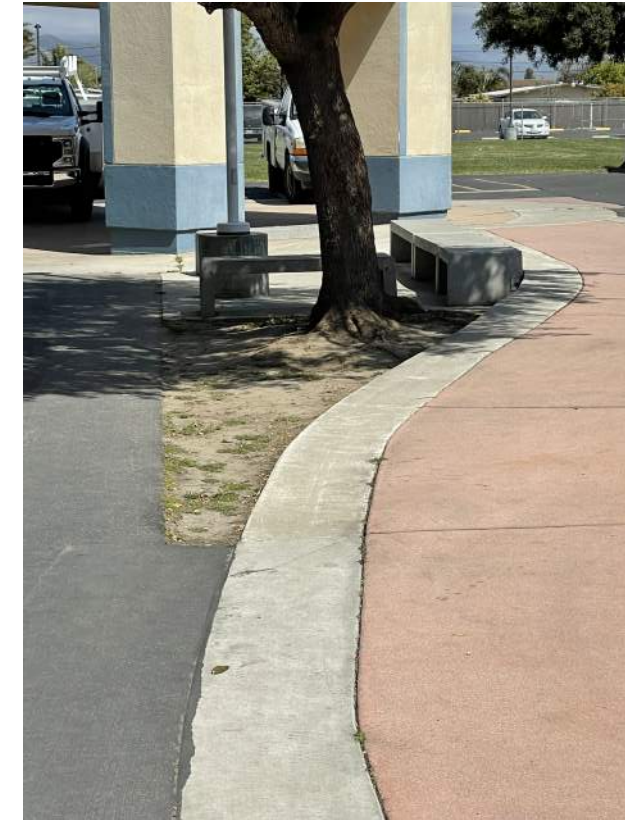
Image 2.1.5 Trip hazards present with uneven walking surfaces. Taken on 05/02/2022 by Belli Architectural Group.

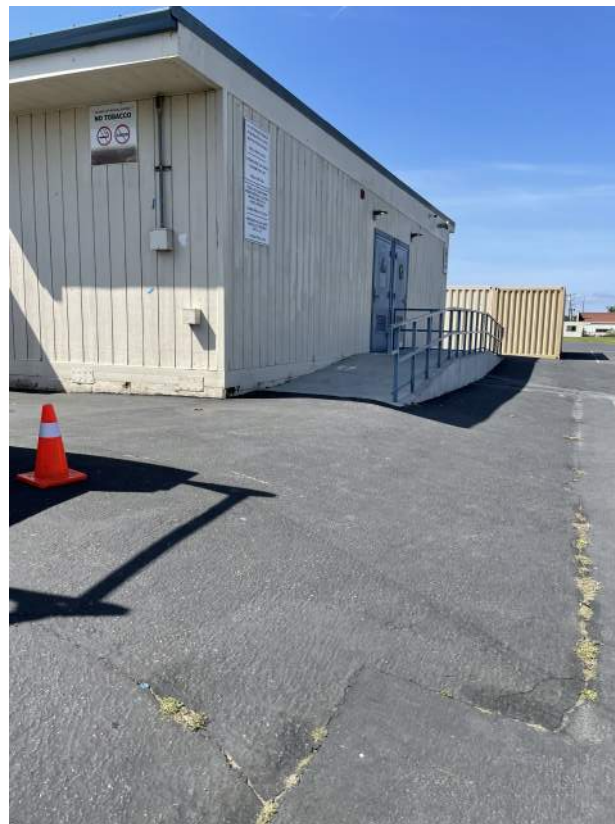
Image 2.1.2 Steep slopes on asphalt paving. Taken on 05/02/2022 by Belli Architectural Group.

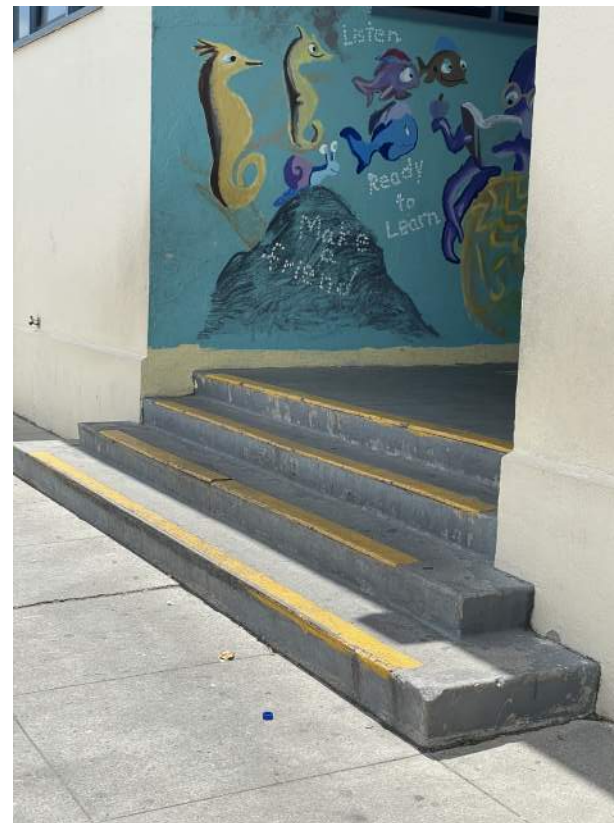
Image 2.1.4 Non-accessible stairs. Taken on 04/26/2022 by Belli Architectural Group.

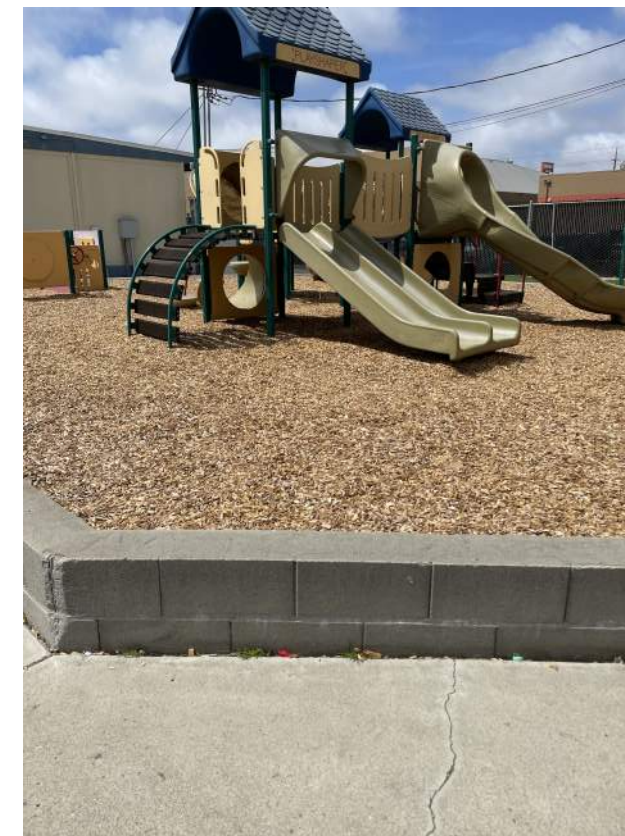
Image 2.1.6 Non-accessible playground at SPED yard. Taken on 05/02/2022 by Belli Architectural Group.

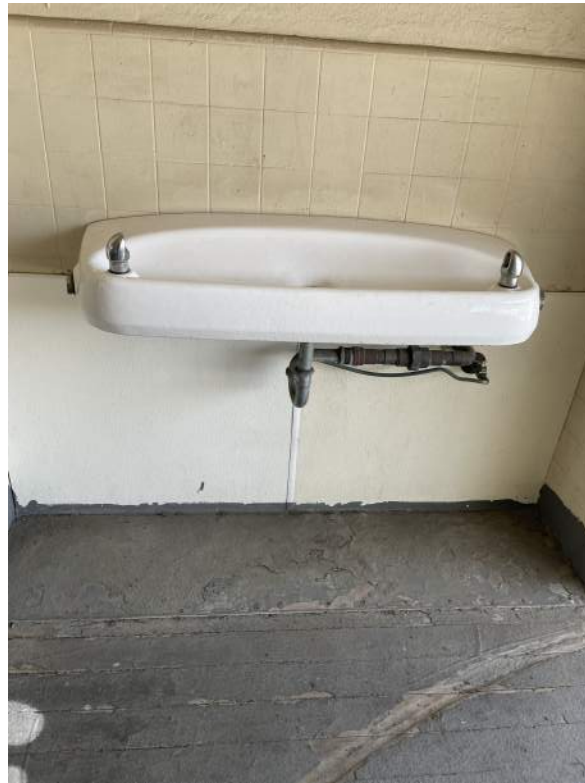
Image 2.1.7 Non-accessible drinking fountain. Taken on 05/02/2022 by Belli Architectural Group.

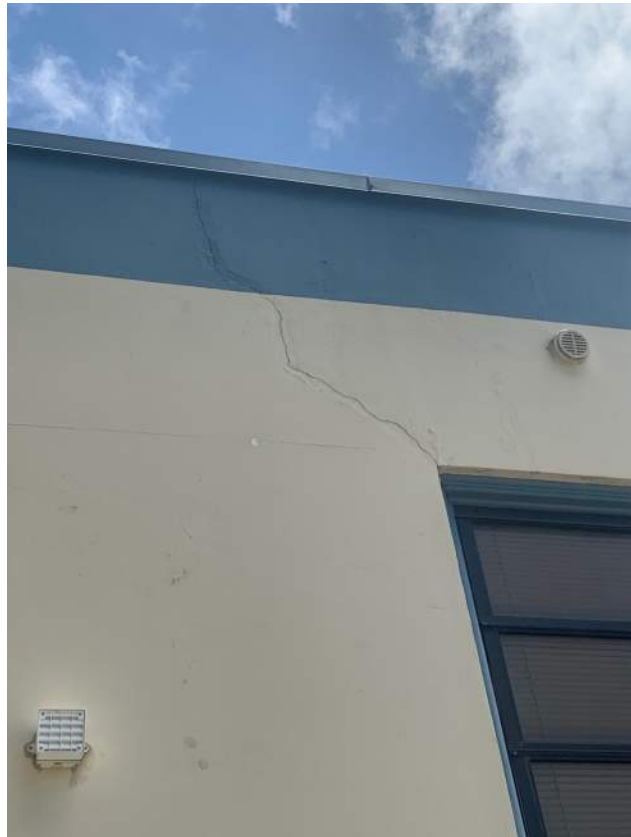
Image 2.2.4 Building A, exterior cracks. Taken on 05/02/2022 by Belli Architectural Group.

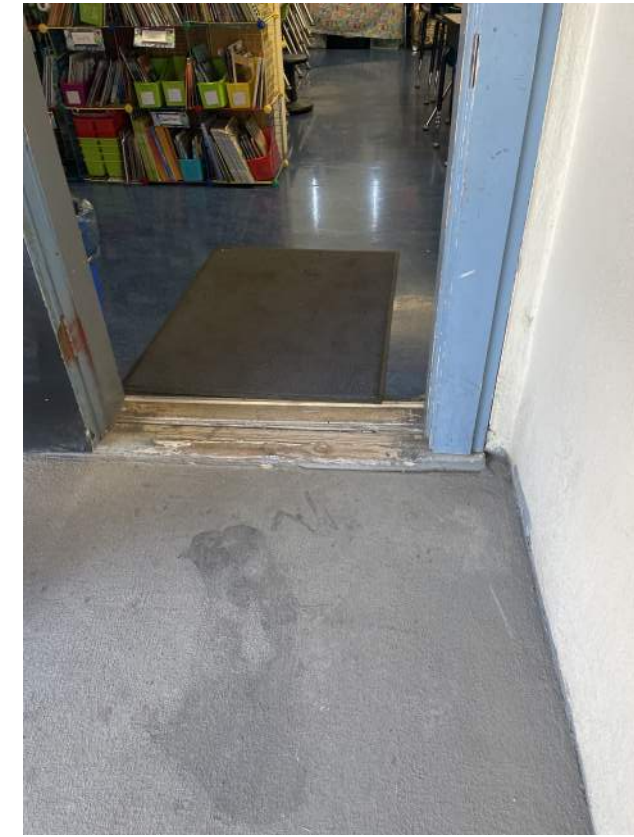
Image 2.2.8 Non-compliant door threshold at building B. Taken on 05/02/2022 by Belli Architectural Group.

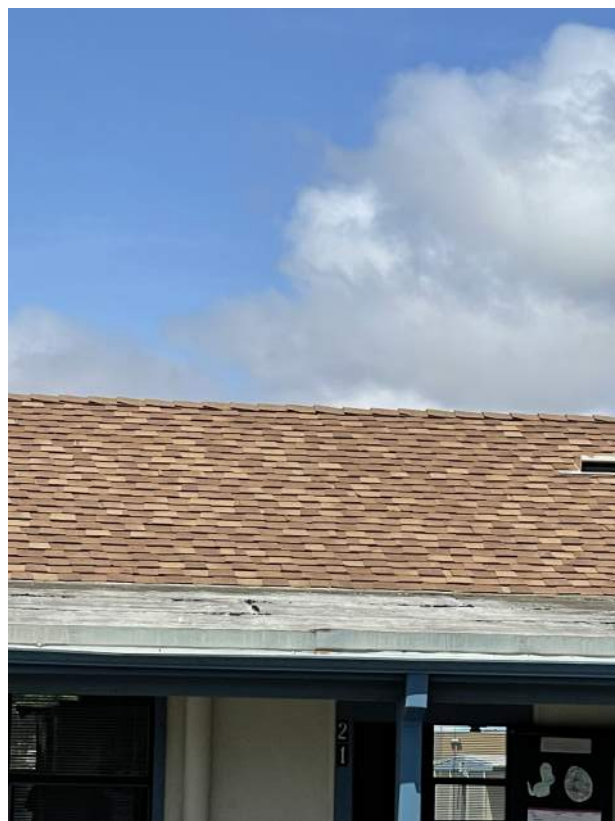
Image 2.2.5 Building B, old, damaged roof at outdoor covered walkway. Taken on 05/02/2022 by Belli Architectural Group.

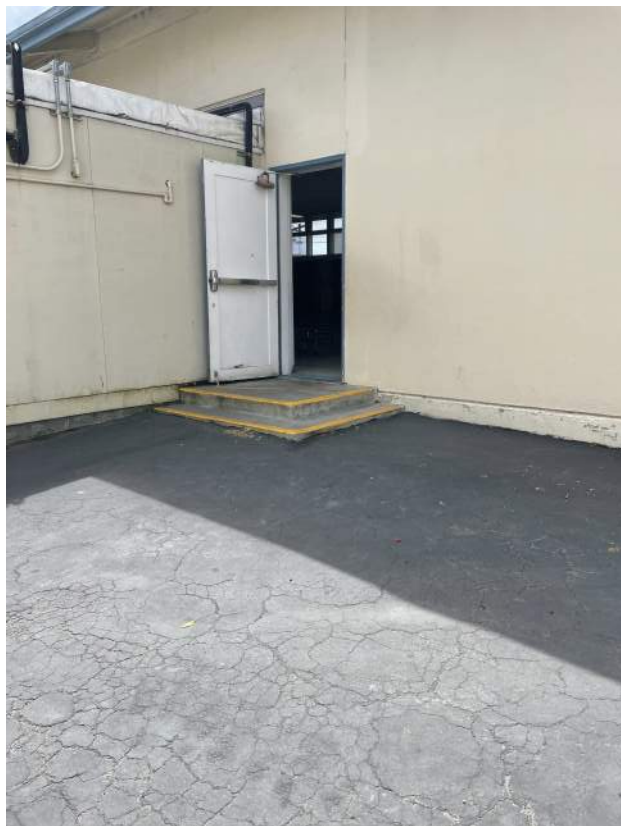
Image 2.2.11 Building D, non-accessible entry. Taken on 05/02/2022 by Belli Architectural Group.

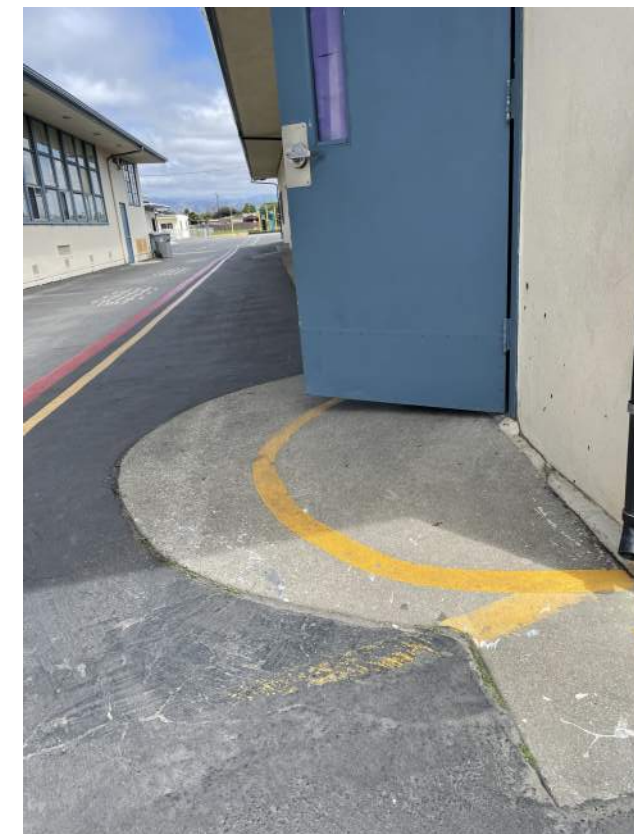
Image 2.2.14 Non-accessible entry at Building F. Taken on 05/02/2022 by Belli Architectural Group.

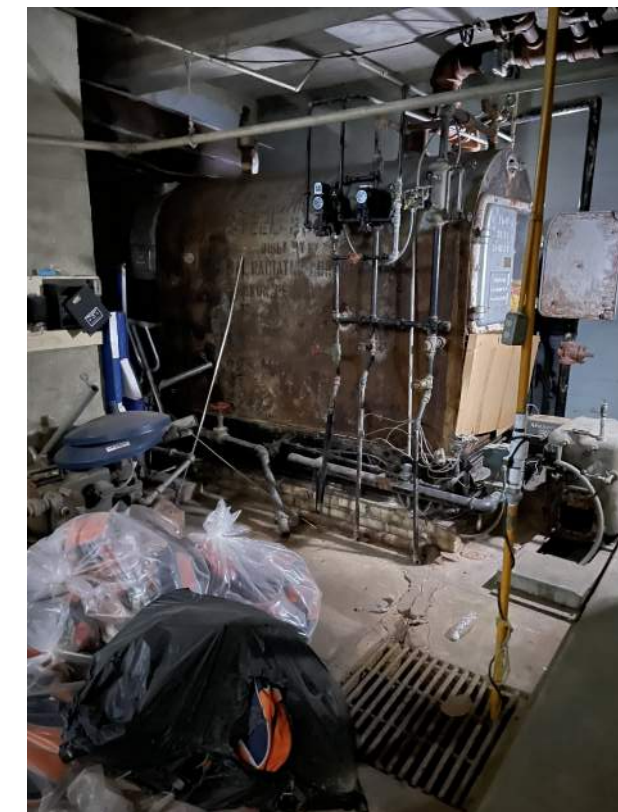
- Old boiler not in use. Should be removed.
- Restrooms due for modernization.
- Non-accessible student restrooms.
- Aging casework.
- Broken lamps.
- Non-accessible sinks in classrooms.
- 3 full-size classrooms are being used as storage.
- Vandalized restrooms.
- Deteriorated plaster at walls.

Image 2.3.1 Old boiler present at Building A. Taken on 05/02/2022 by Belli Architectural Group.

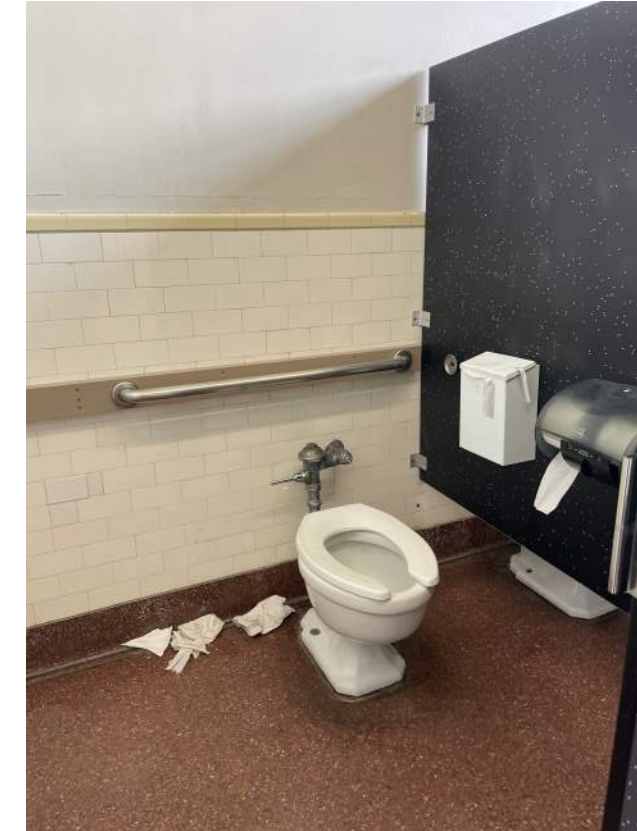
Image 2.4.1 Non-ADA compliant restrooms. Taken on 05/02/2022 by Belli Architectural Group.

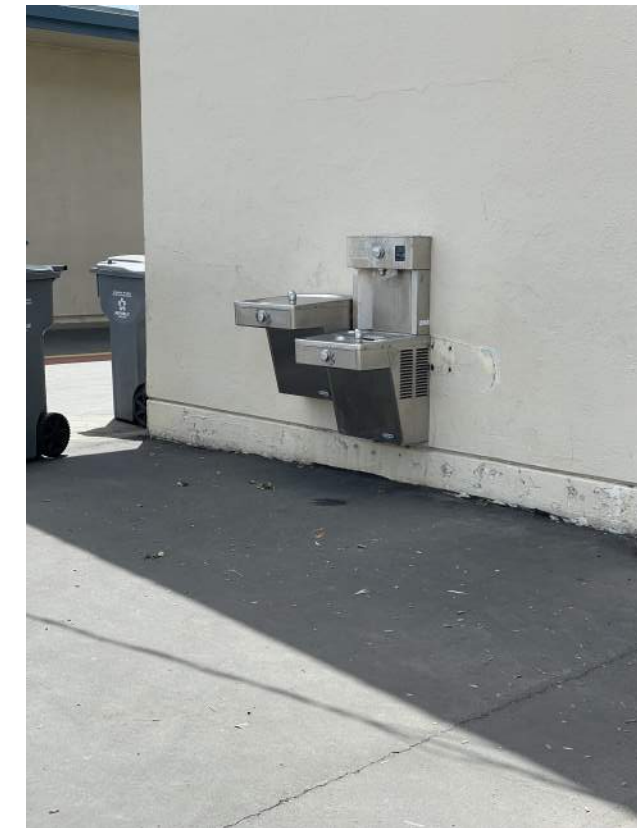
Image 2.4.2 Drinking fountain missing cane detection rails. Taken on 05/02/2022 by Belli Architectural Group.

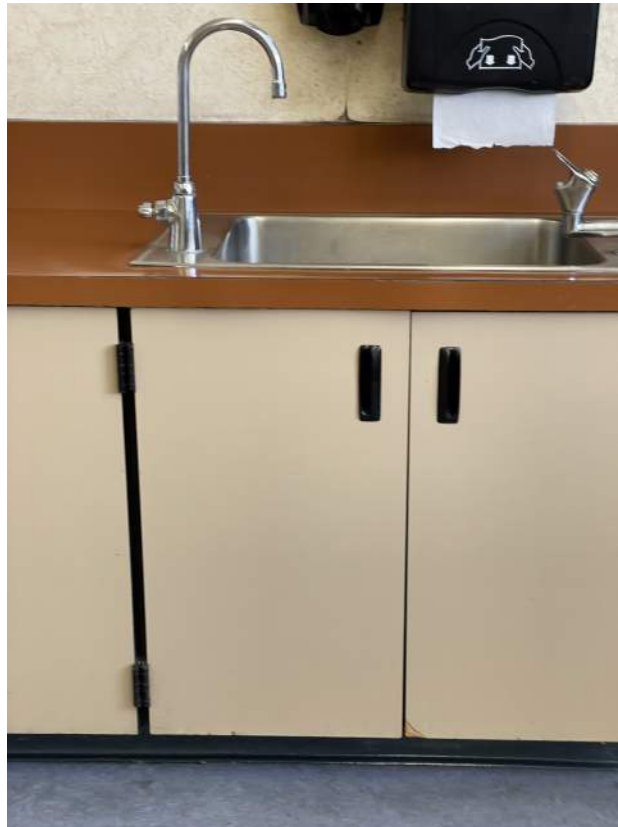
Image 2.4.3 Non-ADA compliant classroom sink. Taken on 05/02/2022 by Belli Architectural Group.

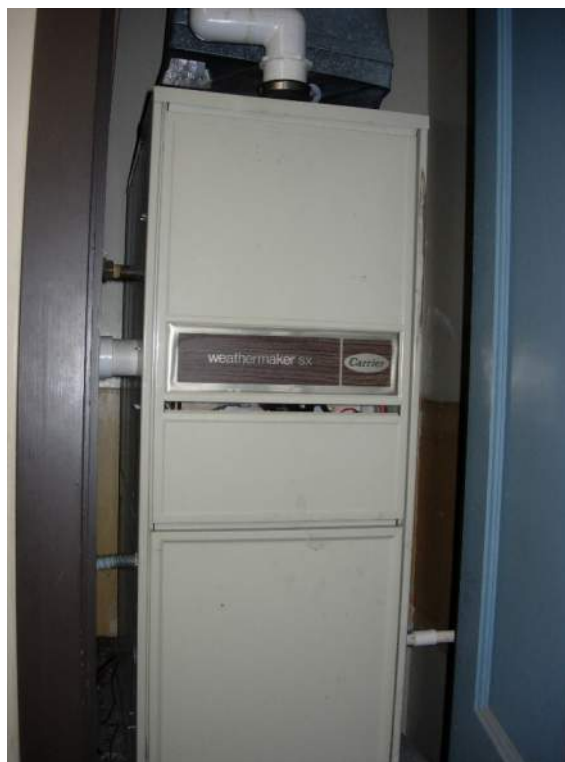
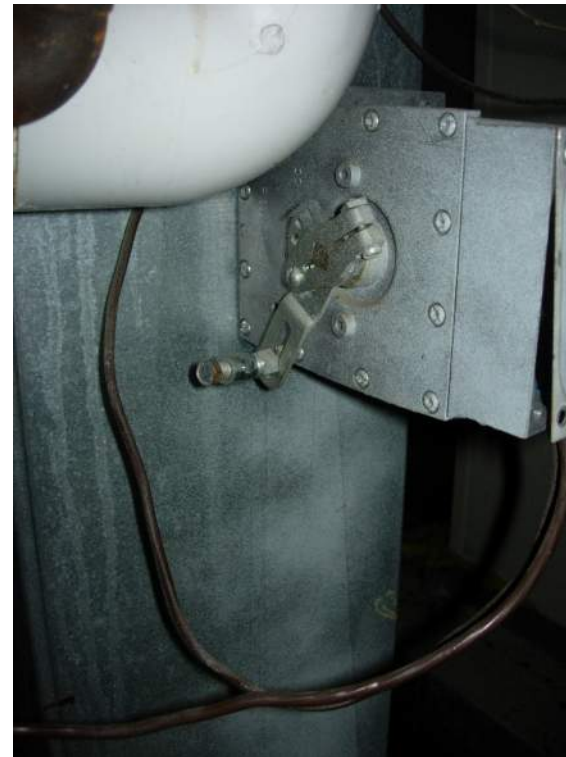
The heating system for this area is served by a Carrier Weathermaker Six up-flow gas-fired furnace located in a closet across the hall. The Teacher's Lounge and adjacent Work Room is served by another Carrier Weathermaker Six unit in the same closet. These furnaces are pre 1990's era and should be replaced. The motorized outside air damper linkage for these units has been disconnected and needs repairing.

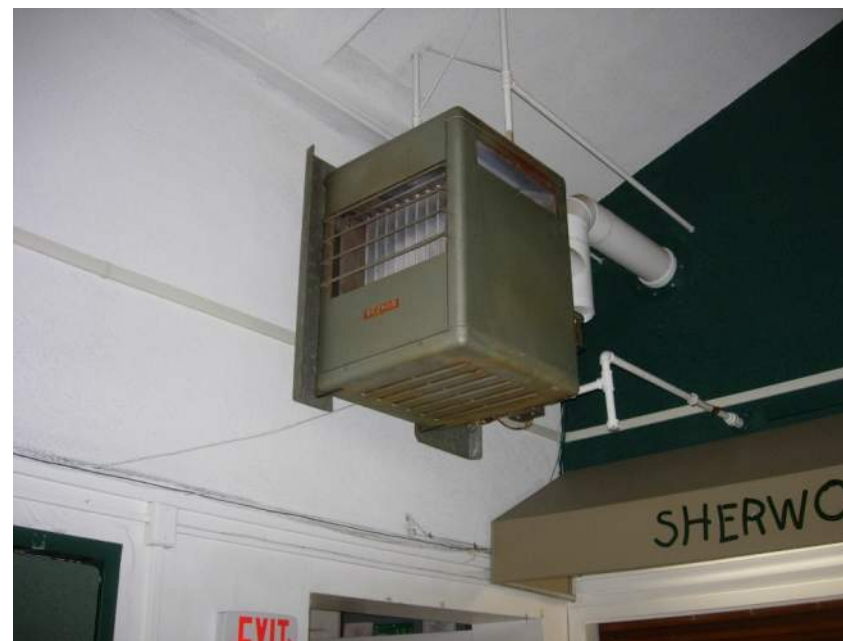
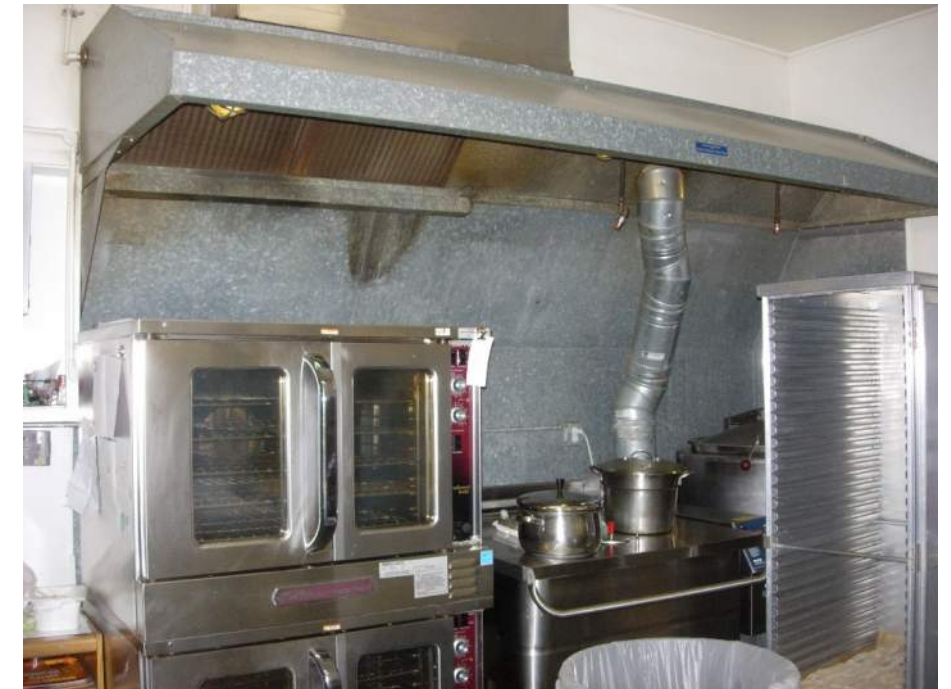
The heating system for the Multi-Purpose room is with two (2) suspended gas-fired unit heaters. These appear to be original and should be replaced. The kitchen food service equipment appears to be original and in need of replacement.

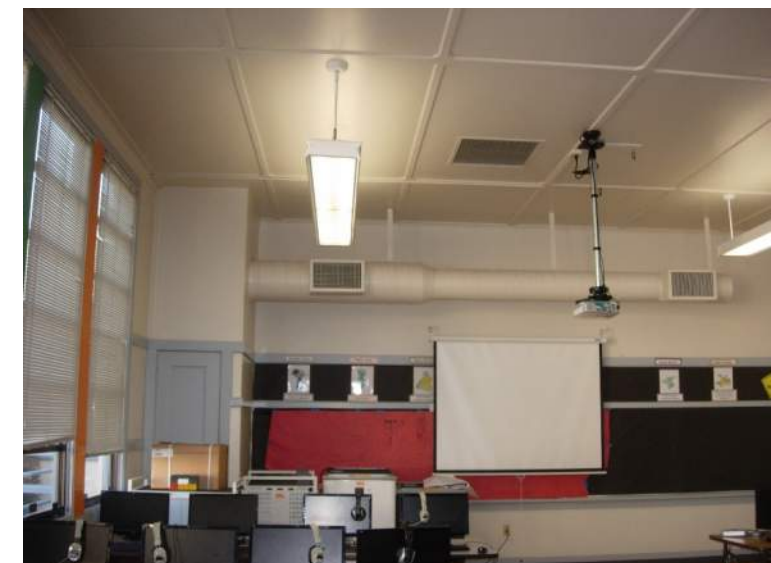
These rooms are served by individual Carrier Weathermaster 6 up-flow gas-fired furnaces located in a closet inside the room. Supply ductwork is exposed. The Computer Lab had two (2) separate furnaces serving this room. All of these furnaces are 1990's era and should be replaced. The photo below is of the Computer Lab.

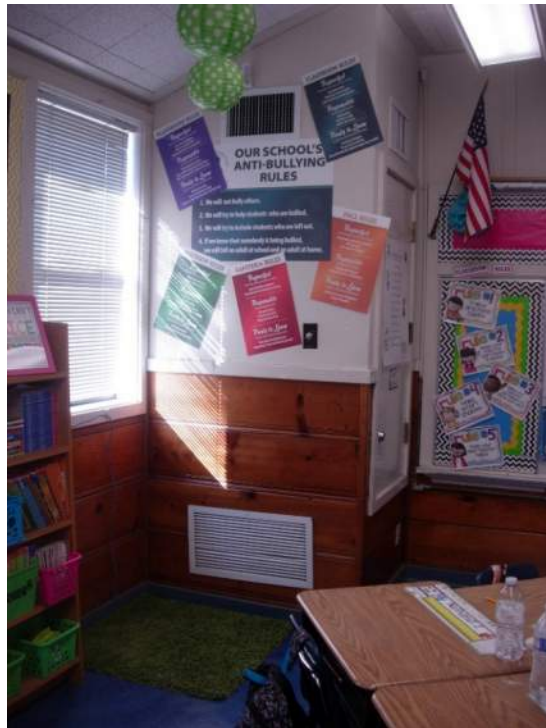
This is a separate stand-alone building. These six (6) classroom rooms are served by six (6) individual Day and Night Plus 80 up-flow gas-fired furnaces located in a closet inside the room. All of these furnaces are 1990's era and should be replaced. The photo below is of the Classroom 18.

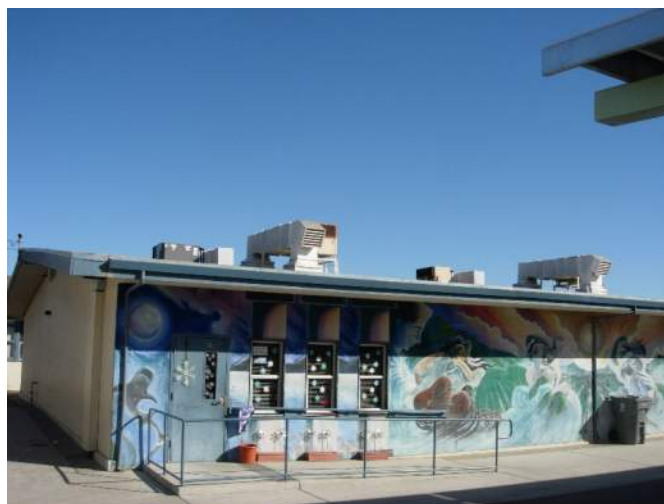
These five (5) classrooms are in a stand-alone building and are served by five (5) rooftop gas heat/electric cooling units. The unit serving classroom 24 was recently replaced. The other four (4) units also need replacing.

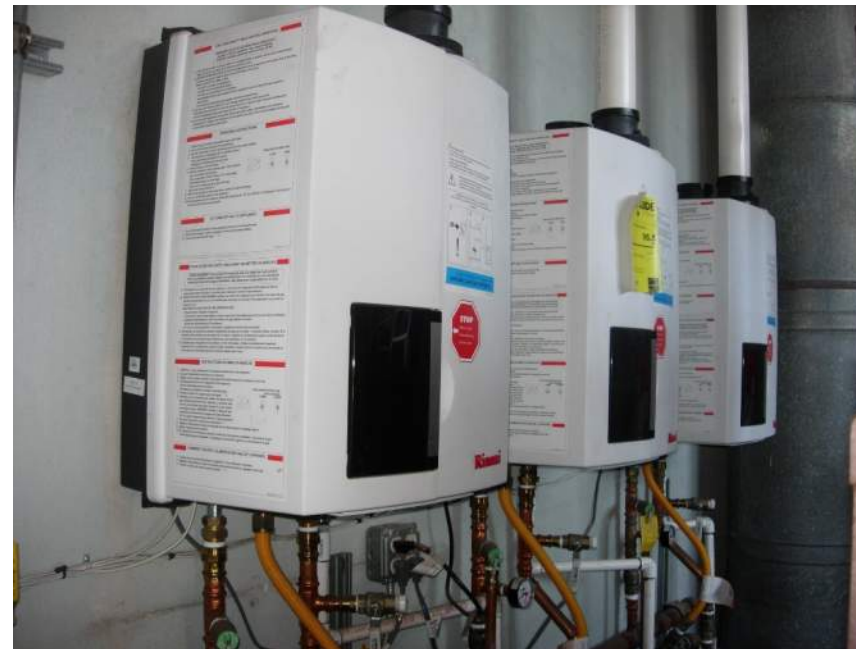
These four (4) classrooms are in a stand-alone building and are heated with three (3) new gas-fired wall mounted tankless boilers and four (4) individual hot water window console type fan-coil units. The boiler needs pipe insulation on all exposed heating water piping.

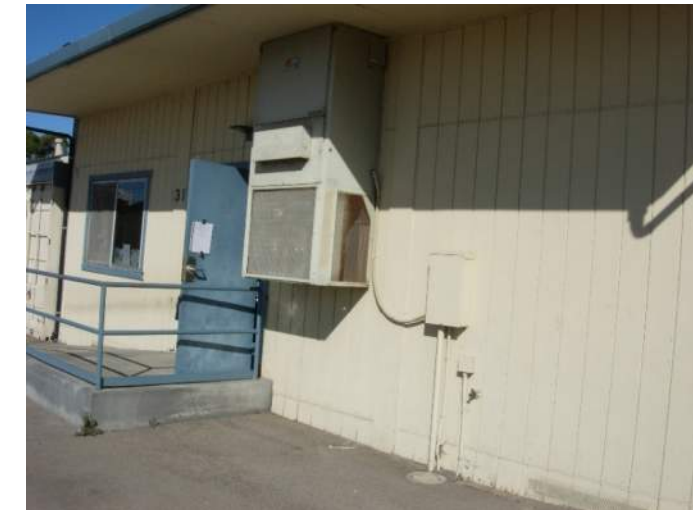
These are portable classroom consisting of the exterior wall mounted “Bard” type heat pump units. All portables utilize this type of equipment. These units throughout the campus appear to be operating. Older (20 years) units should be replaced. The photo below is of Classroom 31.

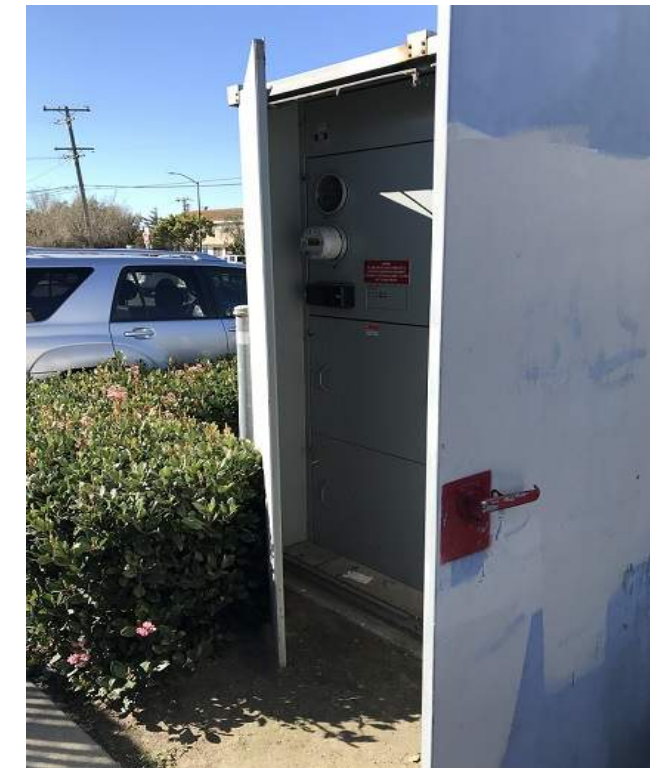
There are (3) existing main “metered” electrical service switchboards (MSB1, MSB2 and MSB3). MSB1 is a 1200 amp, 120/208 volt, 3 phase, NEMA 3R, Square D, service located at the front parking lot of the Upper Sherwood area. MSB1 has a connection for the existing Solar PV system. The Solar PV is connected ahead of the main breaker at MSB1. MSB1 serves in large part, the entire Upper Sherwood area including modular/portable buildings (approximately 29 total modular buildings). MSB1 expected life 20 yrs. MSB2 is a 600 amp, 120/240V, 3-phase, NEMA 1 service located in the Multi-Purpose building at the Lower Sherwood area. MSB2 feeds the MPR building and several portable classrooms located near the playground area. The manufacturer is Trumbull Electric and it is discontinued. If electrical renovation/upgrade takes place in the MPR building, it is recommended to replace the switchboard with a new switchboard. MSB2 expected life; 5 to 10 yrs. MSB3 is a 600amp, 120/240V, 1-phase, NEMA 3R, Square D service located on the north exterior wall of classroom #32. MSB3 feeds several modular classrooms clustered at the northwest of campus. MSB3 has an overhead service fed from PG&E pole mounted 50KVA transformer. Switchboard NEMA 3R enclosure is old and rusty. MSB3 expected life; 4 to 6 yrs. The electrical services are used primarily for lighting and heating equipment, with minimal plug loads. Some of the electrical distribution system panels that are located around the site and are original to the main campus buildings when the school was built, are old and manufactured by a company that no longer exists. The reliability of the system’s breakers to function correctly when necessary cannot be relied upon. It is recommended to replace the oldest panels within the classroom wings of the main campus building. Where the District plans to add HVAC to the site, the switchboards that are serving those locations may require an upgrade based on what type of system is recommended for HVAC upgrades. See attached photos MSB1, MSB2 and MSB3.
