FACILITIES NEEDS ASSESSMENT

UNIVERSITY PARK

PREPARED BY BELLI ARCHITECTURAL GROUP

2022

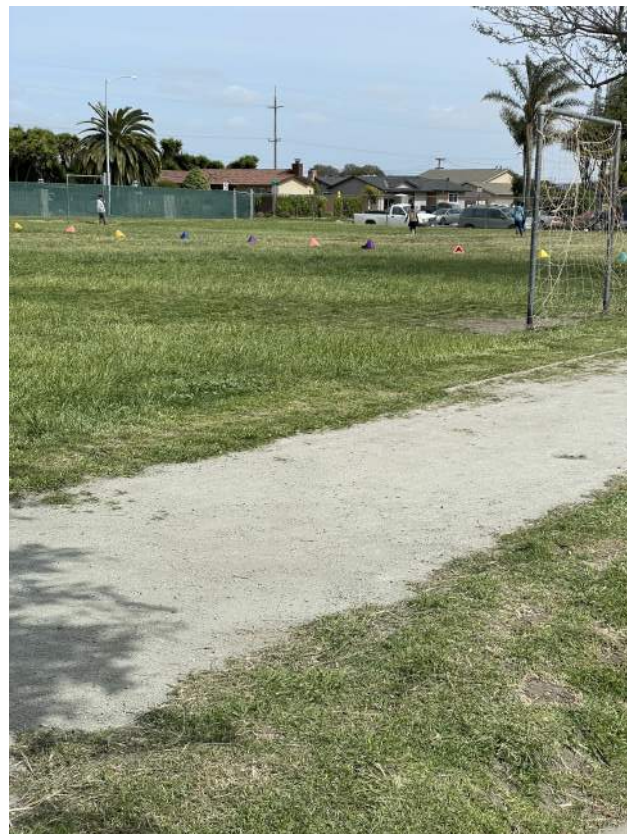
Image 2.1.1 Deteriorated track. Taken on 04/27/2022 by Belli Architectural Group.

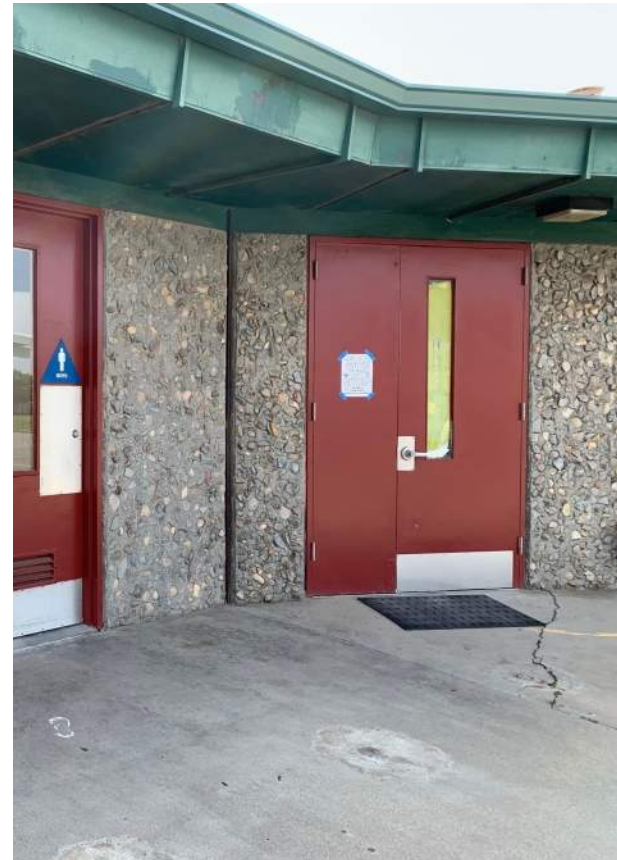
Image 2.1.2 Concrete cracks and weathered plywood soffit. Taken on 04/27/2022 by Belli Architectural Group.

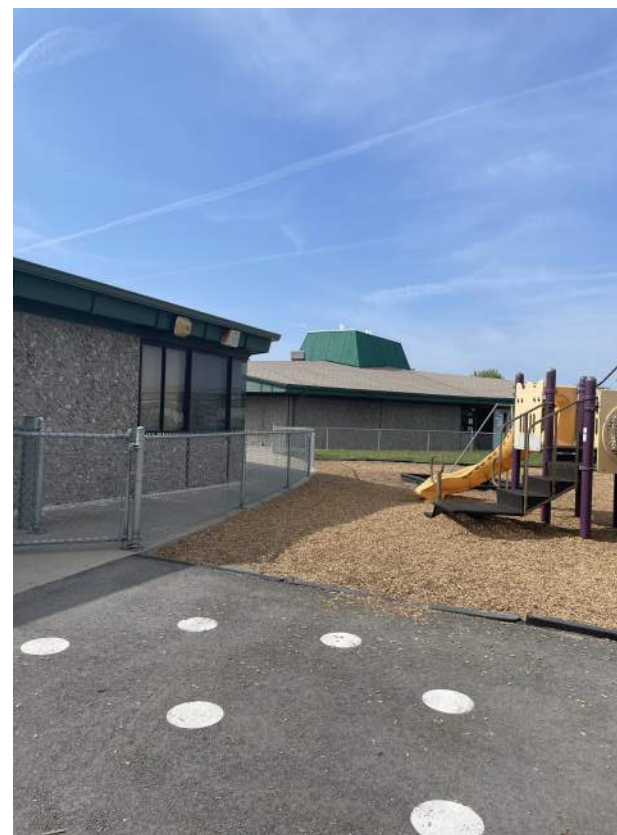
Image 2.1.3 Kindergarten playground. Taken on 04/27/2022 by Belli Architectural Group.

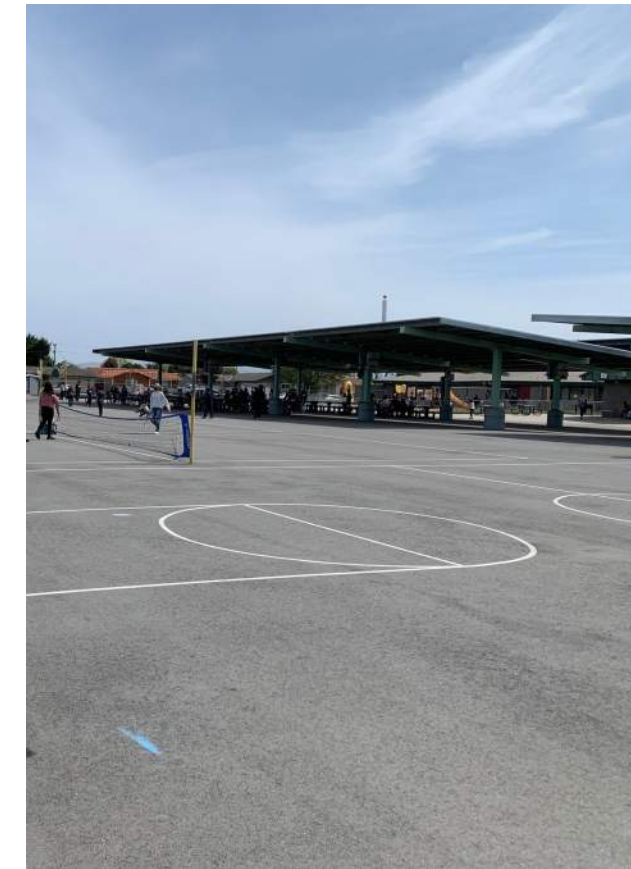
Image 2.1.4 Asphalt surfaces. Taken on 04/27/2022 by Belli Architectural Group.

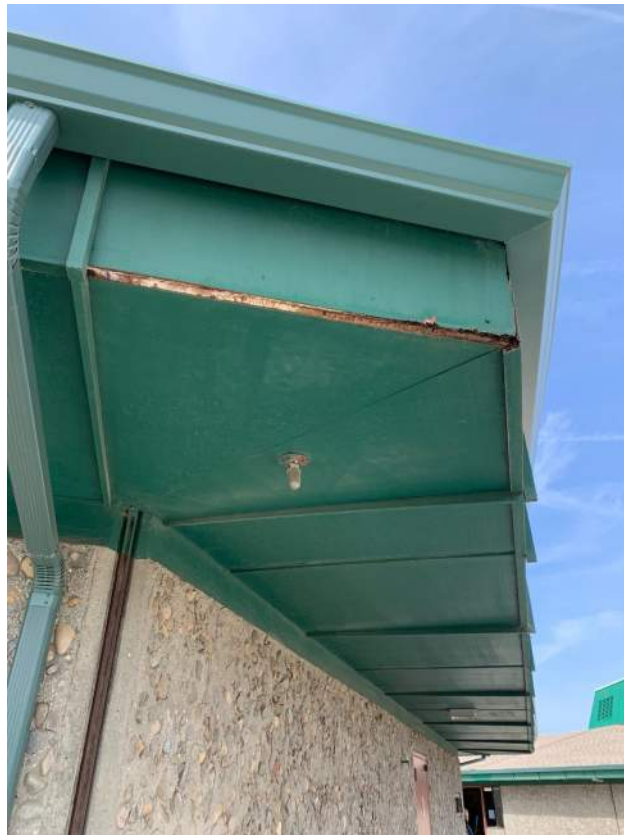
Image 2.2.1 Permanent building plywood soffits. Taken on 04/27/2022 by Belli Architectural Group.

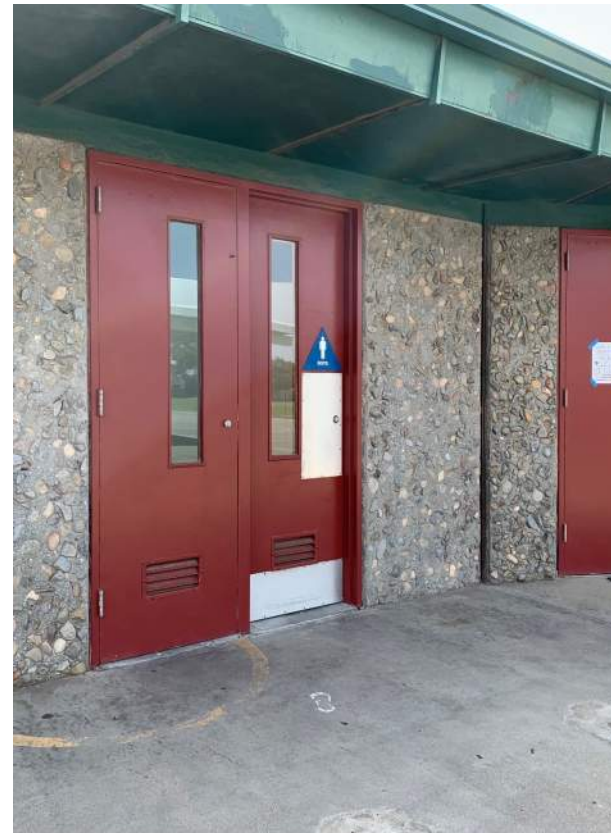
Image 2.2.3 Non-accessible doors and threshold issues. Taken on 04/27/2022 by Belli Architectural Group.

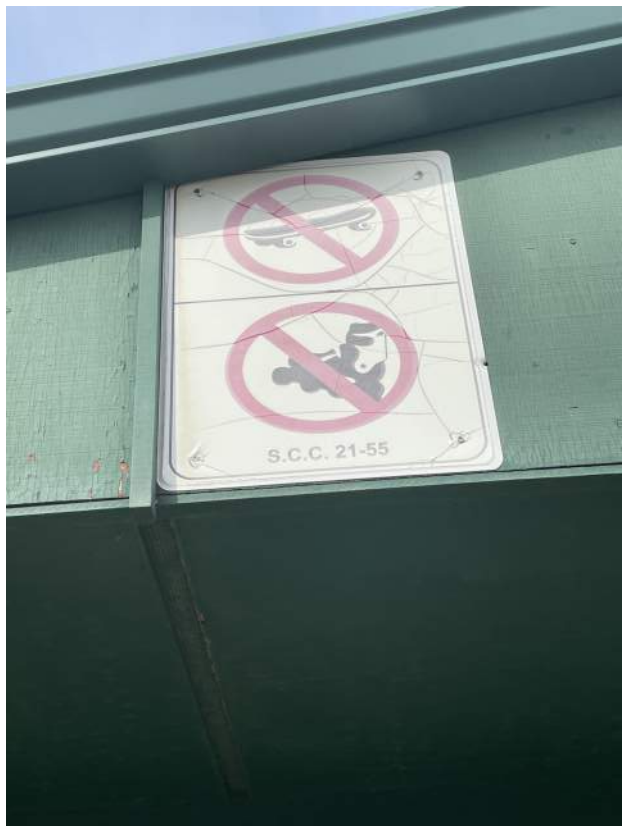
Image 2.2.2 Broken signage. Taken on 04/27/2022 by Belli Architectural Group.

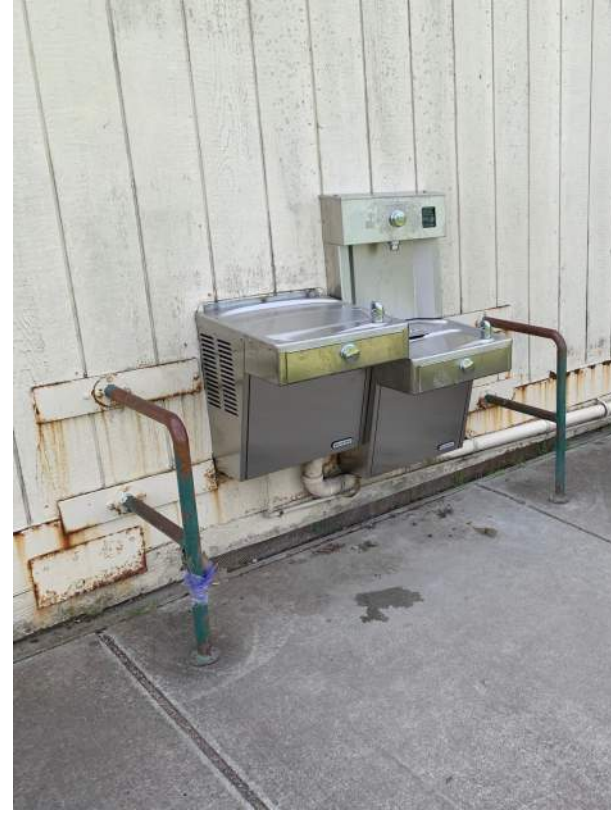
Image 2.2.3 Rust present at relocatable classrooms. Taken on 04/27/2022 by Belli Architectural Group.

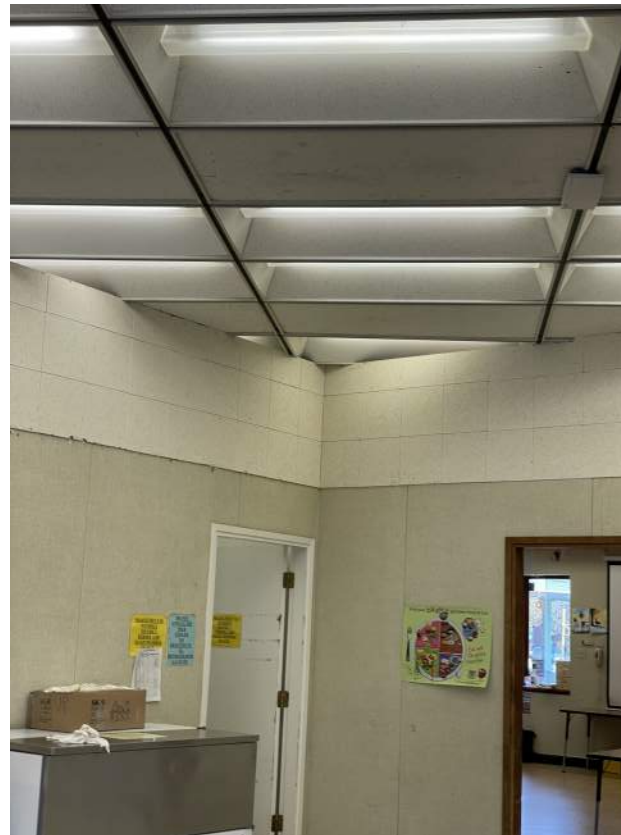
Image 2.3.1 Light fixtures not providing enough light. Taken on 04/27/2022 by Belli Architectural Group.

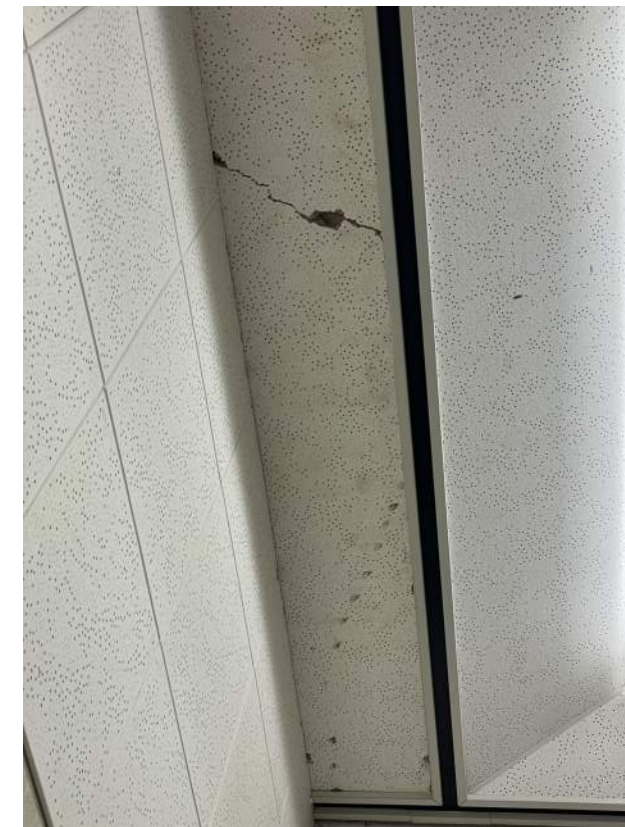
Image 2.3.3 Damaged ceiling panels. Taken on 04/27/2022 by Belli Architectural Group.

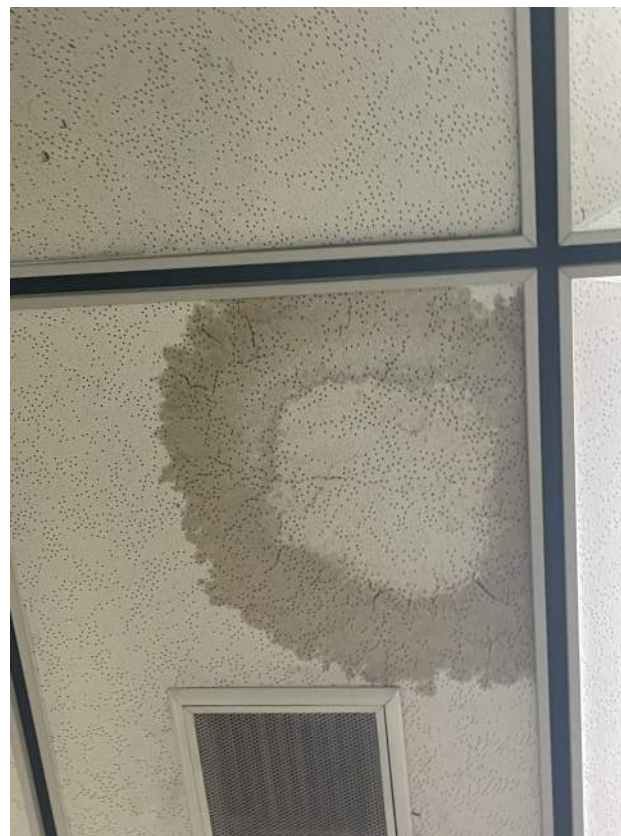
Image 2.3.2 Evidence of leaks in ceiling panels. Taken on 04/27/2022 by Belli Architectural Group.

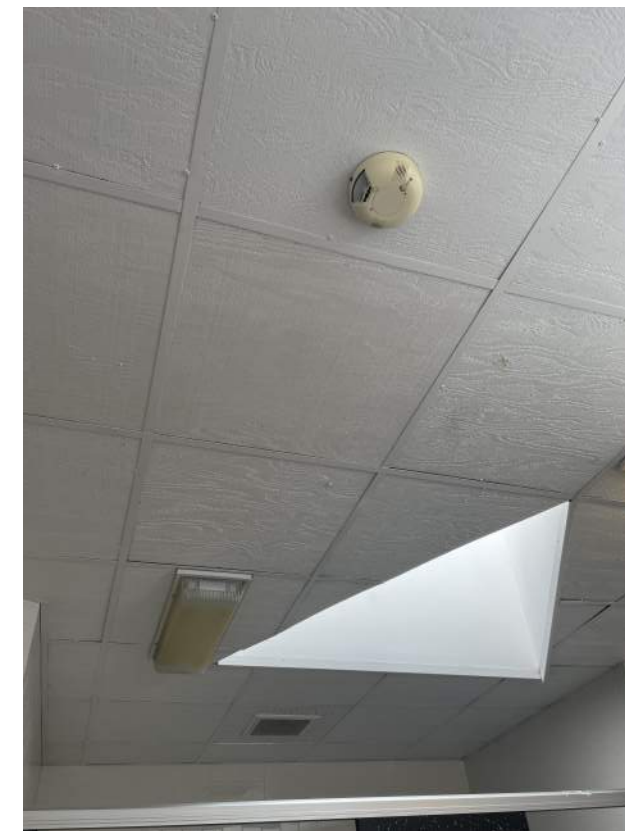
Image 2.3.4 Restroom ceiling. Taken on 04/27/2022 by Belli Architectural Group.

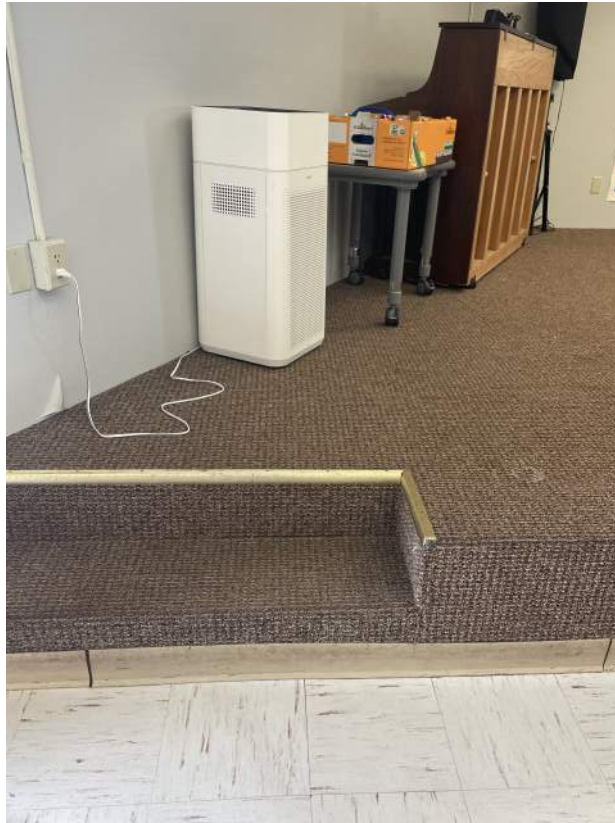
Image 2.3.5 MPR stage carpet. Taken on 04/27/2022 by Belli Architectural Group.

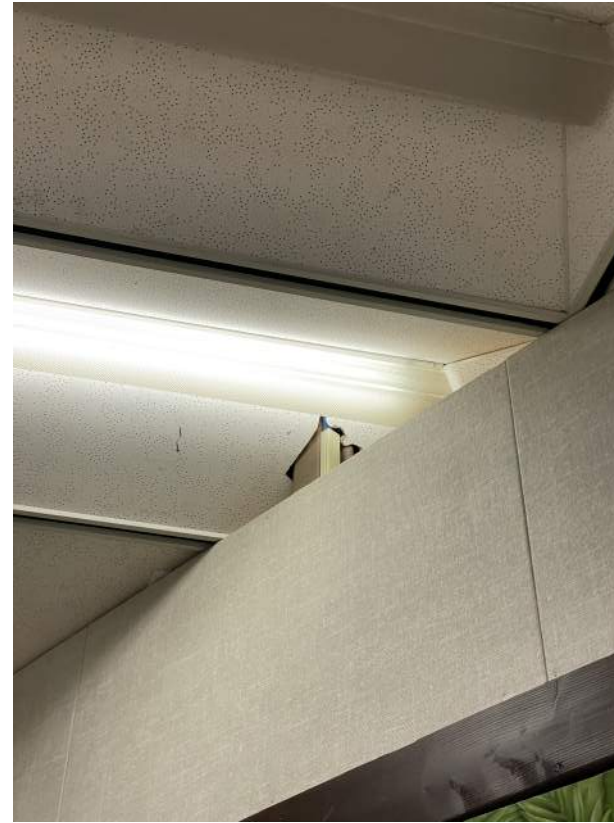
Image 2.3.7 Room partitions. Taken on 04/27/2022 by Belli Architectural Group.

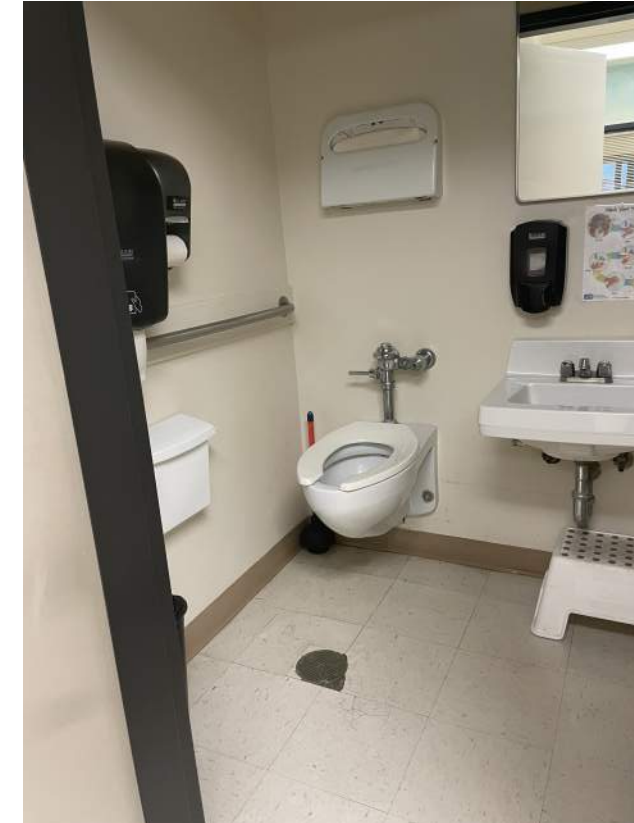
Image 2.3.9 Adult plumbing sized fixtures used by children. Taken on 04/27/2022 by Belli Architectural Group.

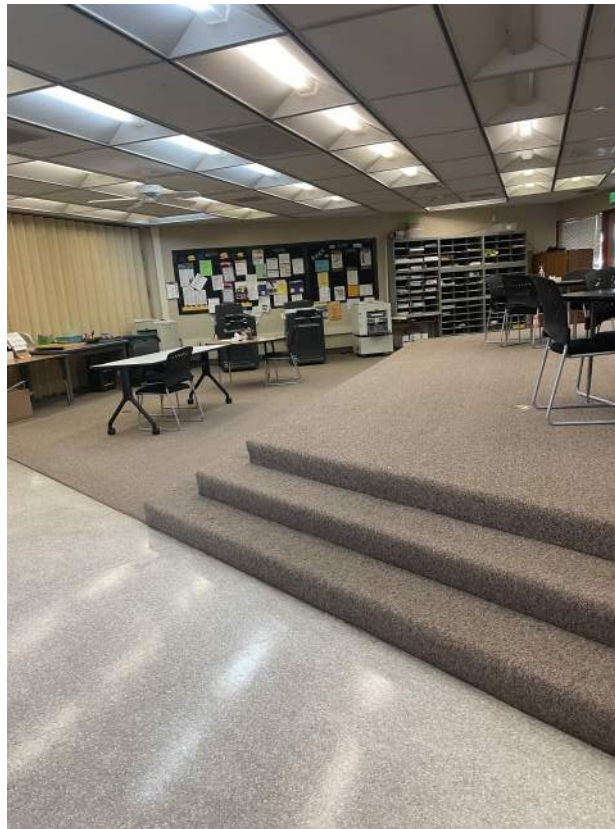
Image 2.3.6 Non-accessible MPR stage. Taken on 04/27/2022 by Belli Architectural Group.

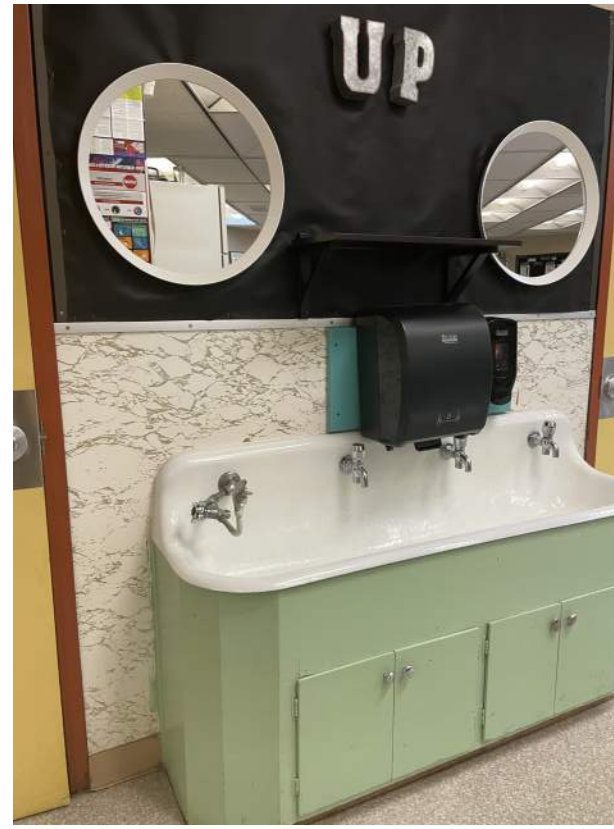
Image 2.3.8 Kindergarten sized plumbing fixtures used by staff. Taken on 04/27/2022 by Belli Architectural Group.

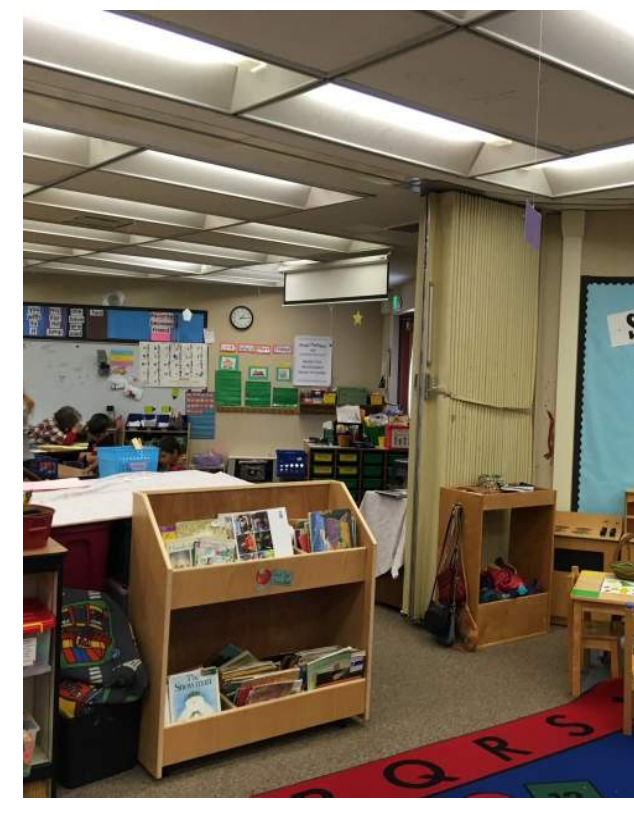
Image 2.3.10 Preschool. Taken on 04/27/2022 by Belli Architectural Group.

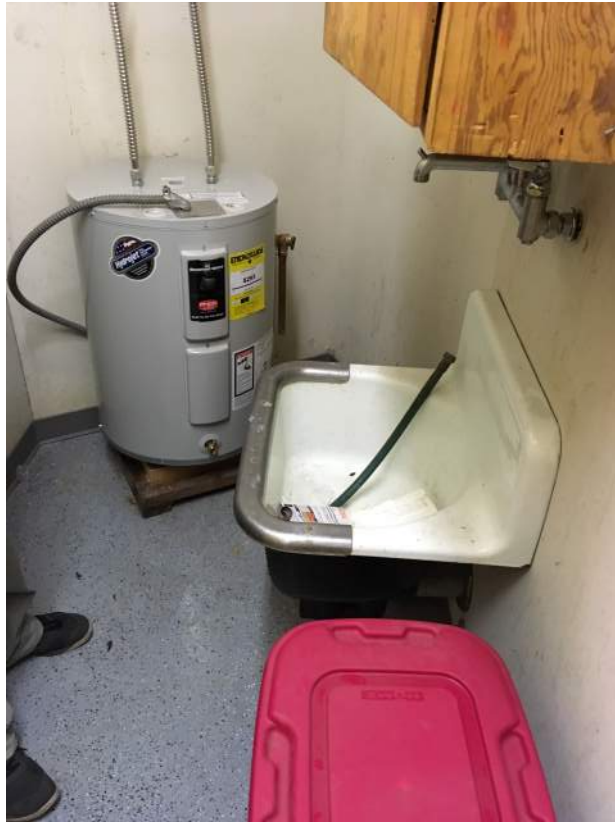
Image 2.3.11 Janitorial room. Taken on 04/27/2022 by Belli Architectural Group.

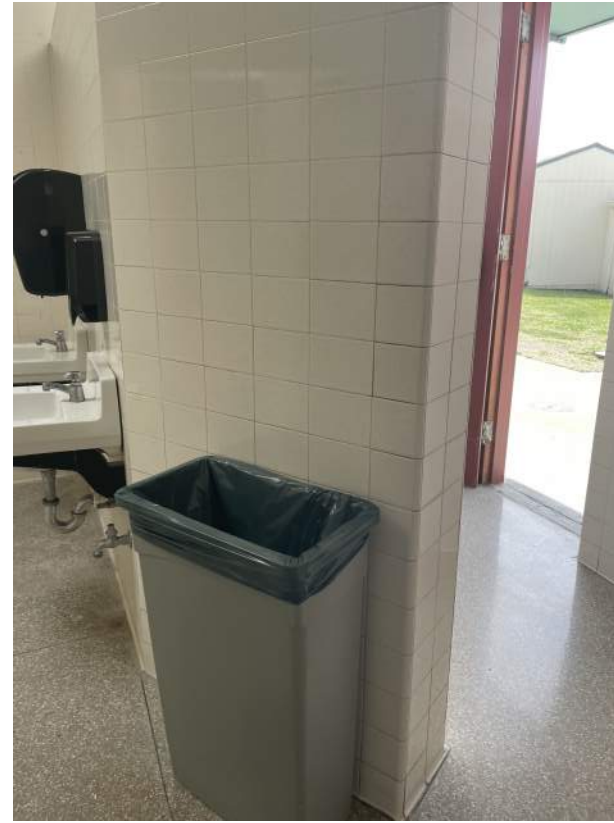
Image 2.4.1 Non-compliant clearances Taken on 04/27/2022 by Belli Architectural Group.

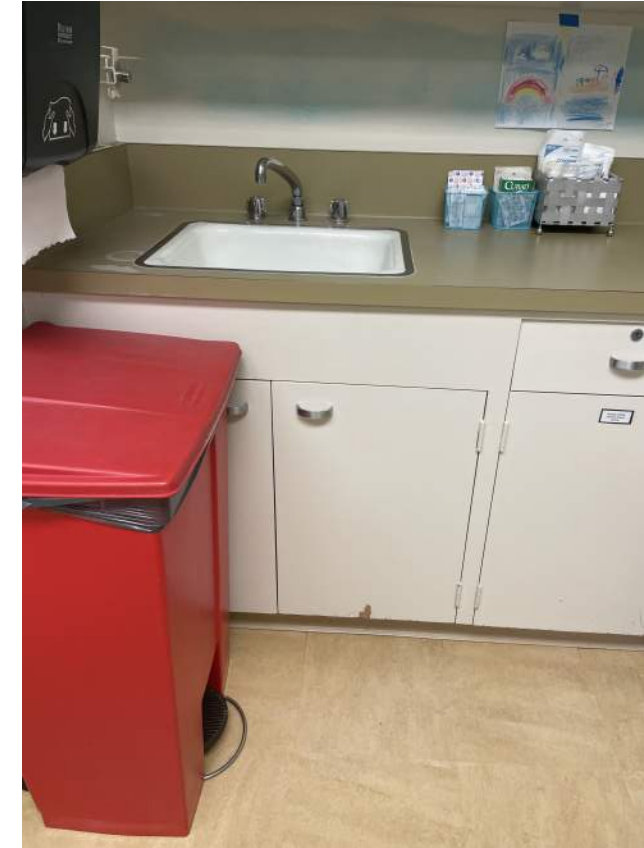
Image 2.4.3 Non-compliant sinks. Taken on 04/27/2022 by Belli Architectural Group.

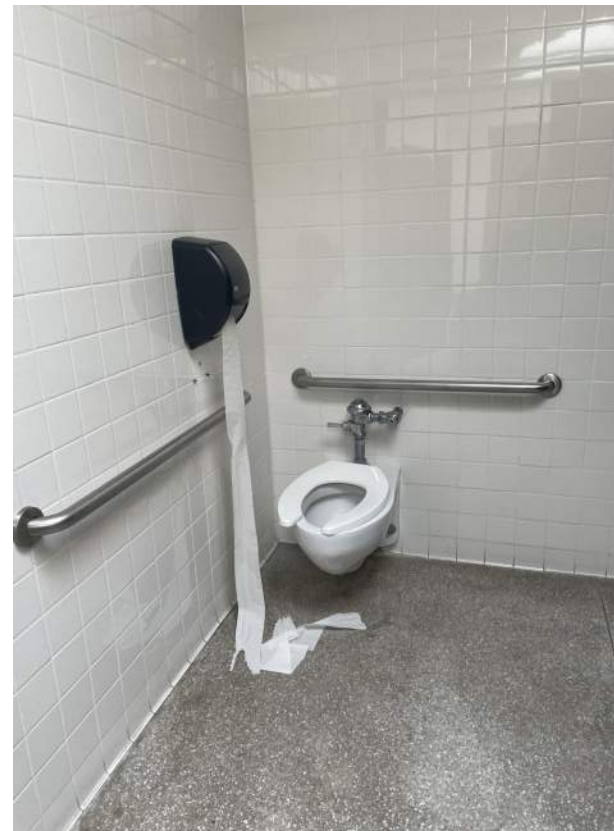
Image 2.4.2 Non-compliant accessories. Taken on 04/27/2022 by Belli Architectural Group.

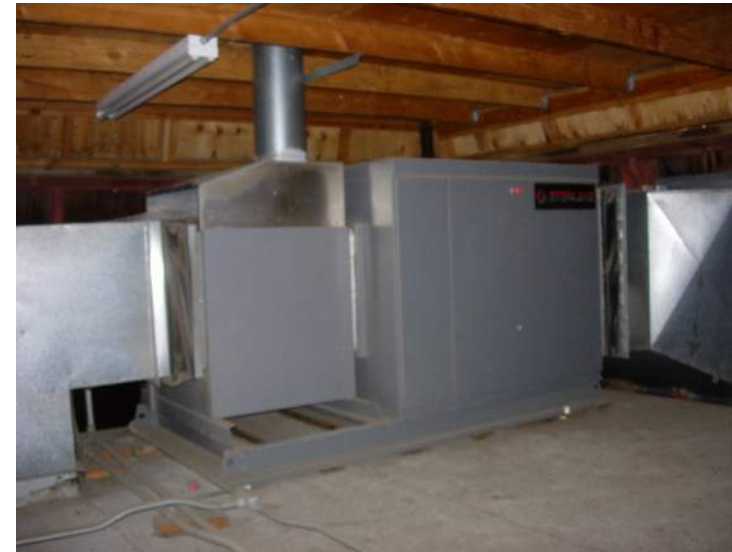
The heating system for this building consist of three (3) Sterling rooftop mounted gas-fired heating units located inside a wood roof structure. The units are from the 2003 modernization and appear to be in fair condition. These heating units are 20 years old and should be replaced.

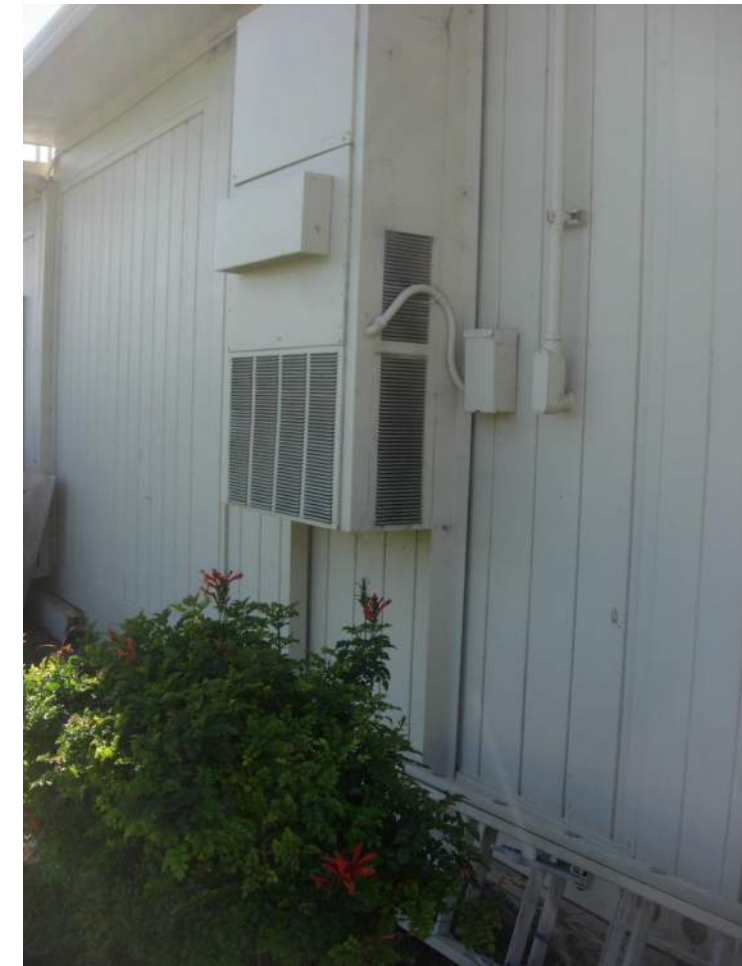
These are portable classroom consisting of the exterior wall mounted "Bard" type heat pump units. All portables utilize this type of equipment. Older (20 years) units should be replaced with new units.

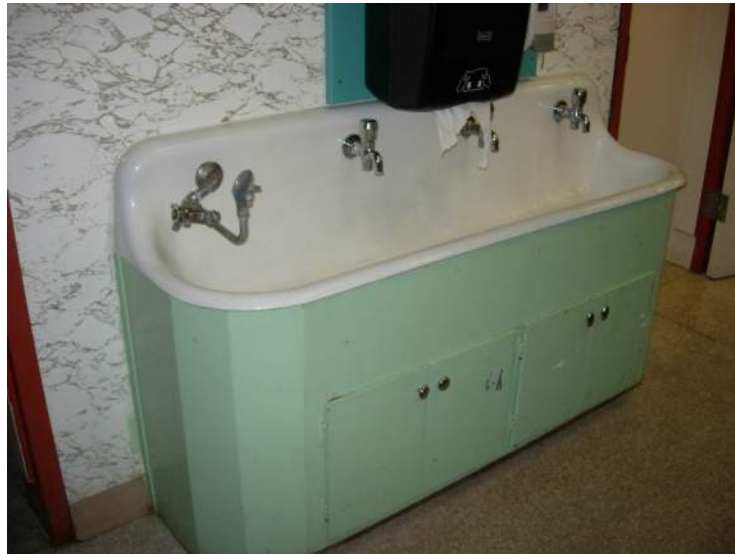
A sink located inside Classroom K1 appears to be original and like many others on the campus, does not meet ADA.

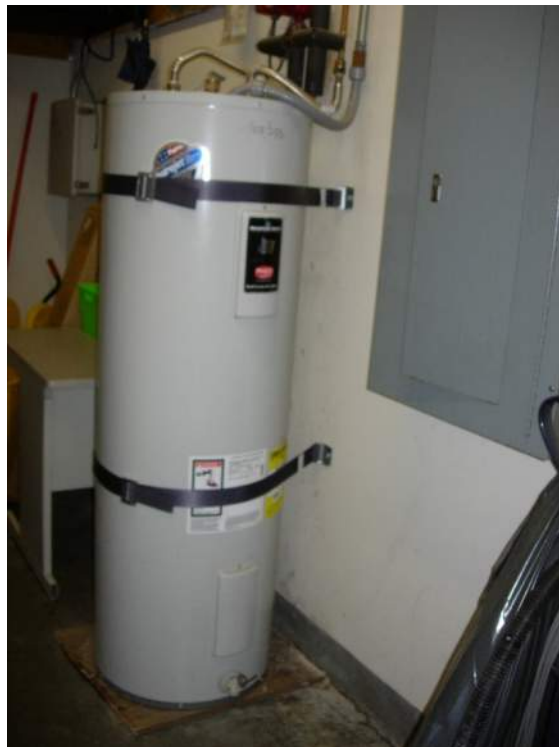
An electric tank type water heater located in the adjacent janitor's closet serving the food service has DSA approved seismic bracing.

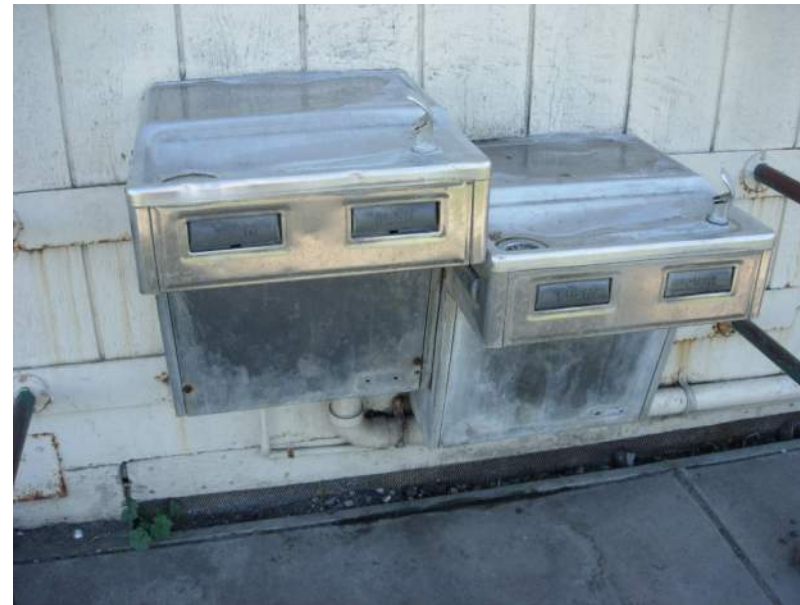
A bi-level drinking fountain located at an exterior location near Classroom 29 that needs replacing.

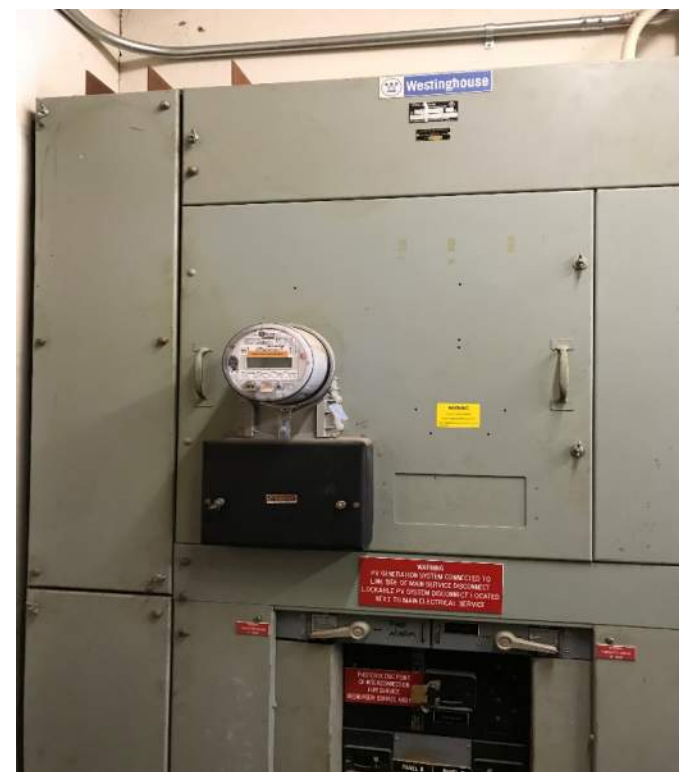
There are (2) existing main “metered” electrical service switchboards (MSB1 and MSB2). MSB1 is a 600 amp, 120/208 volt, 3 phase, NEMA 1, Westinghouse, service located in Multi-Purpose building. MSB1 has a connection for the existing Solar PV system. The Solar PV is connected ahead of the main breaker at MSB1. MSB1 feeds all permanent buildings such as the office, library, MPR and permanent classroom buildings. MSB1 expected life; 8 to 15 yrs. MSB2 is an 800 amp, 120/208V, 3-phase, NEMA 3R, Square D, service located near the back parking lot. The Solar PV is also connected at this switchboard. MSB2 feeds all modular classrooms and restrooms. MSB2 expected life; 15 to 20 yrs. The electrical services are used primarily for lighting and heating equipment, with minimal plug loads. Some of the electrical distribution system panels that are located around the site and are original to the main campus buildings when the school was built, are old and manufactured by a company that no longer exists. The reliability of the system’s breakers to function correctly when necessary cannot be relied upon. It is recommended to replace the oldest panels within the classroom wings of the main campus building. Where the District plans to add HVAC to the site, the switchboards that are serving those locations may require an upgrade based on what type of system is recommended for HVAC upgrades. See attached photos MSB1 and MSB2.

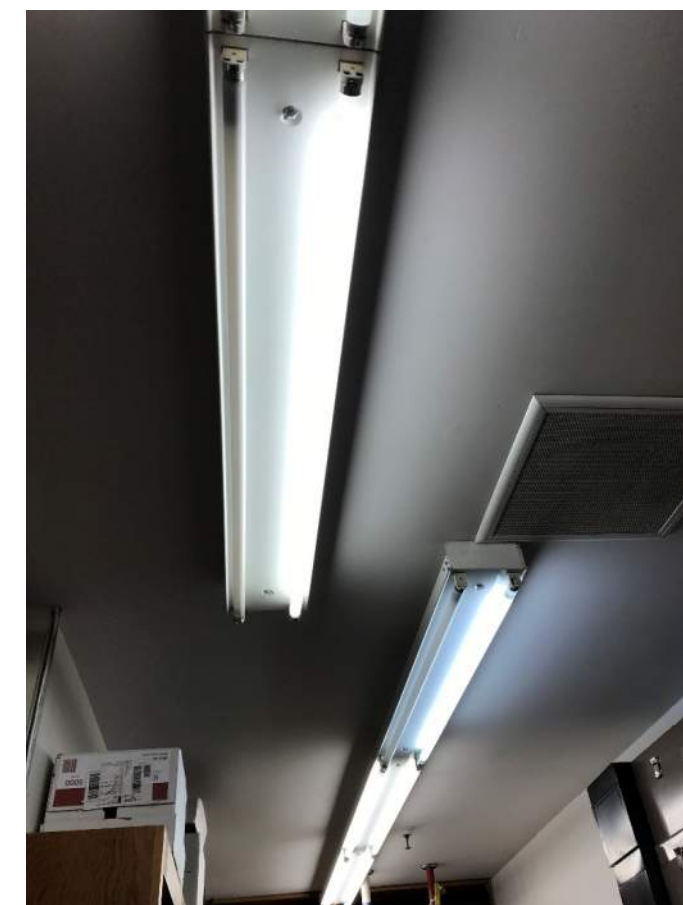
Interior Lighting is primarily fluorescent with T8 or T12 lamps at interior spaces in permanent buildings. Several light fixture lamps and lenses are missing, see attached photo LTG1. The lighting throughout the school campus is old and although there was no mention of complete failure, some light fixtures seemed original to the spaces, so they are likely near their “end of life”, especially with regards to efficiency. There were also several light fixtures in the classrooms that don’t work. Emergency lighting was not apparent at any classrooms, restrooms, or exterior landings. However, in multi-use spaces and hallways, bug-eye type stand-alone emergency light fixtures were installed. Occupant sensors and multilevel switching/dimming necessary for energy conservation is almost non-existent. Expected life; Unknown. It is recommended to retrofit campus wide lighting system with new LED technology in the near future. This would be a good opportunity for reduction in energy use from more efficient lighting fixtures, improved classroom lighting, smart lighting controls, daylight harvesting and would also reduce maintenance costs.

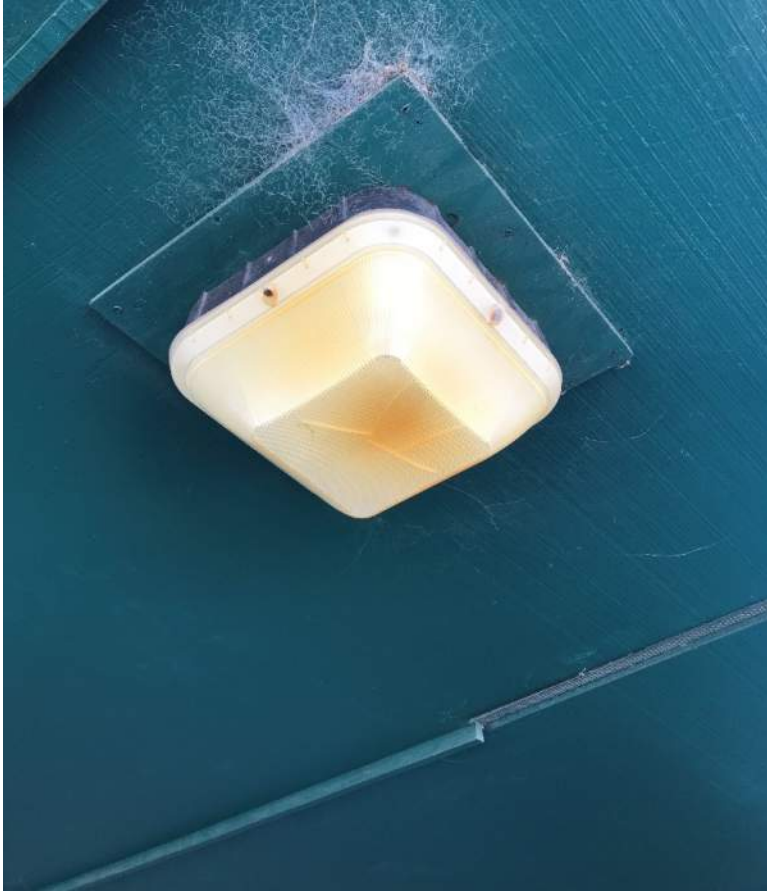
Exterior Lighting at the back parking lot is High Intensity Discharge (HID) lighting poles with a shoebox fixture head type. The front parking lot has no lighting poles other than building lights and one pole light which are not sufficient to illuminate the entire front parking lot and entry/exit driveways. Between buildings, where walkways are present, there are wall mounted fluorescent light fixtures throughout the main campus buildings. Exterior lighting is controlled via time clock or photocell for auto shut-off. There seems to be a lack of building perimeter lighting with respect to light out 10-15 feet away from buildings around the site (although there are residences that may be impacted by new

lighting, considerations of residences should be taken into account where new lighting is proposed. Where new lighting is to be installed, it will need to be controlled via an astronomic time clock or photocell. Motion sensor may be required per T24. Expected life of existing exterior lighting; unknown. See attached photo LTG2.

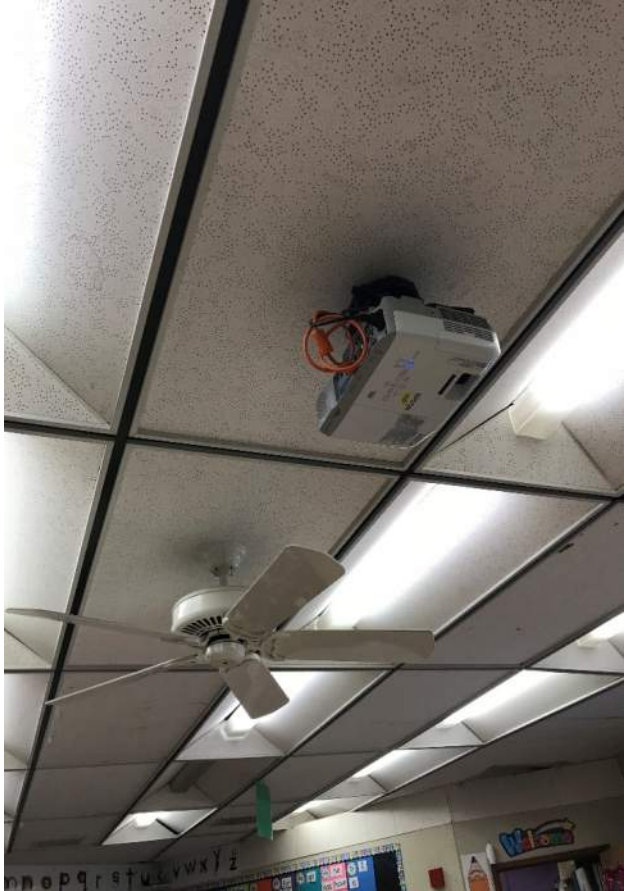
Most of the classrooms have ceiling mounted projectors with associated AV controls located near the teacher’s station. There are no ongoing problems. However, where projectors were installed on an accessible ceilings (TBAR), the associated receptacles were installed above the ceiling with cord passing through the T-BAR up to the receptacle. Current code does not allow this installation. Where classroom renovations occur, it is required to mount the receptacles exposed on the ceiling. See attached photo PROJECTOR1.
