**APPENDIX B**  
**Manhole Inspection Logs**

MANHOLE INSPECTION LOG  
Vernon, Connecticut

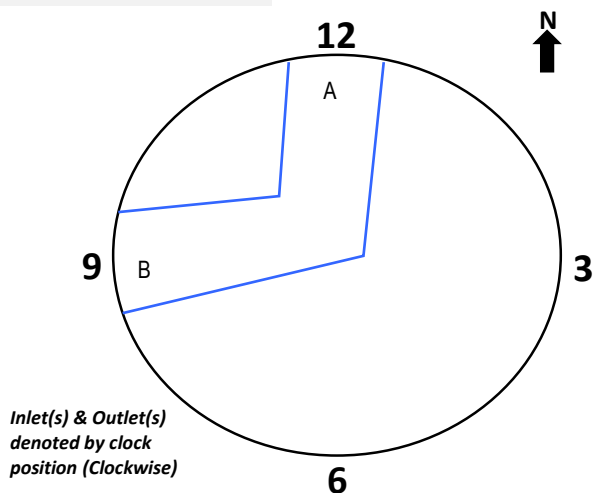
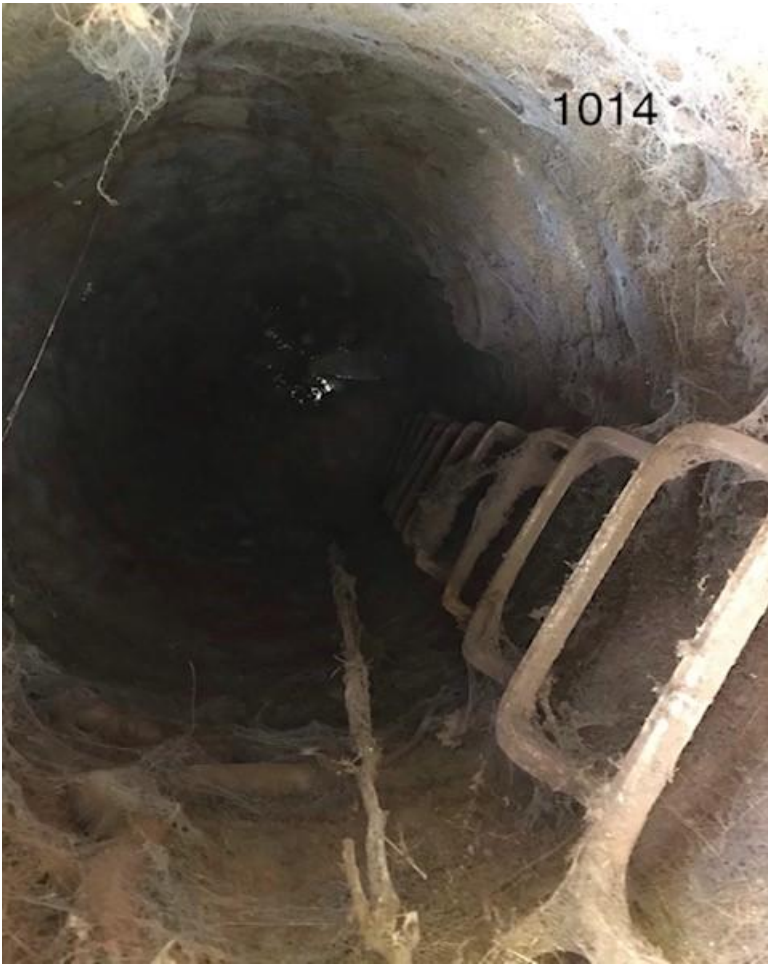
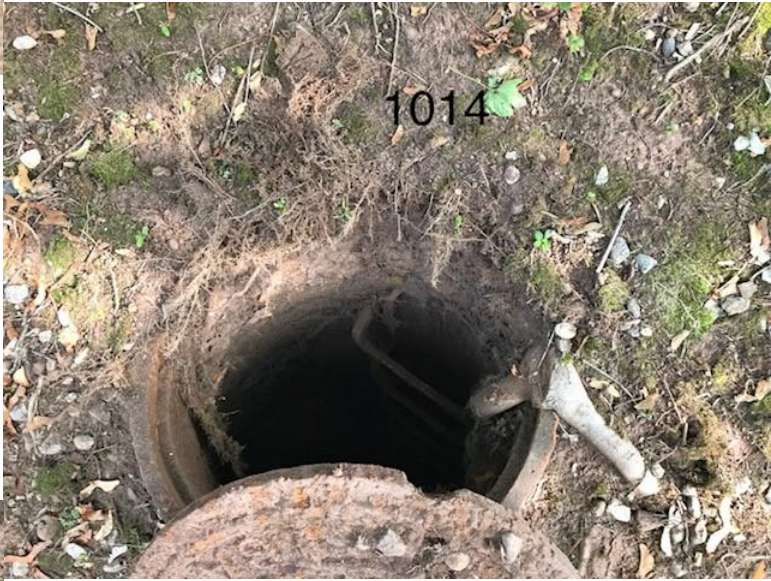
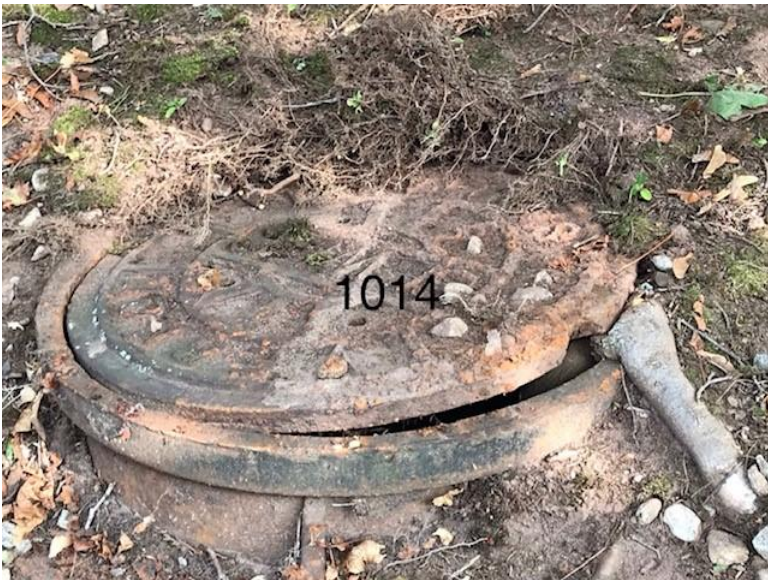
NEEDS ATTENTION, COVER DOESN'T FIT PROPERLY
