# 2021 DISTRICT WIDE BUILDING ENVELOPE ASSESSMENT

## Tamalpais Union High School District

BEAM Professionals  
2600 Tenth Street, Suite 700  
Berkeley, CA 94710  
Ph: (510) 460-1999  
[www.BEAMProf.com](http://www.BEAMProf.com)

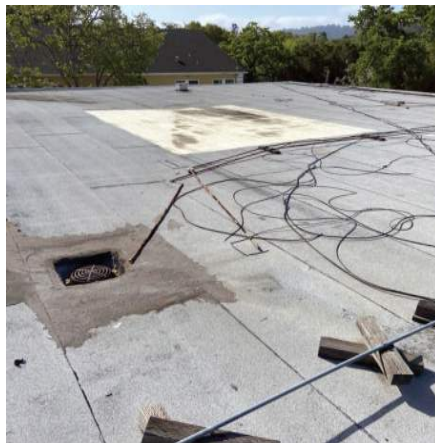
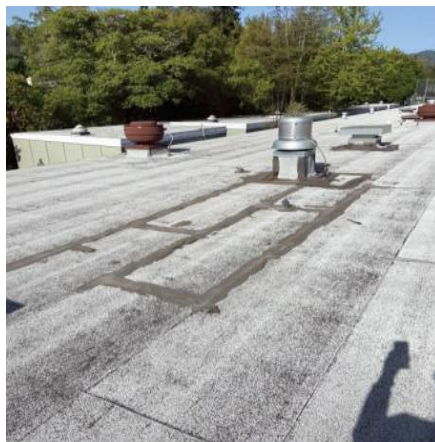
| 1 | Multiple lap repairs which indicate severe chasing water intrusion |

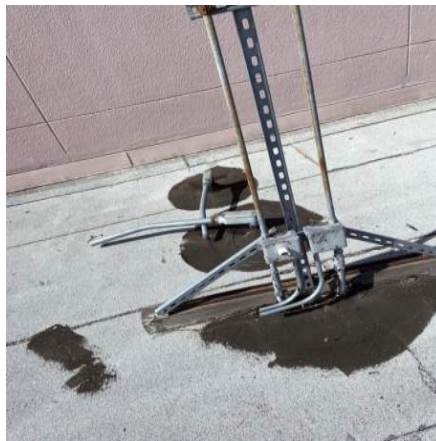
2 Mutiple pipe penetration repairs

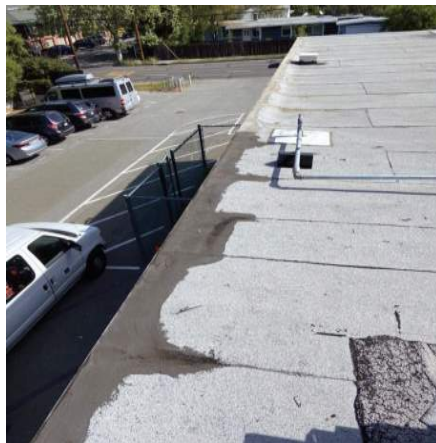
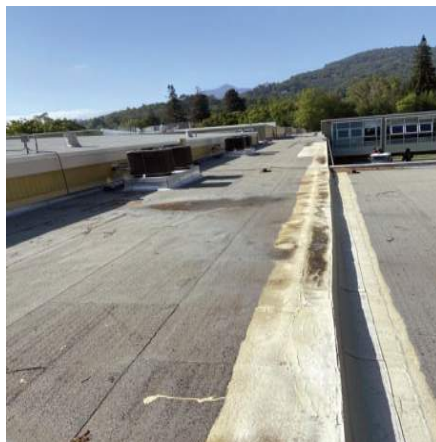
| 3 | Multiple perimeter edge lap repairs possible water intrusion |

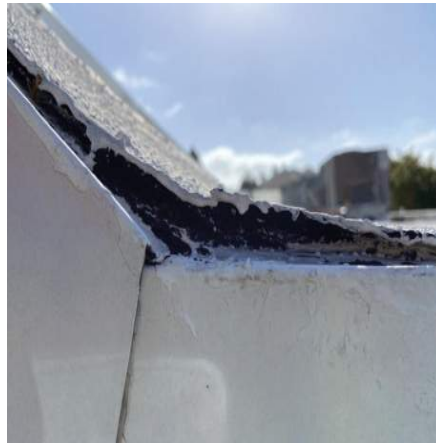
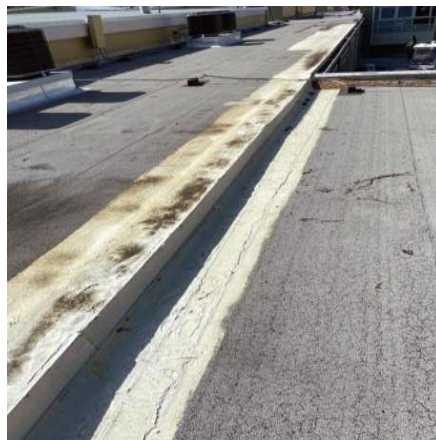
- 4 Transition areas have multiple repairs signs of poor drainage and failed flashing

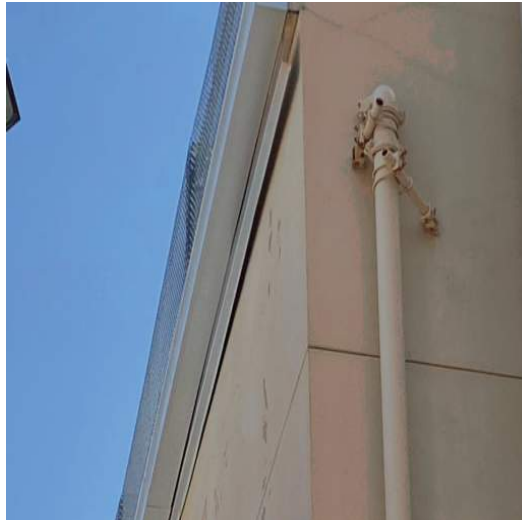
| 1 | Coping not engaged into cleat or secured to substrate |

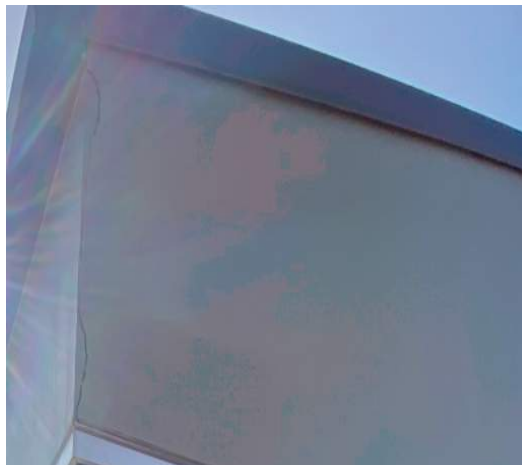
| 2 | Crack in substrate |

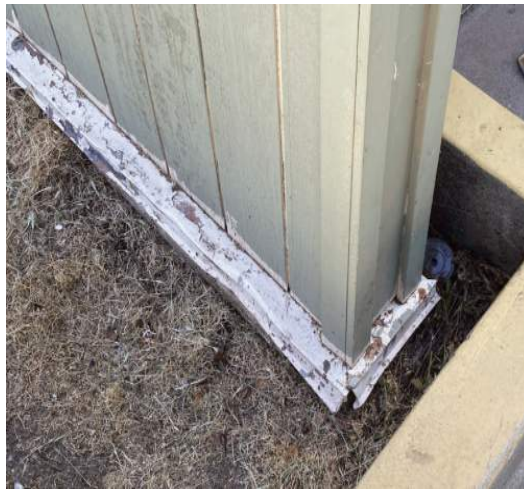
3 Deteriorating base flashing

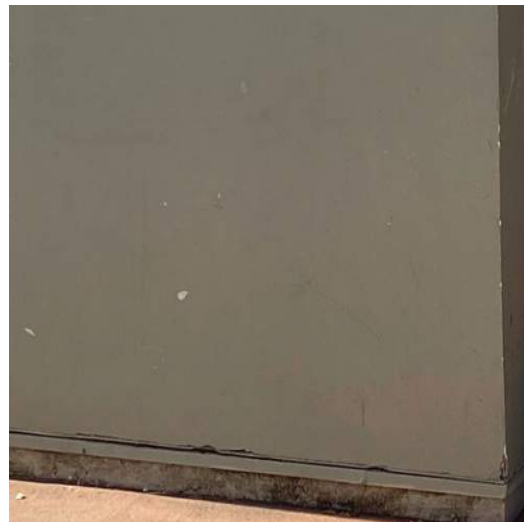
4 Damaged / chipped substrate at through wall flashing

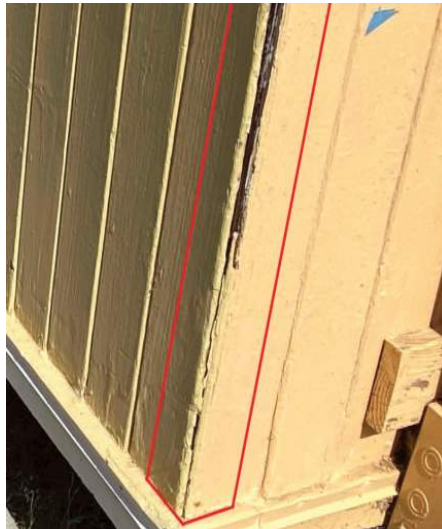
5 Degraded wall paneling / point of intrusion

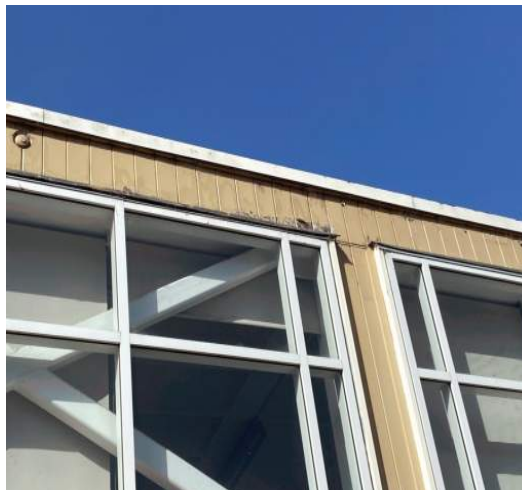
6 Head flashing at spandrel frame is lifting and allowing moisture within system.

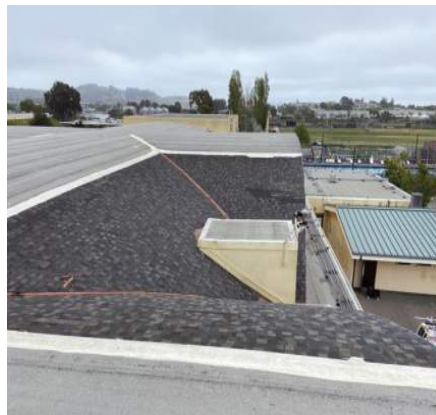
| Drawing Number | Comments |
|---|---|
| 1 | Mutiple repairs at transitions from mod bit to shingles and metal valleys at shingle roofs |

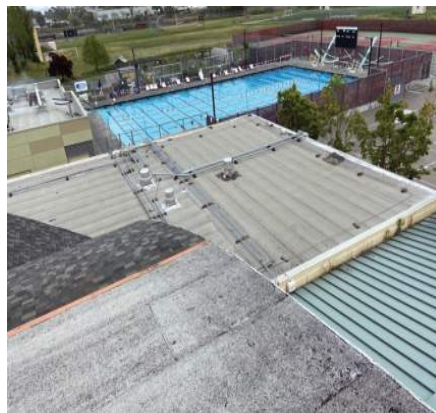
- 2 Multiple repairs made to drains and curbs

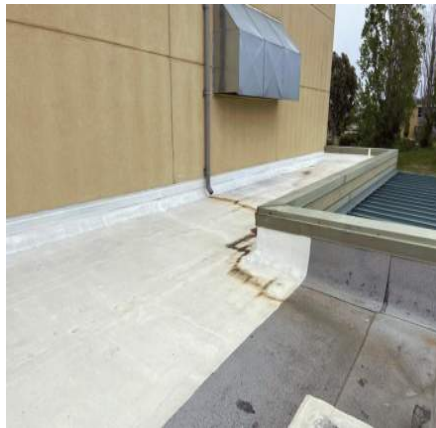
| 3 | Mutiple repairs made to base flashings, field membrane and laps |

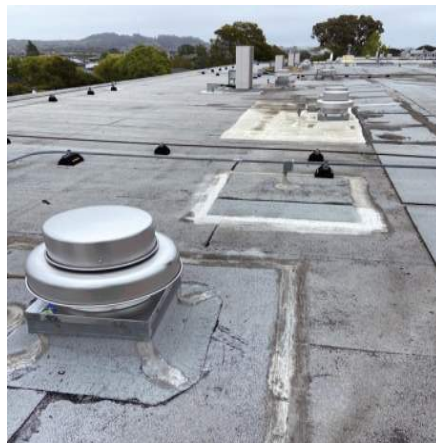
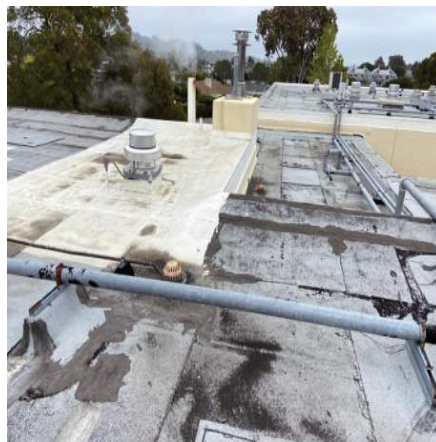
5 Multiple curb and field repairs

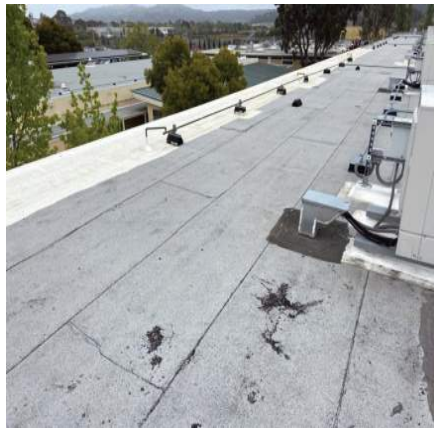
6 Multiple parimeter edge repairs

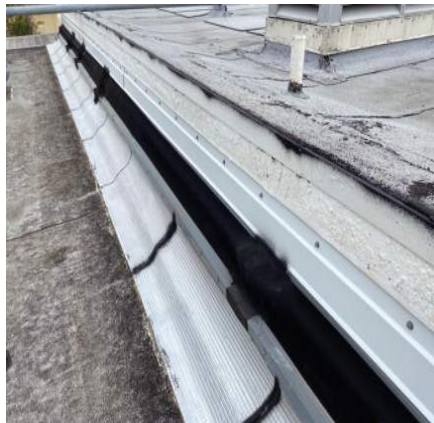
7 Multiple laps failing at Johns Mansville exspansion joints

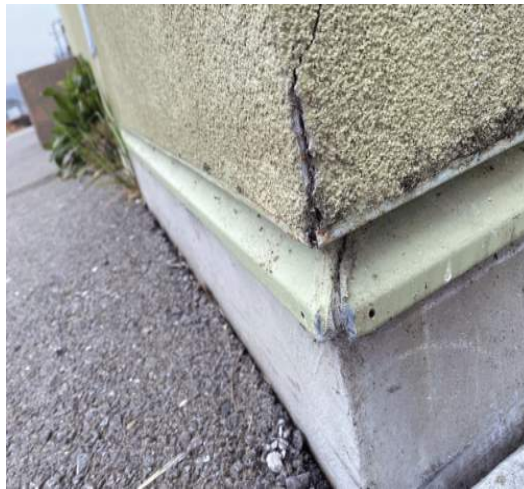
1 crack in though wall, counter flashing, stucco

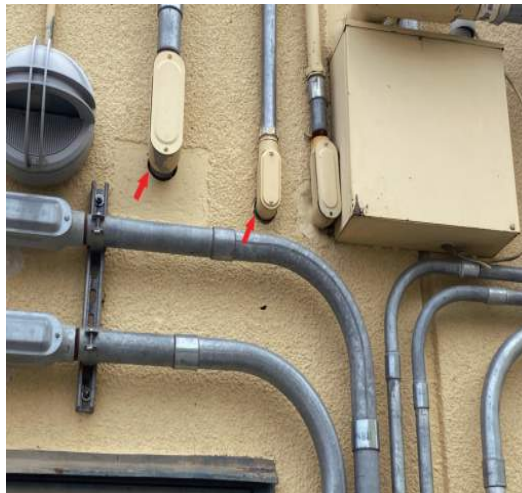
3 Wall penetrations unsealed

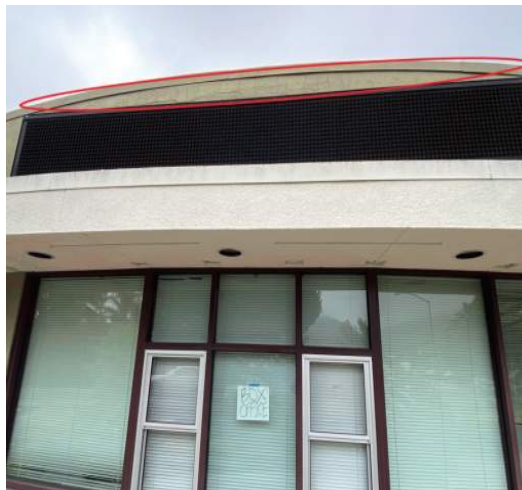
4 B3 cracks in stucco

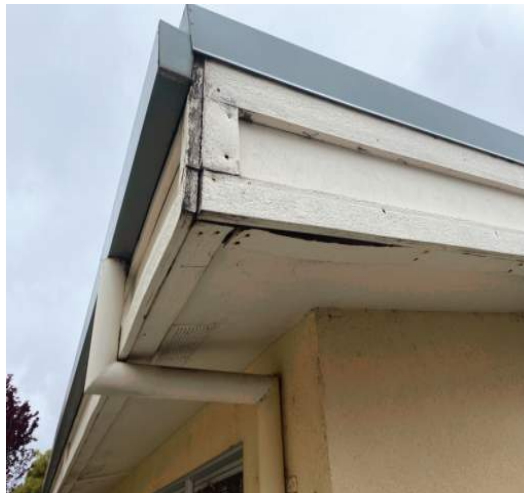
5 C2 fascia and soffit wood deteriorating

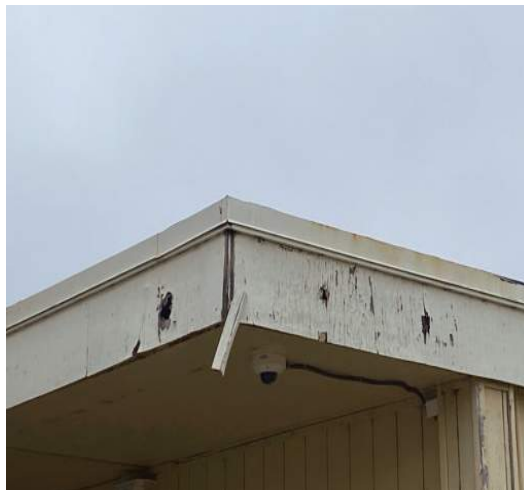
6 C3 fascia deteriorating

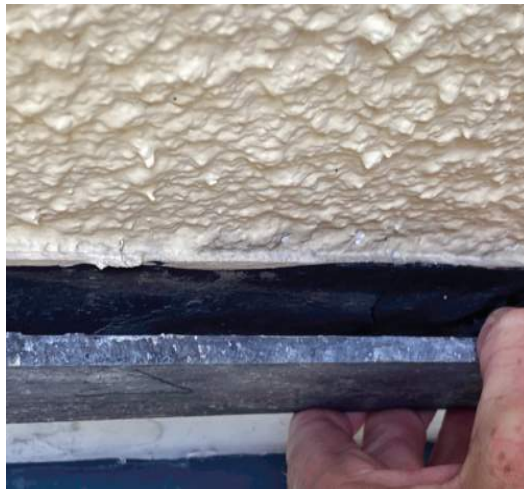
| 13 | Window frame paneling not sealed |

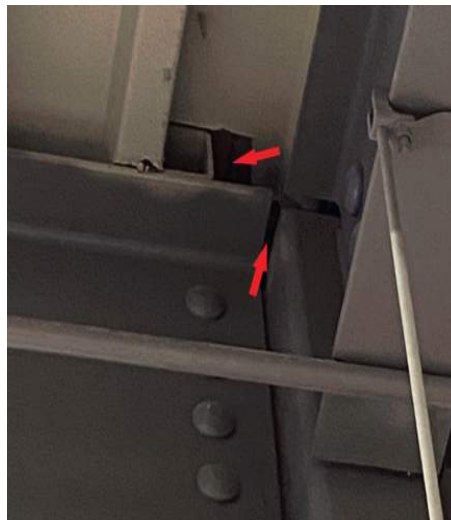
| 14 | Little Gym leak |

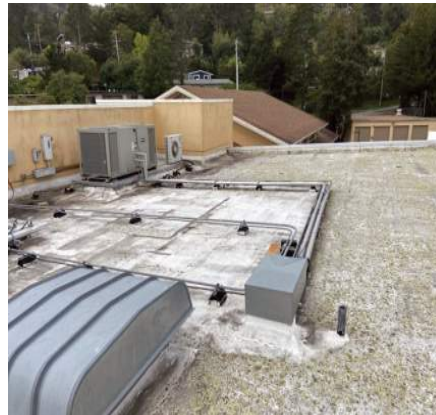
Overall condition of the roofs are in good to fair condition. Coating on modified bitumen roofs have signs of blisters due to water moisture trapped between coating and roof system.

| 1 | Blisters present on mod bit system from coating failing on J4, J6, J7, and J8 |

Performing Capitol Improvement repairs to the coating over the roof areas that are blistering as well as repairs to the exterior will help the useful life of the overall Building Envelope System.

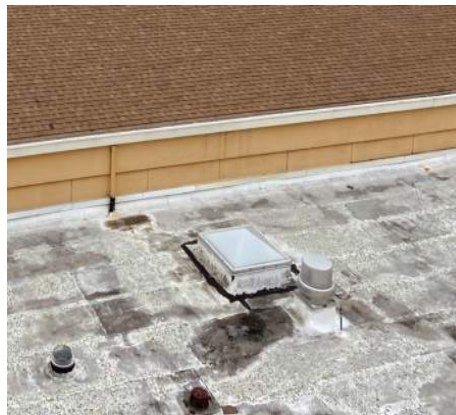
| Drawing Number | Comments |
|---|---|
| 3 | Mutiple repairs at curb flashings starting to separate and crack possible water intrusion |

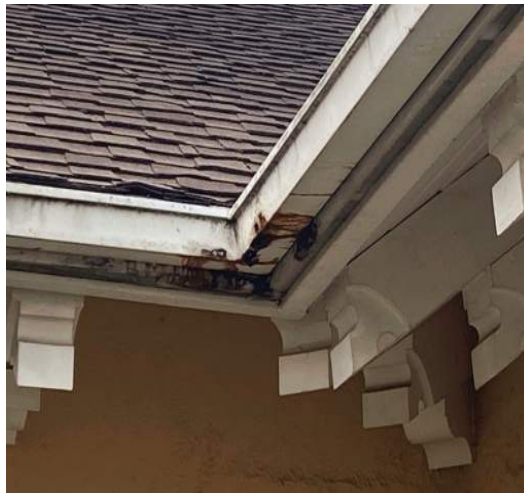
1 A1 - gutter deteriorating

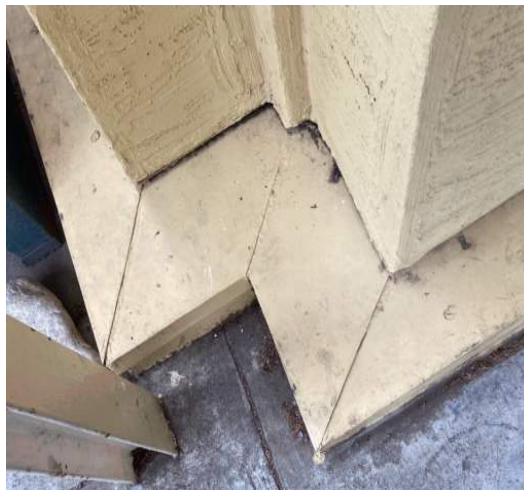
2 Loose unsealed counterflashing

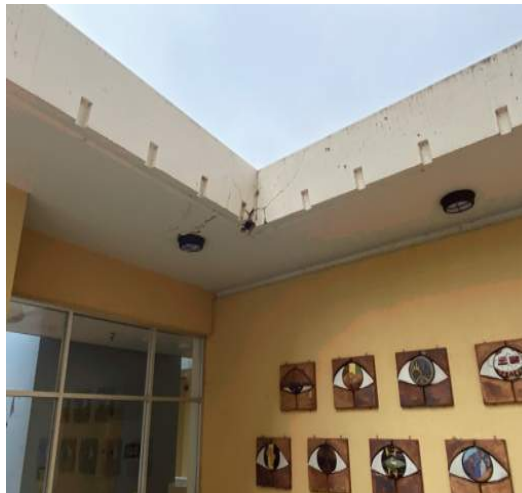
3 Cracked fascia and soffit

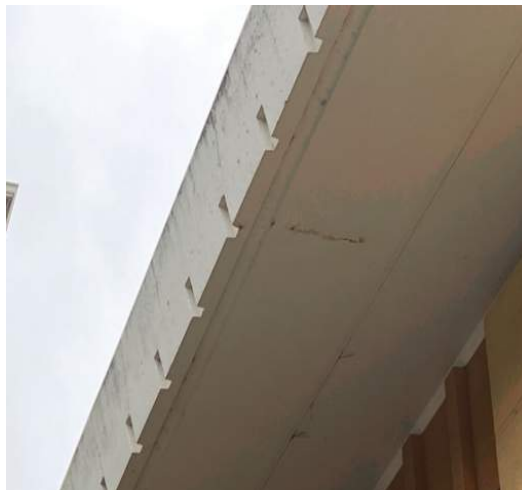
4 Cracks in parapet

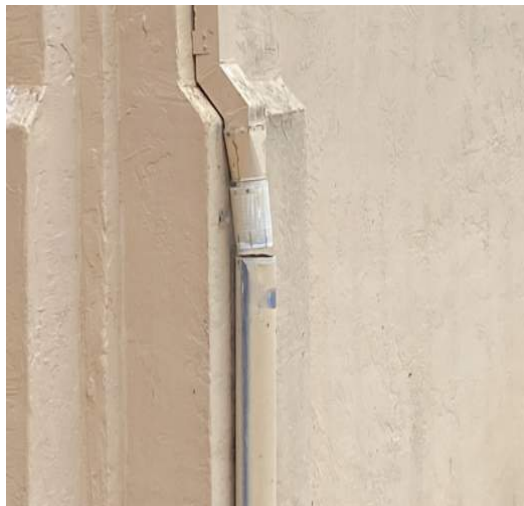
5 Damaged downspout

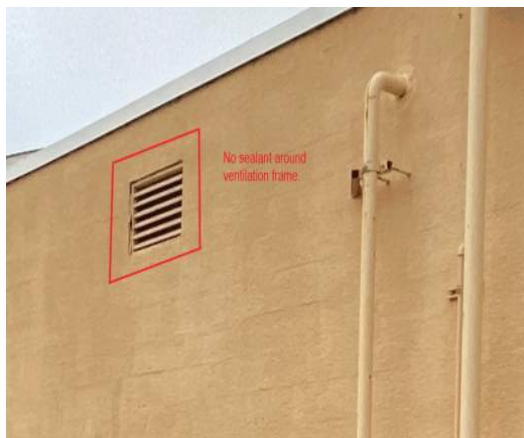
6 Degraded vent - no seal on edge water ingress

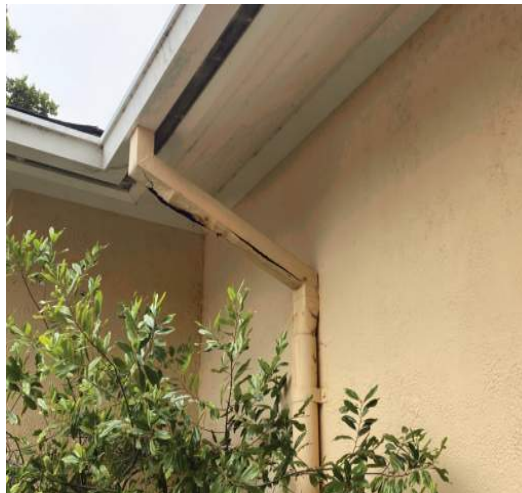
7      Downspout completely rusted through

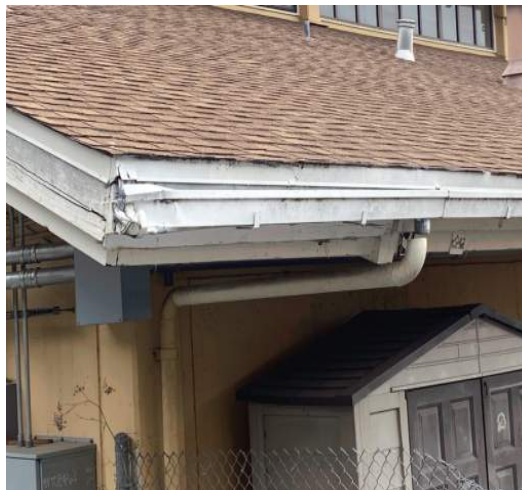
8      Gutter damaged

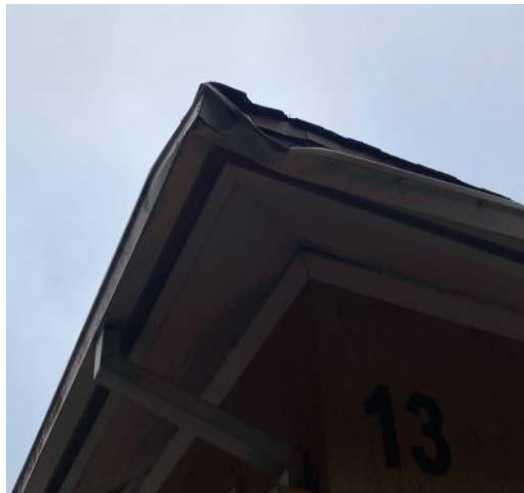
11 Damaged gutter

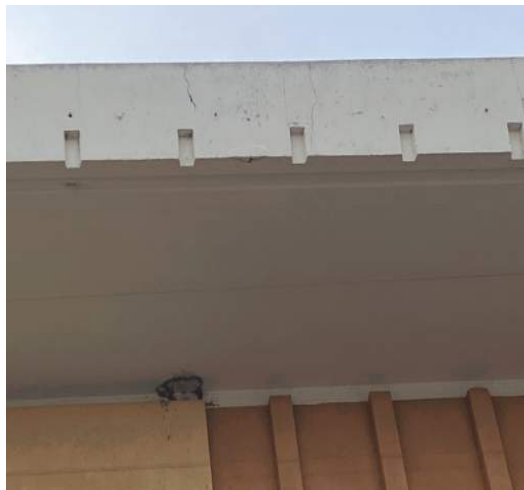
12 Cracks in parapet

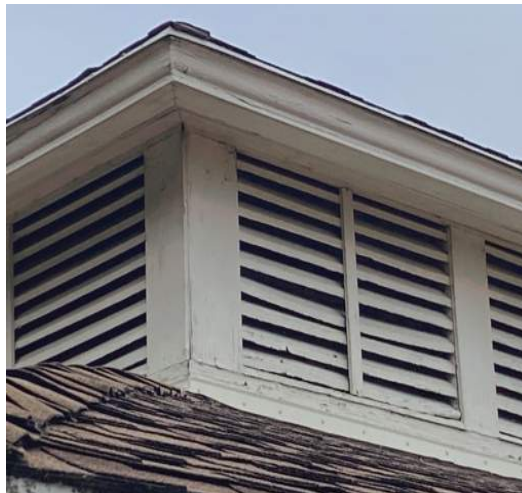
13 Warped and deteriorated wood

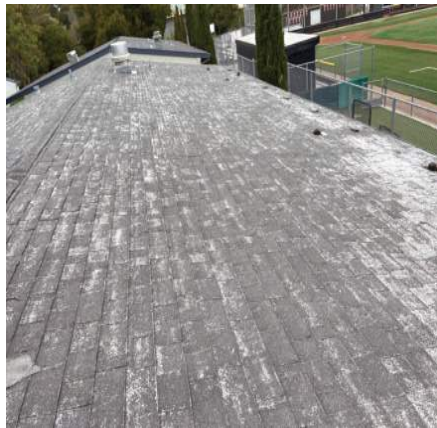
| 1 | Mutiple short term repairs made to shingle roof |

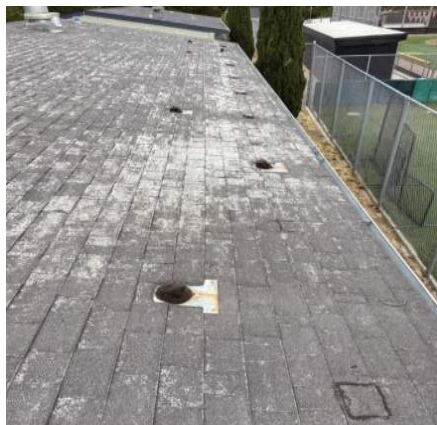
| 2 | Incorrect method of repair at abandoned pipe jacks and supports |

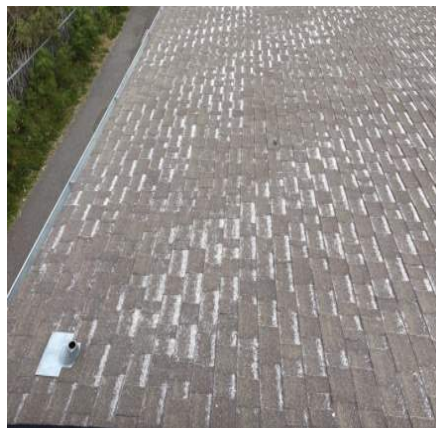
3 Severe granule loss at multiple locations

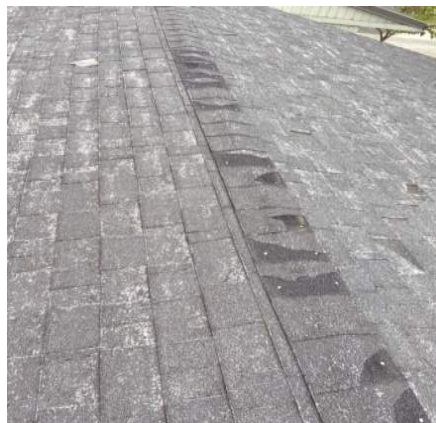
4 Multiple repairs attempted at ridge with exposed nails, leaving shiners

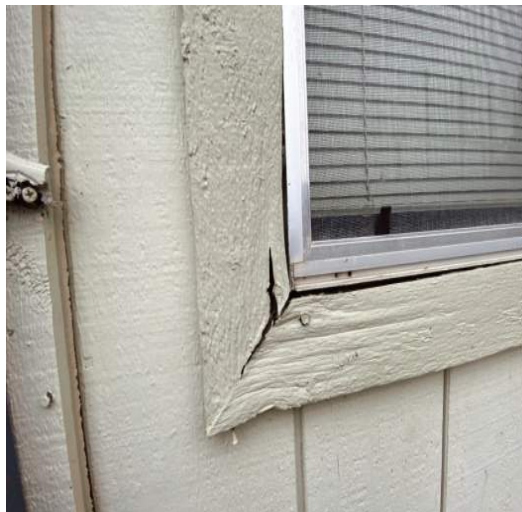
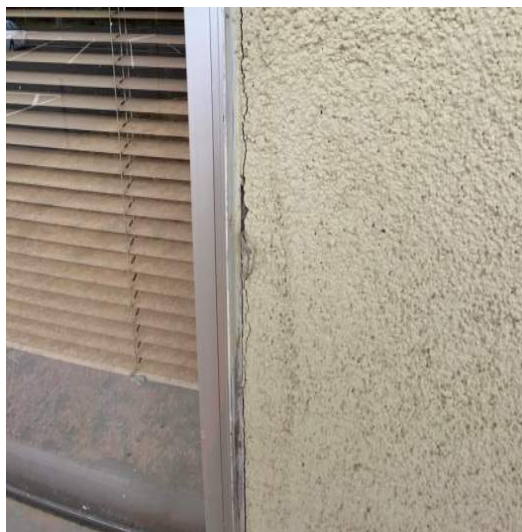
1 Crack at window seal

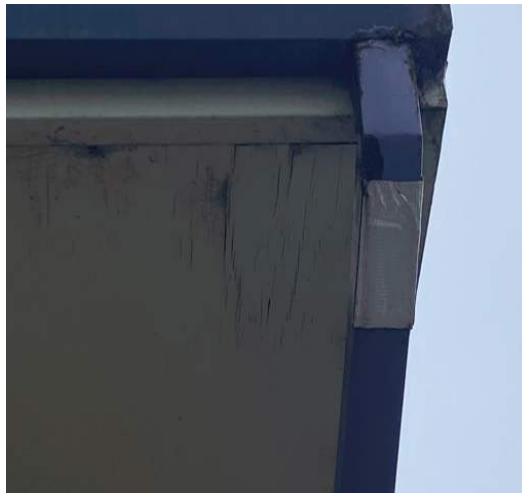
4 Rotten wood on soffit\_gutter deteriorating

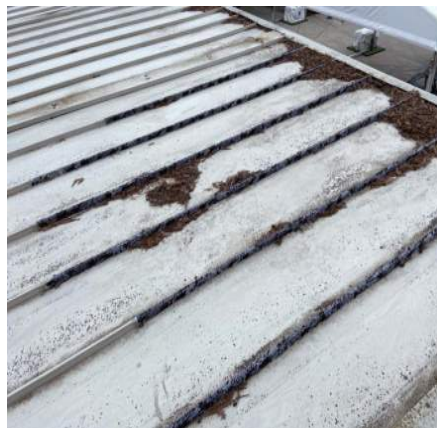
| 1 | Multiple standing seams appears to be uncrimped and have multiple repair attempts |

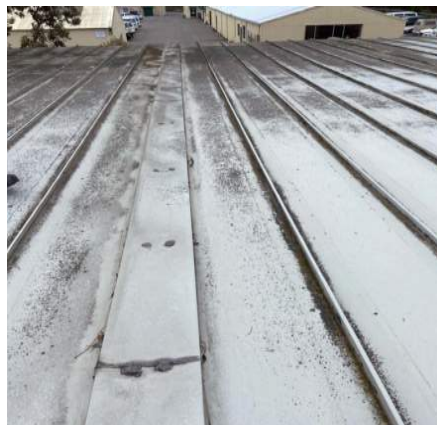
| 2 | Multiple attempts made to repairs failing expansion joints at multiple locations |

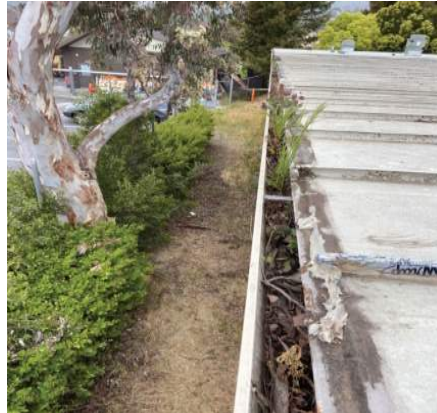
| 3 | Multiple edge metal locations had repairs that are failing, rusted out gutters |

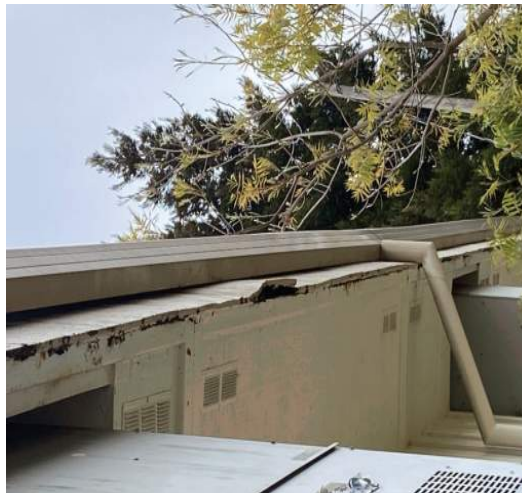
| Drawing Number | Comments |
|---|---|
| 3 | Fascia deteriorating |

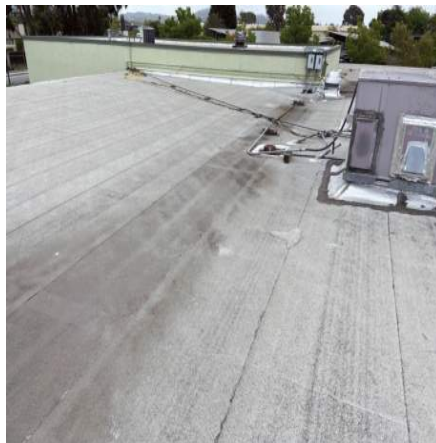
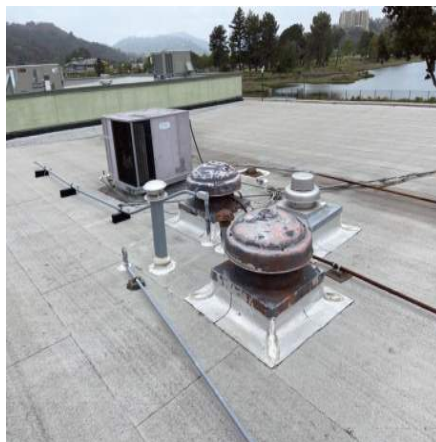
| 1 | Repairs found at curb base flashings and drains some are failing |

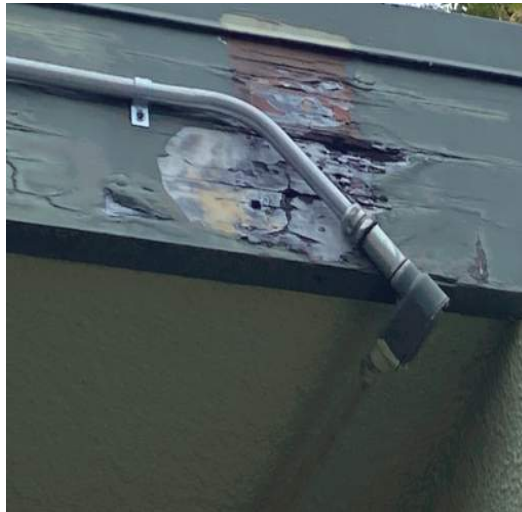
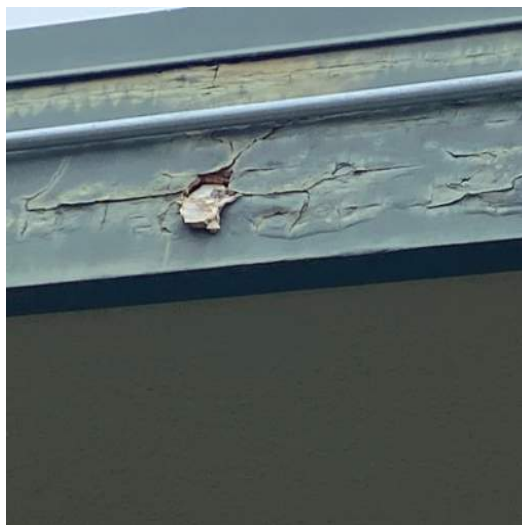
| Drawing Number | Comments |
|---|---|
| 3 | Wood fascia deteriorating |

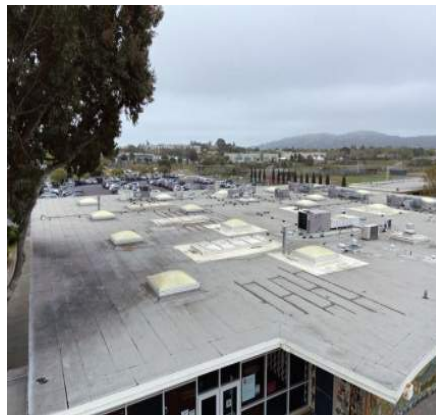
| Drawing Number | Comments |
|---|---|
| 1 | Multiple large repairs made to field membrane starting to separate causing possible water intrusion |

Reccomendation for this site is to replace the existing membrane throughout the site to help extend the useful life of the roof areas.

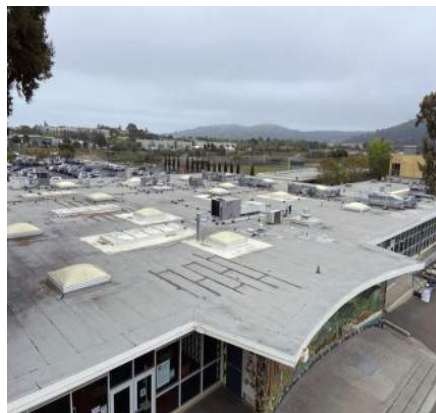
- 2 Multiple lap repairs are separating and causing possible water intrusion

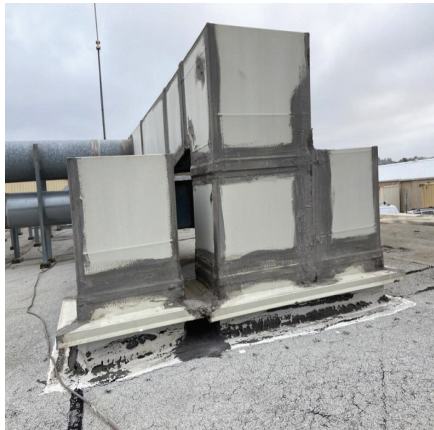
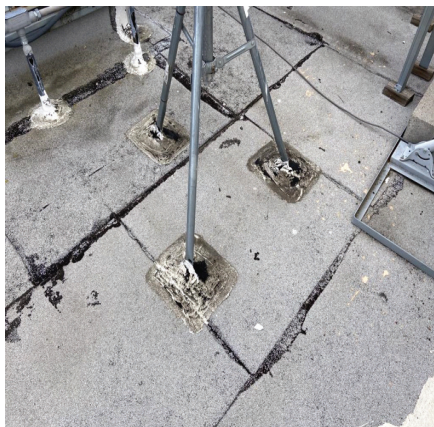
| Drawing Number | Comments |
|---|---|
| 1 | Multiple duct penetrations and pipe penetrations have repairs made to them are separating |

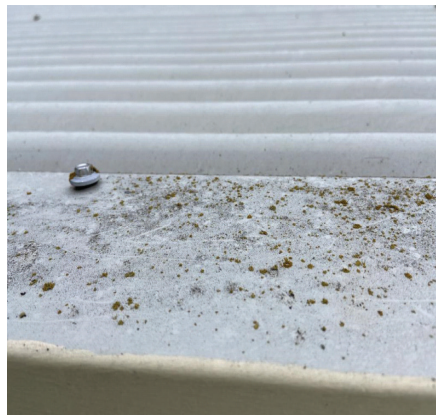
| Drawing Number | Comments |
|---|---|
| 2 | Multiple fasteners on corrugated metal roof appear to be backing out, neoprene washers are beginning to fail |

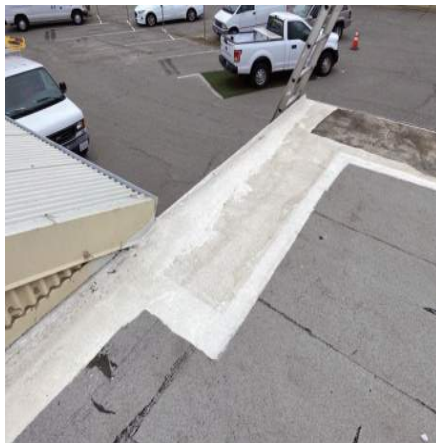
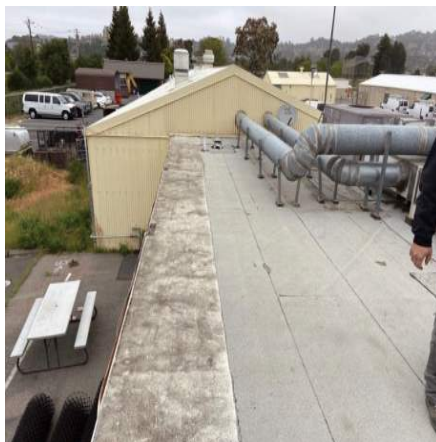
| 4 | Multiple repairs made to primeter edge are starting to fail |

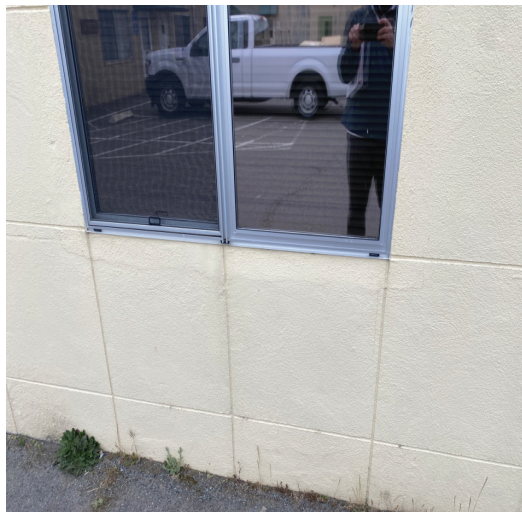
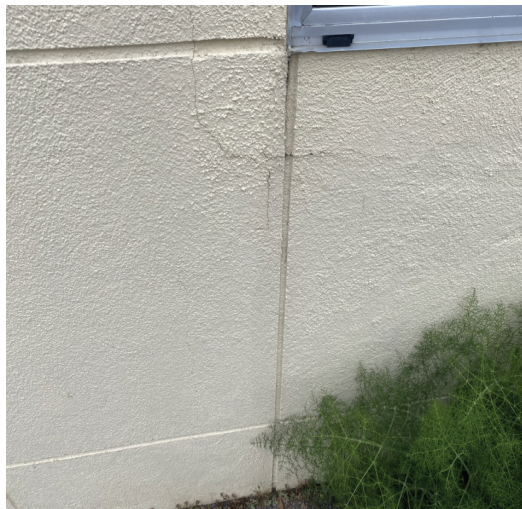
1 Stucco cracking

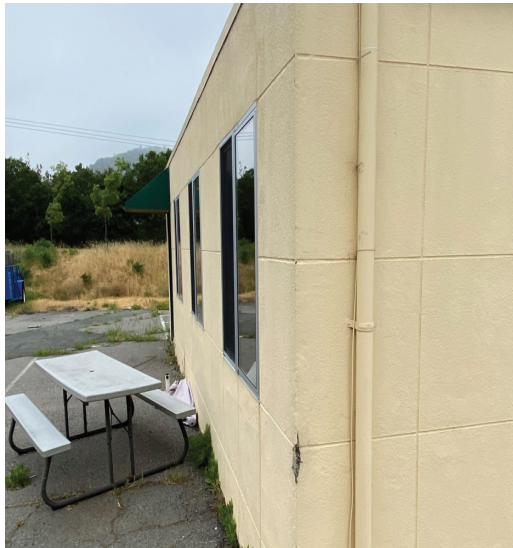
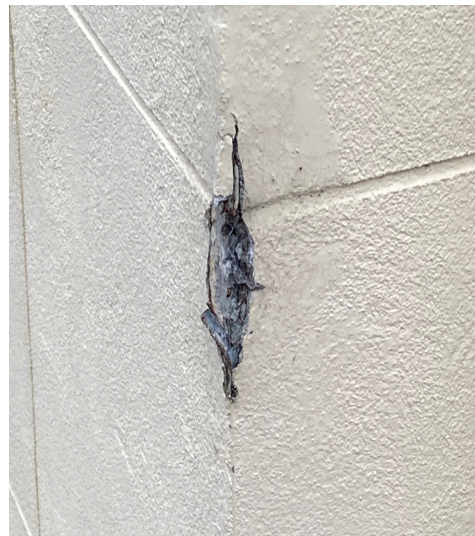
2      Damage to stucco

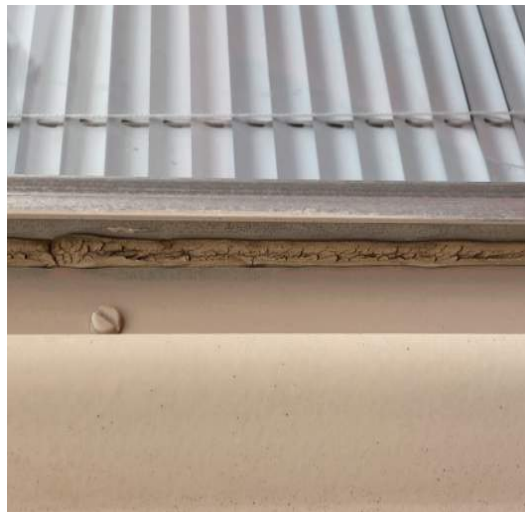
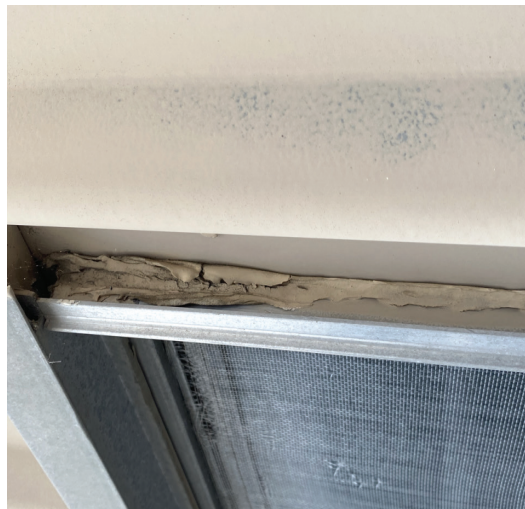
| 4 | Deteriorated caulking around window sills |
