**SITE ASSESSMENT  
FOR  
ADA COMPLIANCE**

**Red Hill Sports Complex  
Shaw Drive  
San Anselmo**

January 18, 2022

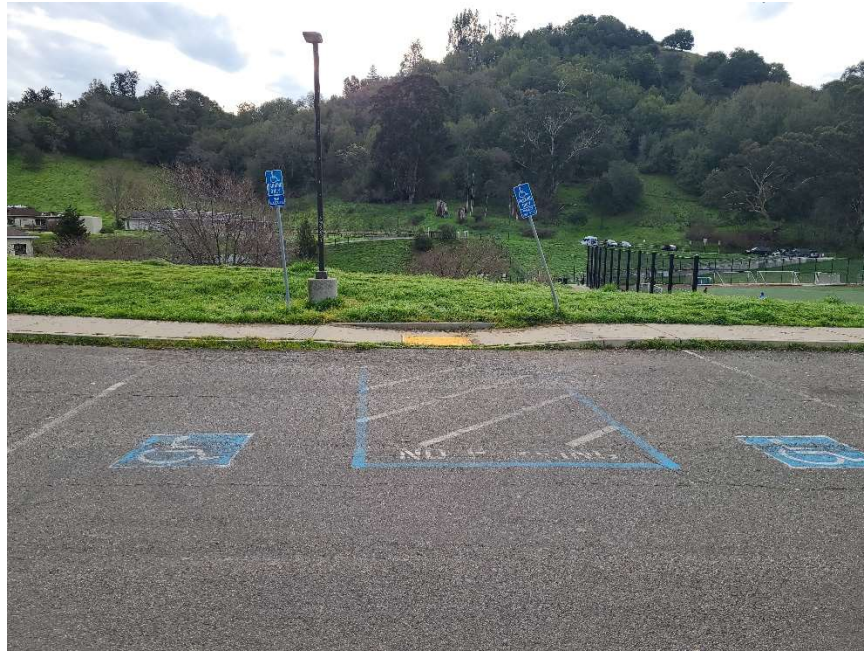
2. In the parking area on the northwest side of the park on Sunny Hills Drive the van accessible parking stall's signage is non-compliant, update signage on this parking stall. Otherwise, the depth of the stalls, striping and slopes are all in compliance.

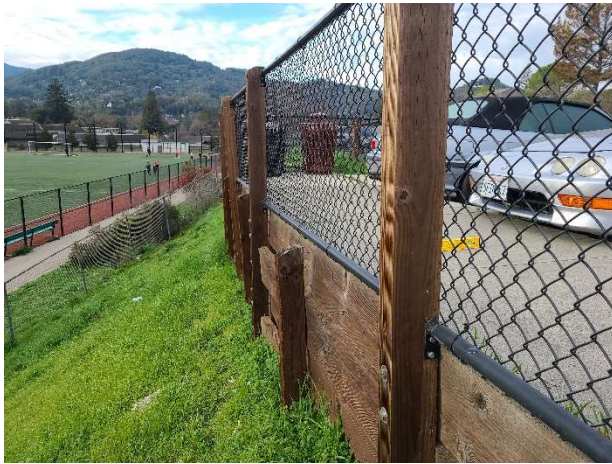
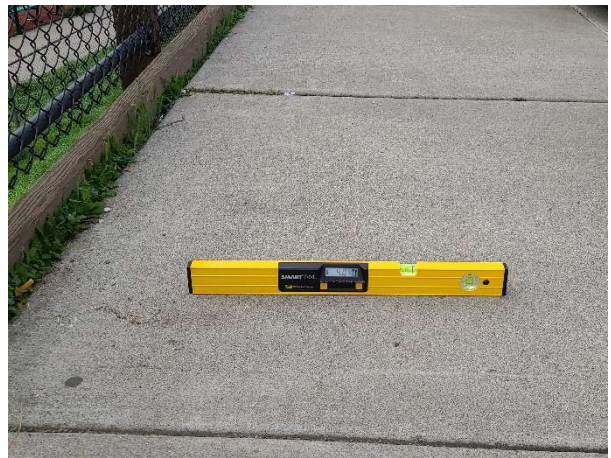
3. At the west end of the parking area on Sunny Hills Drive the retaining wall is failing. The subsequent subsidence has caused the cross slope of the pathway to become non-compliant. The cross slope at this point is 4%, a maximum cross slope of 2% is allowed, this section needs to be replaced.

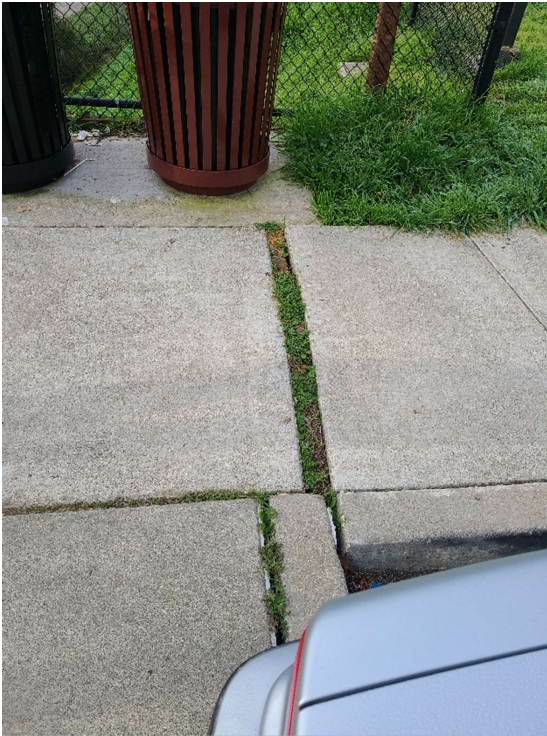
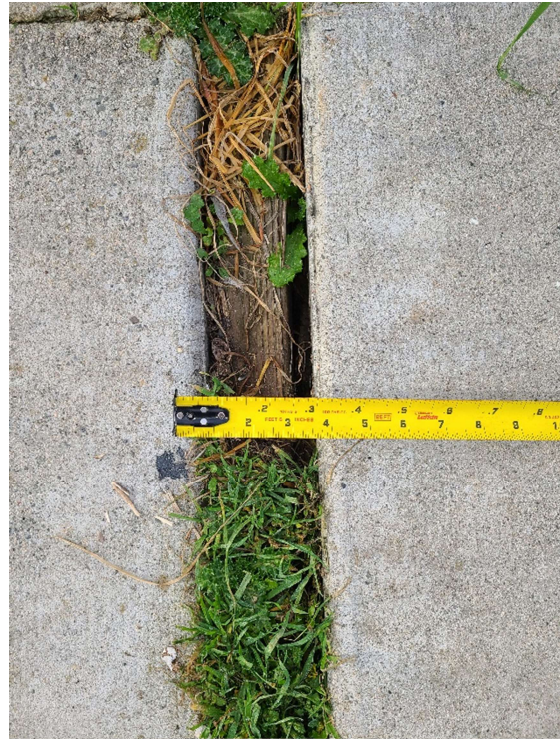
4. At the west end of the parking area on Sunny Hills Drive there is a significant gap in the concrete that is a trip hazard and non-compliant. Any cracks or chips over  $\frac{1}{4}$ " inch are not compliant with current ADA standards. This gap is at least 3" inches and needs to be fixed.

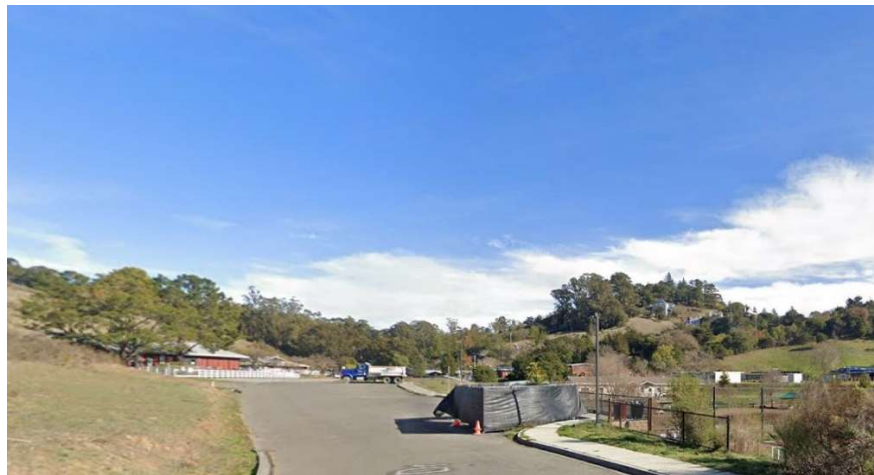
5. The entrance to the parking area is missing "tow away" signage regarding ADA parking stalls. Install a sign at the entrance to the parking area.

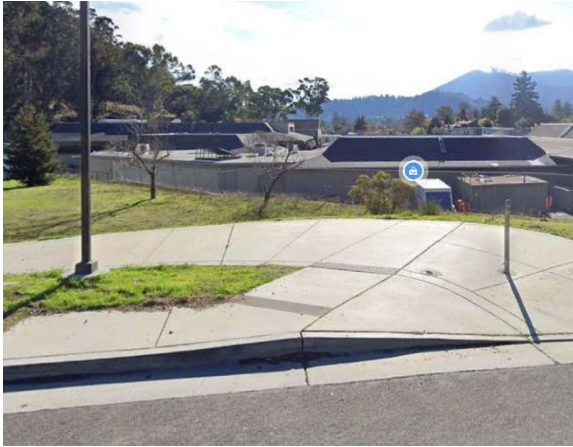
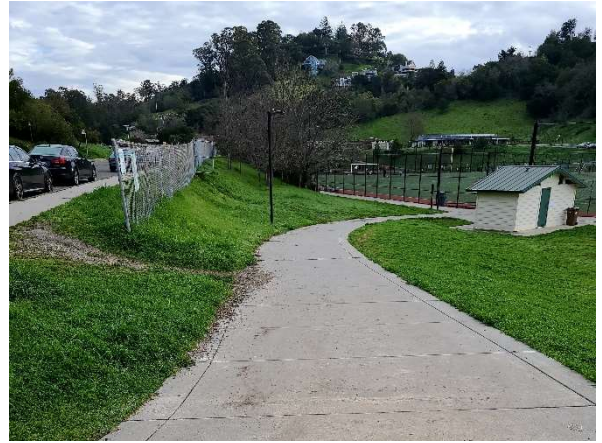
6. The top of the existing ramp at the west end of the athletic fields does not have a landing area. This section needs to be replaced to meet current standards. The downslope and cross-slope of the ramp are in compliance. The landing at the bottom of the ramp also is in compliance.

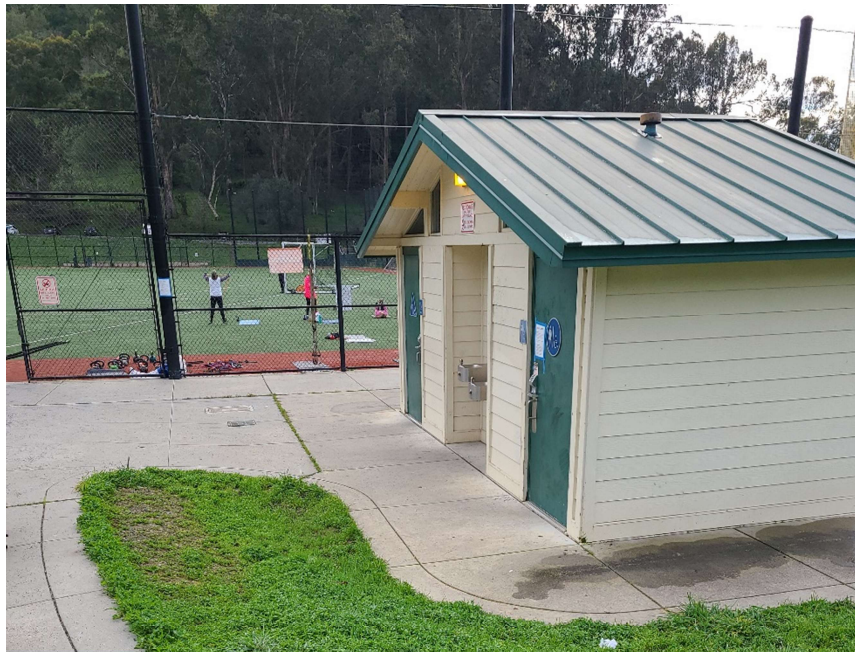
7. The proposed building was built without DSA permits and may need to be brought to current building codes.

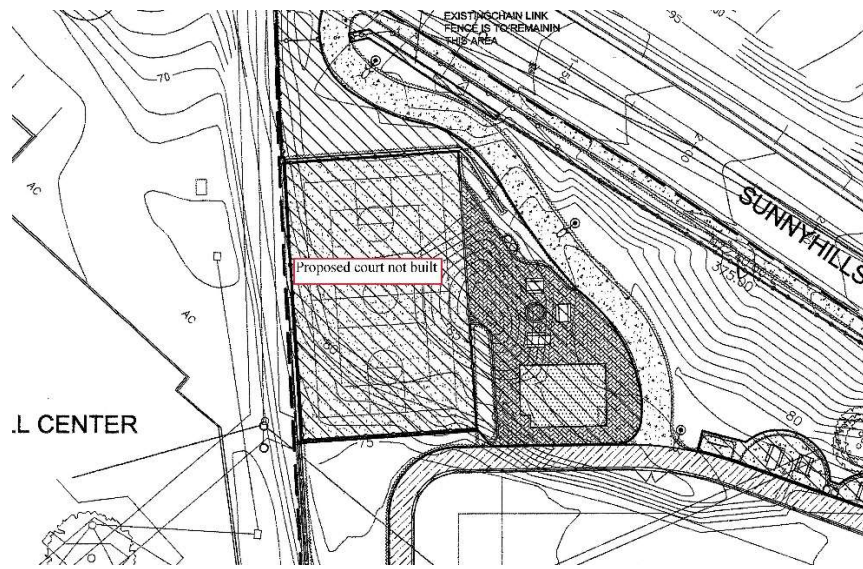
8. The proposed basketball court was not built.

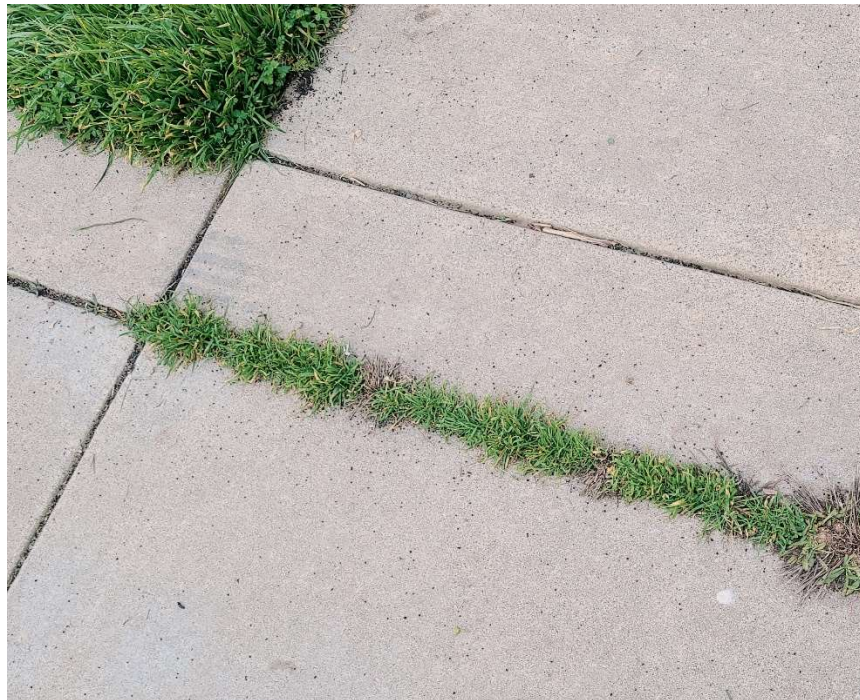
9. The path of travel on the northwest side of the athletic fields is generally in good repair. Check the walkway for cracks greater than 1/4" wide and fill with elastomeric crack sealer as needed.

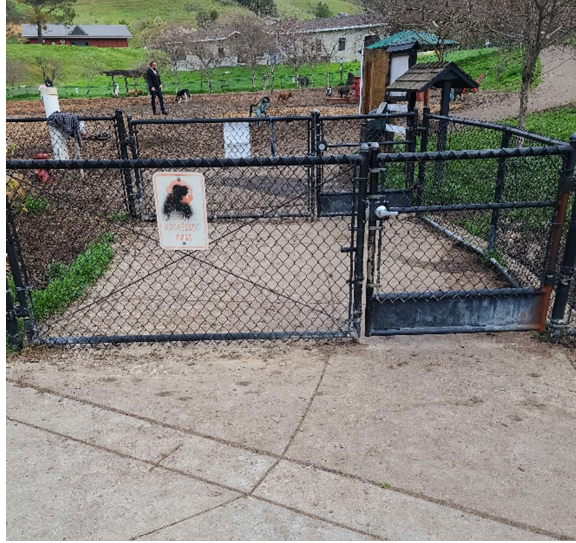
10. At the northeast end of the park there is a dog park, we did not check the hardware or size of the gates for compliance nor did we check the surface material inside the dog park for compliance.

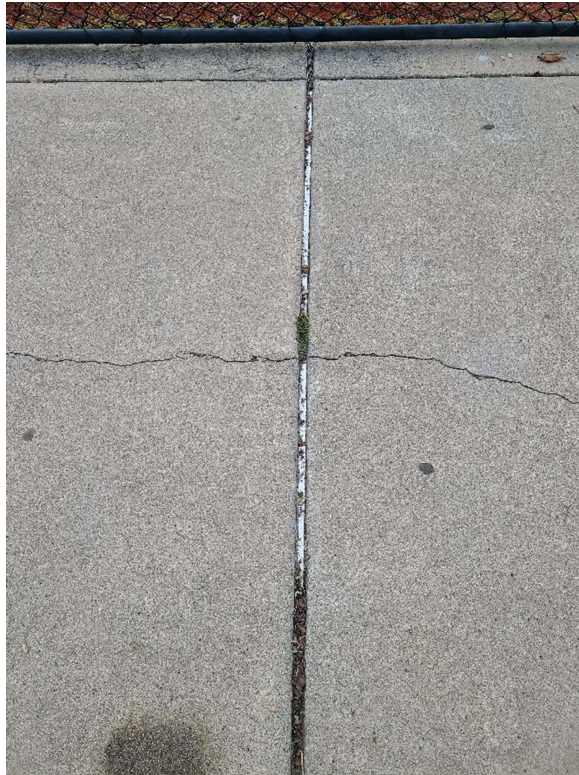
11. The path of travel at the northeast end of the athletic field is generally in good repair. Check the walkway for cracks greater than  $\frac{1}{4}$ " wide and fill with elastomeric crack sealer as needed.

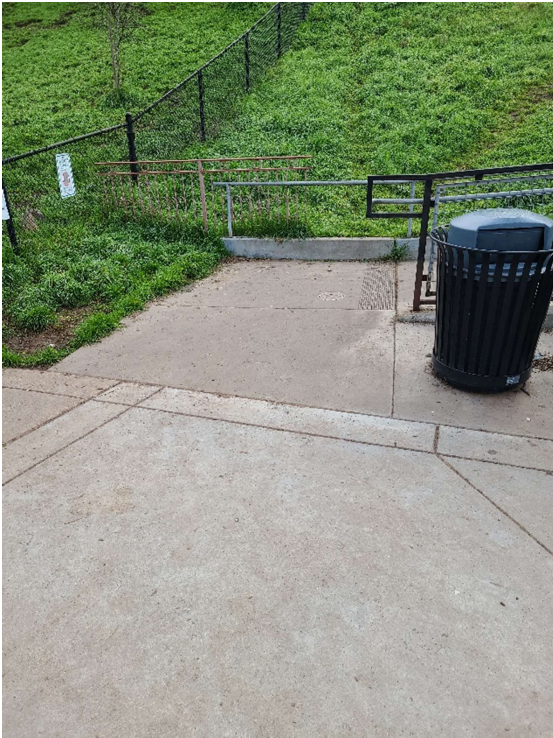
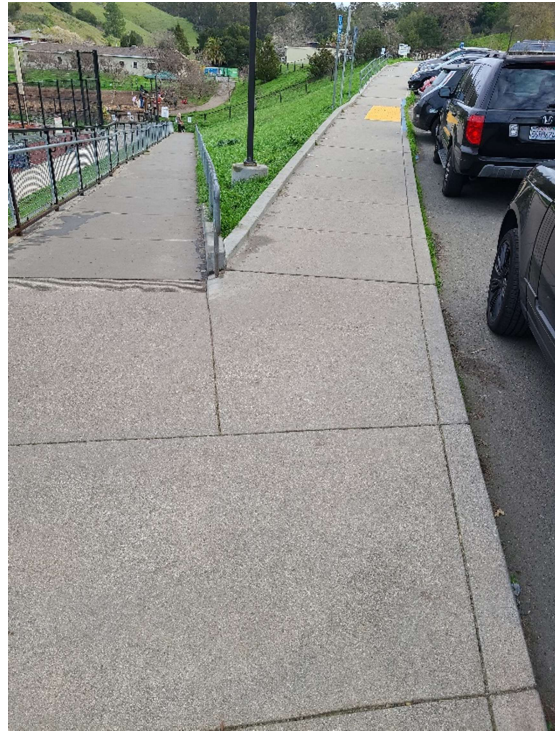
12. At the southeast end of the athletic fields there is a ramp up to the parking area on Shaw Drive. The downslope on a ramp with handrails can be no greater than 8.3%. This ramp has several areas where the downslope is greater than 8.3%, some areas are as much as 9.3%. The cross slope on the bottom landing and the first landing as you go up is greater than the allowable 2% maximum. When this ramp was installed the overall slope might have been in compliance but it appears some subsidence is occurring to change the ramp's slope. This ramp will need to be replaced to meet current standards.

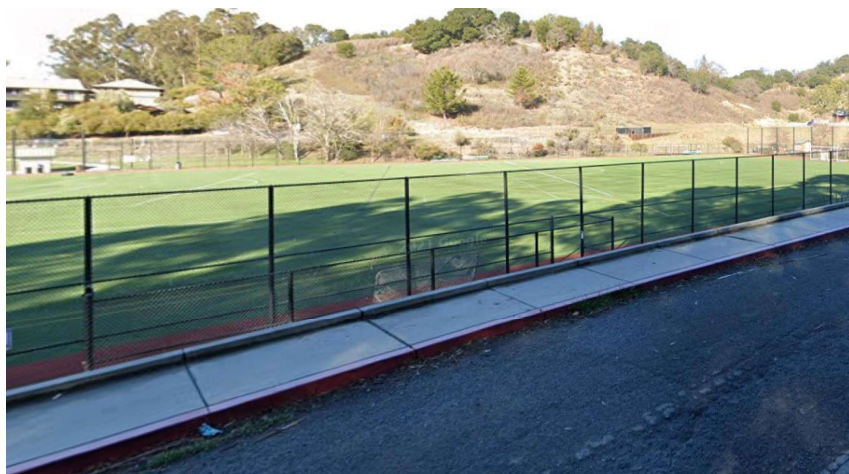
13. The path of travel in the parking area on Shaw Drive is generally in good repair. Check the walkway for cracks greater than 1/4" wide and fill with elastomeric crack sealer as needed.

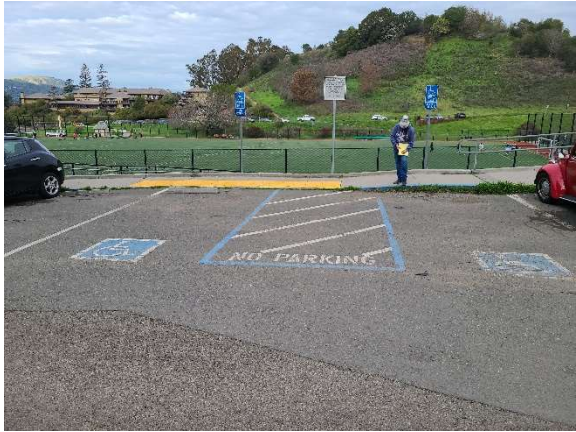
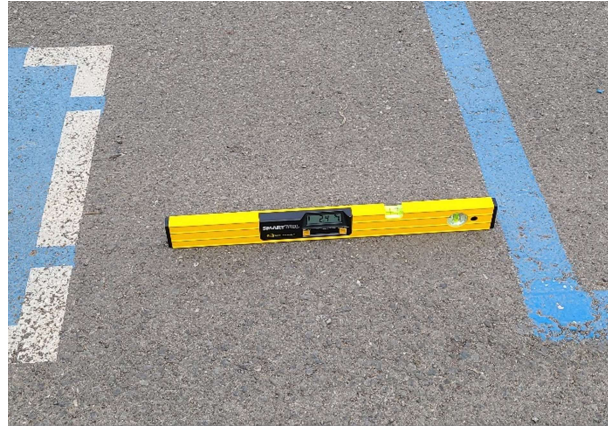
14. In the parking area on the southeast side of the park on Shaw Drive the van accessible parking stall's signage is non-compliant, update signage on this parking stall. The back side of the van accessible stall has a cross slope greater than 2% and will need to be fixed. The "tow-away" sign at this area needs to be moved to the entrance of the parking area. The non-van stall is compliant with depth, striping and slopes but the wheel stop at the front is missing and needs to be replaced.

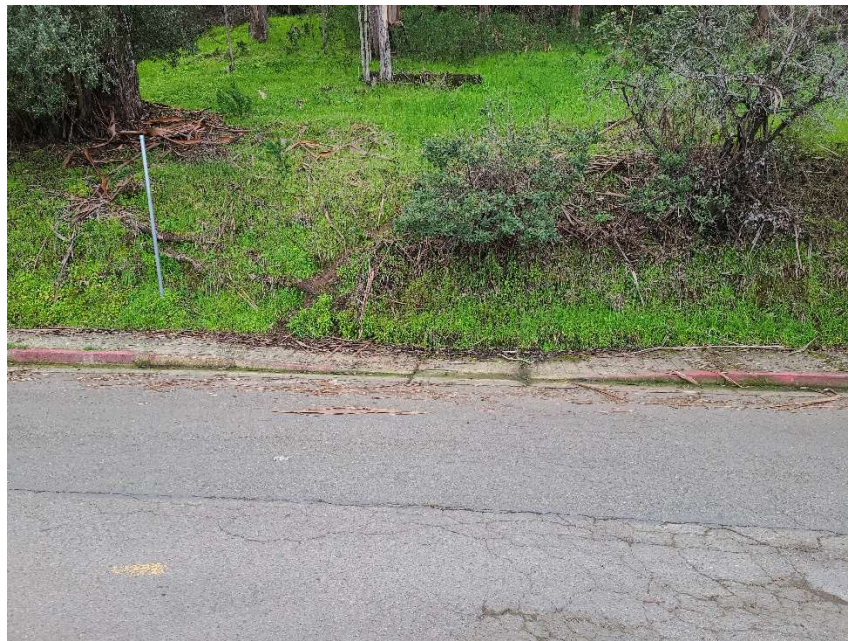
15. At the west end of the parking area on Shaw Drive there is an accessible ramp that looks to be unused that is non-compliant. There should also be a cross walk installed from that ramp to the path of travel entering the sports complex.

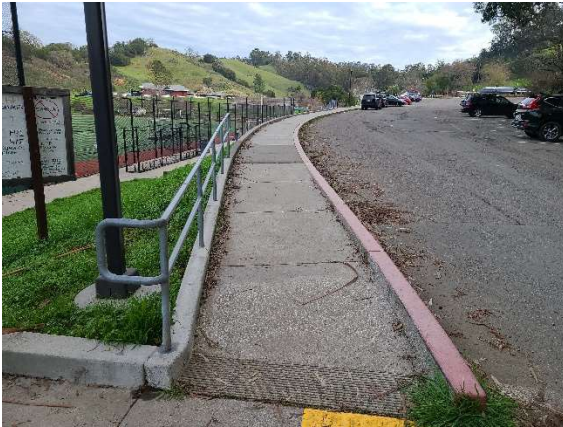
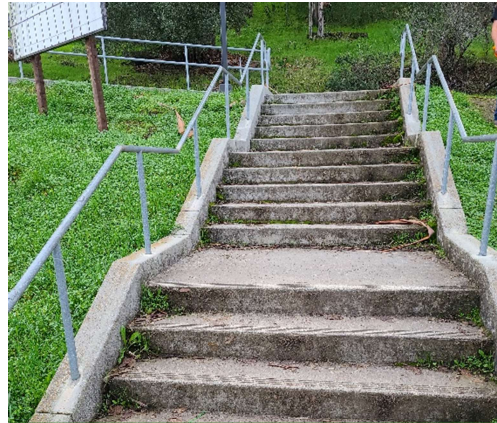
16. The curb ramp at the entrance to the parking area on Shaw Drive has a cross-slope of 3.6% which is non-compliant and should be replaced. The stairs leading down into the sports complex are in generally good repair and are in compliance.

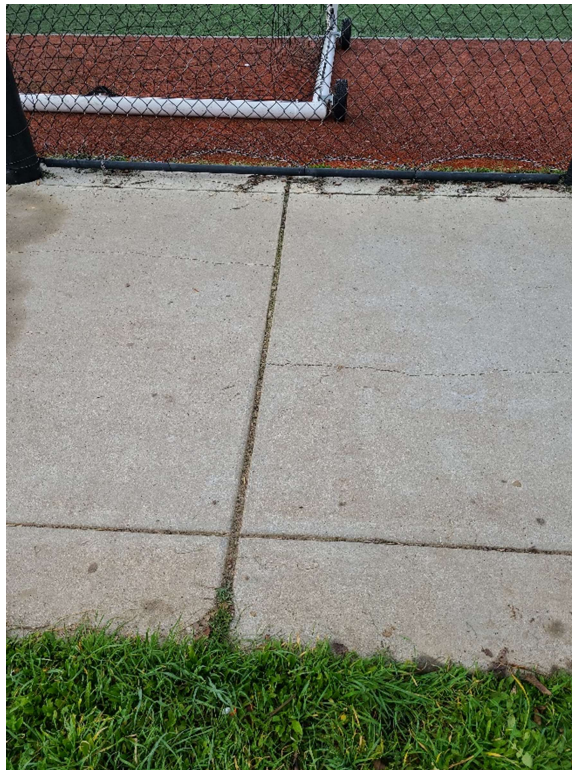
17. The path of travel on the southeast side of the athletic fields is generally in good repair. Check the walkway for cracks greater than 1/4" wide and fill with elastomeric crack sealer as needed.

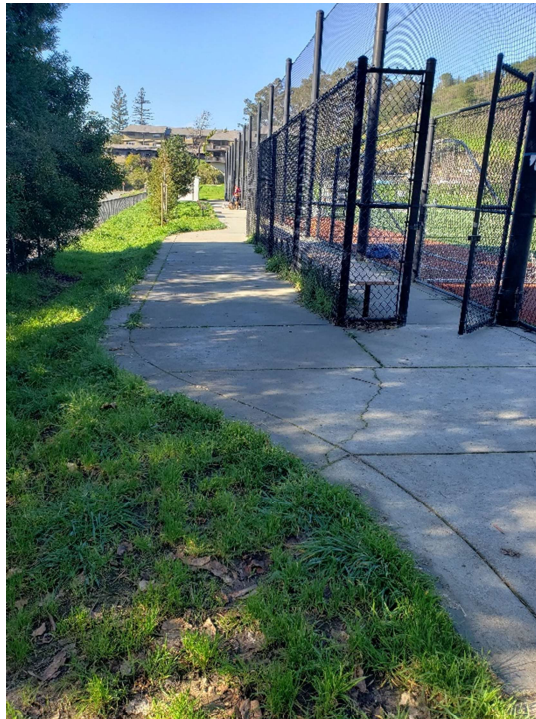
18. The path of travel on the southwest side of the athletic fields from the dugout toward Sunny Hills Drive has experienced some subsidence which has caused the cross-slope of the path to become non-compliant, some areas reaching as much as 2.7%. This section of walkway should be replaced to meet current standards.

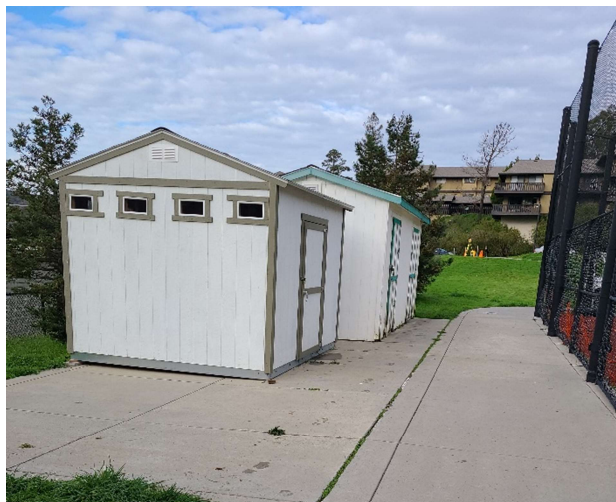
19. The compliance is unknown on the two (2) portable buildings located on the concrete pad at the west end of the athletic fields.

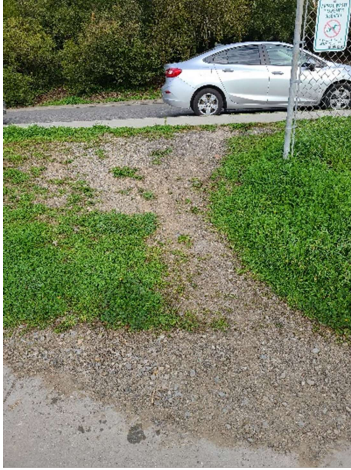
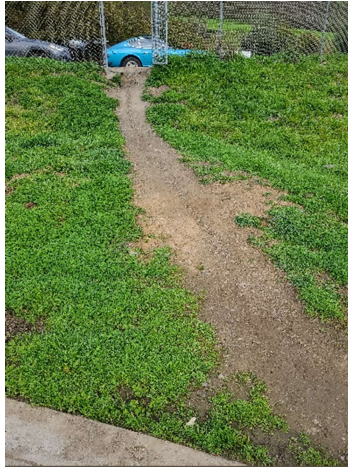
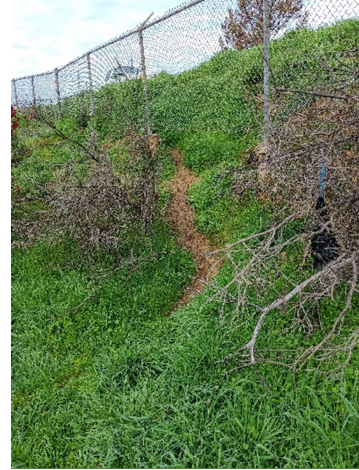
20. On Sunny Hills Drive there are three areas where people are avoiding the paths and entering the park in an unsafe manner. One area people are turning just past the end of the fence and connecting with the path of travel. The second area is an open gate in the fence where people are walking down a steep washed out grade down into the park. The third and possibly most dangerous, people are coming under the fence.

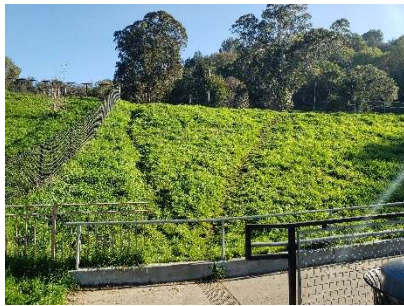
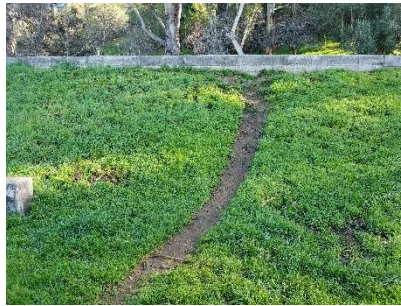
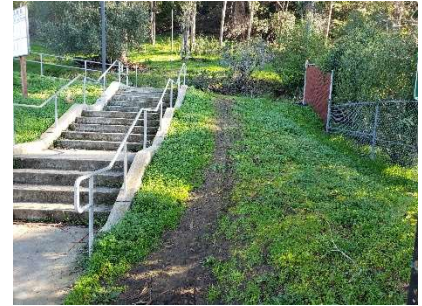
21. On Shaw Drive there are three areas where people are avoiding the paths and entering the park in an unsafe manner. One area at the dog park end of the facility people are coming straight down the hill and jumping the handrail of the ADA ramp. The second area people are climbing the short wall and walking straight down the hill. The third area people are walking down the hill instead of the stairs.

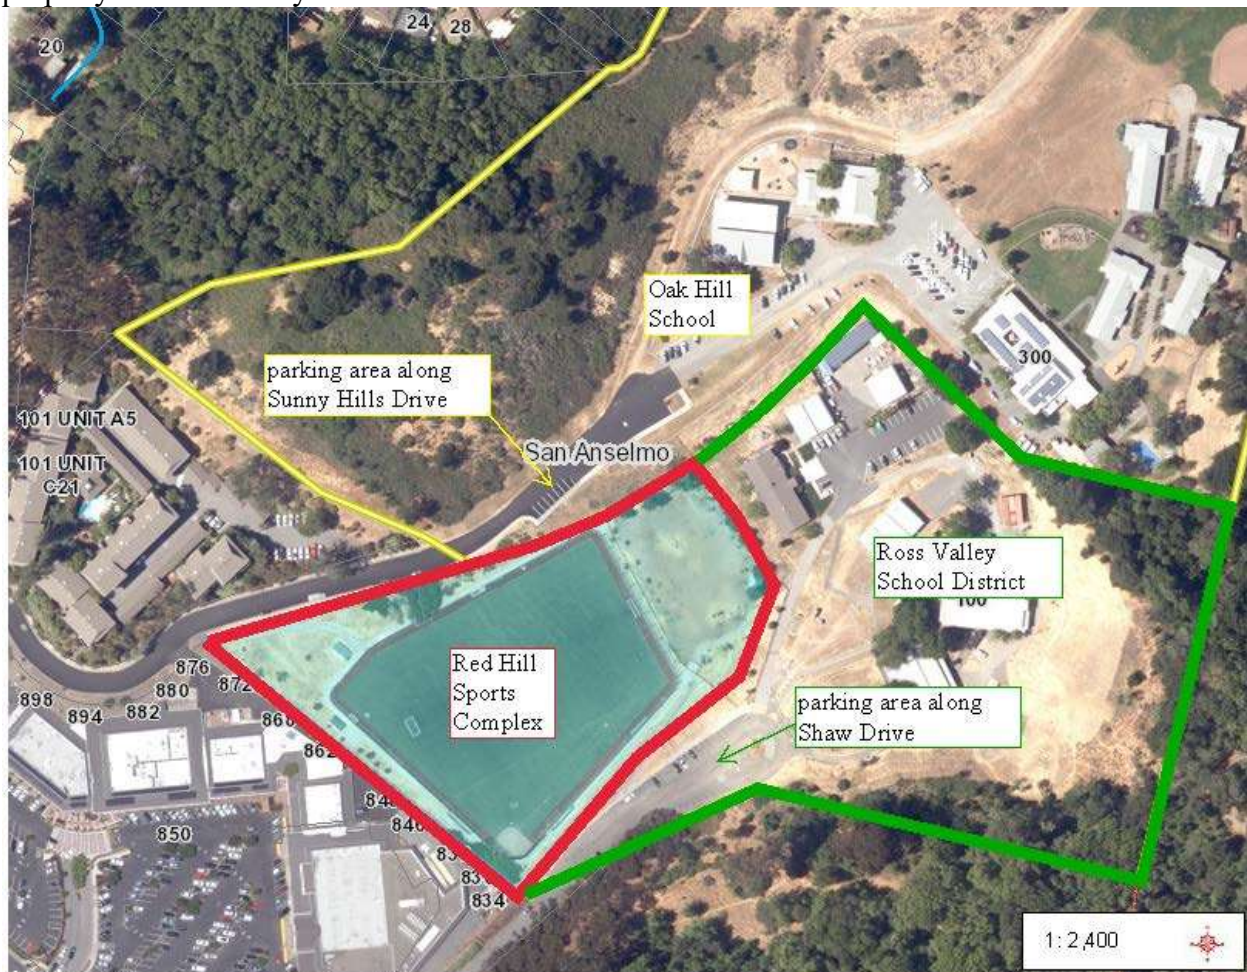
The following exhibit shows the approximate property lines of the Red Hill Sports Complex lands owned by Tamalpais Union High School District shown in red. The Oak Hill School approximate property lines are shown in yellow. The parking area along Sunny Hills Drive is clearly within the property of Oak Hill School. The Ross Valley School District approximate property lines are shown in green. The parking area along Shaw Drive is clearly within the property of Ross Valley School District.
