FACILITY CONDITION ASSESSMENT

LUCHA Elementary School
1711 East San Antonio Street
San Jose, California 95116

159228.22R000-002.354

December 5, 2022

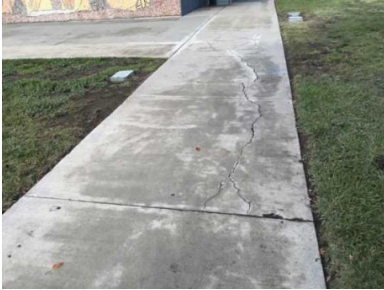
Sidewalk in Poor condition.

Concrete, Small Areas/Sections
Site LUCHA Elementary Site

Broken and displaced throughout campus - AssetCALC ID: 4471580

Uniformat Code: G2030
Recommendation: **Replace in 2023**

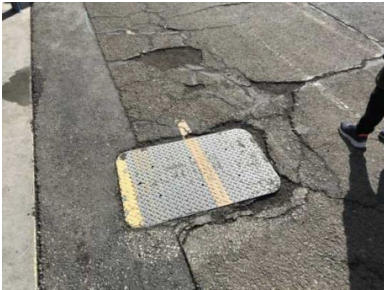
Athletic Surfaces & Courts in Poor condition.

Basketball/General, Asphalt Pavement
Site LUCHA Elementary Site

Broken asphalt pavement - AssetCALC ID: 4471577

Uniformat Code: G2050
Recommendation: **Replace in 2023**

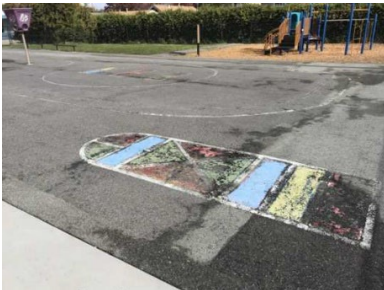
Athletic Surfaces & Courts in Poor condition.

Basketball/General, Asphalt Pavement
Site LUCHA Elementary Site

Worn - AssetCALC ID: 4471563

Uniformat Code: G2050
Recommendation: **Seal & Stripe in 2023**

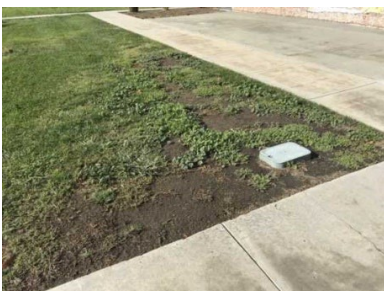
Landscaping in Poor condition.

Sod at Eroded Areas
Site LUCHA Elementary Site

Missing grass fields; sod - AssetCALC ID: 4471564

Uniformat Code: G2080
Recommendation: **Repair in 2023**

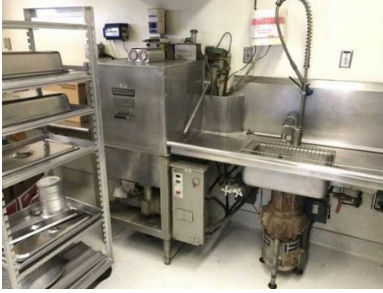
Foodservice Equipment in Poor condition.

Dishwasher Commercial
Multi Use/Cafeteria Building LUCHA Elementary
Kitchen

Broken - AssetCALC ID: 4471429

Uniformat Code: E1030
Recommendation: **Replace in 2023**

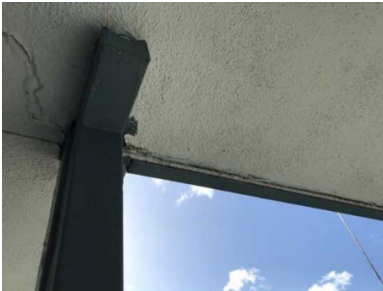
Caulking in Poor condition.

Cold Joints, 0" to 1/2"
Administration Building LUCHA Elementary Building
Exterior

Broken or missing - AssetCALC ID: 4471026

Uniformat Code: B2010
Recommendation: **Replace in 2023**

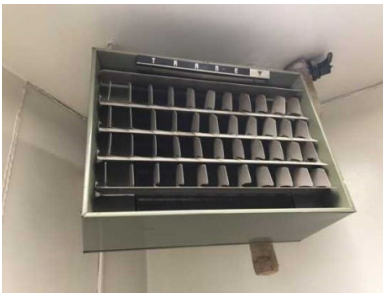
Unit Heater in Poor condition.

Natural Gas
Multi Use/Cafeteria Building LUCHA Elementary
Kitchen

Uniformat Code: D3020
Recommendation: **Replace in 2023**

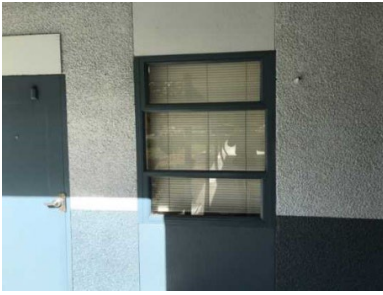
Window in Marginal condition.

Aluminum Double-Glazed, up to 15 SF
Administration Building LUCHA Elementary Building
Exterior

Single pane glass - AssetCALC ID: 4471015

Uniformat Code: B2020
Recommendation: **Replace in 2024**

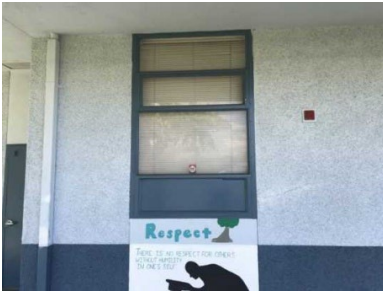
Window in Marginal condition.

Aluminum Double-Glazed, 28-40 SF
Multi Use/Cafeteria Building LUCHA Elementary
Building Exterior

Single pane glass - AssetCALC ID: 4471450

Uniformat Code: B2020
Recommendation: **Replace in 2024**

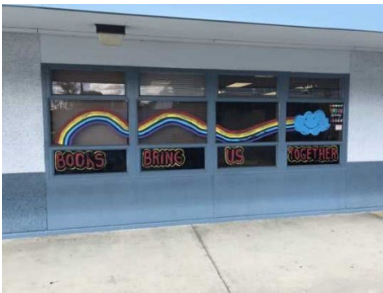
Window in Marginal condition.

Aluminum Double-Glazed, 16-25 SF
Building A LUCHA Elementary Building Exterior

Single pane glass - AssetCALC ID: 4471071

Uniformat Code: B2020
Recommendation: **Replace in 2024**

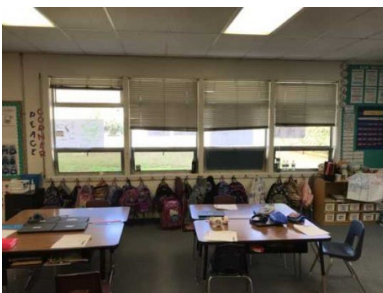
Window in Marginal condition.

Aluminum Double-Glazed, 16-25 SF
Building B LUCHA Elementary Building Exterior

Uniformat Code: B2020
Recommendation: **Replace in 2024**

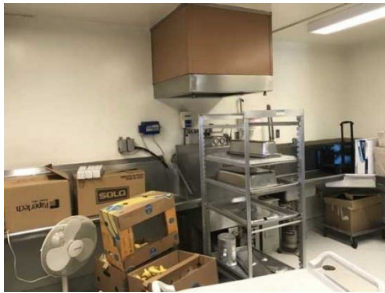
**Recommended Follow-up Study: Mechanical, General Design**Priority Score: **54.9**Mechanical, General Design
Multi Use/Cafeteria Building LUCHA Elementary
Kitchen

Kitchen needs heating and cooling - AssetCALC ID: 4471447

Recommendation: **Design in 2023**

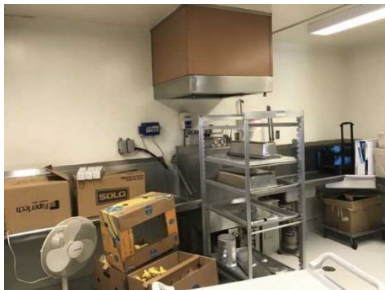
**Split System Ductless in Poor condition.**Priority Score: **54.9**Single Zone
Multi Use/Cafeteria Building LUCHA Elementary
Kitchen

Recommendation: **Replace in 2023**

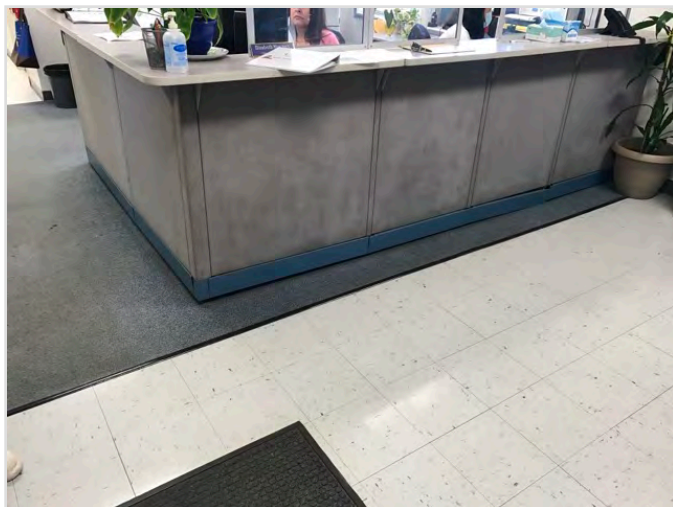
NO LOW COUNTER

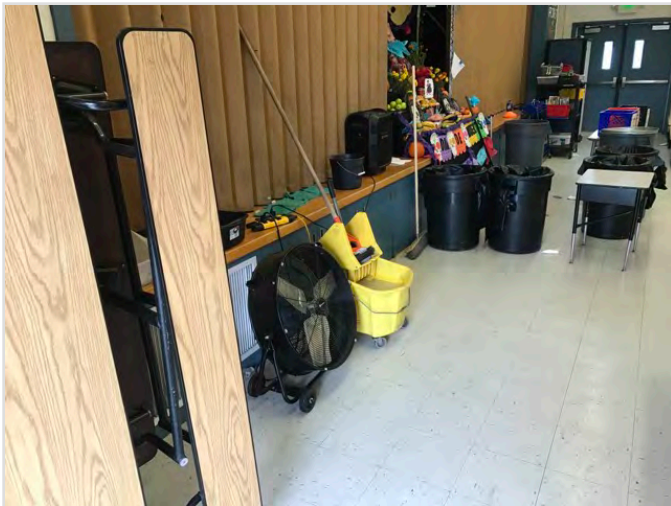
STAGE HAS NO RAMP

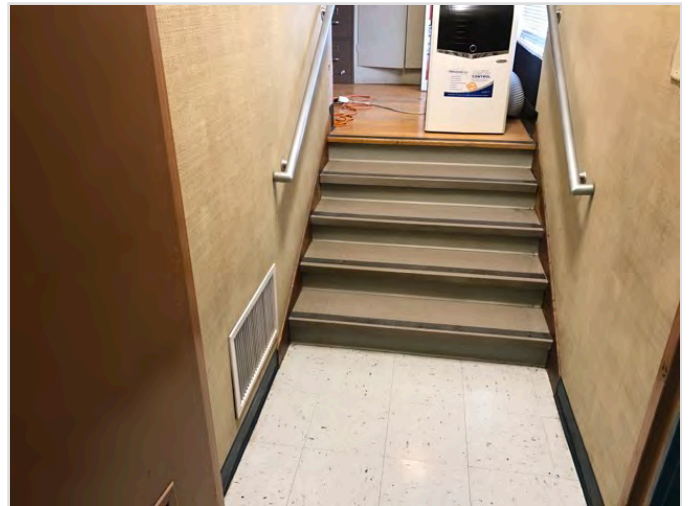
STAGE HAS NO RAMP
