# FACILITY CONDITION ASSESSMENT

**Alum Rock Unified School District**  
2930 Gay Avenue  
San Jose, California 95127  
Kolvira Chheng

Adelante II / Arbuckle  
1970 Cinderella Lane  
San Jose, California 95116

*January 19, 2023*

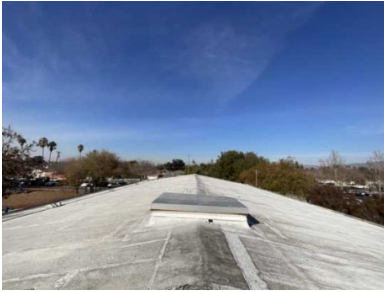
### Roofing in Poor condition.

Modified Bitumen  
Multi Use / Cafeteria Building Adelante II/Arbuckle Roof

Peeling. - AssetCALC ID: 4731136

Uniformat Code: B3010  
Recommendation: **Replace in 2024**

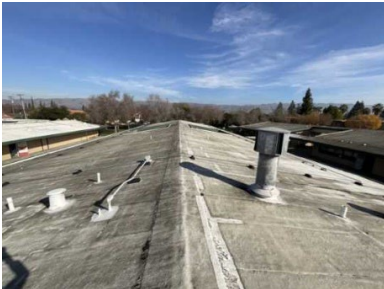
### Roofing in Poor condition.

Modified Bitumen  
Building B Adelante II/Arbuckle Roof

Bubbles - AssetCALC ID: 4731078

Uniformat Code: B3010  
Recommendation: **Replace in 2024**

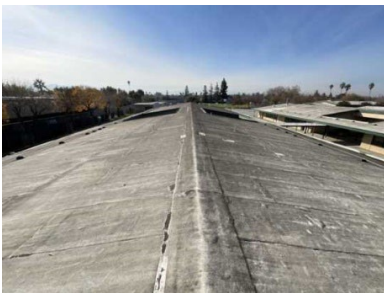
### Roofing in Poor condition.

Modified Bitumen  
Building C Adelante II/Arbuckle Roof

Bubbles. Peeling - AssetCALC ID: 4731108

Uniformat Code: B3010  
Recommendation: **Replace in 2024**

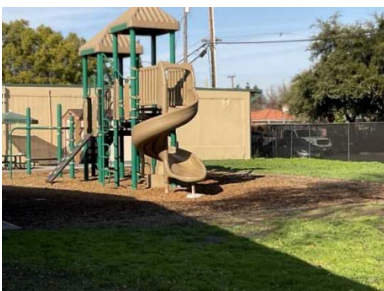
### Playfield Surfaces in Poor condition.

Chips Wood, 6" Depth  
Site Adelante II/Arbuckle Site

Need replacement. - AssetCALC ID: 4731199

Uniformat Code: G2050  
Recommendation: **Replace in 2024**

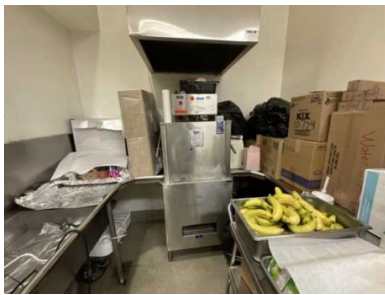
**Foodservice Equipment in Poor condition.**Priority Score: **81.9**

Dishwasher Commercial  
Multi Use / Cafeteria Building Adelante  
II/Arbuckle Kitchen

Uniformat Code: E1030  
Recommendation: **Replace in 2023**
