FACILITY CONDITION ASSESSMENT

Alum Rock Unified School District 2930 Gay Avenue San Jose, California 95127 Kolvira Chheng

Chavez Elementary 2000 Kammerer Avenue San Jose, California 95116

DATE OF REPORT:

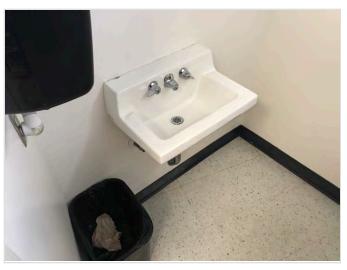
RESTROOM NOT ACCESSIBLE
