FACILITYCONDITION ASSESSMENT

Alum Rock Unified School District 2930 Gay Avenue San Jose, California 95127 Kolvira Chheng

Meyer Elementary 1824 Daytona Drive San Jose, California 95122

January 12, 2023

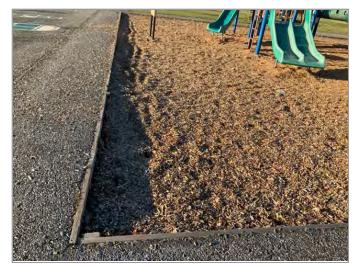
NO ACCESS TO PLAY COMPONENT
