FACILITY CONDITION ASSESSMENT

Alum Rock Unified School District 2930 Gay Avenue San Jose, California 95127 Kolvira Chheng

Hubbard Media Arts Academy 1680 Foley Avenue San Jose, California 95122

DATE OF REPORT: December 20, 2022

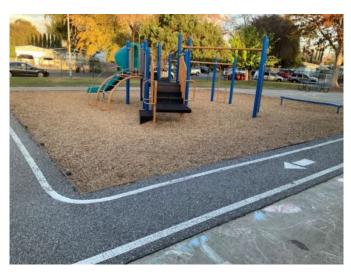
5 - INACCESSIBLE PLAY STRUCTURE

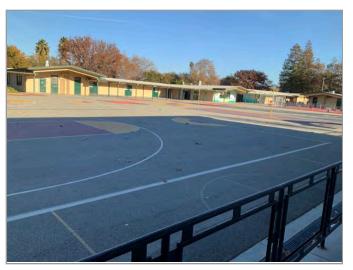
OVERVIEW OF PLAYGROUND

Question	Yes	No	NA	Comments
1	Is there an accessible route to the play area / s?		×		No Accessible route to the kindergarten play structure
2	Has the play area been reviewed for accessibility ?				Unknown
3	Are publicly accessible swimming pools equipped with an entrance lift ?			×	No swimming pool
