FACILITY CONDITION ASSESSMENT

Alum Rock Unified School District 2930 Gay Avenue San Jose, California 95127 Kolvira Chheng

Cureton Elementary 3720 East Hills Drive San Jose, California 95127

DATE OF REPORT: January 3, 2023

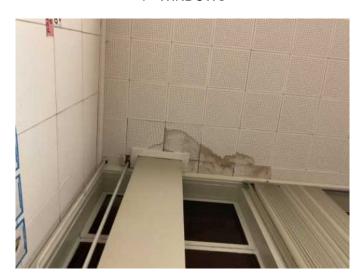
3 - DAMAGED CEILING

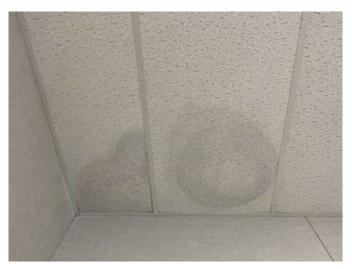
3 - DAMAGED CEILING
