FACILITY CONDITION ASSESSMENT

McCollam Elementary 3311 Lucian Avenue San Jose, California 95127

Bureau Veritas 10461 Mill Run Circle, Suite 1100 Owings Mills, Maryland 21117 800.733.0660 www.us.bureauveritas.com

DATE OF REPORT: January 25, 2023

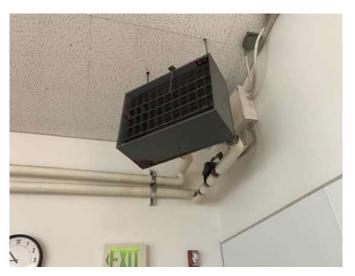
6 - UNIT HEATER

Unit Heater in Failed condition.

Recommendation: Replace in 2023

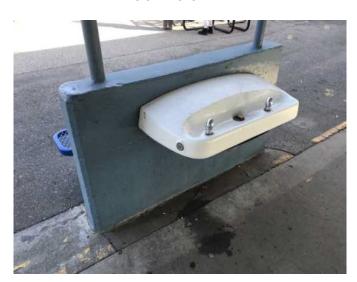
4 - DRINKING FOUNTAIN

Key Issues and Findings	Asphalt playgrounds have many cracks. Site drinking fountains are very old. Ur storm and sewage drainage pipes have blockages.	nderground
