FACILITY CONDITION ASSESSMENT

Lyndale Elementary
13901 Nordyke Drive
San Jose, California 95127

159228.22R000-009.354

January 25, 2023

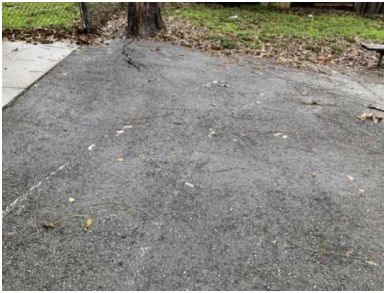
Athletic Surfaces & Courts in Poor condition.

Basketball/General, Asphalt Pavement
Building K1 - K2 Lyndale Elementary Site

Very uneven - AssetCALC ID: 4795661

Uniformat Code: G2050
Recommendation: **Replace in 2023**

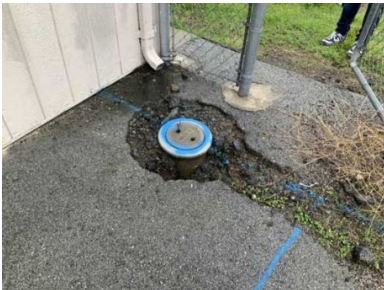
Site paving in Poor condition.

Asphalt
Site Lyndale Elementary Site

Paving was not replaced at water line repair. - AssetCALC ID: 4797443

Uniformat Code: G2010
Recommendation: **Repair in 2023**

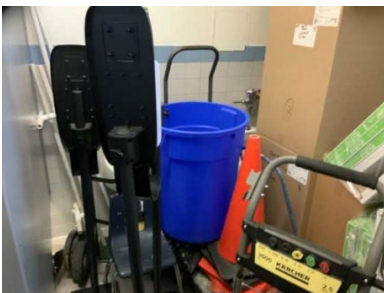
Urinal in Poor condition.

Standard
Classroom Building C Lyndale Elementary
Restrooms

Abandoned in place - AssetCALC ID: 4796036

Uniformat Code: D2010
Recommendation: **Replace in 2023**

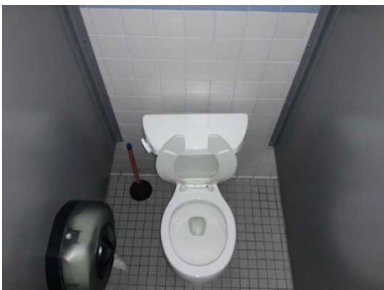
Toilet in Poor condition.

Residential Water Closet
Building K1 - K2 Lyndale Elementary K1

Toilet partition is locked access is not allowed - AssetCALC ID: 4795651

Uniformat Code: D2010
Recommendation: **Replace in 2023**

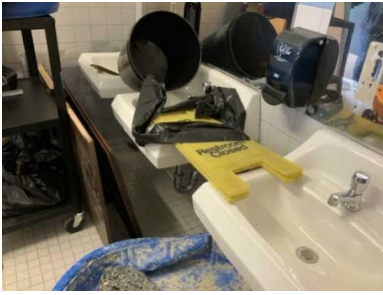
**Sink/Lavatory in Poor condition.**

Wall-Hung, Vitreous China
Classroom Building C Lyndale Elementary
Restrooms

Abandoned in place - AssetCALC ID: 4796039

Uniformat Code: D2010
Recommendation: **Replace in 2023**

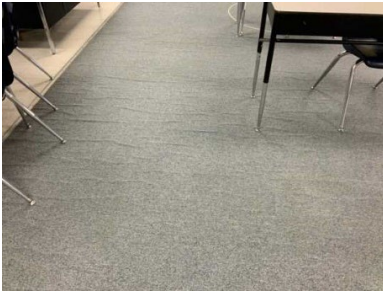
**Flooring in Poor condition.**

Carpet, Commercial Standard
Modular Building (H2-H6) Lyndale Elementary
Throughout building

The carpet is wavy dirty and ripped, replacement is needed - AssetCALC ID: 4797239

Uniformat Code: C2030
Recommendation: **Replace in 2023**

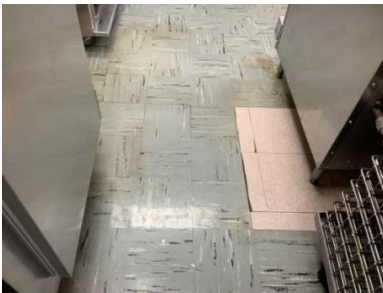
**Flooring in Poor condition.**

Vinyl Tile (VCT)
Multi-Use/Cafeteria Building Lyndale Elementary
Kitchen

Significantly worn throughout - AssetCALC ID: 4795504

Uniformat Code: C2030
Recommendation: **Replace in 2024**

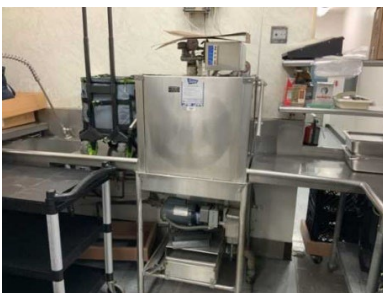
**Foodservice Equipment in Poor condition.**

Dishwasher Commercial
Multi-Use/Cafeteria Building Lyndale Elementary
Kitchen

Uniformat Code: E1030
Recommendation: **Replace in 2024**

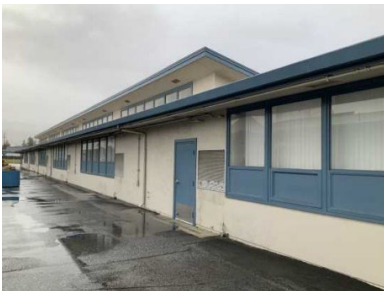
**Window in Poor condition.**

Steel, 16-25 SF
Classroom Building C Lyndale Elementary Building
Exterior

Steel, single glazed - AssetCALC ID: 4796026

Uniformat Code: B2020
Recommendation: **Replace in 2024**

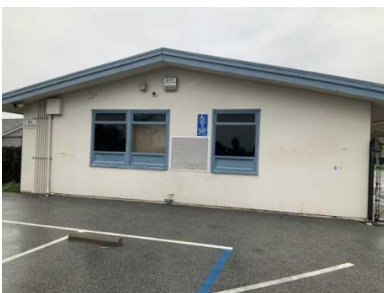
**Window in Poor condition.**

Steel, 16-25 SF
Building PD1-PD2 Lyndale Elementary Building
Exterior

Steel, single glazed windows - AssetCALC ID: 4797270

Uniformat Code: B2020
Recommendation: **Replace in 2024**

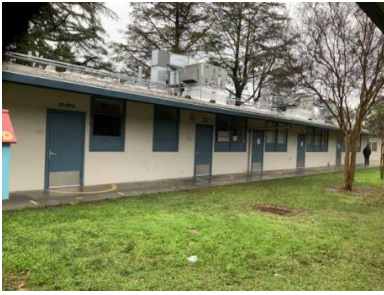
**Window in Poor condition.**

Steel, 16-25 SF
Administration Building Lyndale Elementary Building
Exterior

Single glazed steel sash windows. - AssetCALC ID: 4788244

Uniformat Code: B2020
Recommendation: **Replace in 2024**

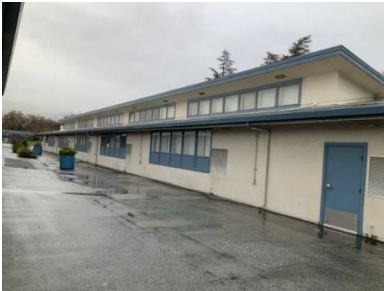
**Window in Poor condition.**

Steel, up to 15 SF
Classroom Building B Lyndale Elementary Building
Exterior

*Steel single glazed windows - AssetCALC ID: 4795836

Uniformat Code: B2020
Recommendation: **Replace in 2024**

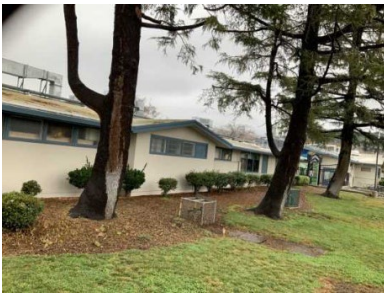
**Window in Poor condition.**

Steel, up to 15 SF
Administration Building Lyndale Elementary Building
Exterior

Single glazed steel sash windows. - AssetCALC ID: 4788261

Uniformat Code: B2020
Recommendation: **Replace in 2024**

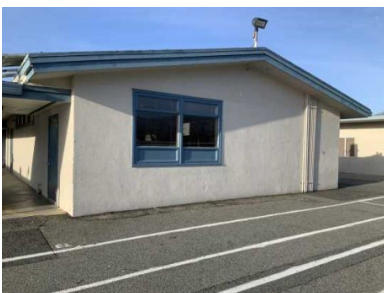
**Window in Poor condition.**

Steel, up to 15 SF
Classroom Building E Lyndale Elementary Building
Exterior

Steel, single glazed - AssetCALC ID: 4797216

Uniformat Code: B2020
Recommendation: **Replace in 2024**

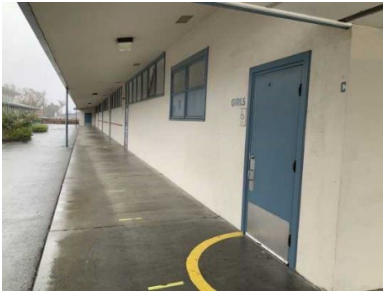
**Window in Poor condition.**

Steel, up to 15 SF
Classroom Building C Lyndale Elementary Building
Exterior

*Steel, single glazed. - AssetCALC ID: 4796024

Uniformat Code: B2020
Recommendation: **Replace in 2024**

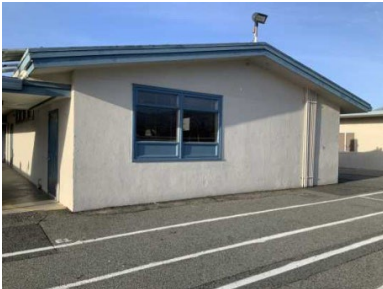
**Window in Poor condition.**

Steel, 16-25 SF
Classroom Building E Lyndale Elementary Building
Exterior

Steel, single glazed - AssetCALC ID: 4797234

Uniformat Code: B2020
Recommendation: **Replace in 2024**

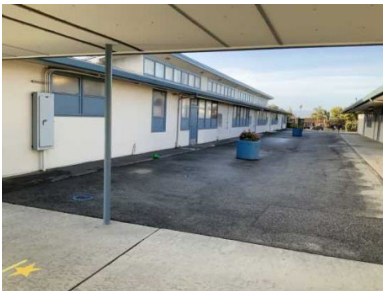
**Window in Poor condition.**

Steel, up to 15 SF
Classroom Building D Lyndale Elementary Building
Exterior

**Steel, single glazed - AssetCALC ID: 4797104

Uniformat Code: B2020
Recommendation: **Replace in 2024**

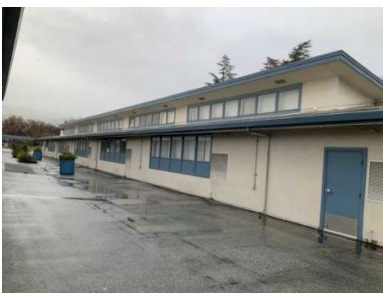
**Window in Poor condition.**

Steel, 16-25 SF
Classroom Building B Lyndale Elementary Building
Exterior

Steel single glazed windows - AssetCALC ID: 4795810

Uniformat Code: B2020
Recommendation: **Replace in 2024**

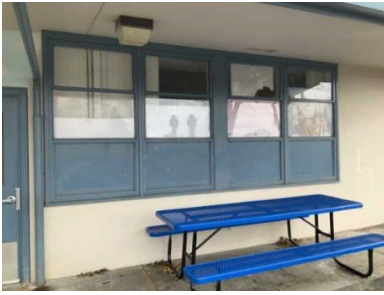
**Window in Poor condition.**

Steel, 16-25 SF
Building K1 - K2 Lyndale Elementary Building
Exterior

Single glazed steel sash windows - AssetCALC ID: 4795636

Uniformat Code: B2020
Recommendation: **Replace in 2024**

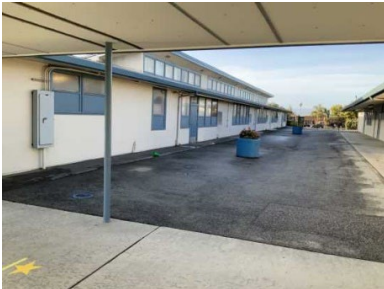
**Window in Poor condition.**

Steel, 16-25 SF
Classroom Building D Lyndale Elementary Building
Exterior

Uniformat Code: B2020
Recommendation: **Replace in 2024**

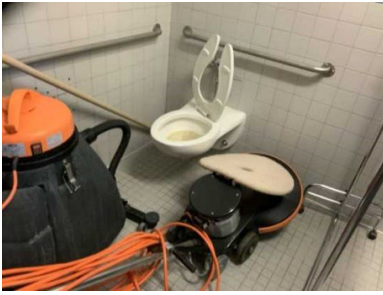
**Toilet in Poor condition.**

Commercial Water Closet
Classroom Building C Lyndale Elementary
Restrooms

Abandoned in place - AssetCALC ID: 4796031

Uniformat Code: D2010
Recommendation: **Replace in 2023**

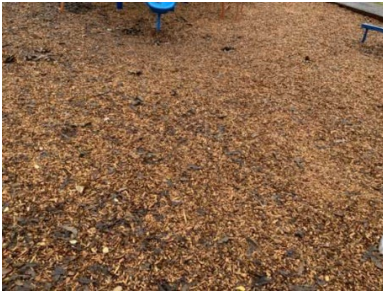
**Playfield Surfaces in Poor condition.**

Chips Wood, 3" Depth
Building K1 - K2 Lyndale Elementary Site

Uniformat Code: G2050
Recommendation: **Replace in 2023**
