FACILITY CONDITION ASSESSMENT

Alum Rock Unified School District
2930 Gay Avenue
San Jose, California 95127
Kolvira Chheng

Mathson Institute of Technology/Renaissance II
2050 Kammerer Avenue
San Jose, California 95116

December 23, 2022

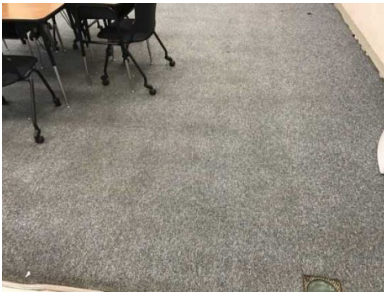
Flooring in Marginal condition.

Carpet, Commercial Standard
Buildings F & G Mathson Institute of
Technology/Renaissance II Throughout building

Very dirty, and worn. - AssetCALC ID: 4589901

Uniformat Code: C2030
Recommendation: **Replace in 2024**

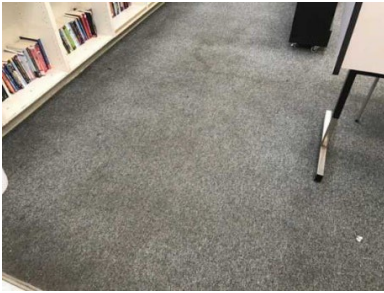
Flooring in Marginal condition.

Carpet, Commercial Standard
Buildings D & E Mathson Institute of
Technology/Renaissance II Throughout building

Very dirty, old, and worn - AssetCALC ID: 4589862

Uniformat Code: C2030
Recommendation: **Replace in 2024**

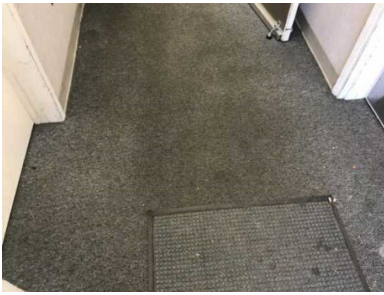
Flooring in Marginal condition.

Carpet, Commercial Standard
Multi Use/Cafeteria Building Mathson Institute of
Technology/Renaissance II Throughout building

Very dirty, worn. - AssetCALC ID: 4589955

Uniformat Code: C2030
Recommendation: **Replace in 2024**
