FACILITY CONDITION ASSESSMENT

Renaissance at Fischer Middle School 1720 Hopkins Drive San Jose, California 95122

Bureau Veritas 10461 Mill Run Circle, Suite 1100 Owings Mills, Maryland 21117 800.733.0660 www.us.bureauveritas.com

October 26, 2022

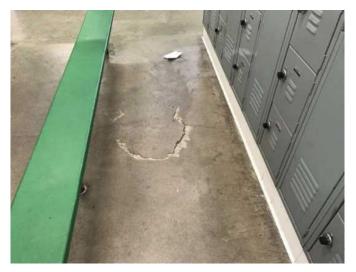
7 - FLOOR DAMAGE

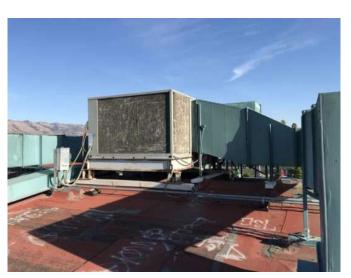
Vandlition has caused the unit to operate poorly - AssetCALC ID: 4297730

10 - PACKAGED UNIT - DAMAGED BY VANDALISM

Recommendation: Replace in 2023

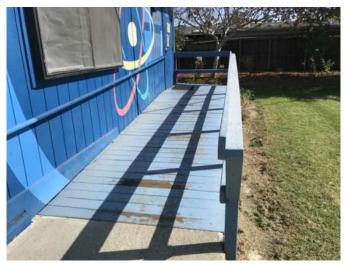
Dry-rot in many places; animals can get access to underfloor area and die there leading to bad smells. - AssetCALC ID: 4298639

7 - STAIRS - DRY ROT

Recommendation: Replace in 2023

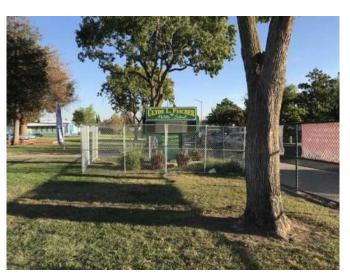
6 - SIGNAGE

In the process of being replaced - AssetCALC ID: 4294549

Recommendation: Replace/Install in 2023
