2023 - 2024 Ventilation Assessment

Saint Paul Public Schools Adams Spanish Immersion

Assessment Date:
Wednesday, April 19, 2023

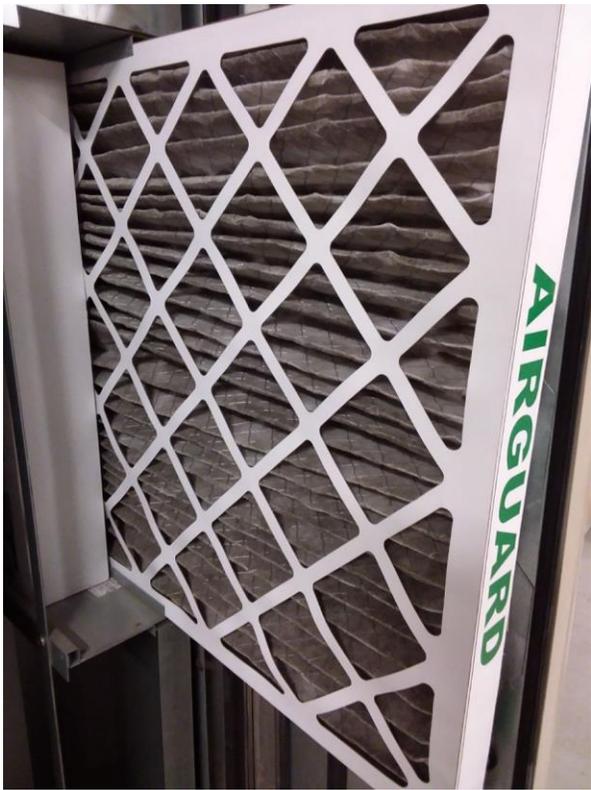
AHU-01

Outdoor Pre-Filter Cleanliness

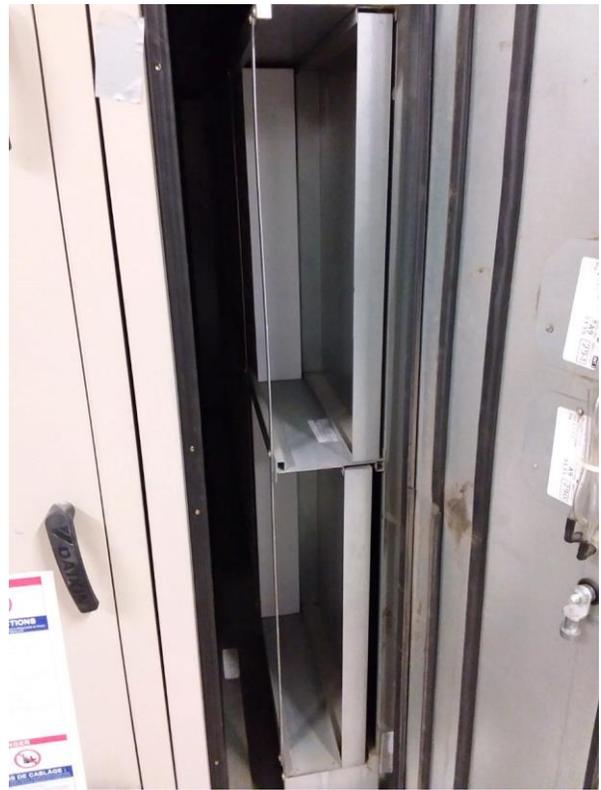
AHU-01

Outdoor Pre-Filter Fit

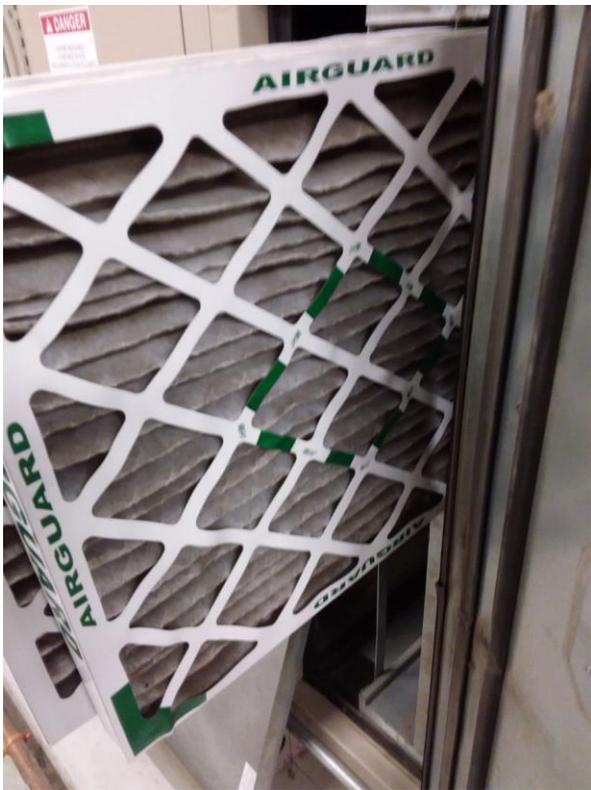
Unit Designation:	AHU-02	
Location of Unit:	Mechanical room 4201	
Areas Served:	See attached map & NE Building VAV's on Levels 1, 2, & 3	
System Enhancements:	None	
Supply System	Outdoor Air	Cleanliness and Observations
Type	Outdoor air intake is inaccessible	Outdoor air pre-filters are somewhat dirty and on the border of needing replacement (scoring 3 out of 5) and fit well. Outdoor air pre-filters are installed correctly. Outdoor air main filters are clean and not in need of replacement (scoring 2 out of 5) and fit well. Outdoor air main filters are installed correctly.
<ul style="list-style-type: none"> • Supply System - VAV • Heating - Hot Water • Cooling - Dx • Energy Recovery Unit (ERU) - Wheel 	Outdoor air intake is located on an exterior wall.	Return air filters are clean and not in need of replacement (scoring 2 out of 5) and fit well. Return air filters are installed correctly.
	It is not known if there are nearby pollution sources.	Drain pans are not plugged. Drain pan condition is poor.

Outdoor Pre-Filter Cleanliness

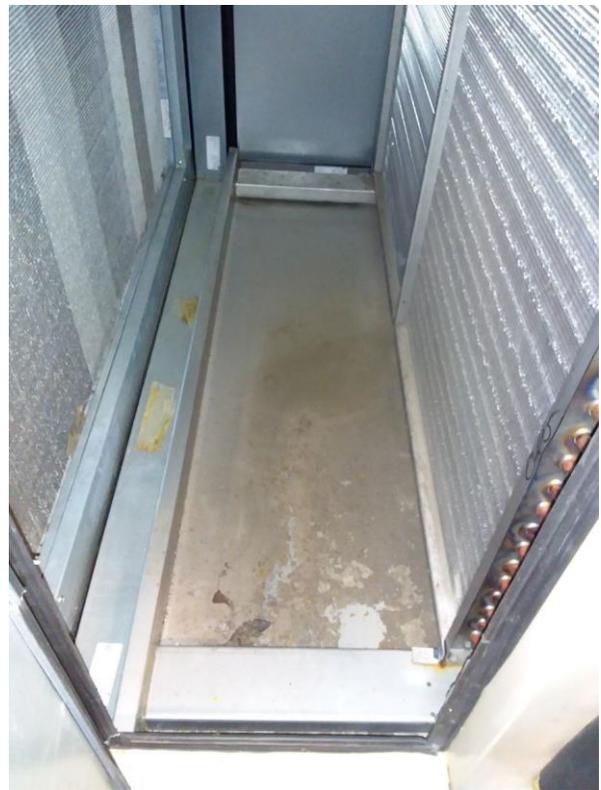
AHU-02

The drain pan for units AHU-02, RTU-01 and RTU-02 was plugged or damaged at the time of the site inspection.

Drain Pans

Recommendation: Damage to the drain pan should be repaired, or the drain pan should be inspected more frequently to ensure that it does not become plugged.

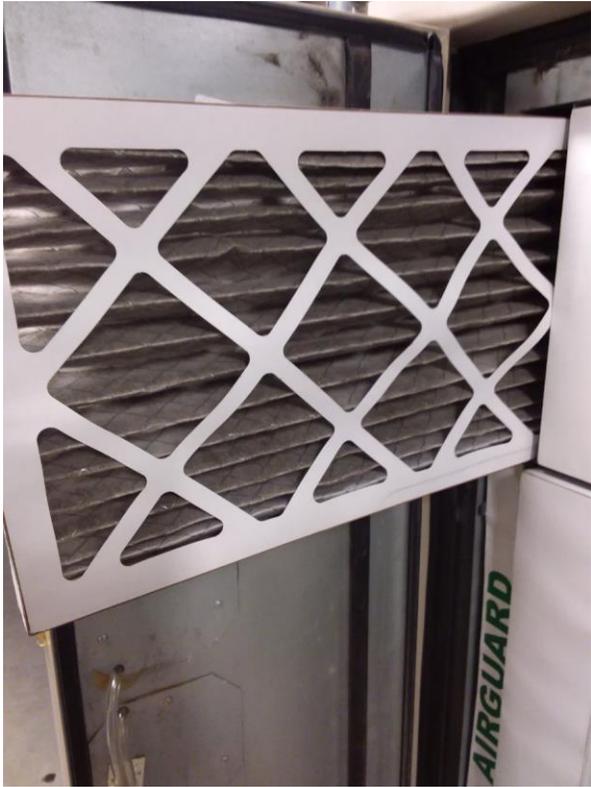
AHU-03

Outdoor Pre-Filter Cleanliness

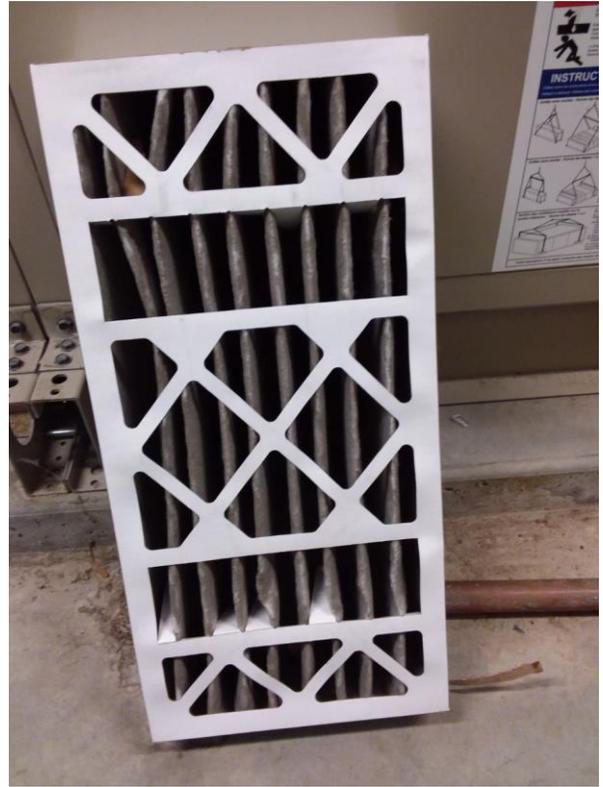
AHU-03

Outdoor Main Filter Cleanliness

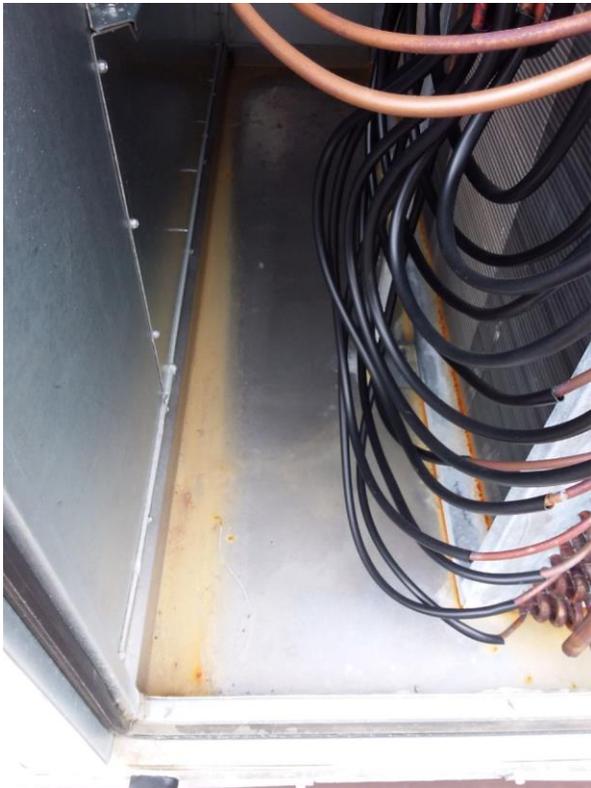
RTU-01

Drain Pans

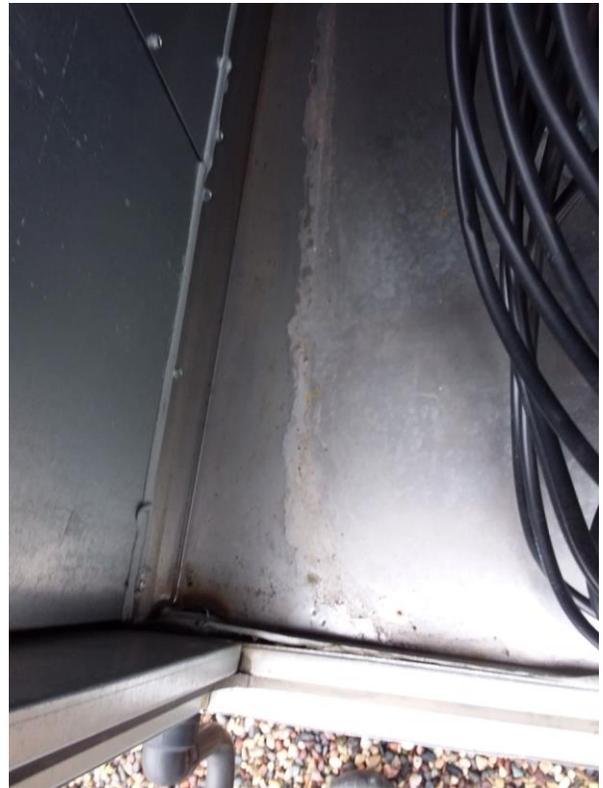
RTU-02

Drain Pans
