Appendix D
Environmental Audits Item 'iii'
Playground Review

Riverside Building

900 Albion Avenue

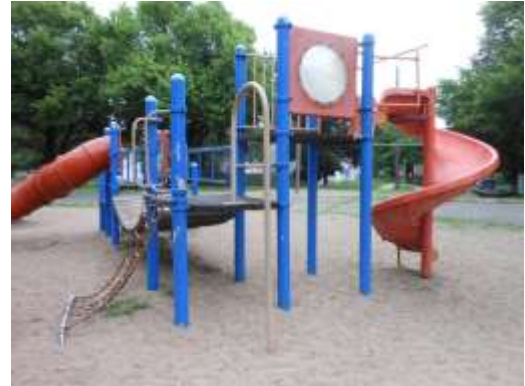
Location A1: Composite

View of composite. There are multiple features of the composite structure that do not comply with ASTM or CPSC requirements.

Priority 1- Remove this composite structure.

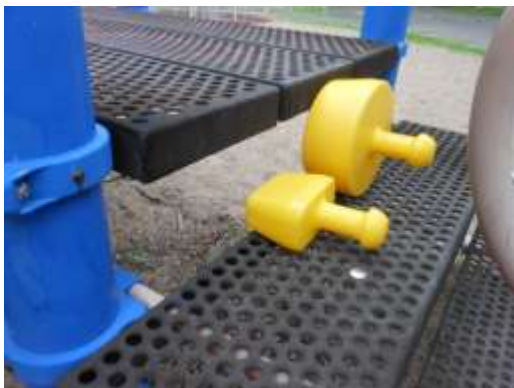
Area of entrapment.

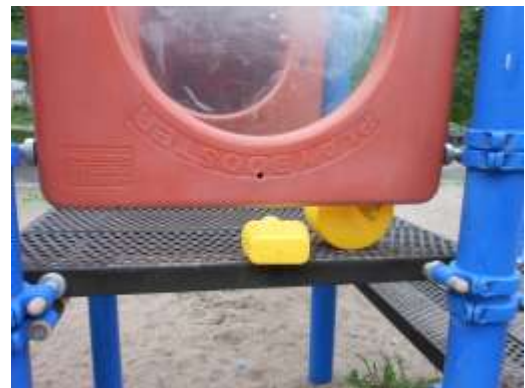
Area of entrapment.

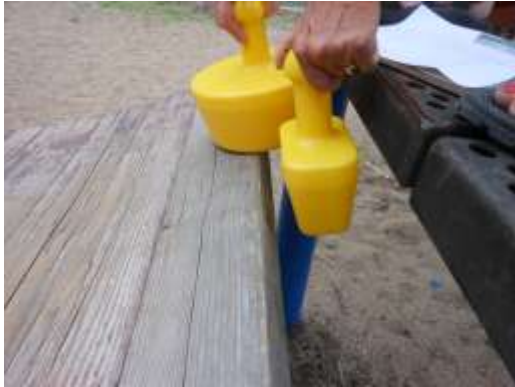
Area of entrapment.

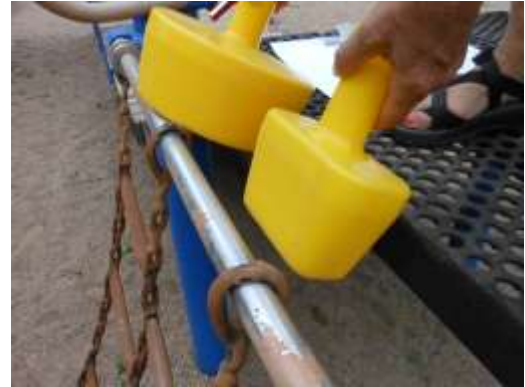
Area of entrapment. Chain climber above deck.

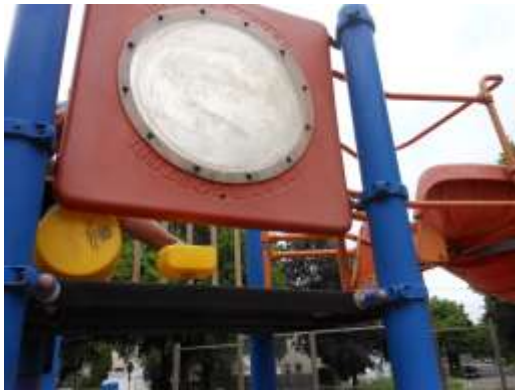
Area of entrapment.

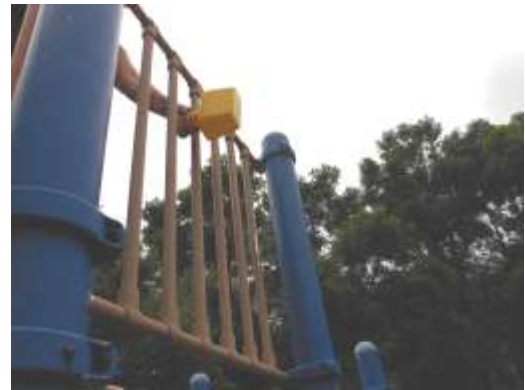
Area of entrapment.

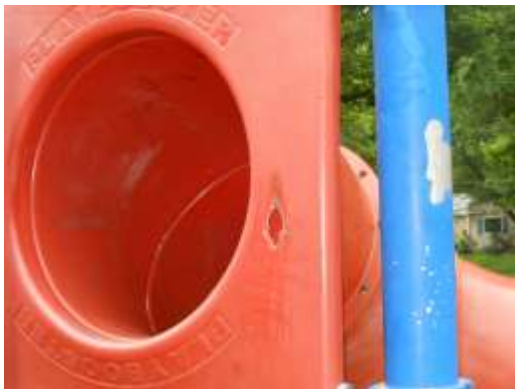
Burn hole. Graffiti.

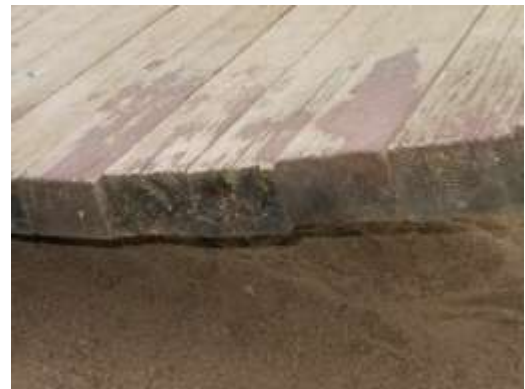
Deteriorating wood at clatter bridge.

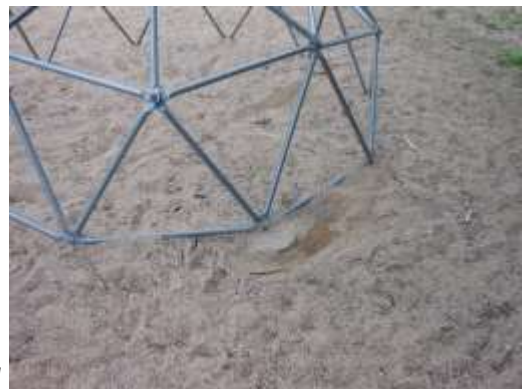
Geodesic Dome

The concrete footing of the geodesic dome is currently exposed.

Priority 2- Add surface material to cover the exposed concrete footing.

- Add surface material to cover the exposed concrete footing at the geodesic dome at location A3
- Remove the spring rockers at location B2

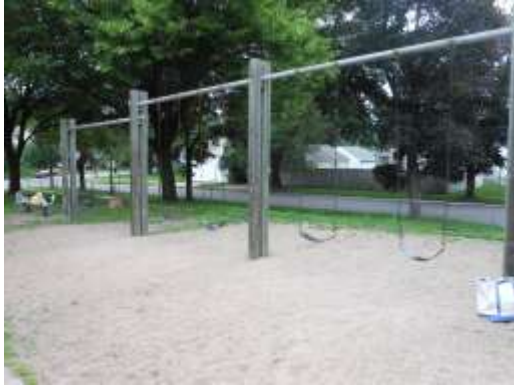
Location B1: Swings

View of swing structure. The swings include 4 strap swings, 2 bucket/tot swings, a missing event (possibly a tire swing) and a tire climber. As per ASTM 8.6.1.1 to-fro swings should be located away from other play structures and not attached to a composite play structure. The strap swings currently provide a use zone of 141". Based on ASTM Figure A1.34 the use zone should be a minimum of 230".

Priority 1- Remove the swing structure.

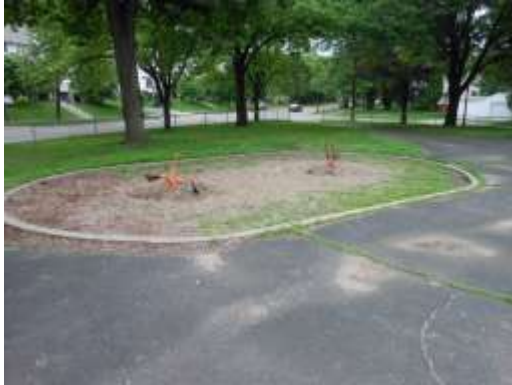
Location C1: Diggers

View of diggers. There is not currently an accessible digger.

Priority 3- Add an accessible digger at an accessible location.

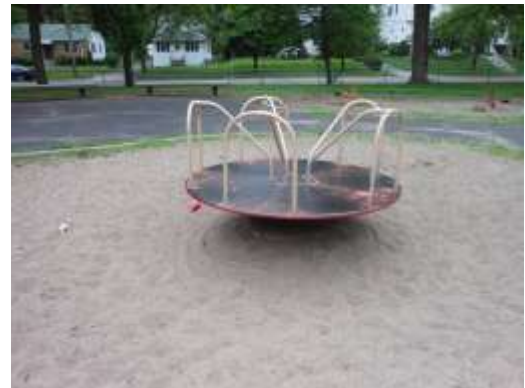
Surface Material- Accessibility

While sand can comply with the impact attenuation requirements when installed and maintained correctly, it does not meet the accessibility requirements of ASTM 1951.

Priority 3- Replace the existing surface material with a type that meets the requirements of ASTM 1951 and 1292.

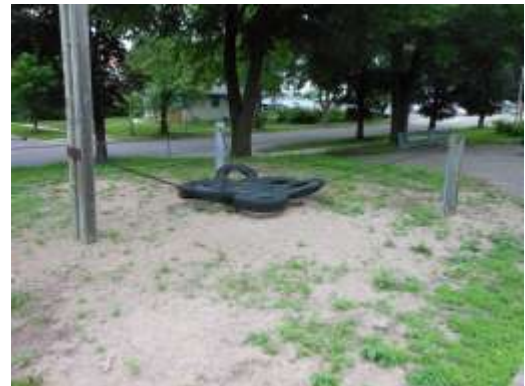
Surface Material- Depth

The depth of the loose fill surface material is currently less than 1" in some locations and in many areas there is no loose fill material (only plant materials).

Priority 1- Add loose fill surface material to a depth that complies with ASTM 1292 requirements for impact attenuation.

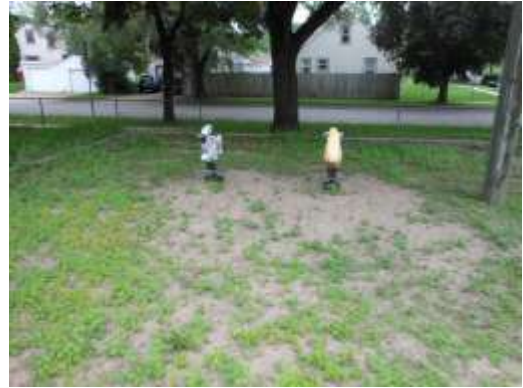
There is currently plant materials growing within the defined play areas.

Priority 1- Frequently inspect the playground and remove trash, debris and any foreign objects from within the defined play area.

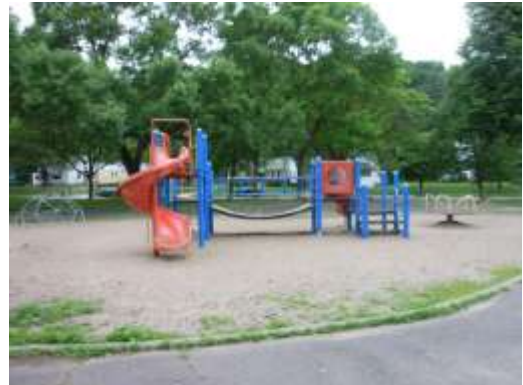
Accessibility

This composite structure currently provides no features of accessibility such as a transfer system and the defined play area does not provide any accessible ground level events.

Priority 3- Add ground level play components at an accessible location.
