2022 - 2023 IAQ Walkthrough

Saint Paul Public Schools Battle Creek Middle School

Walkthrough Date:
Thursday, February 16, 2023

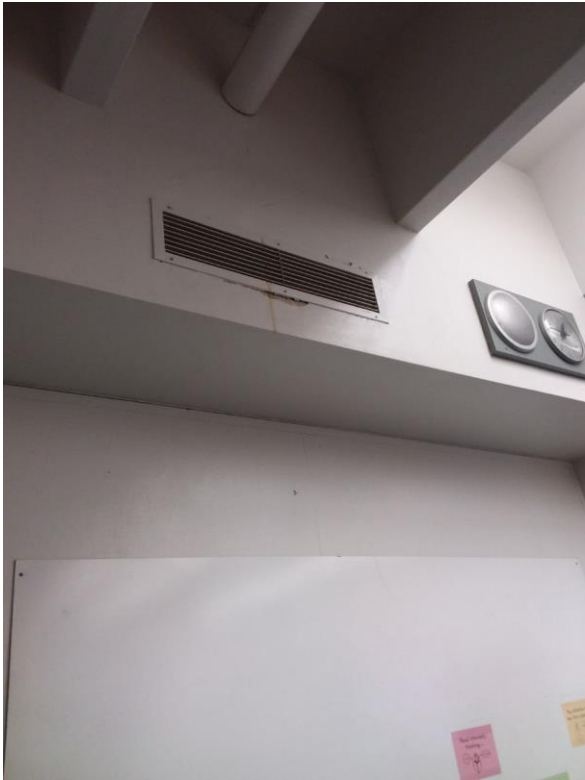
2602

IEA observed bubbling/peeling paint in area(s) within the room(s) listed below. Bubbling/peeling paint can be caused by moisture issues. IEA recommends investigating the cause and repairing the paint. IEA recommends ensuring that the paint is not lead-based prior to disturbance.

Bubbling/Peeling Paint
