2023 - 2024 Ventilation Assessment

Saint Paul Public Schools Battle Creek Middle School

Assessment Date: Friday, April 21, 2023

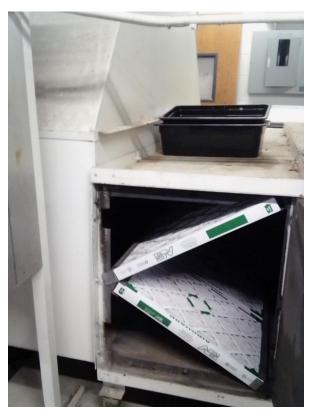
Type Supply System Constant Volume Heating - Hot Water Energy Recovery Unit (ERU) - None Pre-filter: None Main filter: Pleated, MERV 11 Outdoor air intake is inaccessible Outdoor air intake is inaccessible Return air filters are not present. Mixed air pre-filters are not present. Mixed air main filter are clean and not in need of replacement (scoring 1 out of 5) and fit well. Mixed air main filters are installed incorrectly. Drain pans are not applicable or not present. Drain pan condition is not known. Outdoor air intake is in good condition. Heating coils are inaccessible. Heat wheels are not present. Heating coils are inaccessible. Exterior ducting is visible. Exterior ducting insulation in an unknown condition. Interior ducting is of unknown cleanliness. Air handling room is free of trash/chemicals.	Areas Se	rved:	Music-See Attached M	Лар
Outdoor air intake is Supply System Constant Volume Heating - Hot Water Cooling - None Energy Recovery Unit (ERU) - None Filter Type - Mixed Main filter: Pleated, MERV 11 Outdoor air intake is located in an unknown if in good condition. Main filter: Pleated, MERV 11 Outdoor air intake is located in an unknown if in need of replacement (scoring 1 out of 5) and fit well. Mixed air main filters are installed incorrectly. There are nearby Couldoor air intake is in good condition. Mixed air pre-filters are not present. Mixed air main filter are clean and not in need of replacement (scoring 1 out of 5) and fit well. Mixed air main filters are installed incorrectly. There are nearby Couldoor air intake is in good condition. Mixed air pre-filters are not present. Mixed air pre-filters are not present	System E	Enhancements:	None

AHU-02
Mixed Main Filter Installation

Recommendation: The operations and maintenance program for filter changes should be reviewed and revised to ensure proper filter changes to optimize filtration capacity.

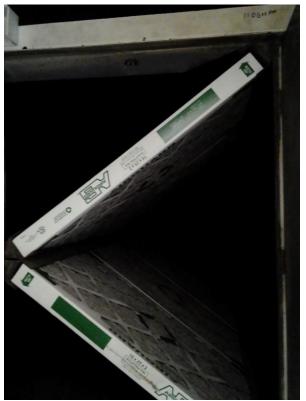
Unit Designation:	AHU-04	
Location of Unit:	1103B, access filters window into 1103B.	through a panel in room 1103. Panel is above viewing
Areas Served:	Shops-See Attached	Мар
System Enhancements:	None	
Supply System	Outdoor Air	Cleanliness and Observations
• Supply System - Constant Volume • Heating - Hot Water • Cooling - None • Energy Recovery Unit (ERU) - None Filter Type - Mixed • Pre-filter: None • Main filter: Pleated, MERV 11	Outdoor air intake is accessible Outdoor air intake is located on an exterior wall. No nearby pollution sources were found. Outdoor air intake is in good condition.

AHU-04
Mixed Main Filter Installation

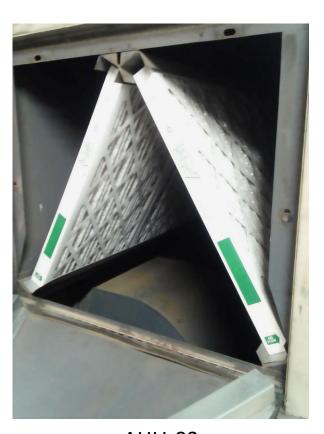
Unit Designation:	AHU-03	
Location of Unit:	1006 mechanical roc	om
Areas Served:	Administration-See A	Attached Map
System Enhancements:	None	
Supply System	Outdoor Air	Cleanliness and Observations
Water • Cooling - Dx	is accessible Outdoor air intake is located on an exterior wall. No nearby pollution sources were found. Outdoor air intake is in good condition.	Outdoor air filters are not present. Return air filters are not present. Mixed air pre-filters are not present. Mixed air main filters are clean and not in need of replacement (scoring 1 out of 5) and fit well. Mixed air main filters are installed incorrectly. Drain pans are not applicable or not present. Drain pan condition is not known. Heating coils are inaccessible and cooling coils are inaccessible. Heat wheels are not present. Exterior ducting is visible. Exterior ducting insulation is not present. Interior ducting is not visible. Interior ducting insulation is in an unknown condition. Interior ducting is of unknown cleanliness. Air handling room is free of trash/chemicals. Outside damper is inaccessible, and its condition is not known. Return damper is closed, and its condition is good. The general condition of the unit is good.

AHU-03
Mixed Main Filter Installation

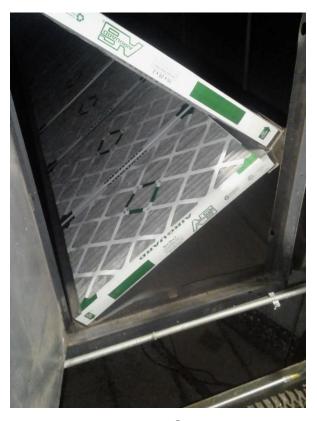
•	Cooling - None		are clean and not in need of replacement (scoring 2 out of 5)
•	Energy		and fit well. Mixed air main filters are installed incorrectly.
	Recovery Unit	No nearby	
	(ERU) - None	-	Drain pans are not applicable or not present. Drain pan
		were found.	condition is not known.
<u>Filter</u>	Type - Mixed

AHU-07
Mixed Main Filter Installation

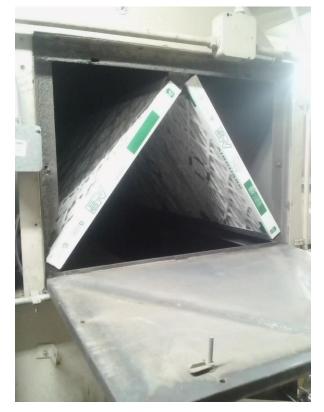
Unit Designation:	AHU-09	
Location of Unit:	2102 mechanical roc	om
Areas Served:	2nd Floor Southeast	Classrooms-See Attached Maps
System Enhancements:	None	
Supply System	Outdoor Air	Cleanliness and Observations
Type Supply System - Constant Volume Heating - Hot Water Cooling - None Energy Recovery Unit (ERU) - None	is accessible Outdoor air intake is located on an exterior wall. No nearby pollution sources were found. Outdoor air intake is in good condition.	Outdoor air filters are not present. Return air filters are not present. Mixed air pre-filters are not present. Mixed air main filters are clean and not in need of replacement (scoring 1 out of 5) and fit well. Mixed air main filters are installed incorrectly. Drain pan plugged status is not known. Drain pan condition is not known. Heating coils are inaccessible. Heat wheels are not present. Exterior ducting is visible. Exterior ducting insulation is not present. Interior ducting is not visible. Interior ducting insulation is in an unknown condition. Interior ducting is of unknown cleanliness. Air handling room is free of trash/chemicals. Outside damper is inaccessible, and its condition is not known. Return damper is closed, and its condition is good.

AHU-09
Mixed Main Filter Installation

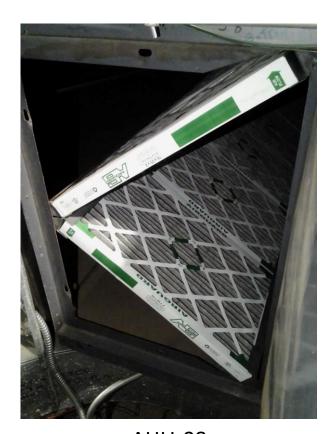
Unit Designation:	AHU-08	
Location of Unit:	2302A	
Areas Served:	North Library-See A	Attached Maps
System Enhancements:	None	
Supply System	Outdoor Air	Cleanliness and Observations
Type Supply System - Constant Volume Heating - None Cooling - None Energy Recovery Unit (ERU) - None Filter Type - Mixed Pre-filter: None Main filter:	Outdoor air intake is accessible Outdoor air intake is located on the roof. No nearby pollution sources were found. Outdoor air intake is in good condition.	Outdoor air filters are not present. Return air filters are not present. Mixed air pre-filters are not present. Mixed air main filters are clean and not in need of replacement (scoring 2 out of 5) and fit well. Mixed air main filters are installed incorrectly. Drain pans are not applicable or not present. Drain pan condition is not known. Heat wheels are not present. Exterior ducting is visible. Exterior ducting insulation is not present.

AHU-08
Mixed Main Filter Installation

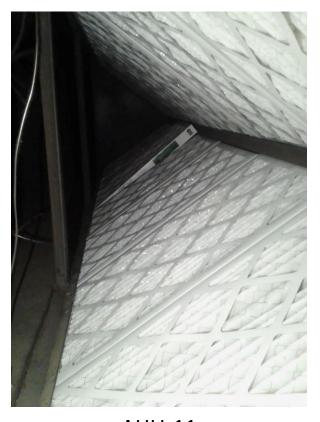
Unit Designation:	AHU-11		
Location of Unit:	Mechanical room 2102		
Areas Served:	1st Floor East Classrooms-See Attached Maps		
System Enhancements:	None		
Supply System	Outdoor Air	Cleanliness and Observations	
Type Supply System - Constant Volume Heating - None Cooling - None Energy Recovery Unit (ERU) - None Filter Type - Mixed Pre-filter: None	Outdoor air intake is accessible Outdoor air intake is located on an exterior wall. No nearby pollution sources were found. Outdoor air intake is in good condition.	Outdoor air filters are not present. Return air filters are not present. Mixed air pre-filters are not present. Mixed air main filters are clean and not in need of replacement (scoring 1 out of 5) and fit poorly. Mixed air main filters are installed

AHU-11 Mixed Main Filter Fit

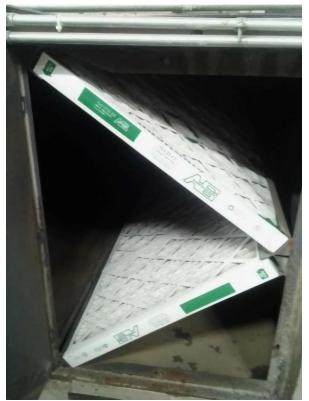
Unit Designation:	AHU-12			
Location of Unit:	Mechanical room 2102			
Areas Served:	Cafeteria-See Attached Maps			
System Enhancements:	None			
Supply System	Outdoor Air	Cleanliness and Observations		
 Heating - Hot Water Cooling - None Energy Recovery Unit (ERU) - None 	is accessible Outdoor air intake is located on an exterior wall. No nearby pollution sources were found. Outdoor air intake is in good condition.	Outdoor air filters are not present. Return air filters are not present. Mixed air pre-filters are not present. Mixed air main filters are clean and not in need of replacement (scoring 1 out of 5) and fit well. Mixed air main filters are installed incorrectly. Drain pan plugged status is not known. Drain pan condition is not known. Heating coils are inaccessible. Heat wheels are not present. Exterior ducting is visible. Exterior ducting insulation is not present. Interior ducting is not visible. Interior ducting insulation is in an unknown condition. Interior ducting is of unknown cleanliness. Air handling room is free of trash/chemicals. Outside damper is inaccessible, and its condition is not known. Return damper is inaccessible, and its condition is not known.

AHU-12
Mixed Main Filter Installation

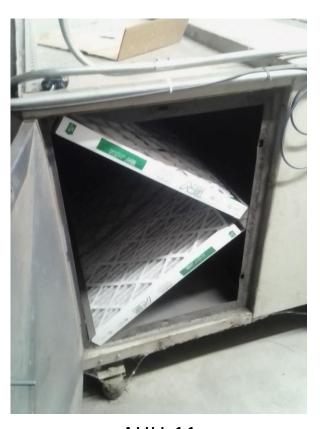
AHU-11
Mixed Main Filter Installation

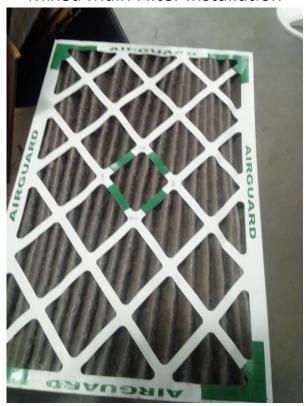
Unit Designation:	AHU-14 (100% OA	A)		
Location of Unit:	2110 loading dock, ceiling			
Areas Served:	Kitchen-See Attac	hed Maps		
System	None	None		
Enhancements:				
Supply System	Outdoor Air	Cleanliness and Observations		
<u>Type</u>	Outdoor air	Outdoor air pre-filters are not present. Outdoor air main filters		
 Supply System 	intake is	are somewhat dirty and on the border of needing replacement

- Constant	accessible	(scoring 3 out of 5) and fit well. Outdoor air main filters are		
Volume		installed correctly.		
 Heating - Hot 	Outdoor air			
Water		Return air filters are not present.		
Cooling - None	on the roof.

AHU-14 (100% OA)
Outdoor Main Filter Cleanliness

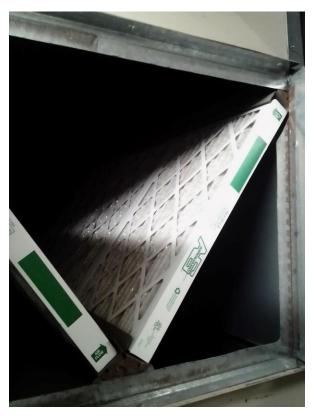
•	•	roof.	are clean and not in need of replacement (scoring 1 out of 5)	
•	Energy		and fit well. Mixed air main filters are installed incorrectly.	
	Recovery Unit	No nearby		
	(ERU) - None	-	Drain pans are not applicable or not present. Drain pan	
		were found.	condition is not known.	
	Type - Mixed

AHU-15
Mixed Main Filter Installation

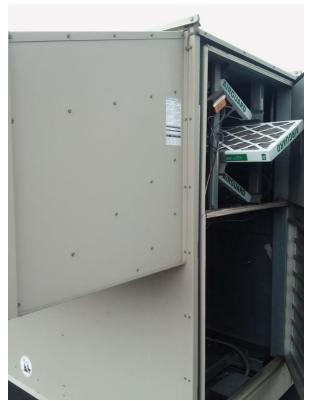
Dirty or poorly fitting filters were observed in units AHU-02, AHU-03, AHU-04, AHU-06, AHU-07, AHU-08, AHU-09, AHU-10, AHU-11, AHU-12, AHU-15 and ERV-16 during the ventilation inspection.

ERV-16
Outdoor Main Filter Installation

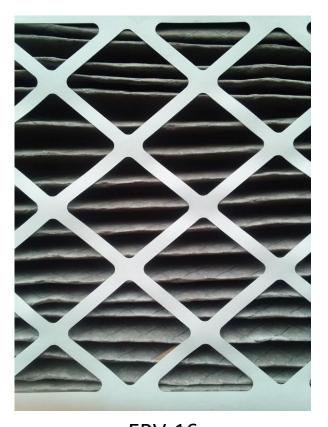
ERV-16
Outdoor Main Filter Cleanliness

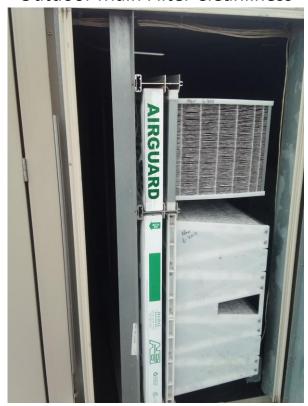
ERV-16
Mixed Pre-Filter Installation

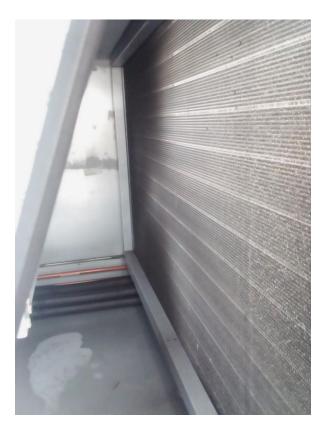
Dirty Coils were observed on unit ERV-16 during the ventilation inspection.

ERV-16 Heating Coils

Recommendation: Impacted/dirty coils can result in poor ventilation air supply as well as be a source for mold and bacterial growth on the coils. Coils should be cleaned annually, or as needed, as identified in the operations and maintenance program.
