2023 - 2024 Ventilation Assessment

Saint Paul Public Schools 271 Belvidere

Assessment Date:
Wednesday, April 12, 2023

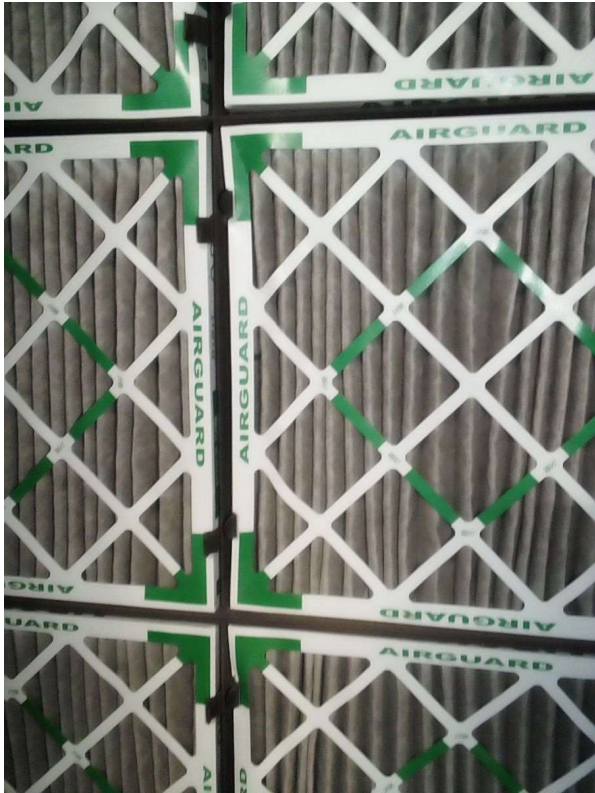
Unit Designation:	AHU_01	
Location of Unit:	Boiler room 0102	
Areas Served:	East Main Building See attached map	
System Enhancements:	None	
Supply System	Outdoor Air	Cleanliness and Observations
Type <ul style="list-style-type: none"> Supply System - Constant Volume Heating - Hot Water Cooling - None Energy Recovery Unit (ERU) - None 	Outdoor air intake is accessible Outdoor air intake is located on an exterior wall. No nearby pollution sources were found.	Outdoor air filters are not present. Return air filters are not present. Mixed air pre-filters are not present. Mixed air main filters are somewhat dirty and on the border of needing replacement (scoring 3 out of 5) and fit well. Mixed air main filters are installed correctly. Drain pans are not applicable or not present. Drain pan condition is not known.
Filter Type - Mixed <ul style="list-style-type: none"> Pre-filter: None Main filter: Pleated, MERV 11 	Outdoor air intake is in good condition.	Heating coils are clean. Heat wheels are not present. Exterior ducting is visible. Exterior ducting insulation is not present. Interior ducting is not visible. Interior ducting insulation is in an unknown condition. Interior ducting is of unknown cleanliness. Air handling room is free of trash/chemicals. Outside damper is unknown, and its condition is not known. Return damper is unknown, and its condition is not known. The general condition of the unit is good.

Mixed Main Filter Cleanliness

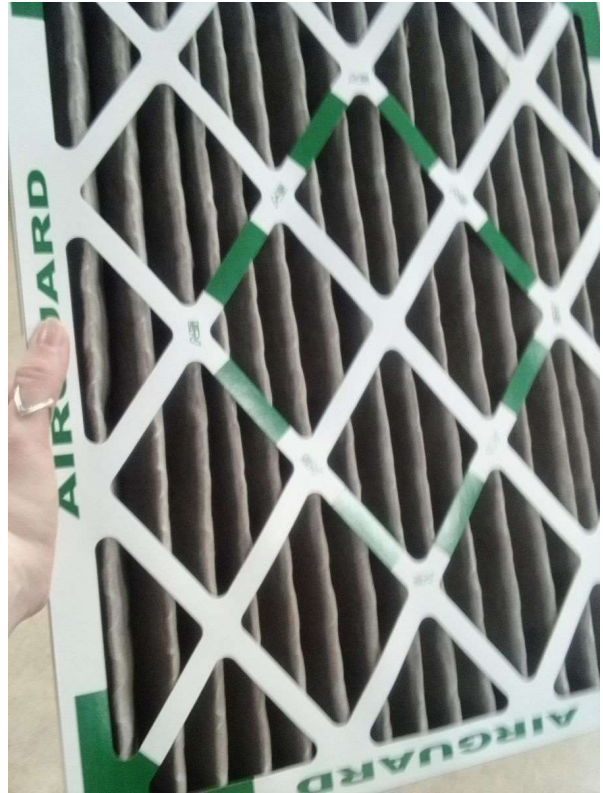
Unit Designation:	AHU_02	
Location of Unit:	Boiler room 0102	
Areas Served:	Kindergarten 1402 See attached map	
System Enhancements:	None	
Supply System	Outdoor Air	Cleanliness and Observations
Type <ul style="list-style-type: none"> Supply System - Constant Volume Heating - Hot Water Cooling - None Energy Recovery Unit (ERU) - None 	<p>Outdoor air intake is accessible</p> <p>Outdoor air intake is located on an exterior wall.</p> <p>It is not known if there are nearby pollution sources.</p>	<p>Outdoor air filters are not present.</p> <p>Return air filters are not present.</p> <p>Mixed air pre-filters are not present. Mixed air main filters are somewhat dirty and on the border of needing replacement (scoring 3 out of 5) and fit well. Mixed air main filters are installed correctly.</p> <p>Drain pans are not applicable or not present. Drain pan condition is not known.</p>
Filter Type - Mixed <ul style="list-style-type: none"> Pre-filter: None Main filter: Pleated, MERV 11 	<p>Outdoor air intake is in good condition.</p>	<p>Heating coils are clean.</p> <p>Heat wheels are not present.</p> <p>Exterior ducting is visible. Exterior ducting insulation is not present.</p> <p>Interior ducting is not visible. Interior ducting insulation is in an unknown condition. Interior ducting is of unknown cleanliness.</p> <p>Air handling room is free of trash/chemicals.</p> <p>Outside damper is unknown, and its condition is not known.</p> <p>Return damper is unknown, and its condition is not known.</p> <p>The general condition of the unit is good.</p>

Mixed Main Filter Cleanliness

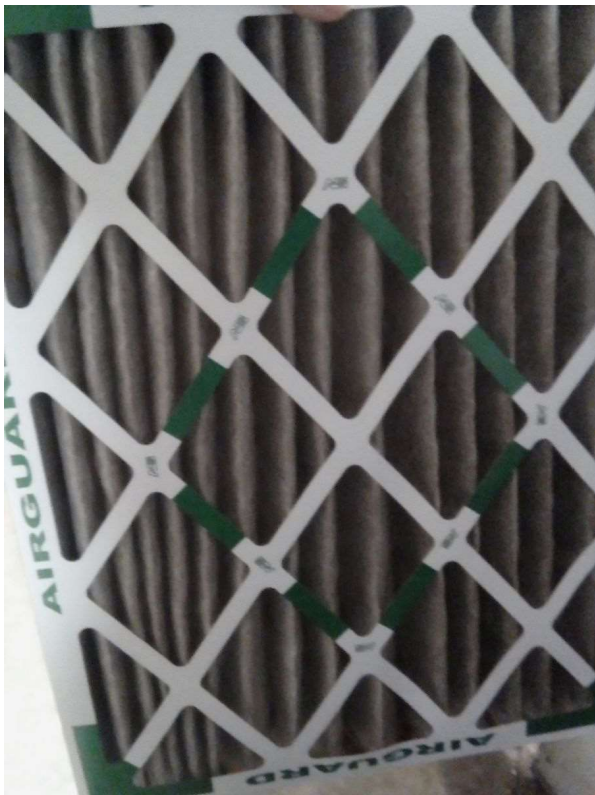
Unit Designation:	AHU_03	
Location of Unit:	1203	
Areas Served:	Gymnasium See attached map	
System Enhancements:	None	
Supply System	Outdoor Air	Cleanliness and Observations
Type <ul style="list-style-type: none"> Supply System - Constant Volume Heating - Hot Water Cooling - None Energy Recovery Unit (ERU) - None 	<p>Outdoor air intake is inaccessible</p> <p>Outdoor air intake is located on an exterior wall.</p> <p>It is not known if there are nearby pollution sources.</p>	<p>Outdoor air filters are not present.</p> <p>Return air filters are not present.</p> <p>Mixed air pre-filters are not present. Mixed air main filters are somewhat dirty and on the border of needing replacement (scoring 3 out of 5) and fit well. Mixed air main filters are installed correctly.</p> <p>Drain pans are not applicable or not present. Drain pan condition is not known.</p>
Filter Type - Mixed <ul style="list-style-type: none"> Pre-filter: None Main filter: Pleated, MERV 11 	<p>Outdoor air intake is in good condition.</p>	<p>Heating coils are inaccessible.</p> <p>Heat wheels are not present.</p> <p>Exterior ducting is visible. Exterior ducting insulation is not present.</p> <p>Interior ducting is not visible. Interior ducting insulation is in good condition. Interior ducting is clean.</p> <p>Air handling room is free of trash/chemicals.</p> <p>Outside damper is open, and its condition is good.</p> <p>Return damper is open, and its condition is good.</p> <p>The general condition of the unit is good.</p>

Mixed Main Filter Cleanliness

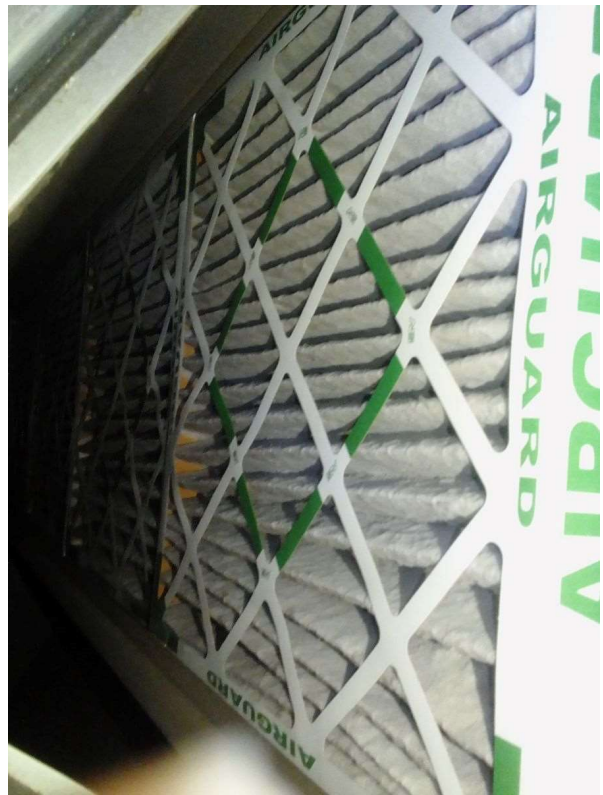
Unit Designation:	AHU_07	
Location of Unit:	1303	
Areas Served:	NW classrooms See attached map	
System Enhancements:	None	
Supply System	Outdoor Air	Cleanliness and Observations
Type <ul style="list-style-type: none"> Supply System - Constant Volume Heating - Hot Water Cooling - None Energy Recovery Unit (ERU) - None 	<p>Outdoor air intake is inaccessible</p> <p>Outdoor air intake is located in an unknown location.</p> <p>It is not known if there are nearby pollution sources.</p>	<p>Outdoor air filters are not present.</p> <p>Return air filters are not present.</p> <p>Mixed air pre-filters are not present. Mixed air main filters are somewhat dirty and on the border of needing replacement (scoring 3 out of 5) and fit well. Mixed air main filters are installed correctly.</p> <p>Drain pans are not applicable or not present. Drain pan condition is not known.</p>
Filter Type - Mixed <ul style="list-style-type: none"> Pre-filter: None Main filter: Pleated, MERV 11 	<p>Outdoor air intake is in good condition.</p>	<p>Heating coils are inaccessible.</p> <p>Heat wheels are not present.</p> <p>Exterior ducting is visible. Exterior ducting insulation is not present.</p> <p>Interior ducting is not visible. Interior ducting insulation is in an unknown condition. Interior ducting is of unknown cleanliness.</p> <p>Air handling room is free of trash/chemicals.</p> <p>Outside damper is open, and its condition is good.</p> <p>Return damper is open, and its condition is good.</p> <p>The general condition of the unit is good.</p>

Mixed Main Filter Cleanliness
