2022 - 2023 IAQ Walkthrough

Saint Paul Public Schools Administration Building

Walkthrough Date:
Monday, December 5, 2022
Retest Date: January 26, 2023

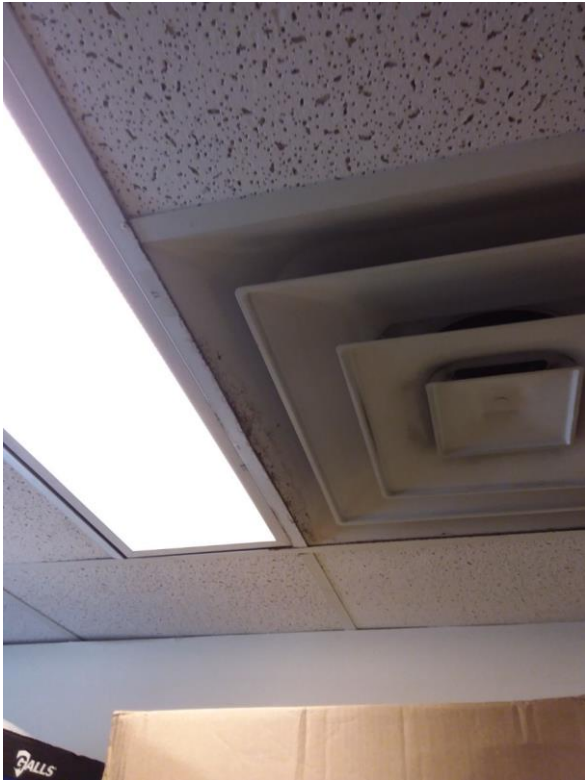
- 108 *Rust*
- 230

Moisture-Impacted Materials

Moisture-impacted building materials should be repaired or replaced when discoloration or water staining is observed. Moisture-impacted building materials can be a source for microbial growth. The source for the moisture infiltration should be investigated and repaired if not easily identified.

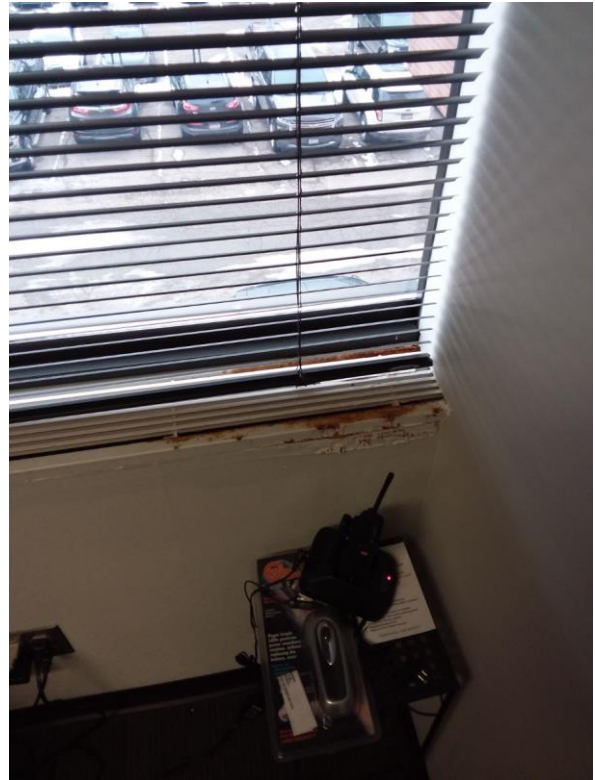
230

Moisture-Impacted Materials
