2023 - 2024 Ventilation Assessment

Saint Paul Public Schools Administration Building

Assessment Date:
Thursday, April 20, 2023

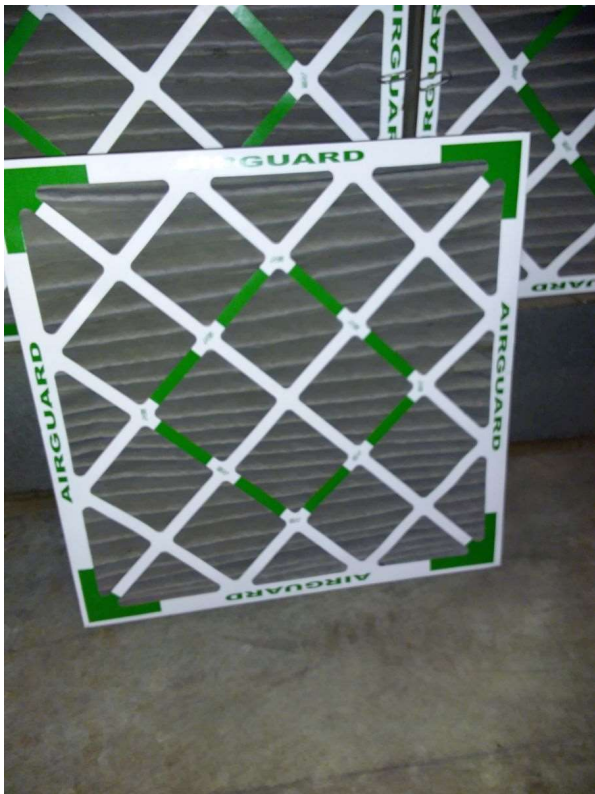
Unit Designation:	AHU_01	
Location of Unit:	Basement near Custodial Office (Boiler Room)	
Areas Served:	5-Story Building See attached map	
System Enhancements:	None	
Supply System	Outdoor Air	Cleanliness and Observations
Type <ul style="list-style-type: none"> Supply System - Constant Volume Heating - Hot Water Cooling - Chilled Water Energy Recovery Unit (ERU) - None Filter Type - Mixed <ul style="list-style-type: none"> Pre-filter: None Main filter: Pleated, MERV 11 	<p>Outdoor air intake is accessible</p> <p>Outdoor air intake is located on an exterior wall.</p> <p>No nearby pollution sources were found.</p> <p>Outdoor air intake is in good condition.</p>	<p>Outdoor air filters are not present.</p> <p>Return air filters are not present.</p> <p>Mixed air pre-filters are not present. Mixed air main filters are somewhat dirty and on the border of needing replacement (scoring 3 out of 5) and fit well. Mixed air main filters are installed correctly.</p> <p>Drain pans are not plugged. Drain pan condition is good.</p> <p>Heating coils are clean and cooling coils are clean.</p> <p>Heat wheels are not present.</p> <p>Exterior ducting is visible. Exterior ducting insulation is not present.</p> <p>Interior ducting is not visible. Interior ducting insulation is in an unknown condition. Interior ducting is of unknown cleanliness.</p> <p>Air handling room is free of trash/chemicals.</p> <p>Outside damper is open, and its condition is good.</p> <p>Return damper is open, and its condition is good.</p> <p>The general condition of the unit is good.</p>

Mixed Main Filter Cleanliness

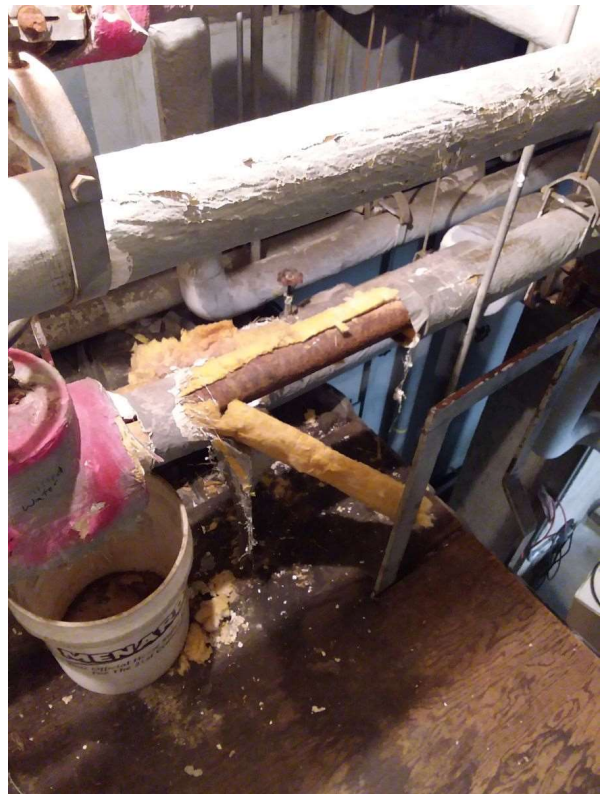
Unit Designation:	AHU_02	
Location of Unit:	Mechanical room L001/mezzanine (Directly above AHU_1 in Boiler Room)	
Areas Served:	Board Room See attached map	
System Enhancements:	None	
Supply System	Outdoor Air	Cleanliness and Observations
<u>Type</u> <ul style="list-style-type: none"> • Supply System - Constant Volume • Heating - Hot Water • Cooling - Chilled Water • Energy Recovery Unit (ERU) - None 	<p>Outdoor air intake is inaccessible</p> <p>Outdoor air intake is located on an exterior wall.</p> <p>It is not known if there are nearby pollution sources.</p>	<p>Outdoor air filters are not present.</p> <p>Return air filters are not present.</p> <p>Mixed air filters are of unknown cleanliness and fit is unknown. Mixed air filters are installed but it is unknown whether they are installed correctly.</p> <p>Drain pan plugged status is not known. Drain pan condition is not known.</p>
<u>Filter Type - Mixed</u> <ul style="list-style-type: none"> • Pre-filter: Inaccessible • Main filter: Inaccessible 	<p>Condition of the outdoor air intake is not known.</p>	<p>Heating coils are clean and cooling coils are inaccessible.</p> <p>Heat wheels are not present.</p> <p>Exterior ducting is visible. Exterior ducting insulation is not present.</p> <p>Interior ducting is not visible. Interior ducting insulation is in an unknown condition. Interior ducting is of unknown cleanliness.</p> <p>Air handling room is free of trash/chemicals.</p> <p>Outside damper is open, and its condition is good.</p> <p>Return damper is open, and its condition is good.</p> <p>The general condition of the unit is poor.</p>

The general condition of unit AHU_02 was poor.

General Condition

Recommendation: The units should be repaired or cleaned as needed.

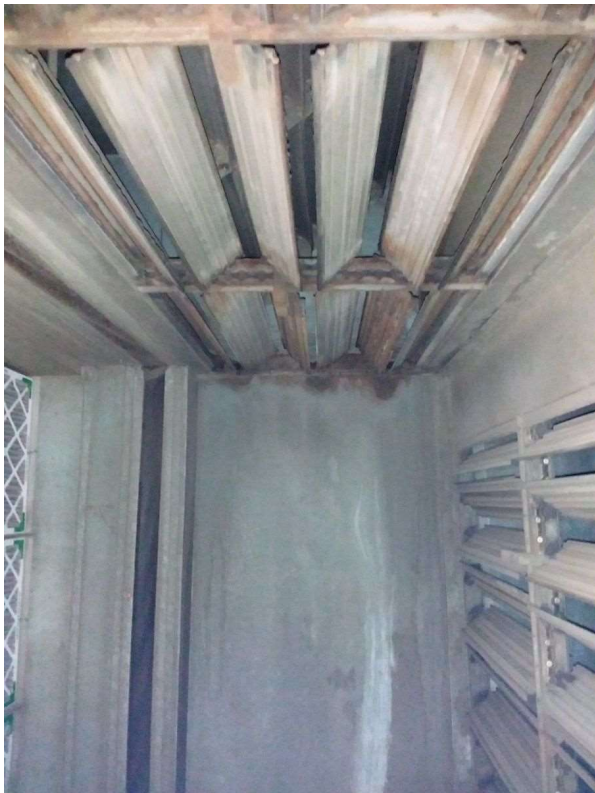
Unit Designation:	AHU_03	
Location of Unit:	On map: Mechanical room B219 (360 Colborne) In building:Electrical Room at the end of "Legal Counseling" corridor	
Areas Served:	2-Story Building See attached map	
System Enhancements:	None	
Supply System	Outdoor Air	Cleanliness and Observations
Type <ul style="list-style-type: none"> • Supply System - Constant Volume • Heating - Steam • Cooling - Chilled Water • Energy Recovery Unit (ERU) - None Filter Type - Mixed <ul style="list-style-type: none"> • Pre-filter: None • Main filter: Pleated, MERV 11 	<p>Outdoor air intake is inaccessible</p> <p>Outdoor air intake is located on an exterior wall.</p> <p>It is not known if there are nearby pollution sources.</p> <p>Outdoor air intake is in good condition.</p>	<p>Outdoor air filters are not present.</p> <p>Return air filters are not present.</p> <p>Mixed air pre-filters are not present. Mixed air main filters are somewhat dirty and on the border of needing replacement (scoring 3 out of 5) and fit well. Mixed air main filters are installed correctly.</p> <p>Drain pans are not plugged. Drain pan condition is good.</p> <p>Heating coils are clean and cooling coils are clean.</p> <p>Heat wheels are not present.</p> <p>Exterior ducting is not visible. Exterior ducting insulation is in an unknown condition.</p> <p>Interior ducting is not visible. Interior ducting insulation is in an unknown condition. Interior ducting is of unknown cleanliness.</p> <p>Air handling room is free of trash/chemicals.</p> <p>Outside damper is open, and its condition is poor. The seal is damaged and .</p> <p>Return damper is open, and its condition is good.</p> <p>The general condition of the unit is good.</p>

Outside Damper

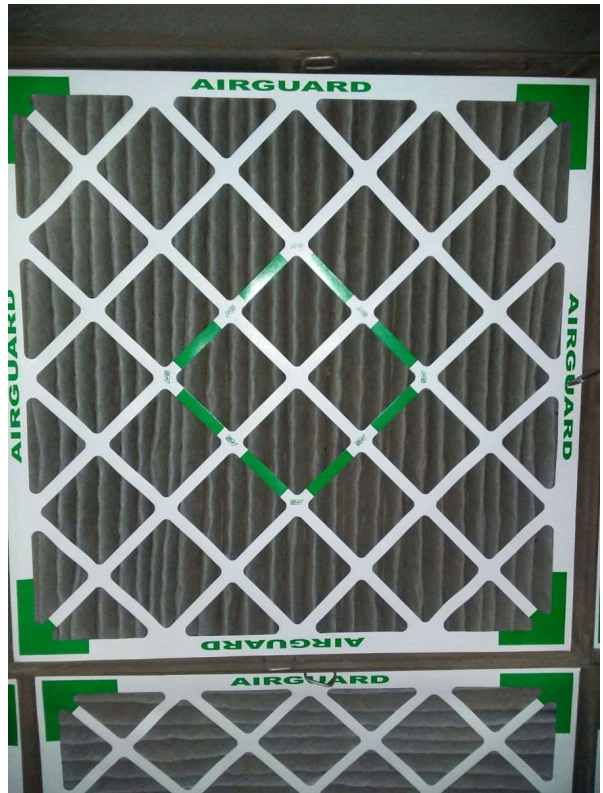
AHU_03

Mixed Main Filter Cleanliness

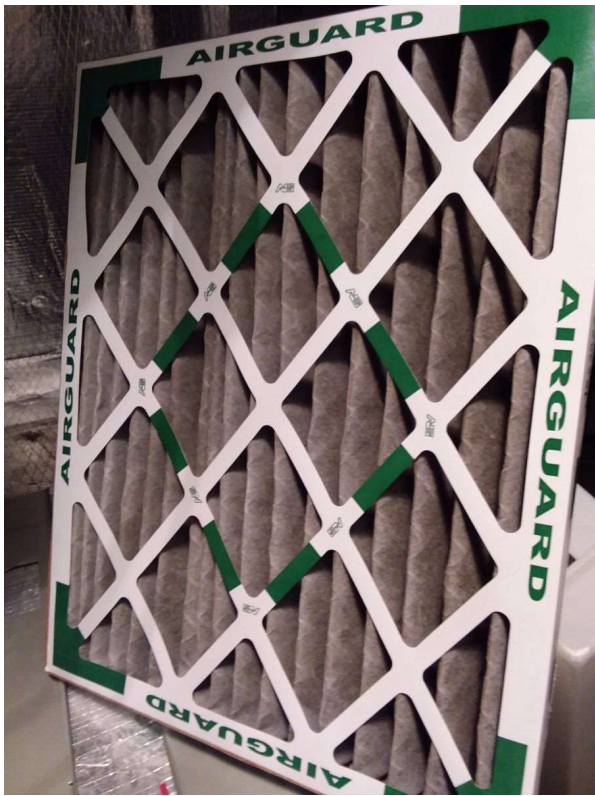
Unit Designation:	AHU_04	
Location of Unit:	On map: Mechanical room B219 (360 Colborne) In building:Electrical Room at the end of "Legal Counseling" corridor	
Areas Served:	See attached map.	
System Enhancements:	None	
Supply System	Outdoor Air	Cleanliness and Observations
Type <ul style="list-style-type: none"> • Supply System - Unknown • Heating - Steam • Cooling - Chilled Water • Energy Recovery Unit (ERU) - None 	<p>Outdoor air intake is inaccessible</p> <p>Outdoor air intake is located on an exterior wall.</p> <p>It is not known if there are nearby pollution sources.</p>	<p>Outdoor air filters are not present.</p> <p>Return air filters are not present.</p> <p>Mixed air pre-filters are not present. Mixed air main filters are somewhat dirty and on the border of needing replacement (scoring 3 out of 5) and fit well. Mixed air main filters are installed correctly.</p> <p>Drain pans are not plugged. Drain pan condition is good.</p>

Filter Type - Mixed <ul style="list-style-type: none"> • Pre-filter: None • Main filter: Pleated, MERV 11 	<p>Outdoor air intake is in good condition.</p>	<p>Heating coils are clean and cooling coils are clean.</p> <p>Heat wheels are not present.</p> <p>Exterior ducting is not visible. Exterior ducting insulation is in an unknown condition.</p> <p>Interior ducting is not visible. Interior ducting insulation is in an unknown condition. Interior ducting is of unknown cleanliness.</p> <p>Air handling room is free of trash/chemicals.</p> <p>Outside damper is open, and its condition is good.</p> <p>Return damper is open, and its condition is good.</p> <p>The general condition of the unit is good.</p>

Mixed Main Filter Cleanliness

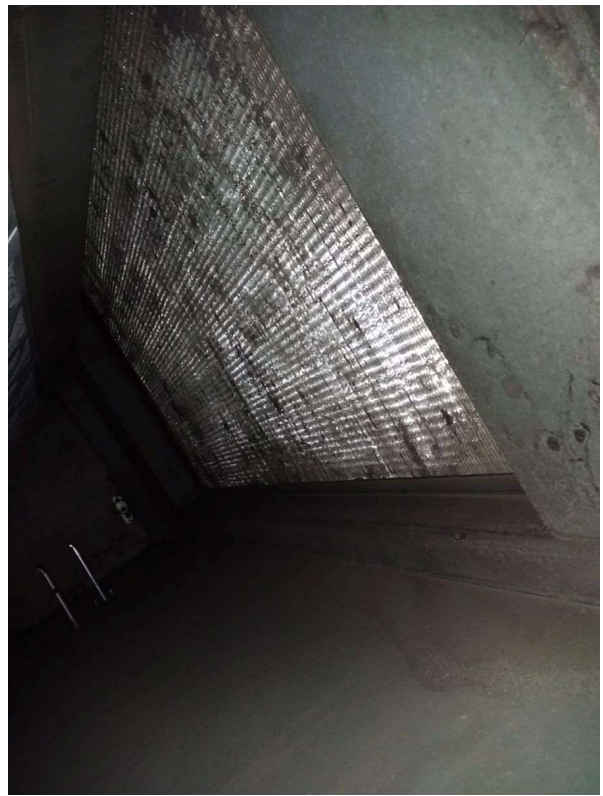
Unit Designation:	AHU_05	
Location of Unit:	Mechanical room 1201B SE (Bridgeview)	
Areas Served:	North Gym See attached map	
System Enhancements:	None	
Supply System	Outdoor Air	Cleanliness and Observations
Type <ul style="list-style-type: none"> Supply System - Constant Volume Heating - Hot Water Cooling - None Energy Recovery Unit (ERU) - None 	<p>Outdoor air intake is accessible</p> <p>Outdoor air intake is located on an exterior wall.</p> <p>It is not known if there are nearby pollution sources.</p>	<p>Outdoor air filters are not present.</p> <p>Return air filters are not present.</p> <p>Mixed air pre-filters are not present. Mixed air main filters are clean and not in need of replacement (scoring 2 out of 5) and fit well. Mixed air main filters are installed correctly.</p> <p>Drain pans are not applicable or not present. Drain pan condition is not known.</p>
Filter Type - Mixed <ul style="list-style-type: none"> Pre-filter: None Main filter: Pleated, MERV 11 	<p>Outdoor air intake is in good condition.</p>	<p>Heating coils are dirty.</p> <p>Heat wheels are not present.</p> <p>Exterior ducting is visible. Exterior ducting insulation is not present.</p> <p>Interior ducting is not visible. Interior ducting insulation is in an unknown condition. Interior ducting is of unknown cleanliness.</p> <p>Air handling room is free of trash/chemicals.</p> <p>Outside damper is inaccessible, and its condition is not known.</p> <p>Return damper is open, and its condition is good.</p> <p>The general condition of the unit is good.</p>

Dirty Coils were observed on units AHU_05, AHU_06 and AHU_12 during the ventilation inspection.

Heating Coils

Recommendation: Impacted/dirty coils can result in poor ventilation air supply as well as be a source for mold and bacterial growth on the coils. Coils should be cleaned annually, or as needed, as identified in the operations and maintenance program.

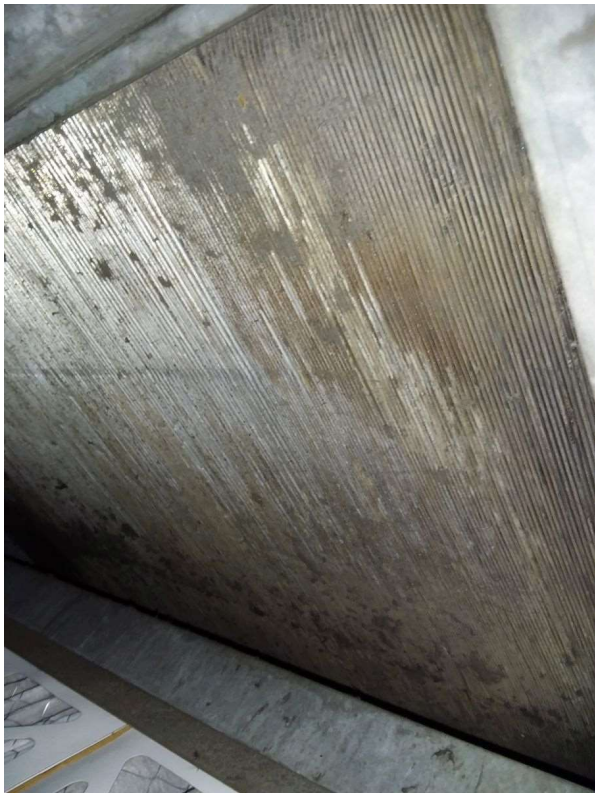
Unit Designation:	AHU_06	
Location of Unit:	Mechanical room 1202B NW (Bridgeview)	
Areas Served:	South Gym See attached map	
System Enhancements:	None	
Supply System	Outdoor Air	Cleanliness and Observations
Type <ul style="list-style-type: none"> Supply System - Constant Volume Heating - Hot Water Cooling - None Energy Recovery Unit (ERU) - None Filter Type - Mixed <ul style="list-style-type: none"> Pre-filter: None Main filter: Pleated, MERV 11 	<p>Outdoor air intake is inaccessible</p> <p>Outdoor air intake is located on an exterior wall.</p> <p>No nearby pollution sources were found.</p> <p>Outdoor air intake is in good condition.</p>	<p>Outdoor air filters are not present.</p> <p>Return air filters are not present.</p> <p>Mixed air pre-filters are not present. Mixed air main filters are clean and not in need of replacement (scoring 2 out of 5) and fit well. Mixed air main filters are installed correctly.</p> <p>Drain pans are not applicable or not present. Drain pan condition is not known.</p> <p>Heating coils are dirty.</p> <p>Heat wheels are not present.</p> <p>Exterior ducting is visible. Exterior ducting insulation is not present.</p> <p>Interior ducting is not visible. Interior ducting insulation is in an unknown condition. Interior ducting is of unknown cleanliness.</p> <p>Air handling room is free of trash/chemicals.</p> <p>Outside damper is inaccessible, and its condition is not known.</p> <p>Return damper is open, and its condition is good.</p> <p>The general condition of the unit is good.</p>

Heating Coils

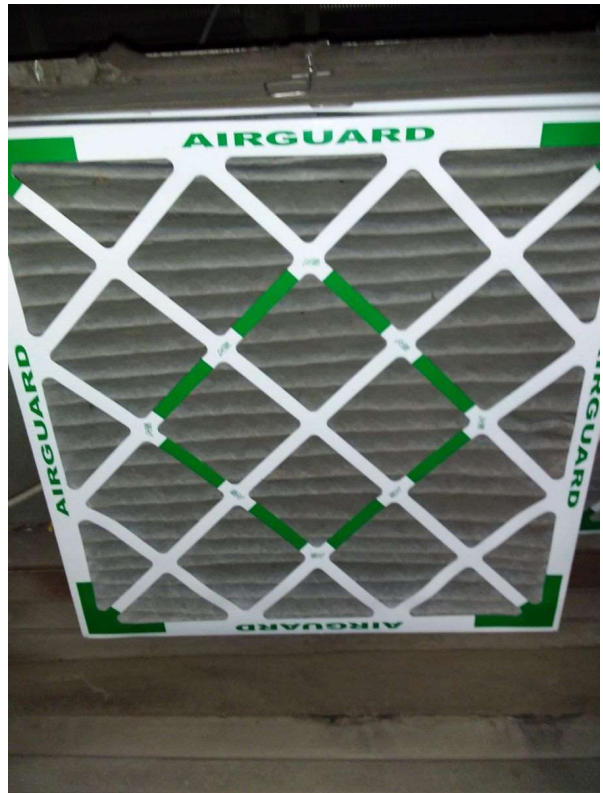
Unit Designation:	AHU_07	
Location of Unit:	Mechanical room BV penthouse	
Areas Served:	Pods C & D See attached map	
System Enhancements:	None	
Supply System	Outdoor Air	Cleanliness and Observations
Type <ul style="list-style-type: none"> Supply System - Constant Volume Heating - Hot Water Cooling - Chilled Water Energy Recovery Unit (ERU) - None Filter Type - Mixed <ul style="list-style-type: none"> Pre-filter: None Main filter: Pleated, MERV 11 	<p>Outdoor air intake is inaccessible</p> <p>Outdoor air intake is located on an exterior wall.</p> <p>It is not known if there are nearby pollution sources.</p> <p>Outdoor air intake is in good condition.</p>	<p>Outdoor air filters are not present.</p> <p>Return air filters are not present.</p> <p>Mixed air pre-filters are not present. Mixed air main filters are somewhat dirty and on the border of needing replacement (scoring 3 out of 5) and fit well. Mixed air main filters are installed correctly.</p> <p>Drain pans are not plugged. Drain pan condition is good.</p> <p>Heating coils are clean and cooling coils are clean.</p> <p>Heat wheels are not present.</p> <p>Exterior ducting is visible. Exterior ducting insulation is not present.</p> <p>Interior ducting is not visible. Interior ducting insulation is in an unknown condition. Interior ducting is of unknown cleanliness.</p> <p>Air handling room is free of trash/chemicals.</p> <p>Outside damper is open, and its condition is good.</p> <p>Return damper is open, and its condition is good.</p> <p>The general condition of the unit is good.</p>

Mixed Main Filter Cleanliness

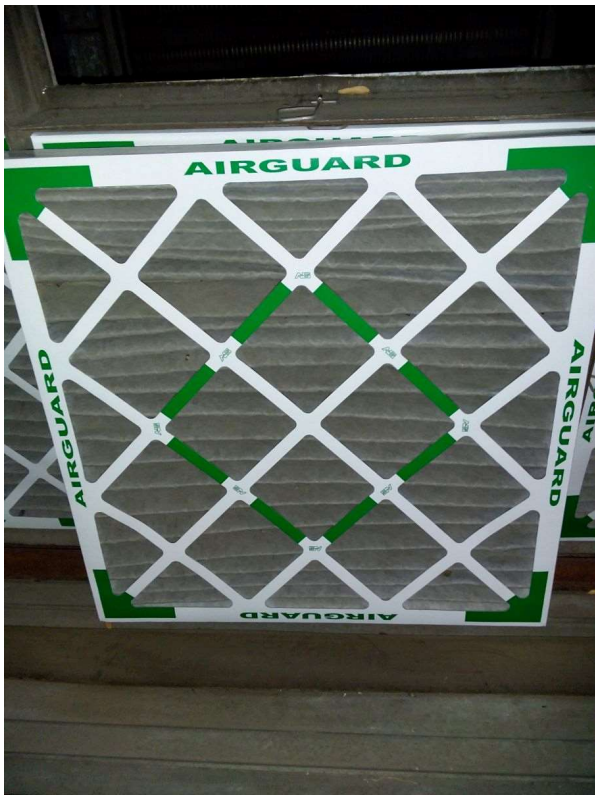
Unit Designation:	AHU_08	
Location of Unit:	Mechanical room BV penthouse	
Areas Served:	Pods A & B See attached map	
System Enhancements:	None	
Supply System	Outdoor Air	Cleanliness and Observations
Type <ul style="list-style-type: none"> Supply System - Constant Volume Heating - Steam Cooling - Chilled Water Energy Recovery Unit (ERU) - None Filter Type - Mixed <ul style="list-style-type: none"> Pre-filter: None Main filter: Pleated, MERV 11 	<p>Outdoor air intake is inaccessible</p> <p>Outdoor air intake is located on an exterior wall.</p> <p>It is not known if there are nearby pollution sources.</p> <p>Condition of the outdoor air intake is not known.</p>	<p>Outdoor air filters are not present.</p> <p>Return air filters are not present.</p> <p>Mixed air pre-filters are not present. Mixed air main filters are somewhat dirty and on the border of needing replacement (scoring 3 out of 5) and fit well. Mixed air main filters are installed correctly.</p> <p>Drain pans are not plugged. Drain pan condition is good.</p> <p>Heating coils are clean and cooling coils are clean.</p> <p>Heat wheels are not present.</p> <p>Exterior ducting is visible. Exterior ducting insulation is not present.</p> <p>Interior ducting is not visible. Interior ducting insulation is in an unknown condition. Interior ducting is of unknown cleanliness.</p> <p>Air handling room is free of trash/chemicals.</p> <p>Outside damper is open, and its condition is good.</p> <p>Return damper is open, and its condition is good.</p> <p>The general condition of the unit is good.</p>

Mixed Main Filter Cleanliness

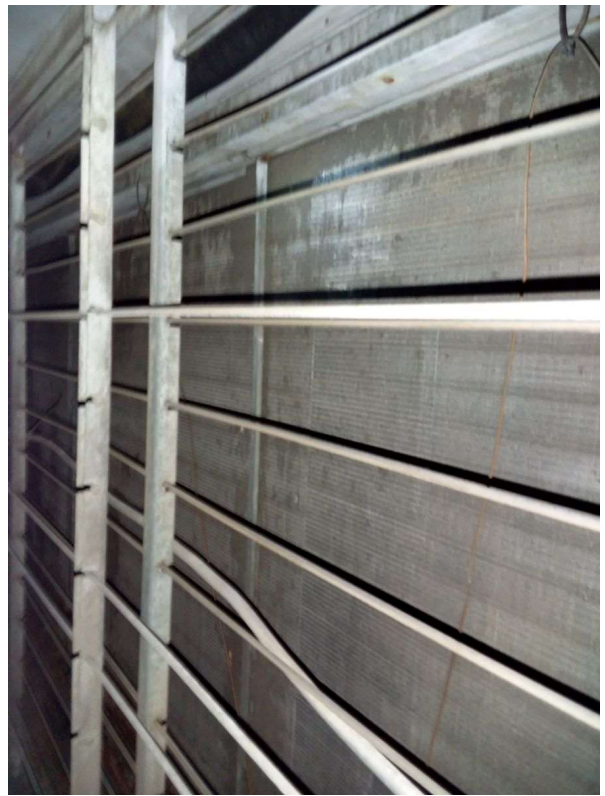
Unit Designation:	AHU_12	
Location of Unit:	Mechanical room BV penthouse	
Areas Served:	See attached map.	
System Enhancements:	None	
Supply System	Outdoor Air	Cleanliness and Observations
<u>Type</u> <ul style="list-style-type: none"> Supply System - Unknown Heating - Steam Cooling - Chilled Water Energy Recovery Unit (ERU) - None 	<p>Outdoor air intake is inaccessible</p> <p>Outdoor air intake is located on an exterior wall.</p> <p>It is not known if there are nearby pollution sources.</p>	<p>Outdoor air filters are not present.</p> <p>Return air filters are not present.</p> <p>Mixed air pre-filters are not present. Mixed air main filters are clean and not in need of replacement (scoring 2 out of 5) and fit well. Mixed air main filters are installed correctly.</p> <p>Drain pan plugged status is not known. Drain pan condition is good.</p>
<u>Filter Type - Mixed</u> <ul style="list-style-type: none"> Pre-filter: None Main filter: Pleated, MERV 11 	<p>Outdoor air intake is in good condition.</p>	<p>Heating coils are inaccessible and cooling coils are dirty.</p> <p>Heat wheels are not present.</p> <p>Exterior ducting is visible. Exterior ducting insulation is not present.</p> <p>Interior ducting is not visible. Interior ducting insulation is in an unknown condition. Interior ducting is of unknown cleanliness.</p> <p>Air handling room is free of trash/chemicals.</p> <p>Outside damper is open, and its condition is good.</p> <p>Return damper is inaccessible, and its condition is good.</p> <p>The general condition of the unit is good.</p>

Cooling Coils

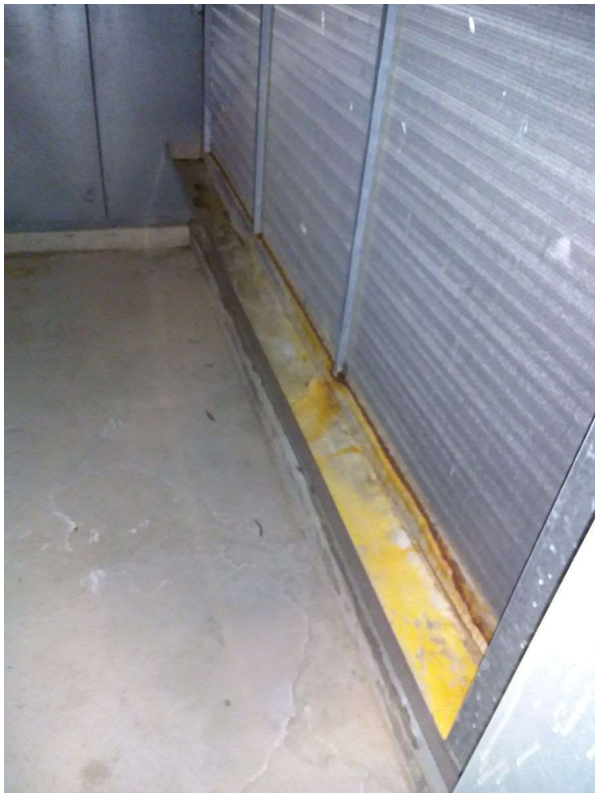
Unit Designation:	AHU_13	
Location of Unit:	Mechanical room FB boiler room	
Areas Served:	Focus Beyond See attached map	
System Enhancements:	None	
Supply System	Outdoor Air	Cleanliness and Observations
Type <ul style="list-style-type: none"> • Supply System - VAV • Heating - Hot Water • Cooling - Chilled Water • Energy Recovery Unit (ERU) - None 	<p>Outdoor air intake is accessible</p> <p>Outdoor air intake is located on an exterior wall.</p> <p>No nearby pollution sources were found.</p> <p>Outdoor air intake is in good condition.</p>	<p>Outdoor air pre-filters are not present. Outdoor air main filters are not present.</p> <p>Return air filters are not present.</p> <p>Mixed air pre-filters are not present. Mixed air main filters are clean and not in need of replacement (scoring 2 out of 5) and fit well. Mixed air main filters are installed correctly.</p> <p>Drain pans are not plugged. Drain pan condition is poor.</p> <p>Heating coils are clean and cooling coils are clean.</p> <p>Heat wheels are not present.</p> <p>Exterior ducting is visible. Exterior ducting insulation is not present.</p> <p>Interior ducting is not visible. Interior ducting insulation is in an unknown condition. Interior ducting is of unknown cleanliness.</p> <p>Air handling room is free of trash/chemicals.</p> <p>Outside damper is open, and its condition is good.</p> <p>Return damper is inaccessible, and its condition is not known.</p> <p>The general condition of the unit is good.</p>

The drain pan for unit AHU_13 was plugged or damaged at the time of the site inspection.

Drain Pans

Recommendation: Damage to the drain pan should be repaired, or the drain pan should be inspected more frequently to ensure that it does not become plugged.

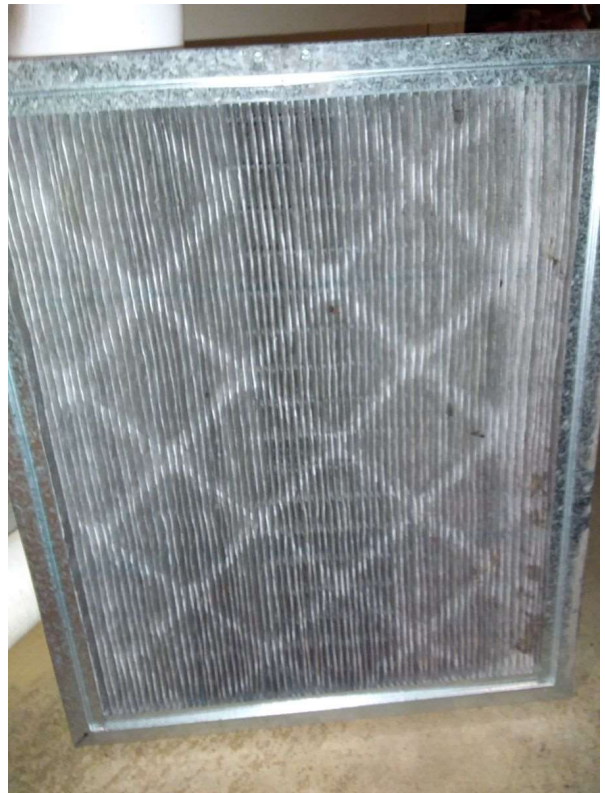
Unit Designation:	MAU_01	
Location of Unit:	Mechanical room 360 chiller rm	
Areas Served:	Chiller Room See attached map	
System Enhancements:	None	
Supply System	Outdoor Air	Cleanliness and Observations
Type <ul style="list-style-type: none"> • Supply System - Constant Volume • Heating - Steam • Cooling - None • Energy Recovery Unit (ERU) - None 	<p>Outdoor air intake is inaccessible</p> <p>Outdoor air intake is located on an exterior wall.</p> <p>It is not known if there are nearby pollution sources.</p> <p>Outdoor air intake is in good condition.</p>	<p>Outdoor air pre-filters are clean and not in need of replacement (scoring 1 out of 5) and fit well. Outdoor air pre-filters are installed correctly. Outdoor air main filters are somewhat dirty and on the border of needing replacement (scoring 3 out of 5) and fit well. Outdoor air main filters are installed correctly.</p> <p>Return air filters are not present.</p> <p>Drain pans are not plugged. Drain pan condition is good.</p> <p>Heating coils are clean.</p> <p>Heat wheels are not present.</p> <p>Exterior ducting is visible. Exterior ducting insulation is not present.</p> <p>Interior ducting is not visible. Interior ducting insulation is in an unknown condition. Interior ducting is of unknown cleanliness.</p> <p>Air handling room is free of trash/chemicals.</p> <p>Outside damper is open, and its condition is good.</p> <p>Return damper is not present.</p> <p>The general condition of the unit is good.</p>

Filter Type - Outdoor <ul style="list-style-type: none"> • Pre-filter: Pleated, MERV 11 • Main filter: Pleated, N/A

Outdoor Main Filter Cleanliness
