2023 - 2024 Ventilation Assessment

Saint Paul Public Schools Chelsea Heights Elementary School

Assessment Date:
Thursday, April 20, 2023

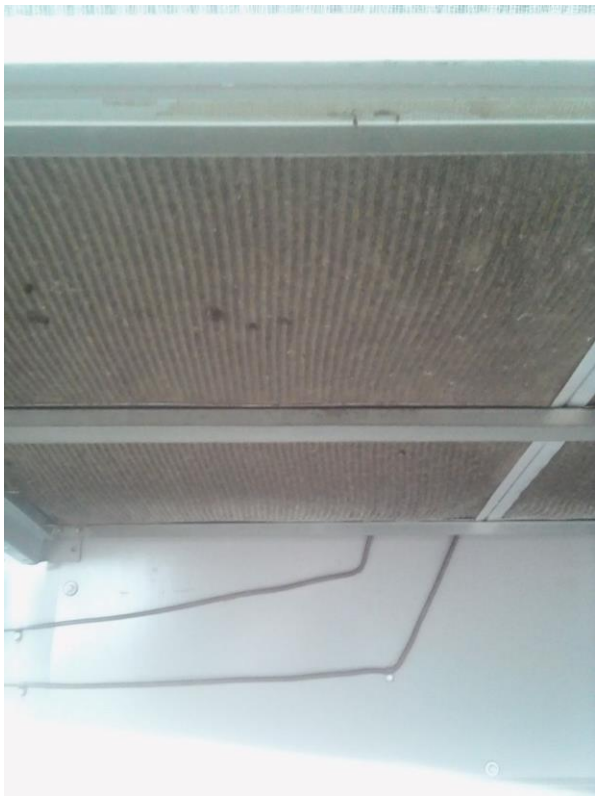
Unit Designation:	RTU-04	
Location of Unit:	high roof 1932	
Areas Served:	See attached map 2nd Floor East	
System Enhancements:	None	
Supply System	Outdoor Air	Cleanliness and Observations
Type <ul style="list-style-type: none"> • Supply System - VAV • Heating - Hot Water • Cooling - Dx • Energy Recovery Unit (ERU) - None 	<p>Outdoor air intake is accessible</p> <p>Outdoor air intake is located on the unit.</p> <p>No nearby pollution sources were found.</p>	<p>Outdoor air pre-filters are not present. Outdoor air main filters are somewhat dirty and on the border of needing replacement (scoring 3 out of 5) and fit well. Outdoor air main filters are installed correctly.</p> <p>Return air filters are not present.</p> <p>Mixed air pre-filters are not present. Mixed air main filters are clean and not in need of replacement (scoring 2 out of 5) and fit well. Mixed air main filters are installed correctly.</p>

Outdoor Main Filter Cleanliness
