# 2022 - 2023 IAQ Walkthrough

## Saint Paul Public Schools Cherokee Heights Elementary School

Walkthrough Date:  
Friday, February 10, 2023  
Retest Date: March 22, 2023

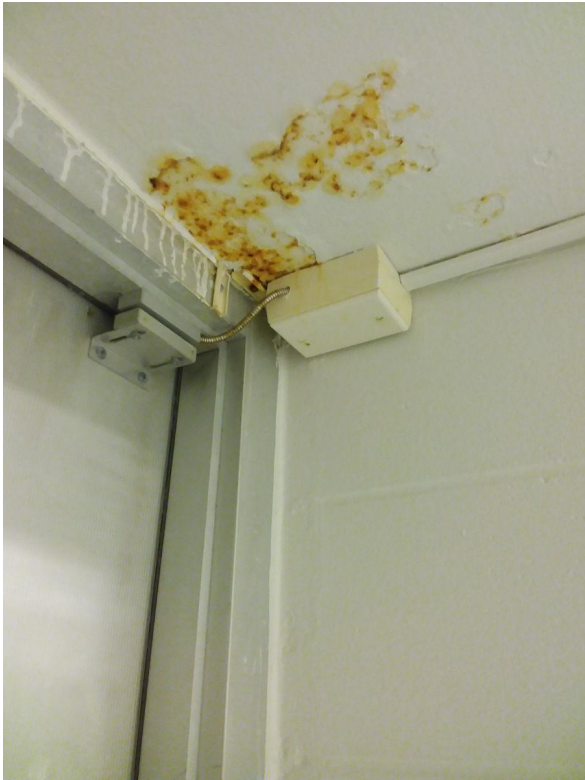
**POOL**

Moisture-impacted building materials should be repaired or replaced when discoloration or water staining is observed. Moisture-impacted building materials can be a source for microbial growth. The source for the moisture infiltration should be investigated and repaired if not easily identified.

**Moisture Impacted Materials**

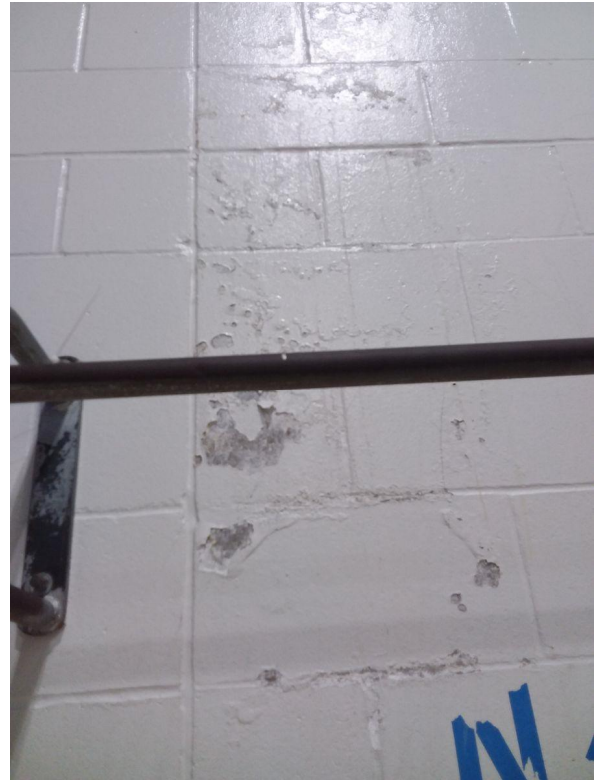
**1208**

IEA observed bubbling/peeling paint in area(s) within the room(s) listed below. Bubbling/peeling paint can be caused by moisture issues. IEA recommends investigating the cause and repairing the paint. IEA recommends ensuring that the paint is not lead-based prior to disturbance.

**Bubbling/Peeling Paint**
