2022 - 2023 IAQ Walkthrough

Saint Paul Public Schools Como Park Elementary School

Walkthrough Date:
Monday, November 14, 2022

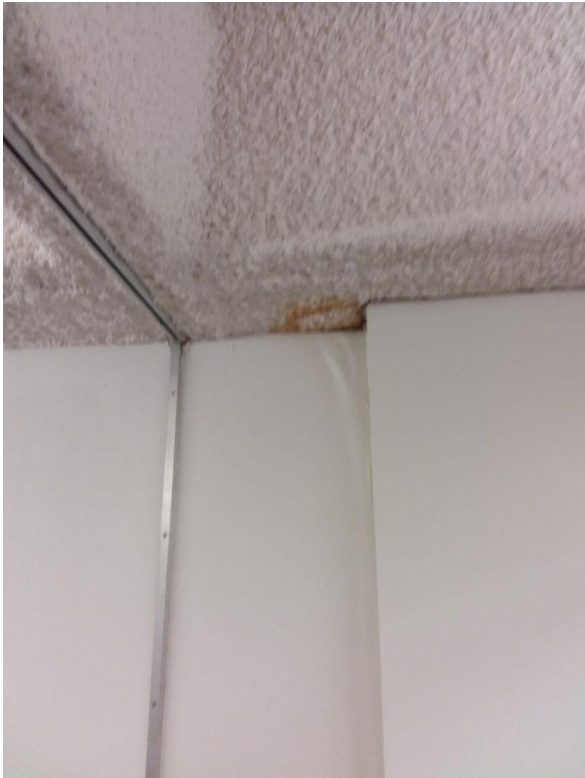
- 1124
- 2606 *Rust dripping down the S wall*

Moisture Impacted Materials

Moisture-impacted building materials should be repaired or replaced when discoloration or water staining is observed. Moisture-impacted building materials can be a source for microbial growth. The source for the moisture infiltration should be investigated and repaired if not easily identified.
