IEA, INC.

2022 - 2023 IAQ Walkthrough

Saint Paul Public Schools Como Park Senior High School

Walkthrough Date:
Thursday, January 19, 2023
March 24, 2023

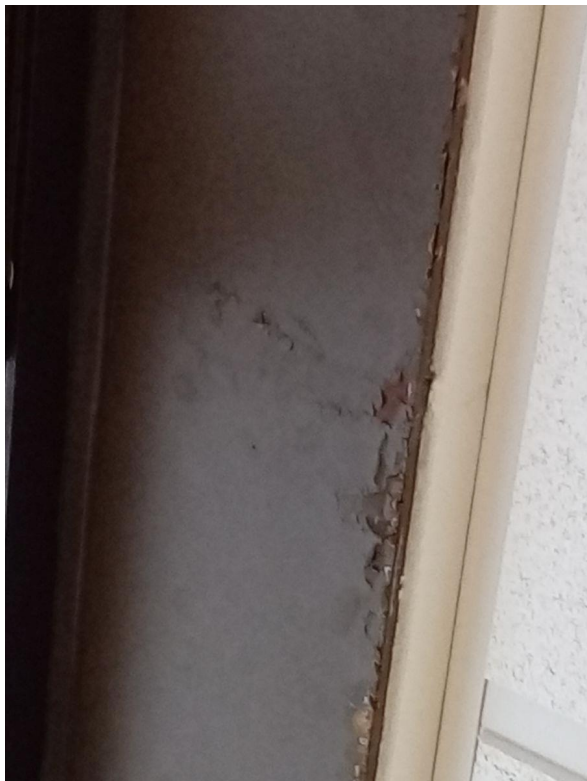
1013

Moisture-Impacted Materials

Moisture-impacted building materials should be repaired or replaced when discoloration or water staining is observed. Moisture-impacted building materials can be a source for microbial growth. The source for the moisture infiltration should be investigated and repaired if not easily identified.

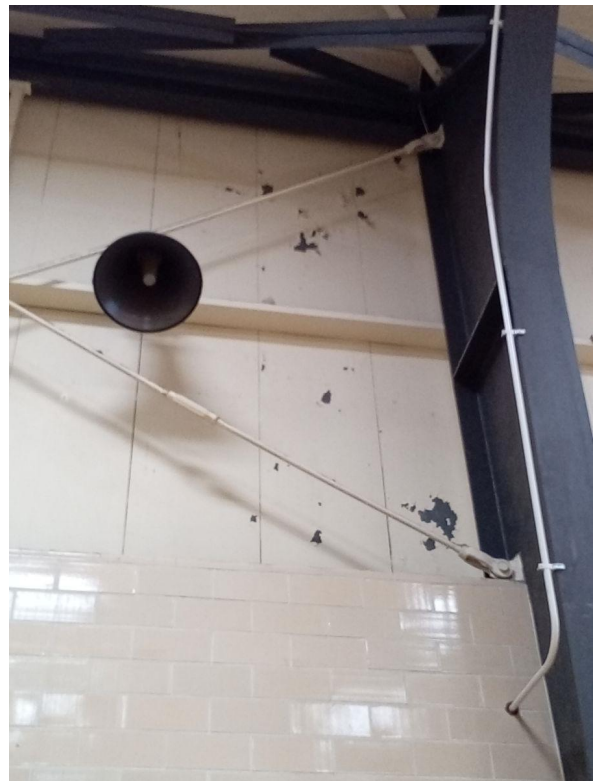
1101 GYMNASIUM

Bubbling/Peeling Paint

IEA observed bubbling/peeling paint in area(s) within the room(s) listed below. Bubbling/peeling paint can be caused by moisture issues. IEA recommends investigating the cause and repairing the paint. IEA recommends ensuring that the paint is not lead-based prior to disturbance.

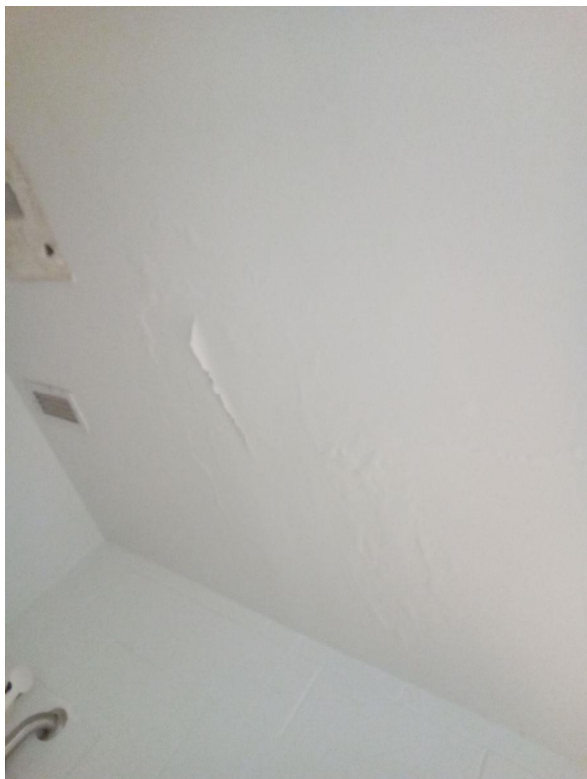
1112B

Bubbling/Peeling Paint

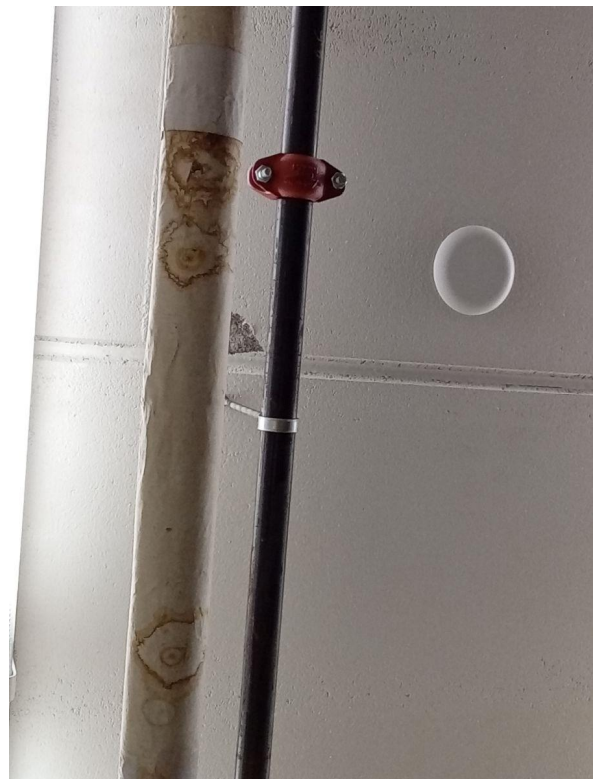
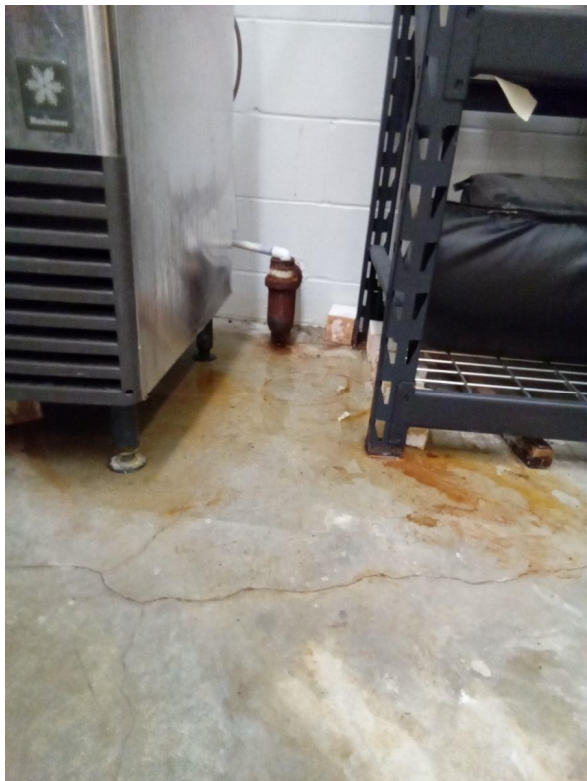
1104

Moisture-Impacted Materials

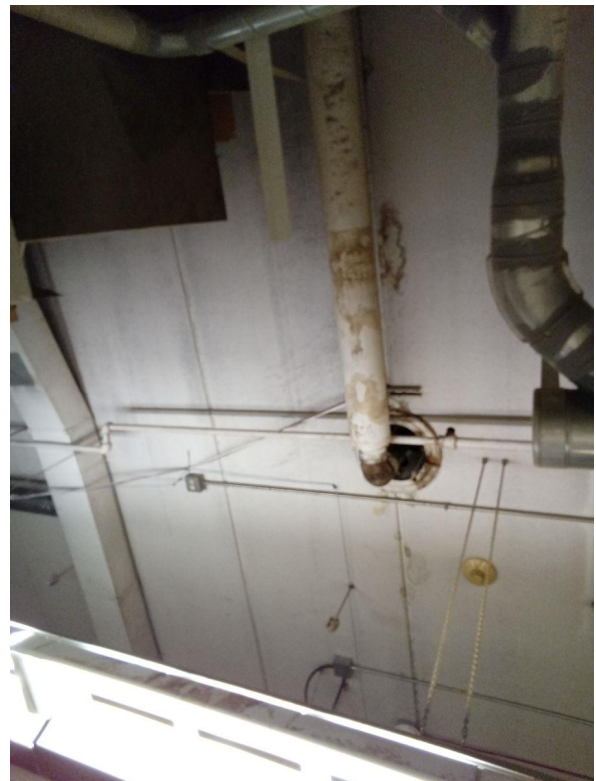
1218

Moisture-Impacted Materials

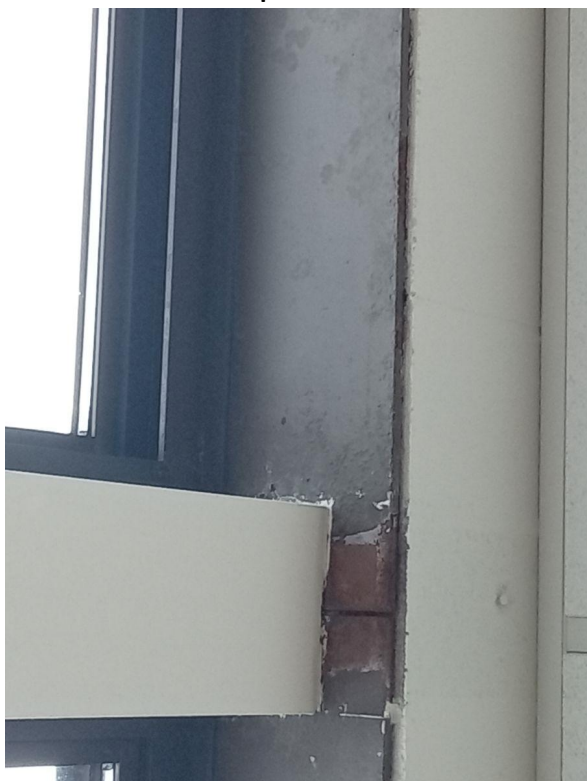
1007

Moisture-Impacted Materials

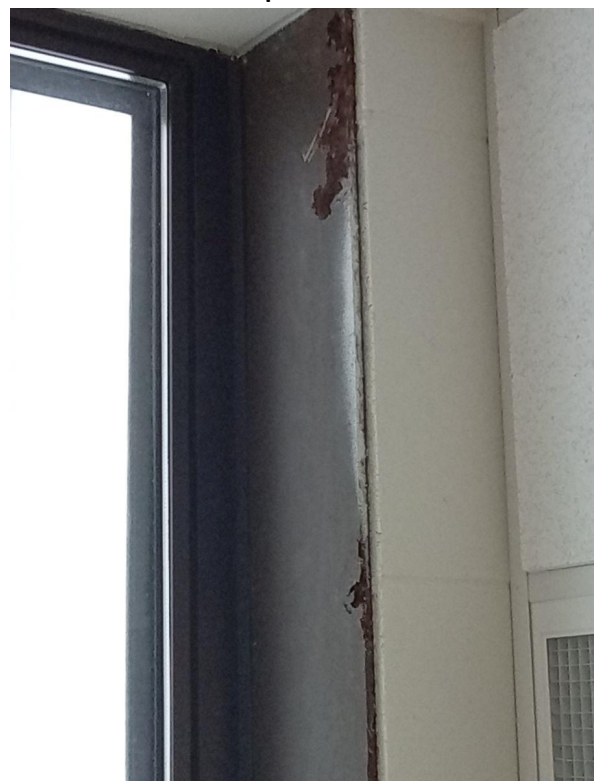
1005

Moisture-Impacted Materials

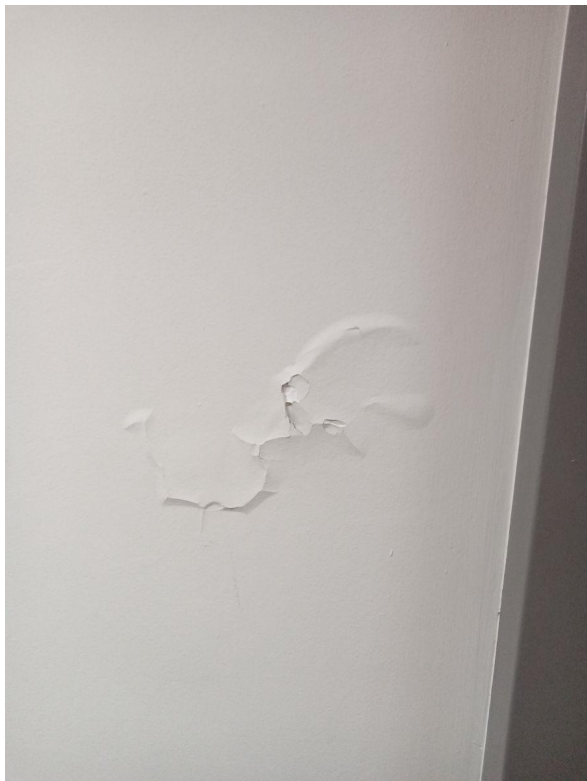
1215

Bubbling/Peeling Paint

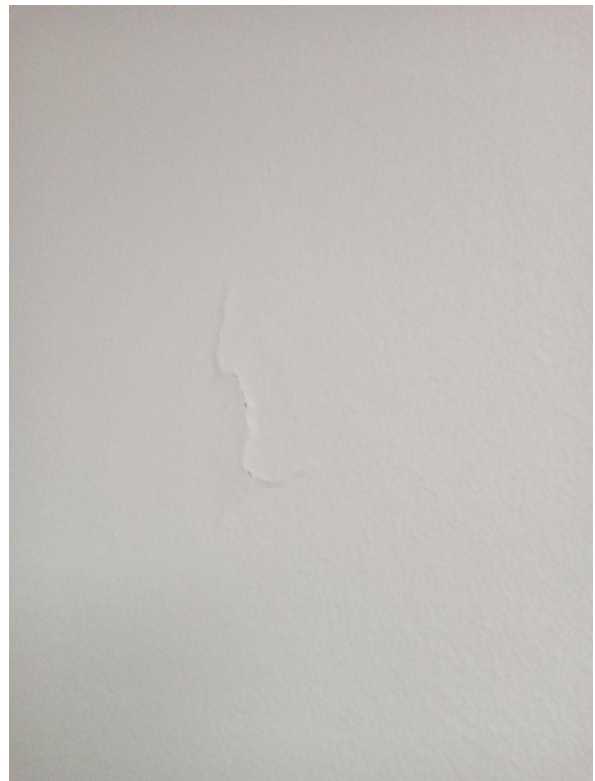
1217

Bubbling/Peeling Paint

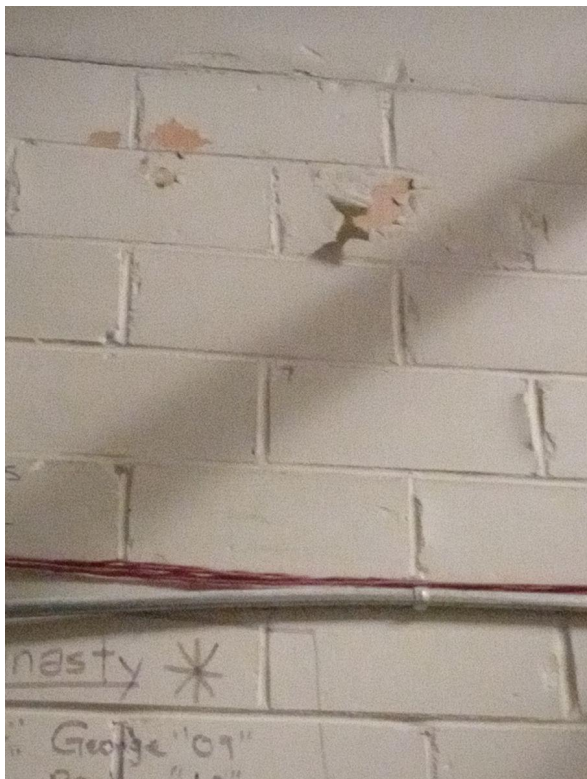
1033 STAGE

Bubbling/Peeling Paint

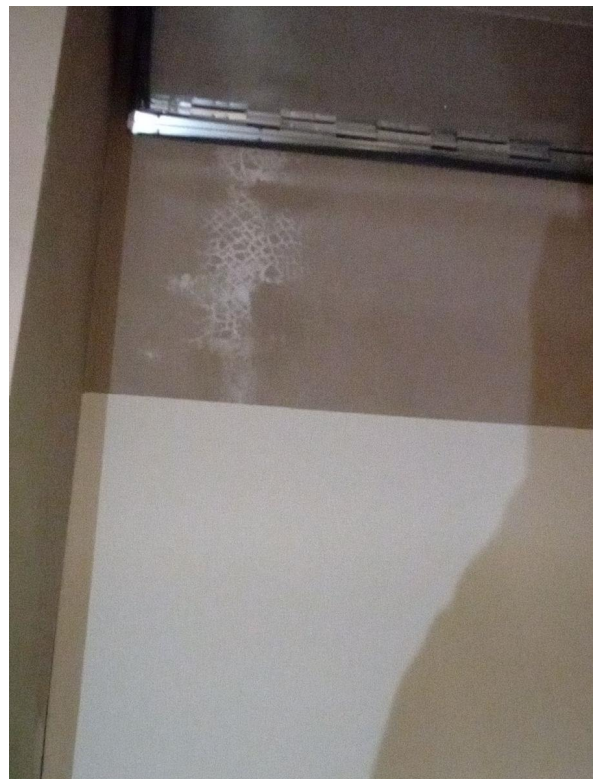
- 1033 STAGE *NW corner, South wall and near SW corner*

Efflorescence

IEA identified area(s) with efflorescence within the room(s) listed below. IEA recommends the moisture concern causing the efflorescence be investigated. Building materials should be repaired or replaced.
