2023 - 2024 Ventilation Assessment

Saint Paul Public Schools Como Park Senior High School

Assessment Date: Friday, April 21, 2023

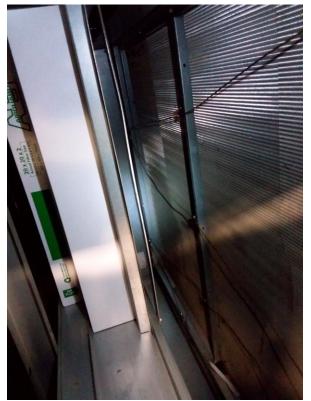
AHU02 Cooling Coils

Dirty Coils were observed on unit AHU02 during the ventilation inspection.

Recommendation: Impacted/dirty coils can result in poor ventilation air supply as well as be a source for mold and bacterial growth on the coils. Coils should be cleaned annually, or as needed, as identified in the operations and maintenance program.

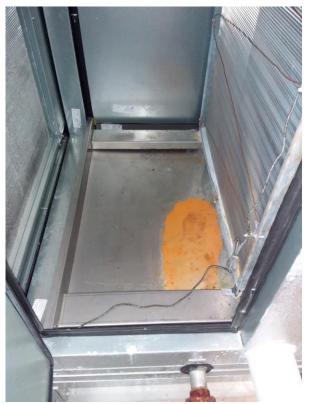
AHU06 Drain Pans

The drain pan for units AHU06, AHU07, AHU09, AHU18, AHU20, RAHU01 and RAHU05 was plugged or damaged at the time of the site inspection.

Recommendation: Damage to the drain pan should be repaired, or the drain pan should be inspected more frequently to ensure that it does not become plugged.

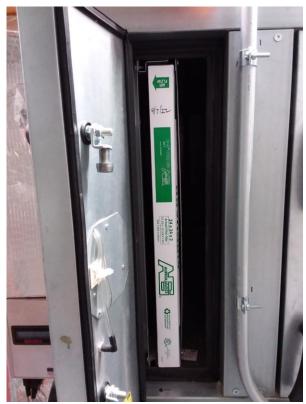
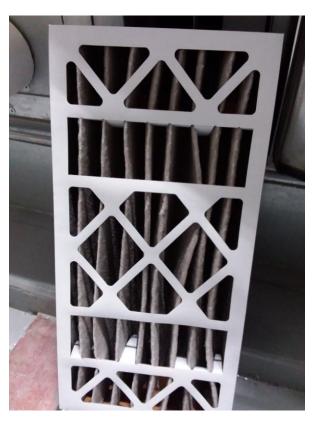
Dirty or poorly fitting filters were observed in units AHU13, AHU18, AHU20, DHU01 and RAHU03 during the ventilation inspection.

Recommendation: The operations and maintenance program for filter changes should be reviewed and revised to ensure proper filter changes to optimize filtration capacity.
