2022 - 2023 IAQ Walkthrough

Saint Paul Public Schools Creative Arts Secondary School

Walkthrough Date:
Monday, December 12, 2022
Retest Date: March 23, 2023

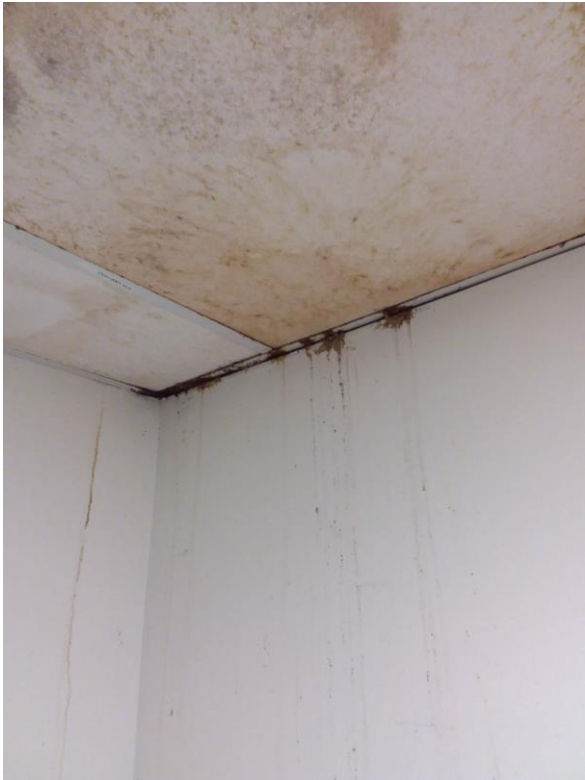
0116

Moisture-impacted building materials should be repaired or replaced when discoloration or water staining is observed. Moisture-impacted building materials can be a source for microbial growth. The source for the moisture infiltration should be investigated and repaired if not easily identified.

Moisture-Impacted Materials

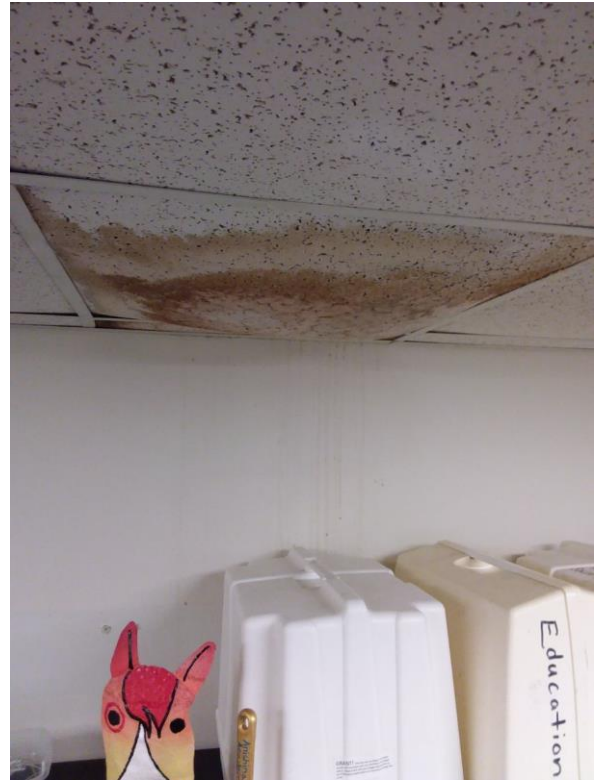
0116

Stained Ceiling Tiles

Stained ceiling tiles were found in the room(s) shown below. The impacted ceiling tiles should be removed and replaced, and the cause of the moisture repaired.
