IEA, INC.

2023 - 2024 Ventilation Assessment

Saint Paul Public Schools Creative Arts Secondary School

Assessment Date:
4/13/2023 - 4/14/2023

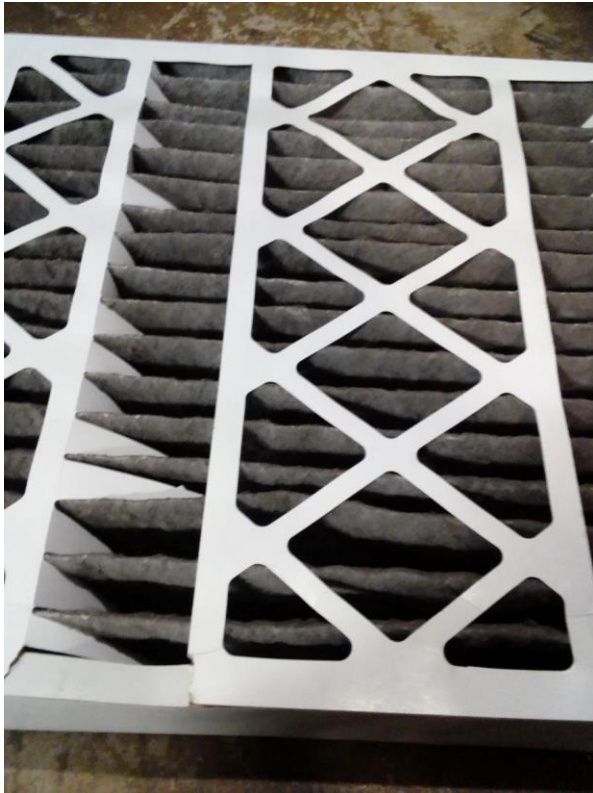
Unit Designation:	AHU_04	
Location of Unit:	Mechanical room ground 0203	
Areas Served:	1FL Science 1203 See attached map	
System Enhancements:	None	
Supply System	Outdoor Air	Cleanliness and Observations
Type <ul style="list-style-type: none"> Supply System - Constant Volume Heating - Hot Water Cooling - Chilled Water Energy Recovery Unit (ERU) - None 	Outdoor air intake is accessible Outdoor air intake is located on an exterior wall. No nearby pollution sources were found. Outdoor air intake is in good condition.	Outdoor air filters are not present. Return air filters are not present. Mixed air pre-filters are not present. Mixed air main filters are somewhat dirty and on the border of needing replacement (scoring 4 out of 5) and fit well. Mixed air main filters are installed correctly. Drain pans are not plugged. Drain pan condition is good. Heating coils are clean and cooling coils are clean. Heat wheels are not present. Exterior ducting is visible. Exterior ducting insulation is in good condition. Interior ducting is visible. Interior ducting insulation is in good condition. Interior ducting is clean. Air handling room is free of trash/chemicals. Outside damper is open, and its condition is good. Return damper is open, and its condition is good. The general condition of the unit is good.

Mixed Main Filter Cleanliness

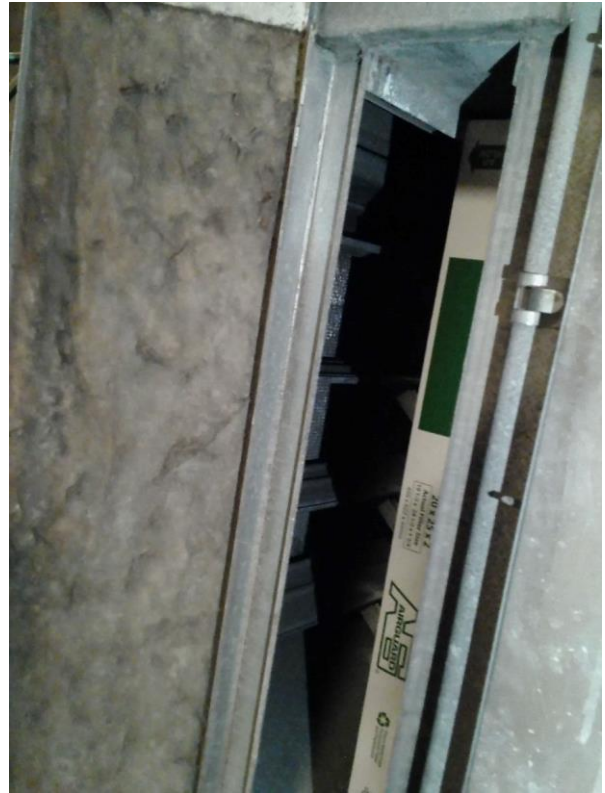
Unit Designation:	AHU_05	
Location of Unit:	Mechanical room ground 0203	
Areas Served:	Supplement to AHU-04 See attached map	
System Enhancements:	None	
Supply System	Outdoor Air	Cleanliness and Observations
Type <ul style="list-style-type: none"> Supply System - Constant Volume Heating - Hot Water Cooling - Chilled Water Energy Recovery Unit (ERU) - None 	<p>Outdoor air intake is accessible</p> <p>Outdoor air intake is located on an exterior wall.</p> <p>No nearby pollution sources were found.</p> <p>Outdoor air intake is in good condition.</p>	<p>Outdoor air filters are not present.</p> <p>Return air filters are not present.</p> <p>Mixed air pre-filters are not present. Mixed air main filters are clean and not in need of replacement (scoring 2 out of 5) and fit poorly. Mixed air main filters are installed correctly.</p> <p>Drain pans are not plugged. Drain pan condition is good.</p> <p>Heating coils are clean and cooling coils are clean.</p>

Filter Type - Mixed <ul style="list-style-type: none"> Pre-filter: None Main filter: Pleated, MERV 11 		<p>Heat wheels are not present.</p> <p>Exterior ducting is visible. Exterior ducting insulation is in good condition.</p> <p>Interior ducting is visible. Interior ducting insulation is in good condition. Interior ducting is clean.</p> <p>Air handling room is free of trash/chemicals.</p> <p>Outside damper is open, and its condition is good.</p> <p>Return damper is open, and its condition is good.</p> <p>The general condition of the unit is good.</p>

Dirty or poorly fitting filters were observed in units AHU_05 and AHU_11 during the ventilation inspection.

Mixed Main Filter Fit

Recommendation: The operations and maintenance program for filter changes should be reviewed and revised to ensure proper filter changes to optimize filtration capacity.

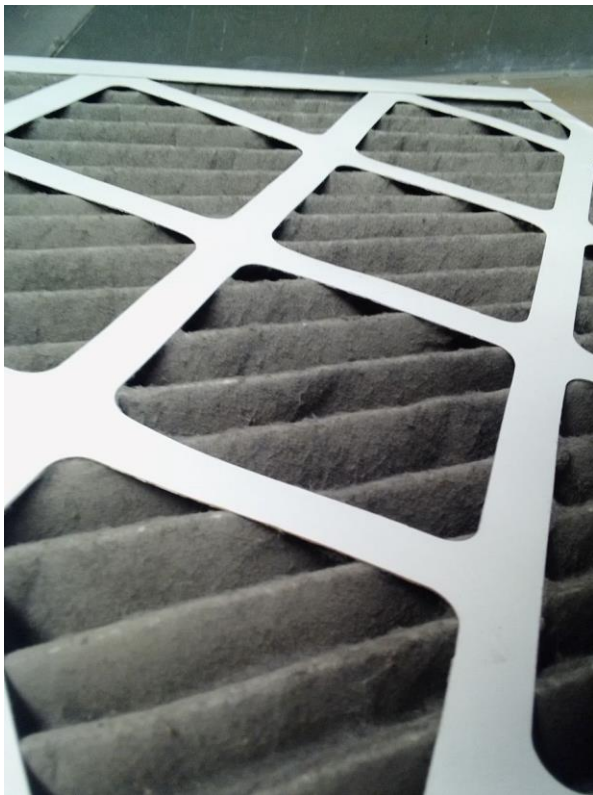
Unit Designation:	AHU_08	
Location of Unit:	Mechanical room 3rd fl playdeck	
Areas Served:	Gymnasium See attached map	
System Enhancements:	None	
Supply System	Outdoor Air	Cleanliness and Observations
Type <ul style="list-style-type: none"> Supply System - Constant Volume Heating - Hot Water Cooling - Chilled Water Energy Recovery Unit (ERU) - None 	Outdoor air intake is accessible Outdoor air intake is located on the roof. No nearby pollution sources were found.	Outdoor air filters are not present. Return air filters are not present. Mixed air pre-filters are not present. Mixed air main filters are somewhat dirty and on the border of needing replacement (scoring 4 out of 5) and fit well. Mixed air main filters are installed correctly. Drain pans are not plugged. Drain pan condition is good. Heating coils are clean and cooling coils are clean.
Filter Type - Mixed <ul style="list-style-type: none"> Pre-filter: None Main filter: Pleated, MERV 11 	Outdoor air intake is in good condition.	Heat wheels are not present. Exterior ducting is visible. Exterior ducting insulation is in good condition. Interior ducting is visible. Interior ducting insulation is in good condition. Interior ducting is clean. Air handling room is free of trash/chemicals. Outside damper is open, and its condition is good. Return damper is open, and its condition is good. The general condition of the unit is good.

Mixed Main Filter Cleanliness

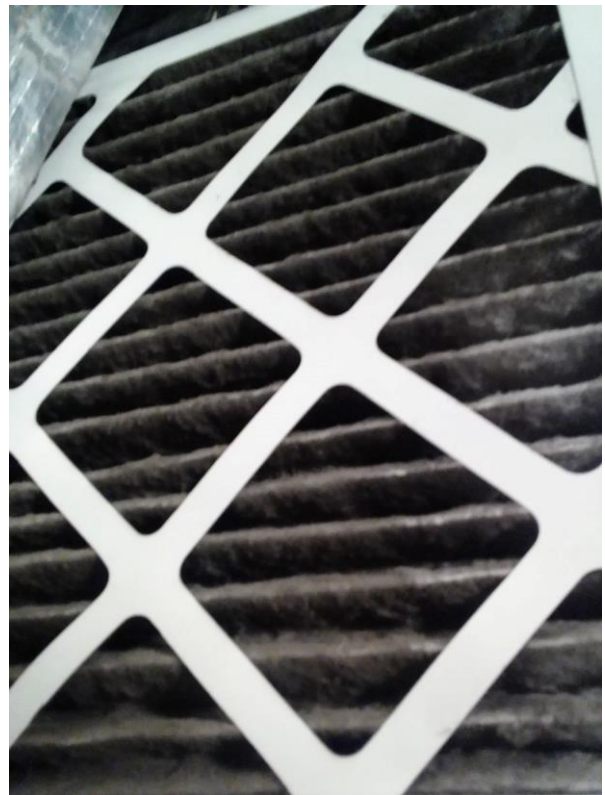
Unit Designation:	AHU_11	
Location of Unit:	Mechanical room 3rd fl playdeck	
Areas Served:	2nd & 3rd Floors See attached map	
System Enhancements:	None	
Supply System	Outdoor Air	Cleanliness and Observations
Type <ul style="list-style-type: none"> Supply System - Constant Volume Heating - Hot Water Cooling - Chilled Water Energy Recovery Unit (ERU) - None 	Outdoor air intake is accessible Outdoor air intake is located on the roof. No nearby pollution sources were found.	Outdoor air filters are not present. Return air filters are not present. Mixed air pre-filters are not present. Mixed air main filters are somewhat dirty and on the border of needing replacement (scoring 4 out of 5) and fit poorly. Mixed air main filters are installed correctly. Drain pans are not plugged. Drain pan condition is good. Heating coils are clean and cooling coils are clean.
Filter Type - Mixed <ul style="list-style-type: none"> Pre-filter: None Main filter: Pleated, MERV 11 	Outdoor air intake is in good condition.	Heat wheels are not present. Exterior ducting is visible. Exterior ducting insulation is in good condition. Interior ducting is visible. Interior ducting insulation is in good condition. Interior ducting is clean. Air handling room is free of trash/chemicals. Outside damper is inaccessible, and its condition is good. Return damper is open, and its condition is good. The general condition of the unit is good.

Mixed Main Filter Cleanliness

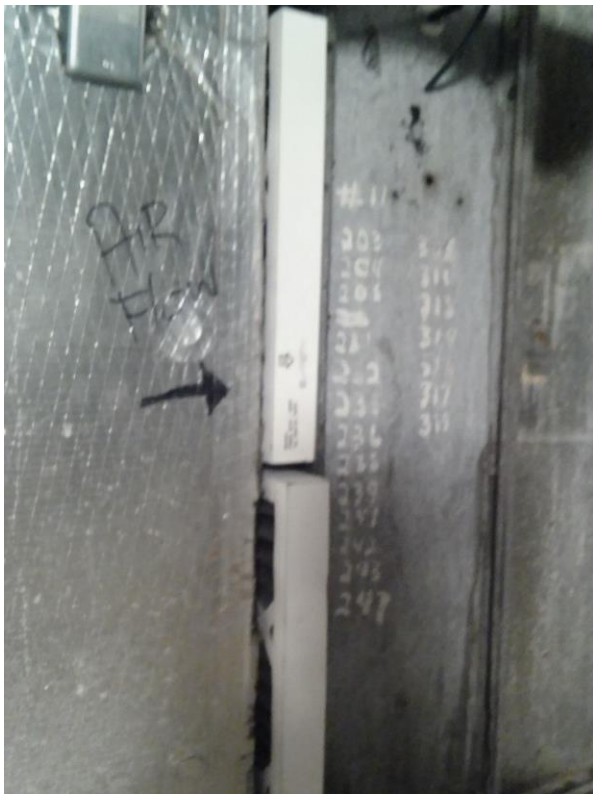
AHU_11

Mixed Main Filter Fit

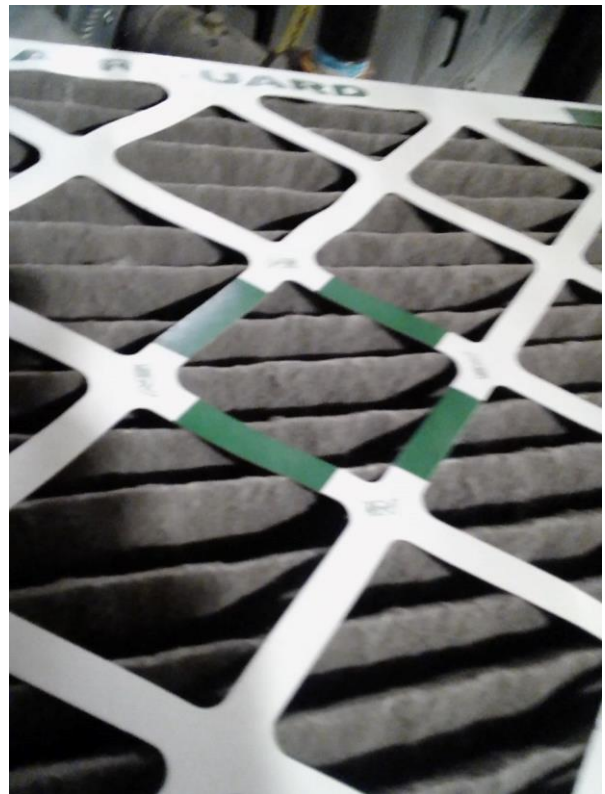
Unit Designation:	AHU_13	
Location of Unit:	Mechanical room mezz (M12)	
Areas Served:	1st Floor VAVs See attached map	
System Enhancements:	None	
Supply System	Outdoor Air	Cleanliness and Observations
Type <ul style="list-style-type: none"> • Supply System - VAV • Heating - Hot Water • Cooling - Chilled Water • Energy Recovery Unit (ERU) - None 	Outdoor air intake is accessible Outdoor air intake is located on an exterior wall. No nearby pollution sources were found.	Outdoor air filters are not present. Return air filters are not present. Mixed air pre-filters are not present. Mixed air main filters are somewhat dirty and on the border of needing replacement (scoring 4 out of 5) and fit well. Mixed air main filters are installed correctly. Drain pans are not plugged. Drain pan condition is good.
Filter Type - Mixed <ul style="list-style-type: none"> • Pre-filter: None • Main filter: Pleated, MERV 11 	Outdoor air intake is in good condition.	Heating coils are clean and cooling coils are clean. Heat wheels are not present. Exterior ducting is visible. Exterior ducting insulation is in good condition. Interior ducting is visible. Interior ducting insulation is in good condition. Interior ducting is clean. Air handling room is free of trash/chemicals. Outside damper is open, and its condition is good. Return damper is closed, and its condition is good. The general condition of the unit is good.

Mixed Main Filter Cleanliness

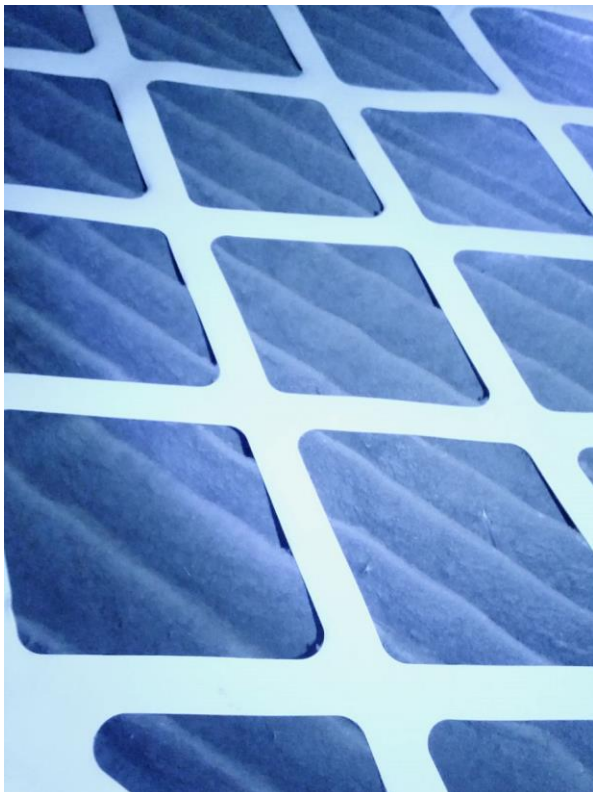
Unit Designation:	AHU_14	
Location of Unit:	Mechanical room mezz (M12)	
Areas Served:	Gallery See attached map	
System Enhancements:	None	
Supply System	Outdoor Air	Cleanliness and Observations
Type <ul style="list-style-type: none"> Supply System - Constant Volume Heating - Hot Water Cooling - Chilled Water Energy Recovery Unit (ERU) - None 	Outdoor air intake is accessible Outdoor air intake is located on an exterior wall. No nearby pollution sources were found. Outdoor air intake is in good condition.	Outdoor air filters are not present. Return air filters are not present. Mixed air pre-filters are not present. Mixed air main filters are somewhat dirty and on the border of needing replacement (scoring 4 out of 5) and fit well. Mixed air main filters are installed correctly. Drain pans are not plugged. Drain pan condition is good. Heating coils are clean and cooling coils are clean. Heat wheels are not present. Exterior ducting is visible. Exterior ducting insulation is in good condition. Interior ducting is visible. Interior ducting insulation is in good condition. Interior ducting is clean. Air handling room is free of trash/chemicals. Outside damper is open, and its condition is good. Return damper is open, and its condition is good. The general condition of the unit is good.

Mixed Pre-Filter Cleanliness

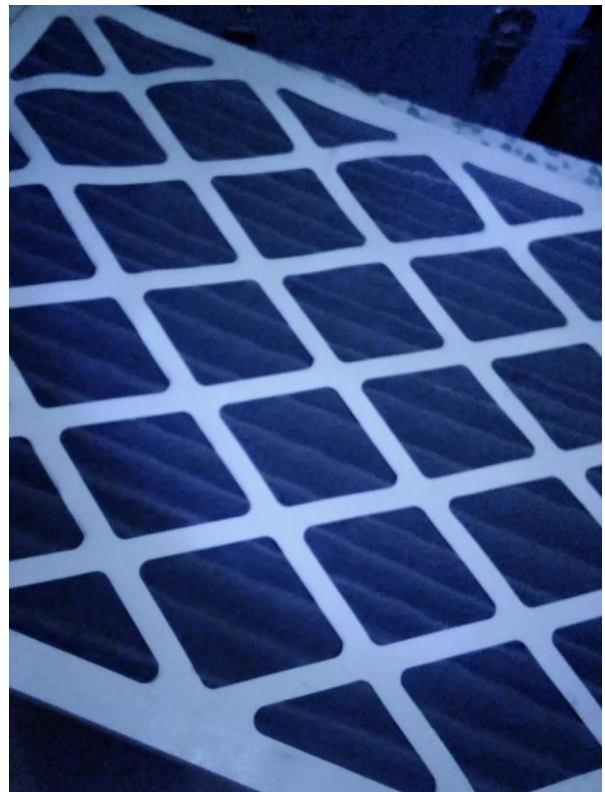
AHU_14

Mixed Main Filter Cleanliness
