## 2023 - 2024 Ventilation Assessment

## Saint Paul Public Schools Crossroads Montessori

Assessment Date:  
Friday, April 7, 2023

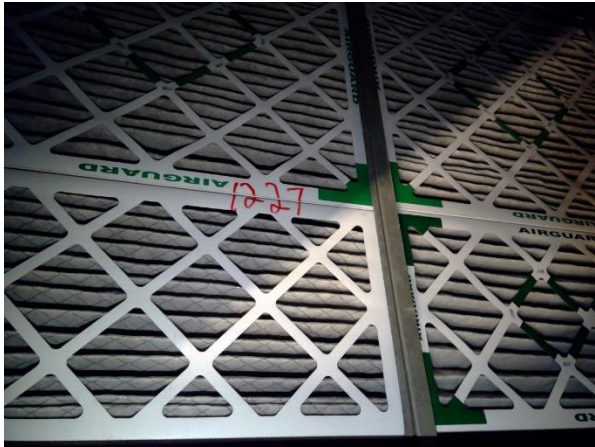
<b>Unit Designation:</b>	AHU-2	
<b>Location of Unit:</b>	3002	
<b>Areas Served:</b>	See attached map.	
<b>System Enhancements:</b>	None	
<b>Supply System</b>	<b>Outdoor Air</b>	<b>Cleanliness and Observations</b>
<b>Type</b> <ul style="list-style-type: none"> <li>• Supply System - VAV</li> <li>• Heating - Hot Water</li> <li>• Cooling - Chilled Water</li> <li>• Energy Recovery Unit (ERU) - Wheel</li> </ul>	Outdoor air intake is accessible  Outdoor air intake is located on the roof.  No nearby pollution sources were found.	Outdoor air filters are not present.  Return air filters are not present.  Mixed air pre-filters are not present. Mixed air main filters are clean and not in need of replacement (scoring 2 out of 5) and fit well. Mixed air main filters are installed incorrectly.  Drain pans are not plugged. Drain pan condition is good.  Heating coils are clean and cooling coils are dirty.  Heat wheel cleanliness is not known.

Dirty or poorly fitting filters were observed in units AHU-12, AHU-2, UV-1405 and UV-1409 during the ventilation inspection.

AHU-2  
Mixed Main Filter Installation

**Recommendation:** The operations and maintenance program for filter changes should be reviewed and revised to ensure proper filter changes to optimize filtration capacity.

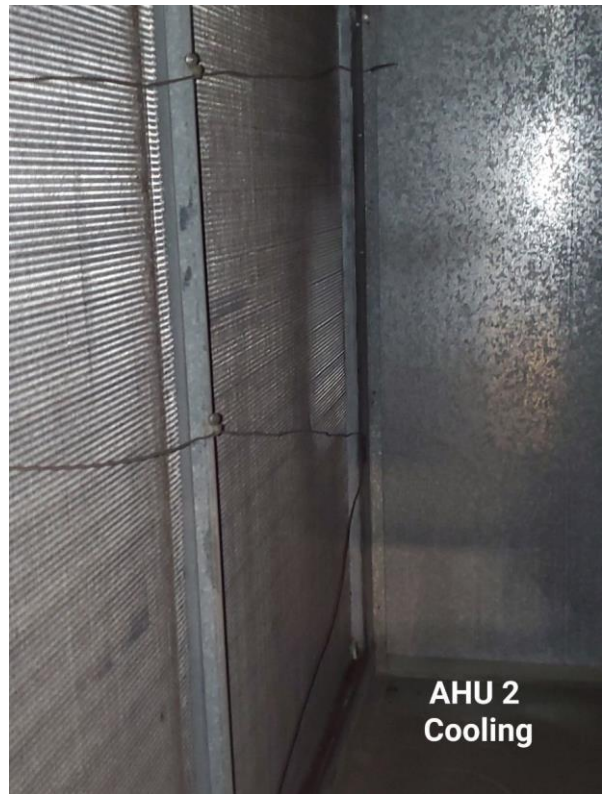
Dirty Coils were observed on units AHU-2, AHU-4, AHU-6, AHU-7, AHU-8 and AHU-9 during the ventilation inspection.

AHU-2  
Cooling Coils

**Recommendation:** Impacted/dirty coils can result in poor ventilation air supply as well as be a source for mold and bacterial growth on the coils. Coils should be cleaned annually, or as needed, as identified in the operations and maintenance program.

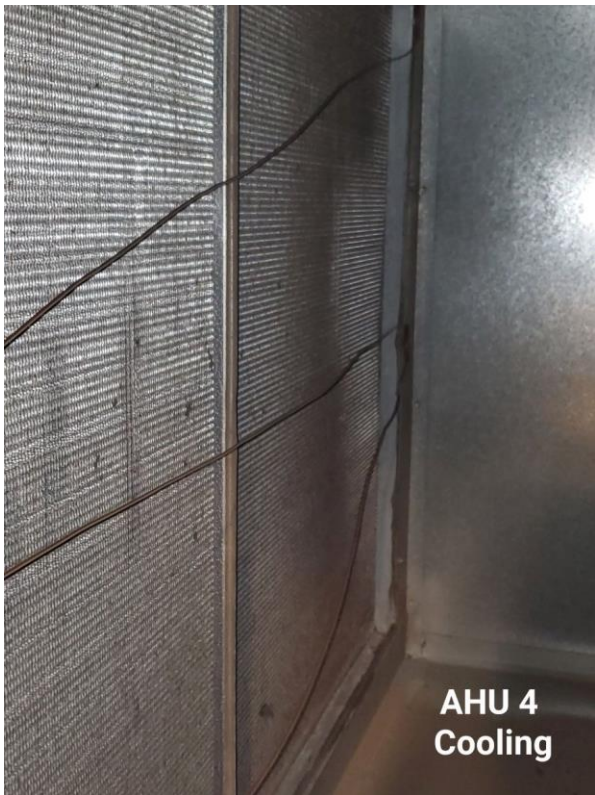
AHU-4  
Cooling Coils

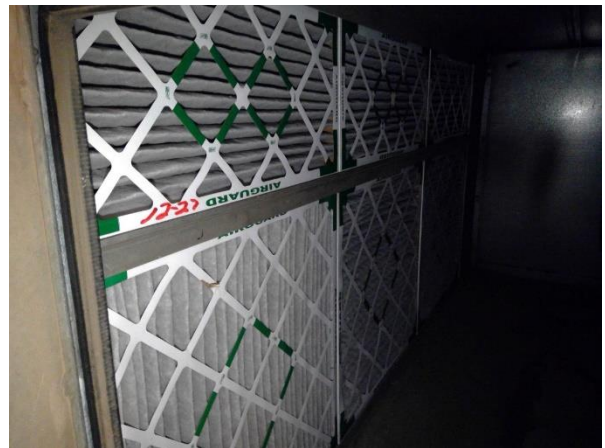
AHU-6  
Mixed Main Filter Cleanliness

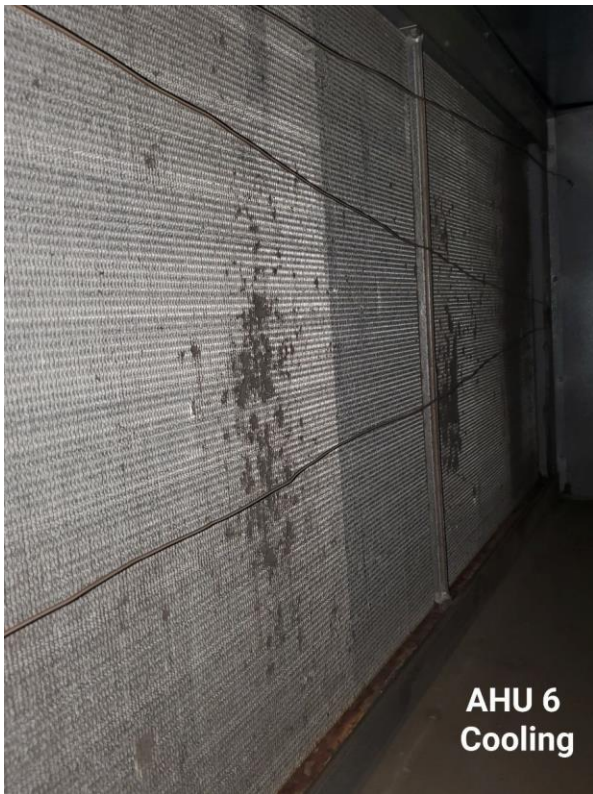
AHU 6  
Cooling

<b>Unit Designation:</b>	AHU-6	
<b>Location of Unit:</b>	2006	
<b>Areas Served:</b>	See attached map.	
<b>System Enhancements:</b>	None	
<b>Supply System</b>	<b>Outdoor Air</b>	<b>Cleanliness and Observations</b>
<b>Type</b> <ul style="list-style-type: none"> <li>• Supply System - Constant Volume</li> <li>• Heating - Hot Water</li> <li>• Cooling - Chilled Water</li> <li>• Energy Recovery Unit (ERU) - Wheel</li> </ul>	<p>Outdoor air intake is accessible</p> <p>Outdoor air intake is located on the roof.</p> <p>No nearby pollution sources were found.</p>	<p>Outdoor air filters are not present.</p> <p>Return air filters are not present.</p> <p>Mixed air pre-filters are not present. Mixed air main filters are somewhat dirty and on the border of needing replacement (scoring 3 out of 5) and fit well. Mixed air main filters are installed correctly.</p> <p>Drain pans are not plugged. Drain pan condition is good.</p> <p>Heating coils are clean and cooling coils are dirty.</p>

AHU-6  
Cooling Coils

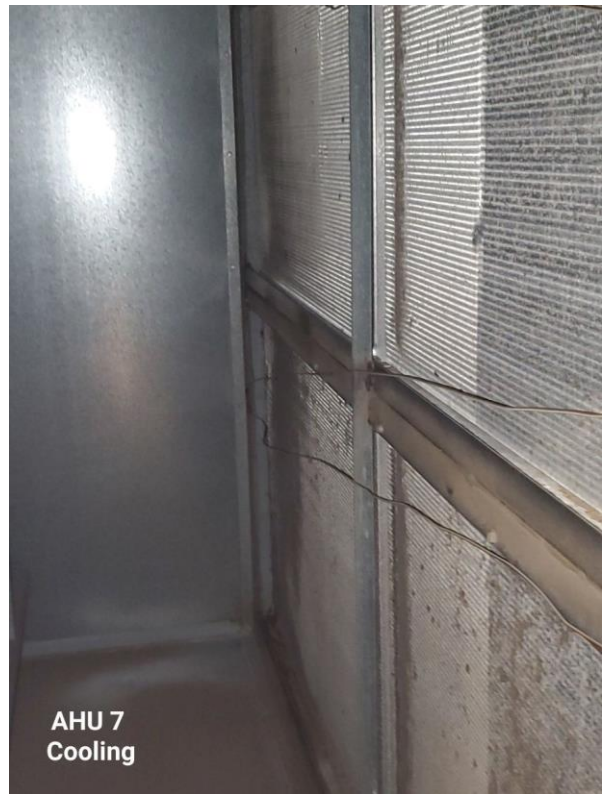
AHU 7  
Cooling

AHU-7  
Cooling Coils

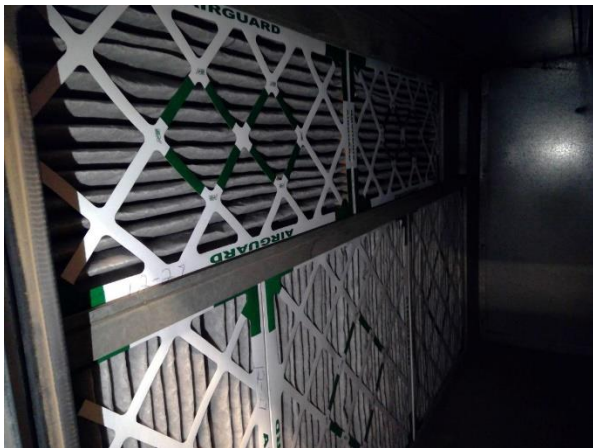
AHU-8  
Mixed Main Filter Cleanliness

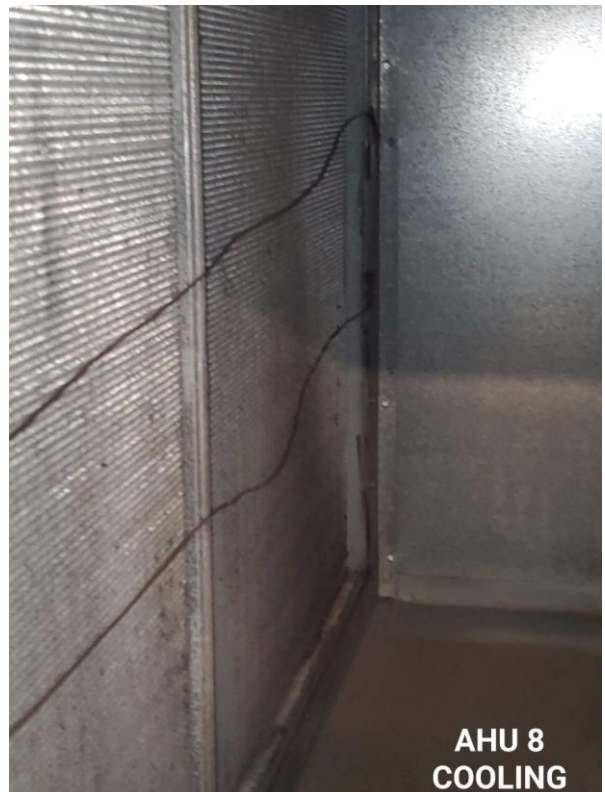
AHU 8  
COOLING

<b>Unit Designation:</b>	AHU-8	
<b>Location of Unit:</b>	3004	
<b>Areas Served:</b>	See attached map.	
<b>System Enhancements:</b>	None	
<b>Supply System</b>	<b>Outdoor Air</b>	<b>Cleanliness and Observations</b>
<b>Type</b> <ul style="list-style-type: none"> <li>Supply System - VAV</li> <li>Heating - Hot Water</li> <li>Cooling - Chilled Water</li> <li>Energy Recovery Unit (ERU) - Wheel</li> </ul>	Outdoor air intake is accessible  Outdoor air intake is located on the roof.  No nearby pollution sources were found.	Outdoor air filters are not present.  Return air filters are not present.  Mixed air pre-filters are not present. Mixed air main filters are somewhat dirty and on the border of needing replacement (scoring 3 out of 5) and fit well. Mixed air main filters are installed correctly.  Drain pans are not plugged. Drain pan condition is good.  Heating coils are clean and cooling coils are dirty.

AHU-8  
Cooling Coils

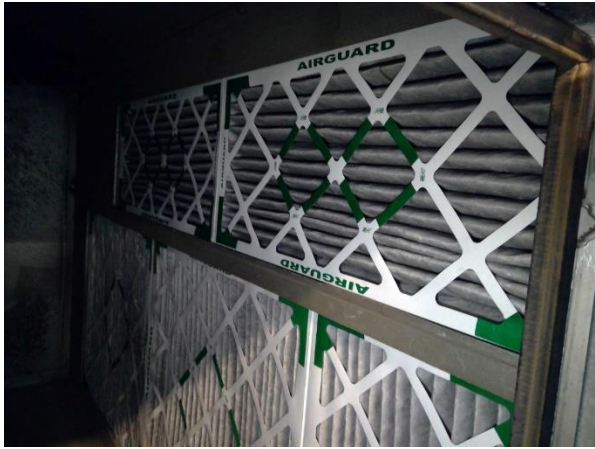
AHU-9  
Mixed Main Filter Cleanliness

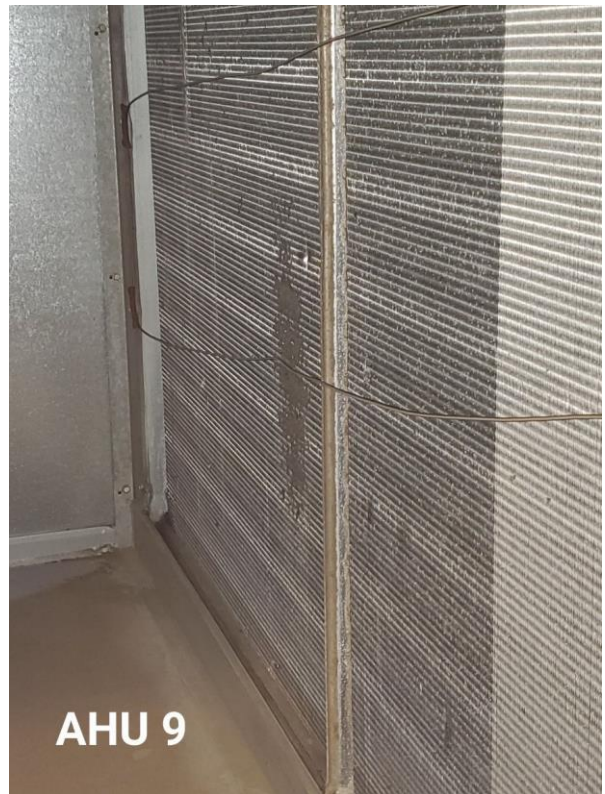
AHU-9  
Heating Coils

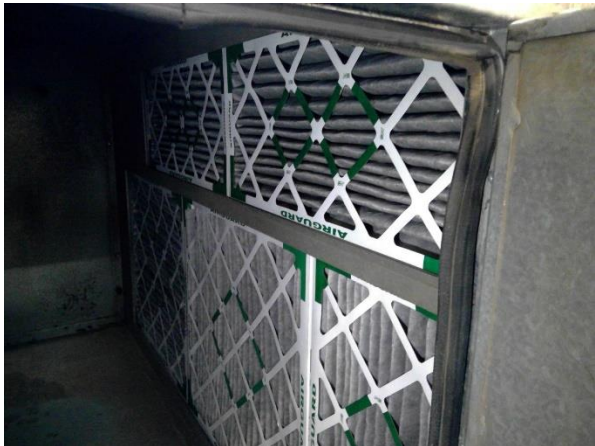
AHU-10  
Mixed Main Filter Cleanliness

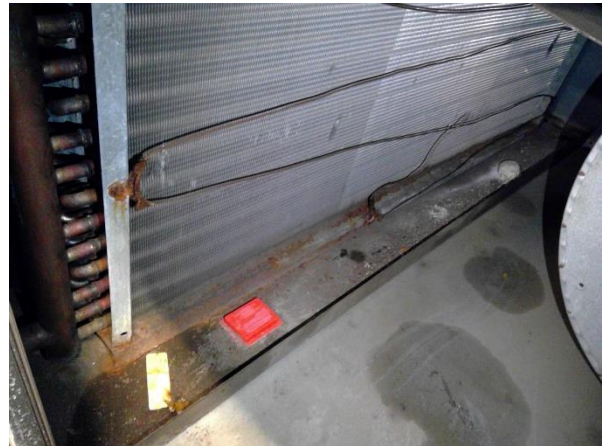
AHU-11 (100% OA)  
Drain Pans

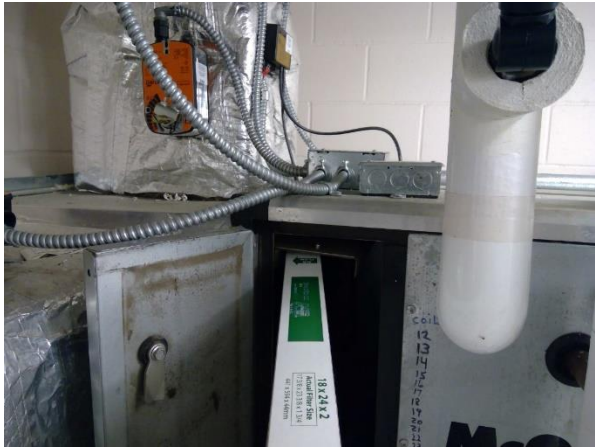
AHU-12

Mixed Main Filter Installation

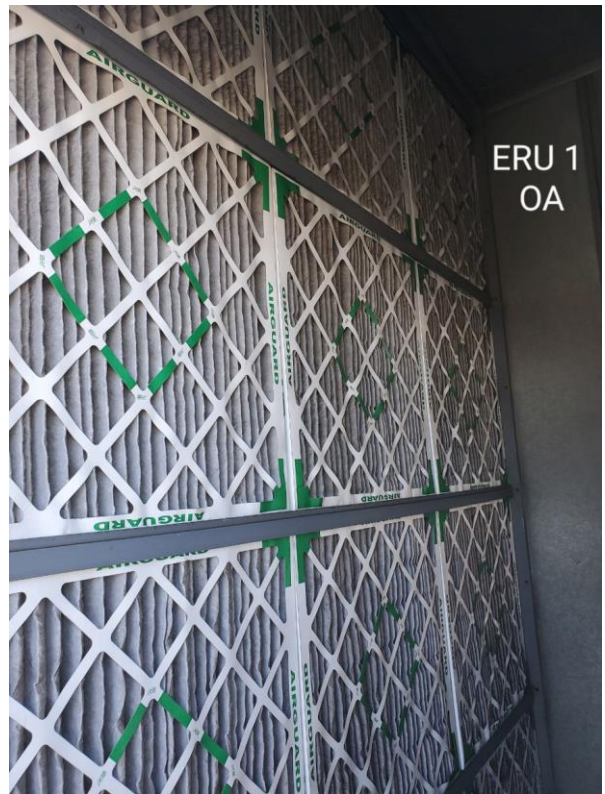
ERU-1

Outdoor Main Filter Cleanliness

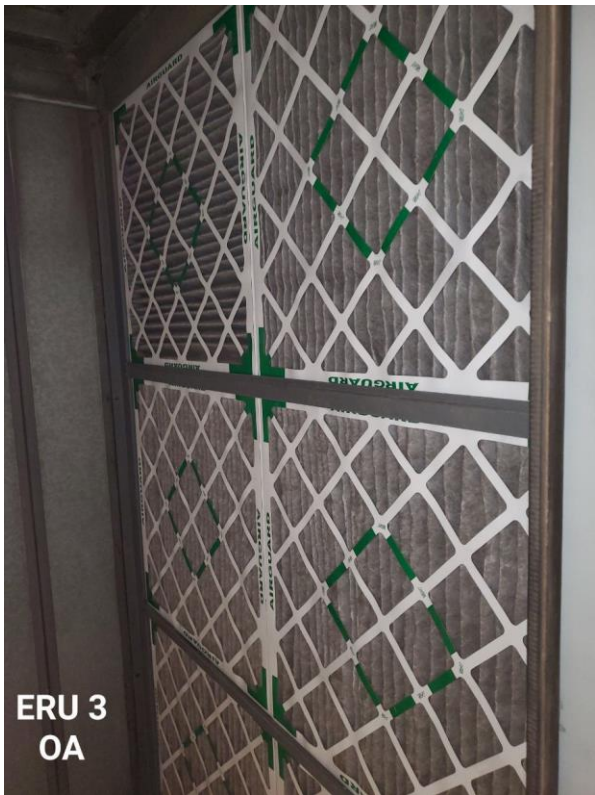
ERU-3

Outdoor Main Filter Cleanliness

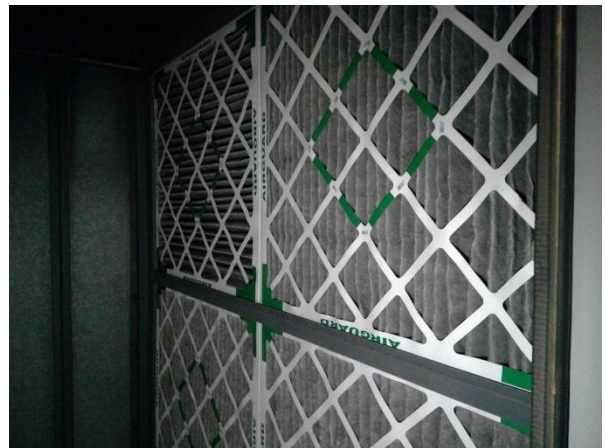
ERU-3

Return Main Filter Cleanliness

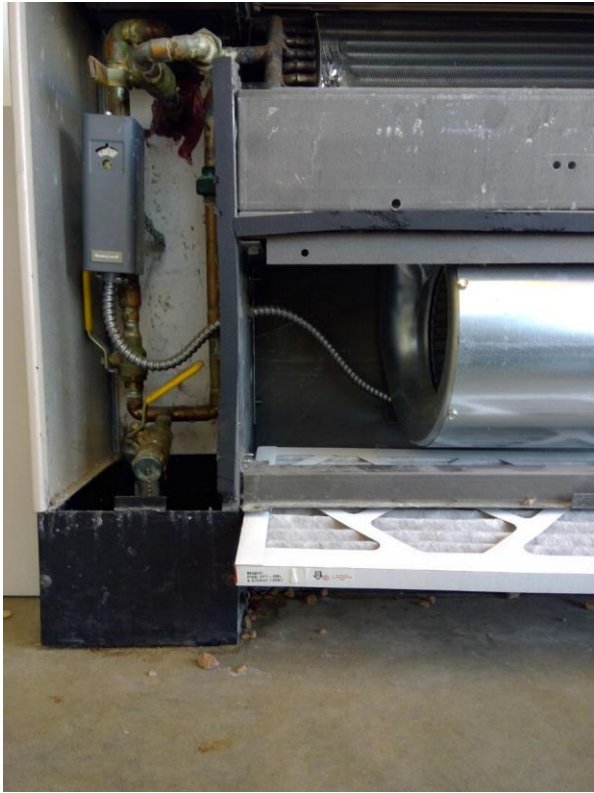
UV-1409  
Return Main Filter Installation

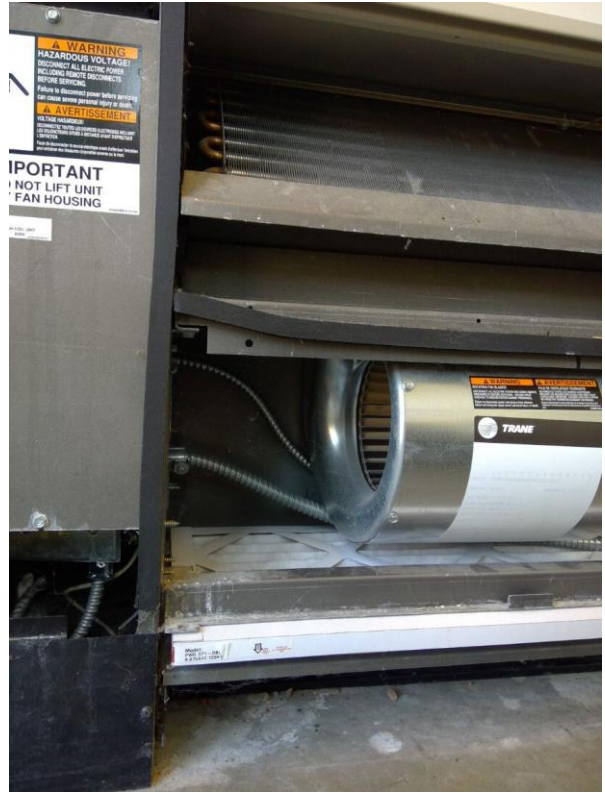
UV-1405  
Return Main Filter Installation

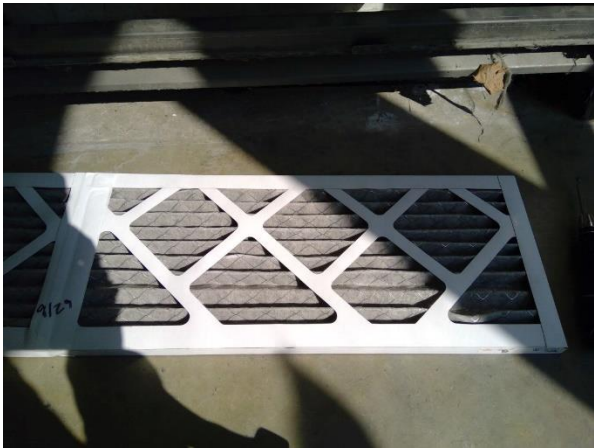
UV-1305  
Return Main Filter Cleanliness
