2021 - 2022 IAQ Walkthrough

Saint Paul Public Schools Jackson Elementary School

Walkthrough Date:
Thursday, November 18, 2021
Retest Dates:
Friday, February 11, 2022
Thursday, February 17, 2022

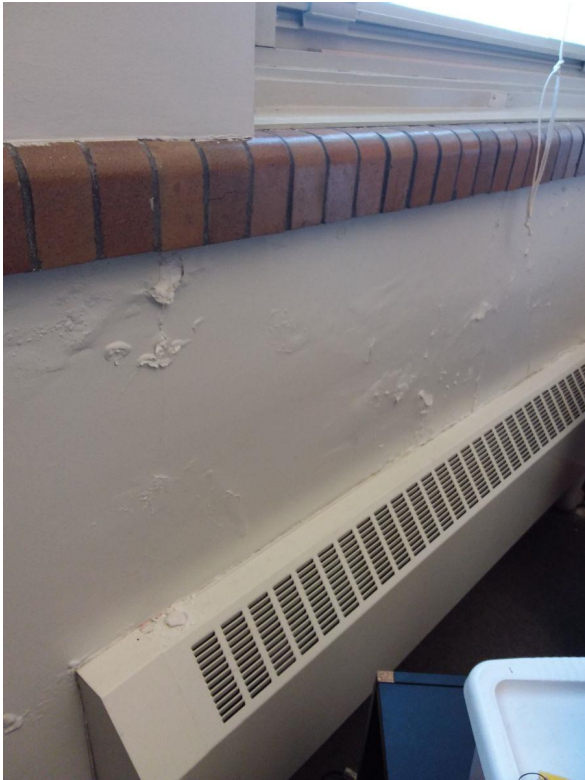
- 1114 *Wood delaminating over windows*
- 3106 *Top of the window stills is cracking and chipping.*
- 3110

Bubbling/Peeling Paint

IEA observed bubbling/peeling paint in area(s) within the room(s) listed below. Bubbling/peeling paint can be caused by moisture issues. IEA recommends investigating the cause and repairing the paint. IEA recommends ensuring that the paint is not lead-based prior to disturbance.

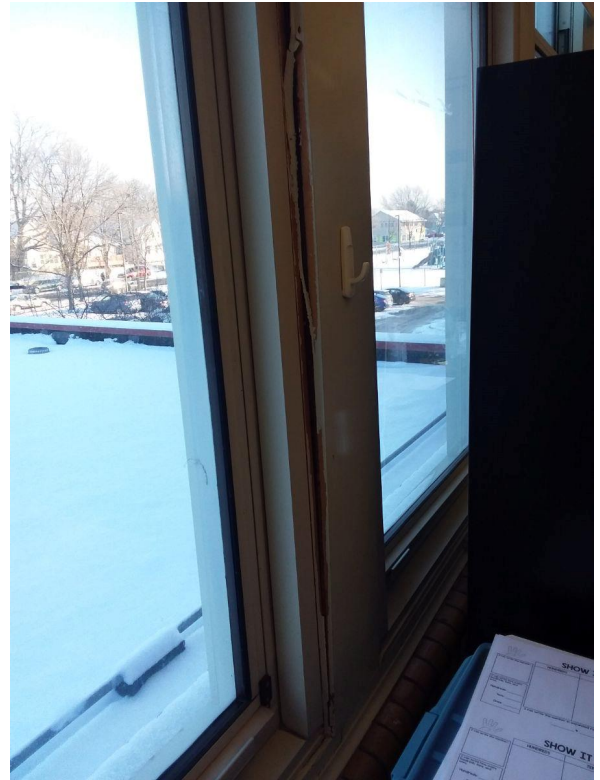
- 1210 *Rusty ceiling grid* • 3112 *Delaminating & paint is chipping*
- 2104

Moisture Impacted Materials

Moisture-impacted building materials should be repaired or replaced when discoloration or water staining is observed. Moisture-impacted building materials can be a source for microbial growth. The source for the moisture infiltration should be investigated and repaired if not easily identified.
