# 2022 - 2023 IAQ Walkthrough

## Saint Paul Public Schools Education & Operations Services

Walkthrough Date:  
Wednesday, December 14, 2022

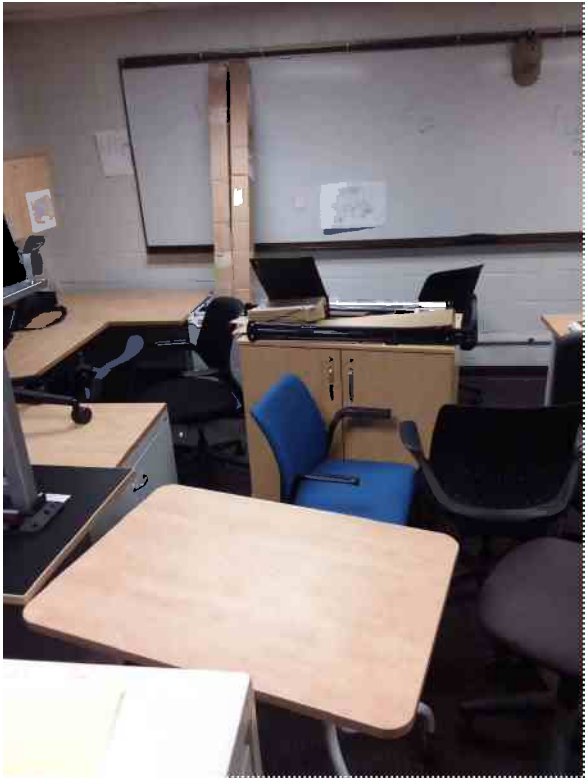
Area(s) identified by IEA as having poor housekeeping (excessive clutter, excessive dust/debris on horizontal surfaces, etc.) were documented within the building. Poor housekeeping can limit building maintenance from conducting a proper cleaning of the area. This can result in elevated potential for allergen issues in sensitized individuals due to dirt and debris loading. Poor housekeeping can also allow for pest (insects and rodents) issues in the space.

- 1607A

Housekeeping
