2023 - 2024 Ventilation Assessment

Saint Paul Public Schools District Service Facility

Assessment Date:
Monday, April 10, 2023

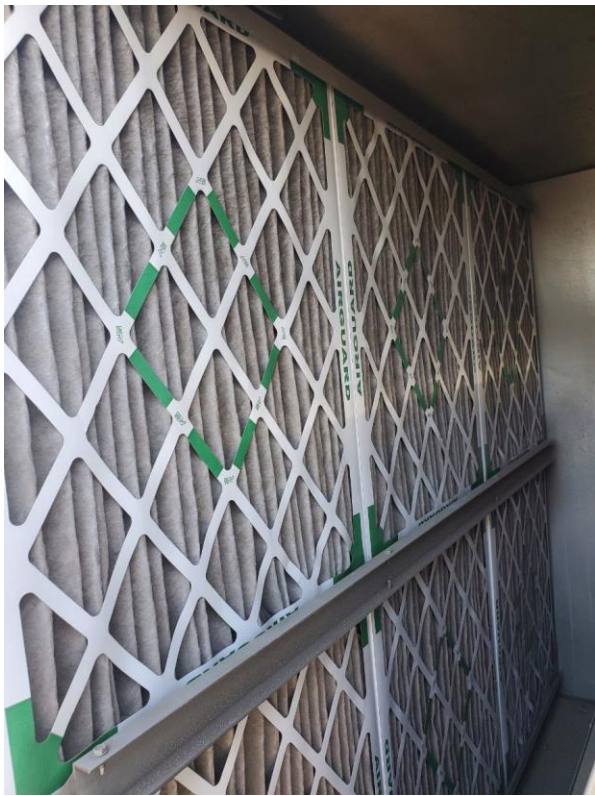
RTU_01

Mixed Main Filter Cleanliness

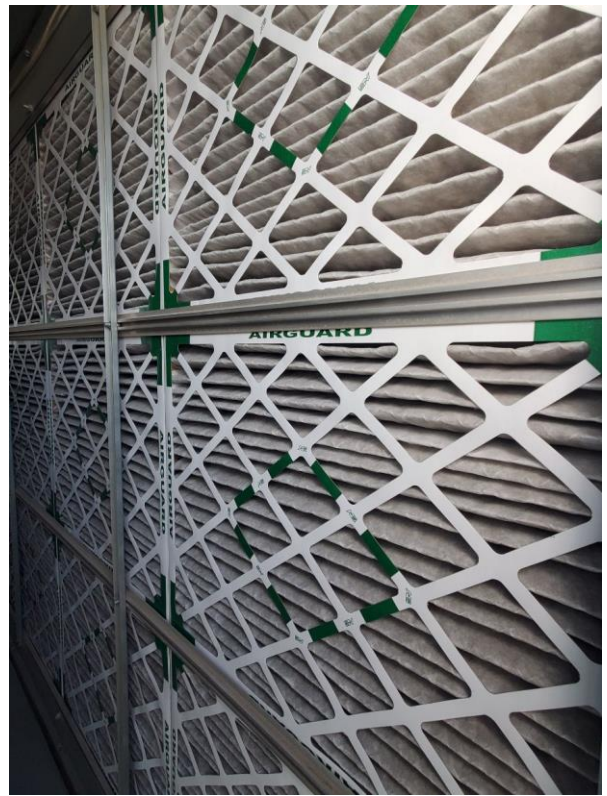
RTU_02

Mixed Main Filter Cleanliness
