2022 - 2023 IAQ Walkthrough

Saint Paul Public Schools Early Childhood Hub West

Walkthrough Date:
Friday, December 9, 2022

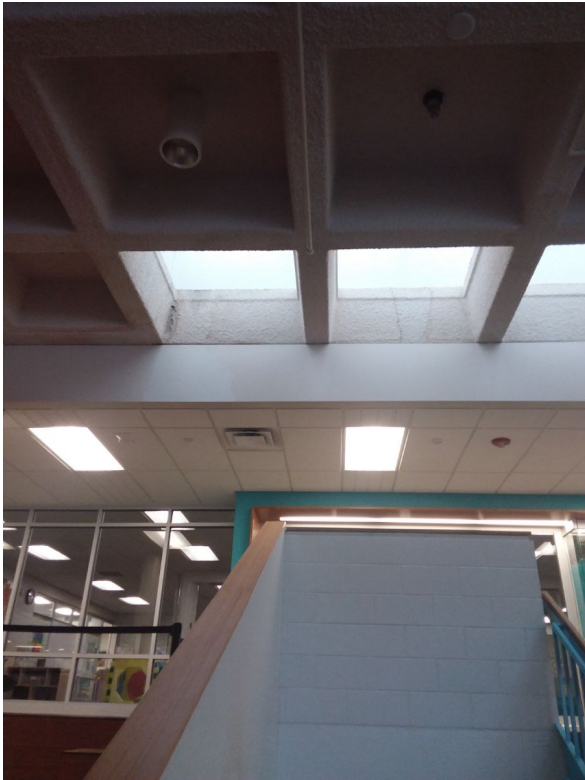
Moisture-Impacted Building Material Concerns

Moisture-impacted building materials should be repaired or replaced when discoloration or water staining is observed. Moisture-impacted building materials can be a source for microbial growth. The source for the moisture infiltration should be investigated and repaired if not easily identified.

- 2200

Moisture Impacted Materials

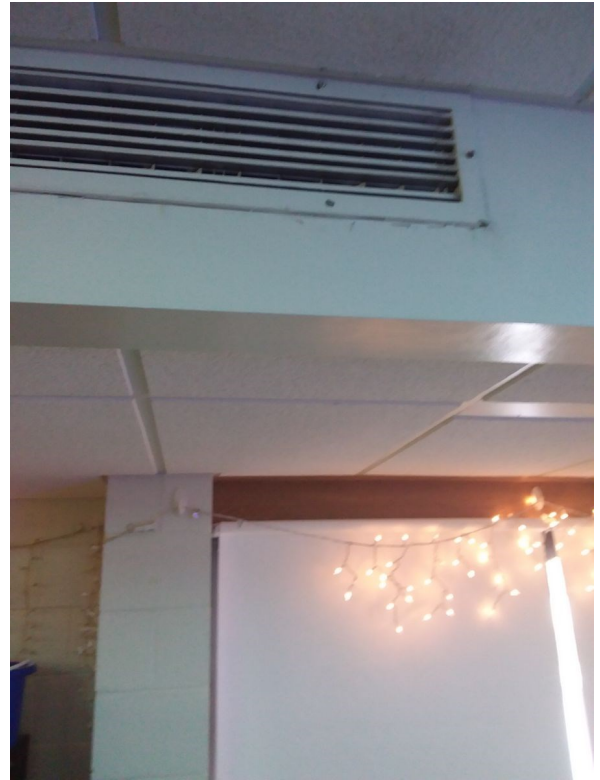
Room / Location	Number of Occupants	Odor Present	Observations	Dust Accumulation	CO ₂ (ppm)	CO (ppm)	RH (%)	Temp (°F)
1154	7	No	<ul style="list-style-type: none"> Plants 	No	382	0.1	21.5	69.9
1155	15	No	<ul style="list-style-type: none"> Bubbling/Peeling Paint: Peeling paint around the air return; See Appendix A 	No	405	0.2	21.9	70.7
1162	0	No		Yes Air Supply, Ceiling Tiles Around Air Supply	365	0.1	22.6	69.8

IEA observed bubbling/peeling paint in area(s) within the room(s) listed below.

- 1155 *Peeling paint around
the air return*

Bubbling/Peeling Paint

Bubbling/peeling paint can be caused by moisture issues. IEA recommends investigating the cause and repairing the paint. IEA recommends ensuring that the paint is not lead-based prior to disturbance.
