## 2022 - 2023 IAQ Walkthrough

## Saint Paul Public Schools Farnsworth Aerospace Lower

Walkthrough Date & Time:  
Thursday, March 2, 2023

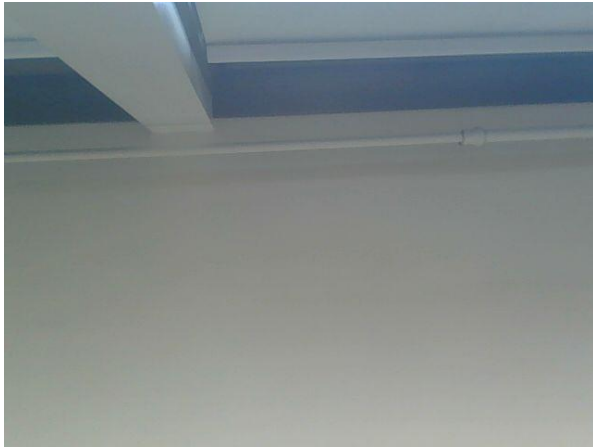
| Room / Location | Number of Occupants | Odor Present | Observations | Dust Accumulation | CO <sub>2</sub> (ppm) | CO (ppm) | RH (%) | Temp (°F) |
|---|---|---|---|---|---|---|---|---|
| 1101 | 22 | Yes<br>Fragrance | • Bubbling/Peeling Paint: Along ceiling above windows; See Appendix A | Yes<br>Air Return | 615 | 0.0 | 25.3 | 70.7 |

- 1101 *Along ceiling above windows*
- 3103 *On wall underneath the windows*
- 2103 *Ceiling above windows*
- 3104 *Throughout ceiling*
- 2105 *Ceiling above windows*
- 3105 *Small area of peeling near NE corner*

**1101**  
Bubbling/Peeling Paint

IEA observed bubbling/peeling paint in area(s) within the room(s) listed below. Bubbling/peeling paint can be caused by moisture issues. IEA recommends investigating the cause and repairing the paint. IEA recommends ensuring that the paint is not lead-based prior to disturbance.

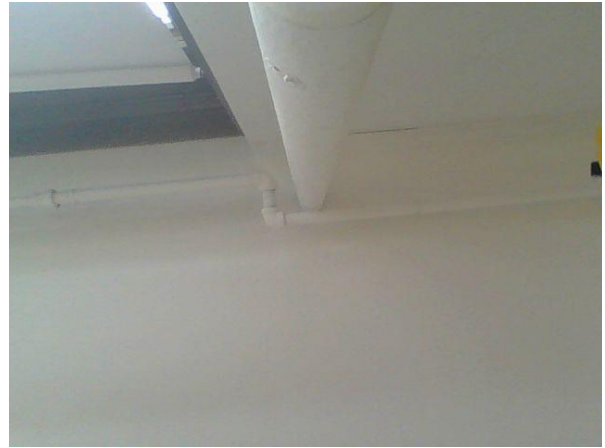
| Room / Location | Number of Occupants | Odor Present | Observations | Dust Accumulation | CO <sub>2</sub> (ppm) | CO (ppm) | RH (%) | Temp (°F) |
|---|---|---|---|---|---|---|---|---|
| 2105 | 0 | No | <ul style="list-style-type: none"> <li>Bubbling/Peeling Paint: Ceiling above windows; See Appendix A</li> <li>Plants</li> <li>Taxidermy</li> </ul> | No | 738 | 0.0 | 26.2 | 70.8 |

**2105**  
Bubbling/Peeling Paint

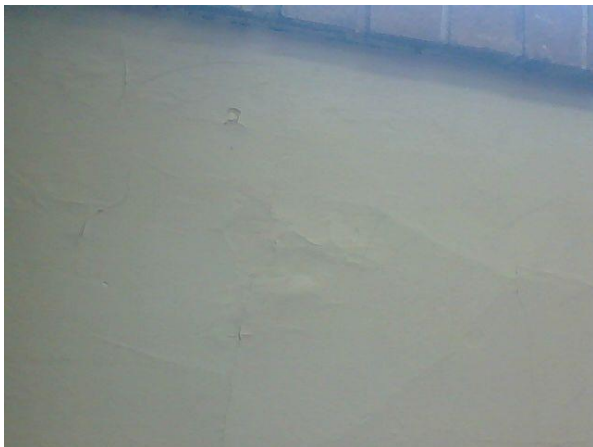
| Room / Location | Number of Occupants | Odor Present | Observations | Dust Accumulation | CO <sub>2</sub> (ppm) | CO (ppm) | RH (%) | Temp (°F) |
|---|---|---|---|---|---|---|---|---|
| 3103 | 19 | No | <ul style="list-style-type: none"> <li>Bubbling/Peeling Paint: On wall underneath the windows; See Appendix A</li> </ul> | No | 832 | 0.0 | 28.0 | 70.1 |

**3103**  
Bubbling/Peeling Paint
