## 2023 - 2024 Ventilation Assessment

## Saint Paul Public Schools Farnsworth Aerospace Upper

Assessment Date:  
Wednesday, April 19, 2023

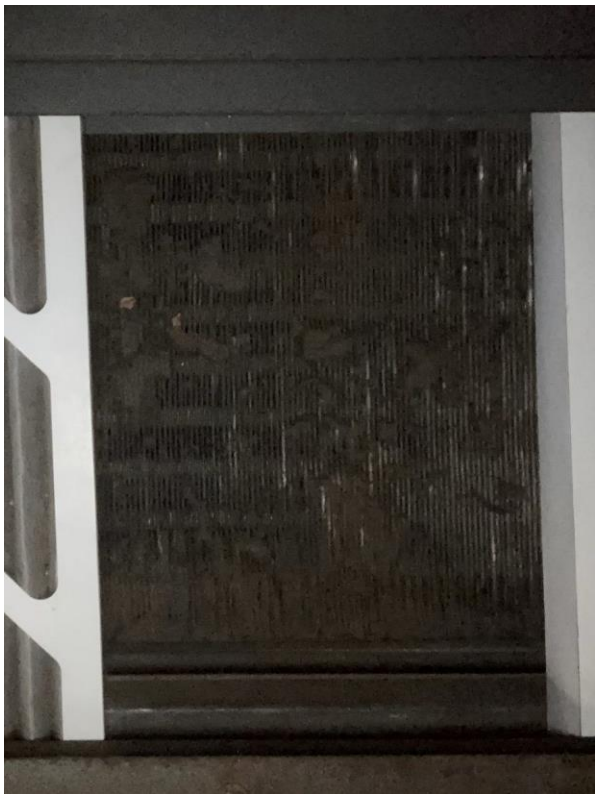
AHU\_03  
Heating Coils

<b>Unit Designation:</b>	AHU_03	
<b>Location of Unit:</b>	Mechanical room 1401	
<b>Areas Served:</b>	Classroom 1402B/C See attached map	
<b>System Enhancements:</b>	None	
<b>Supply System</b>	<b>Outdoor Air</b>	<b>Cleanliness and Observations</b>
<b>Type</b> <ul style="list-style-type: none"> <li>Supply System - Constant Volume</li> <li>Heating - Hot Water</li> <li>Cooling - None</li> <li>Energy Recovery Unit (ERU) - None</li> </ul>	Outdoor air intake is accessible  Outdoor air intake is located on the roof.  No nearby pollution sources were found.	Outdoor air filters are not present.  Return air filters are not present.  Mixed air pre-filters are not present. Mixed air main filters are clean and not in need of replacement (scoring 2 out of 5) and fit well. Mixed air main filters are installed correctly.  Drain pans are not applicable or not present. Drain pan condition is not known.
<b>Filter Type - Mixed</b> <ul style="list-style-type: none"> <li>Pre-filter: None</li> <li>Main filter: Pleated, MERV 11</li> </ul>	Outdoor air intake is in good condition.	Heating coils are dirty.  Heat wheels are not present.  Exterior ducting is visible. Exterior ducting insulation is not present.  Interior ducting is not visible. Interior ducting insulation is in an unknown condition. Interior ducting is of unknown cleanliness.  Air handling room is free of trash/chemicals.  Outside damper is open, and its condition is good.  Return damper is open, and its condition is good.  The general condition of the unit is good.

Dirty Coils were observed on units AHU\_03, AHU\_13 and RTU\_01 during the ventilation inspection.

**Recommendation:** Impacted/dirty coils can result in poor ventilation air supply as well as be a source for mold and bacterial growth on the coils. Coils should be cleaned annually, or as needed, as identified in the operations and maintenance program.

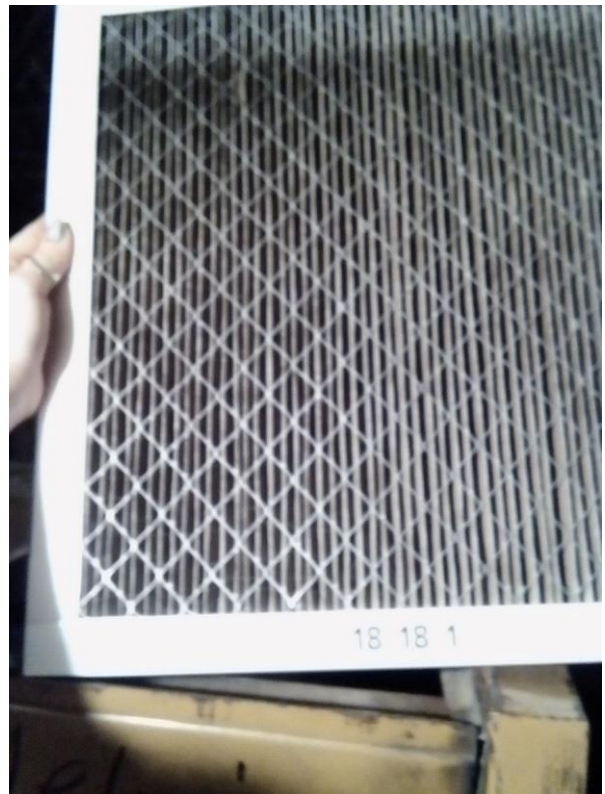
AHU\_11  
Outdoor Main Filter Cleanliness

<b>Unit Designation:</b>	AHU_11	
<b>Location of Unit:</b>	Mechanical room 2108, need key for lock	
<b>Areas Served:</b>	Auditorium - North See attached map	
<b>System Enhancements:</b>	None	
<b>Supply System</b>	<b>Outdoor Air</b>	<b>Cleanliness and Observations</b>
<b>Type</b> <ul style="list-style-type: none"> <li>Supply System - Constant Volume</li> <li>Heating - Hot Water</li> <li>Cooling - None</li> <li>Energy Recovery Unit (ERU) - None</li> </ul>	<p>Outdoor air intake is accessible</p> <p>Outdoor air intake is located on an exterior wall.</p> <p>No nearby pollution sources were found.</p>	<p>Outdoor air pre-filters are not present. Outdoor air main filters are somewhat dirty and on the border of needing replacement (scoring 3 out of 5) and fit well. Outdoor air main filters are installed correctly.</p> <p>Return air filters are not present.</p> <p>Drain pans are not applicable or not present. Drain pan condition is not known.</p> <p>Heating coils are inaccessible.</p>

<b>Filter Type - Outdoor</b> <ul style="list-style-type: none"> <li>Pre-filter: None</li> <li>Main filter: Pleated, MERV 13</li> </ul>	<p>Outdoor air intake is in good condition.</p>	<p>Heat wheels are not present.</p> <p>Exterior ducting is visible. Exterior ducting insulation is not present.</p> <p>Interior ducting is not visible. Interior ducting insulation is in an unknown condition. Interior ducting is of unknown cleanliness.</p> <p>Air handling room is free of trash/chemicals.</p> <p>Outside damper is open, and its condition is good.</p> <p>Return damper is not present.</p> <p>The general condition of the unit is good.</p>

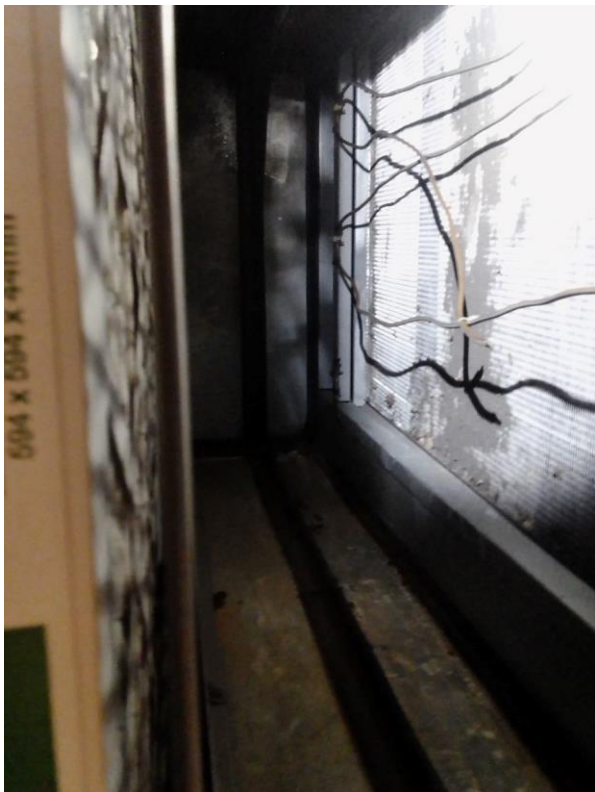
AHU\_13  
Heating Coils

<b>Unit Designation:</b>	AHU_13	
<b>Location of Unit:</b>	Mechanical room 3204A	
<b>Areas Served:</b>	West Science Rooms See attached map	
<b>System Enhancements:</b>	None	
<b>Supply System</b>	<b>Outdoor Air</b>	<b>Cleanliness and Observations</b>
<b>Type</b> <ul style="list-style-type: none"> <li>Supply System - Constant Volume</li> <li>Heating - Hot Water</li> <li>Cooling - None</li> <li>Energy Recovery Unit (ERU) - None</li> </ul>	Outdoor air intake is accessible  Outdoor air intake is located on an exterior wall.  No nearby pollution sources were found.  Outdoor air intake is in good condition.	Outdoor air filters are not present.  Return air filters are not present.  Mixed air pre-filters are not present. Mixed air main filters are clean and not in need of replacement (scoring 2 out of 5) and fit well. Mixed air main filters are installed correctly.  Drain pans are not applicable or not present. Drain pan condition is not known.  Heating coils are dirty.  Heat wheels are not present.  Exterior ducting is visible. Exterior ducting insulation is in good condition.  Interior ducting is not visible. Interior ducting insulation is in an unknown condition. Interior ducting is of unknown cleanliness.  Air handling room is free of trash/chemicals.  Outside damper is open, and its condition is good.  Return damper is open, and its condition is good.  The general condition of the unit is good.

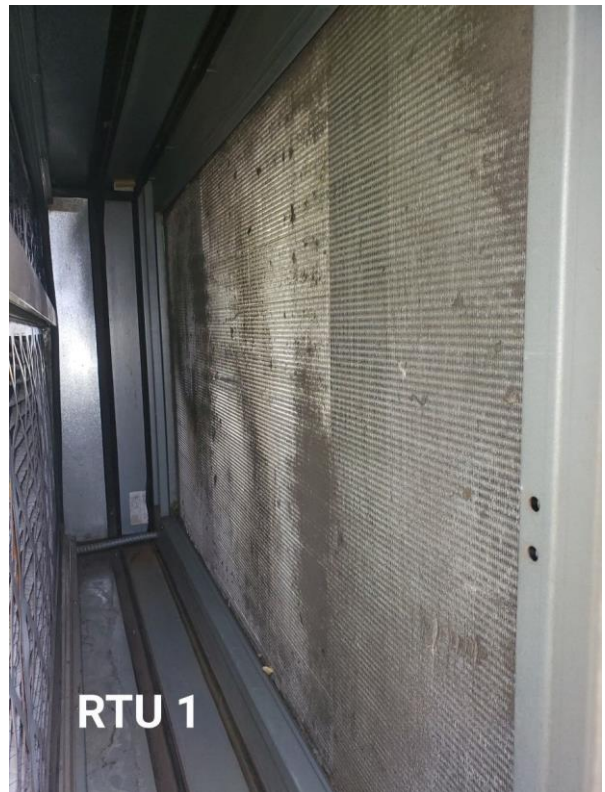
RTU\_01  
Heating Coils

<b>Filter Type - Mixed</b> <ul style="list-style-type: none"> <li>Pre-filter: None</li> <li>Main filter: Pleated, MERV 8</li> </ul>	<p>Outdoor air intake is in good condition.</p>	<p>Heating coils are dirty.</p> <p>Heat wheels are not present.</p> <p>Exterior ducting is visible. Exterior ducting insulation is in good condition.</p> <p>Interior ducting is not visible. Interior ducting insulation is in an unknown condition. Interior ducting is of unknown cleanliness.</p> <p>Air handling room is free of trash/chemicals.</p> <p>Outside damper is open, and its condition is good.</p> <p>Return damper is open, and its condition is good.</p> <p>The general condition of the unit is good.</p>
