2022 - 2023 IAQ Walkthrough

Saint Paul Public Schools Global Arts Plus Upper

Walkthrough Date:
Thursday, February 2, 2023
Retest Date: March 21, 2023

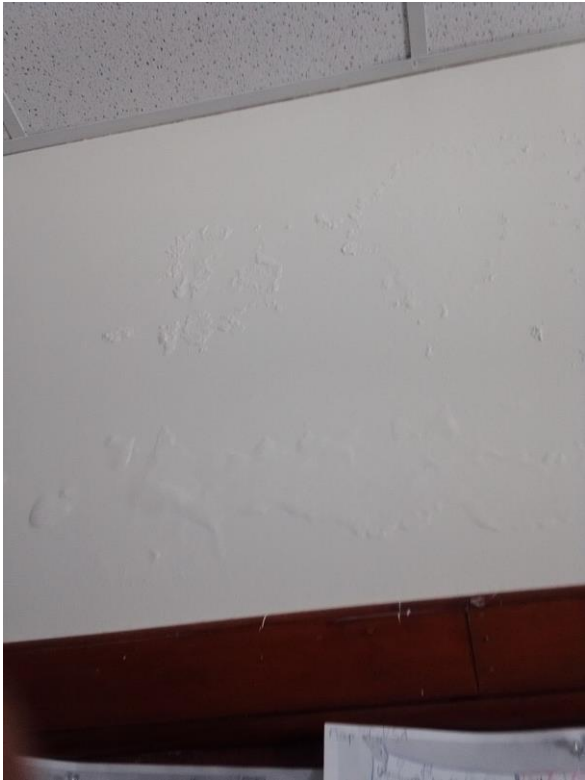
2402

IEA observed bubbling/peeling paint in area(s) within the room(s) listed below. Bubbling/peeling paint can be caused by moisture issues. IEA recommends investigating the cause and repairing the paint. IEA recommends ensuring that the paint is not lead-based prior to disturbance.

Bubbling/Peeling Paint
