## 2023 - 2024 Ventilation Assessment

## Saint Paul Public Schools Harding Senior High School

Assessment Date:  
Tuesday, April 4, 2023

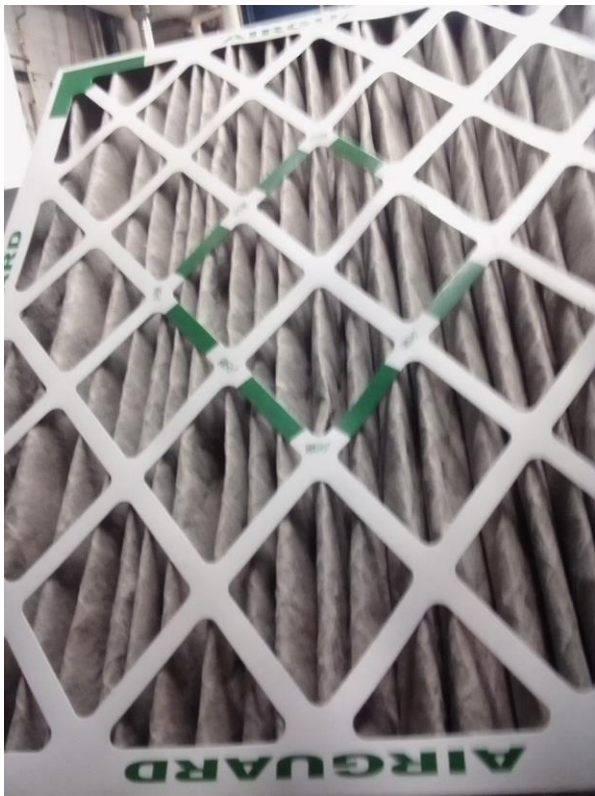
AH\_004

Mixed Main Filter Cleanliness

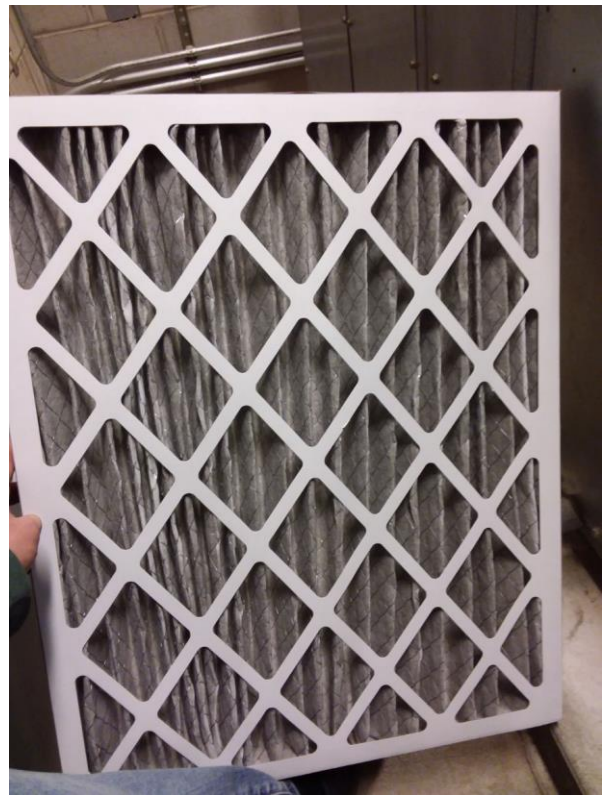
AH\_005

Mixed Main Filter Cleanliness

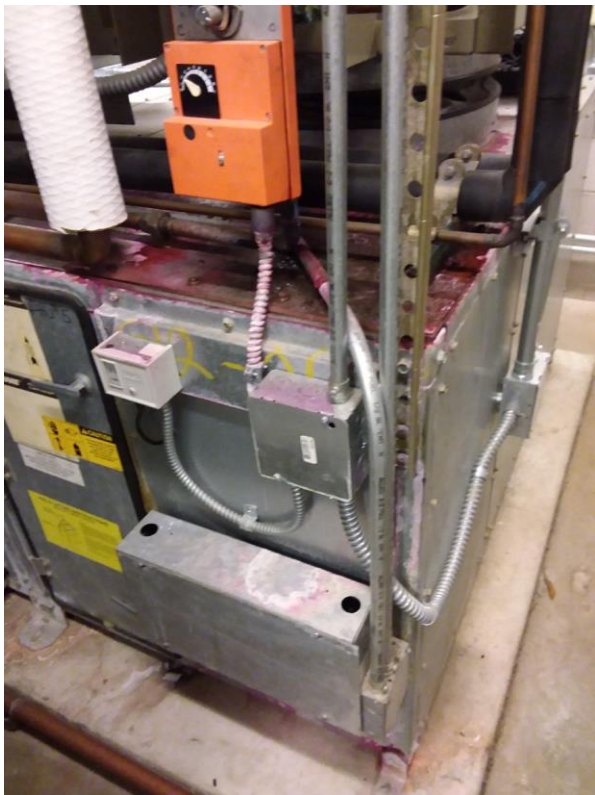
AH\_005

General Condition

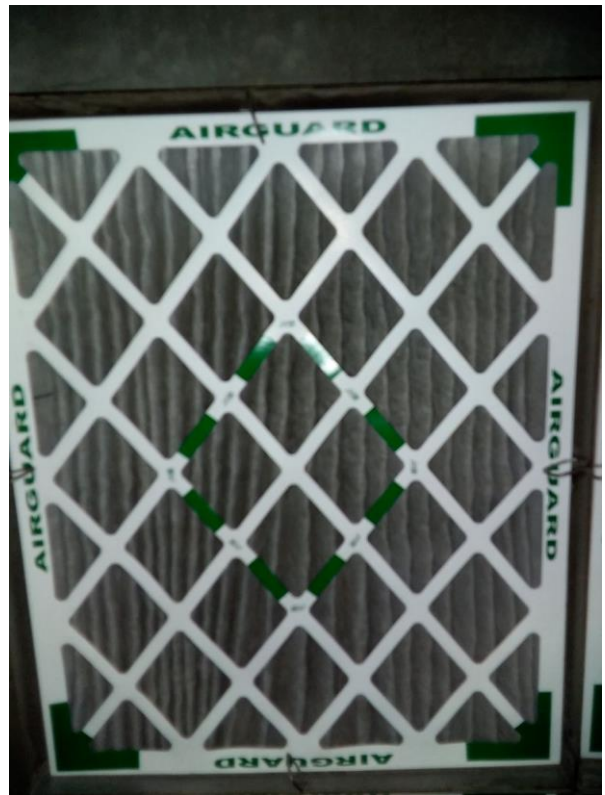
AHU\_01

Mixed Main Filter Cleanliness

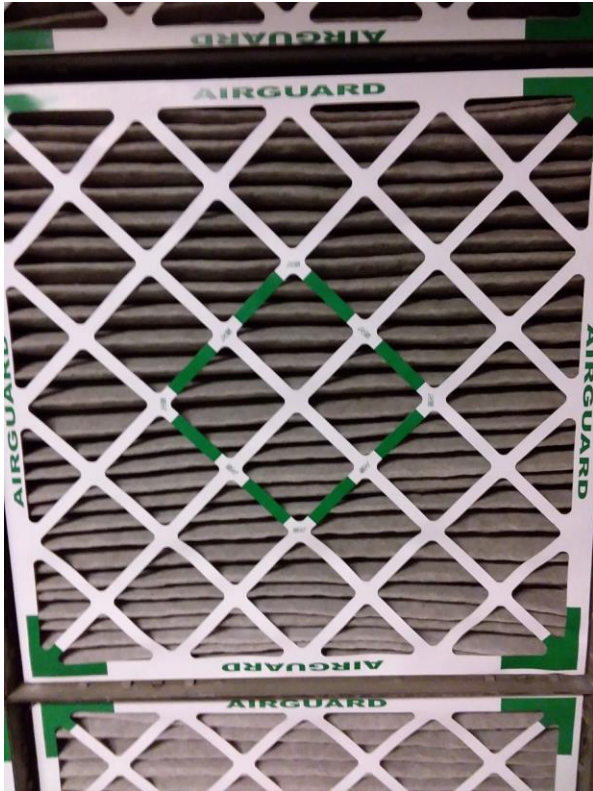
AHU\_02

Mixed Main Filter Cleanliness

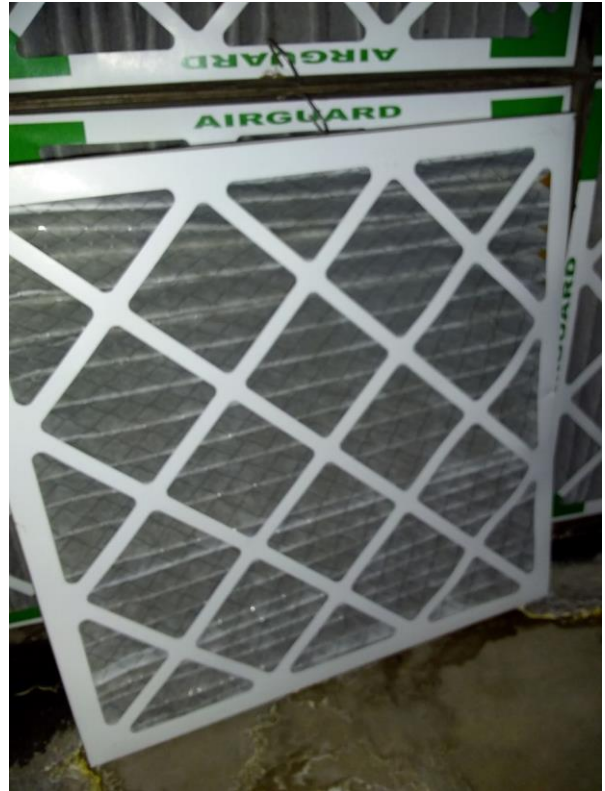
AHU\_03

Mixed Main Filter Cleanliness

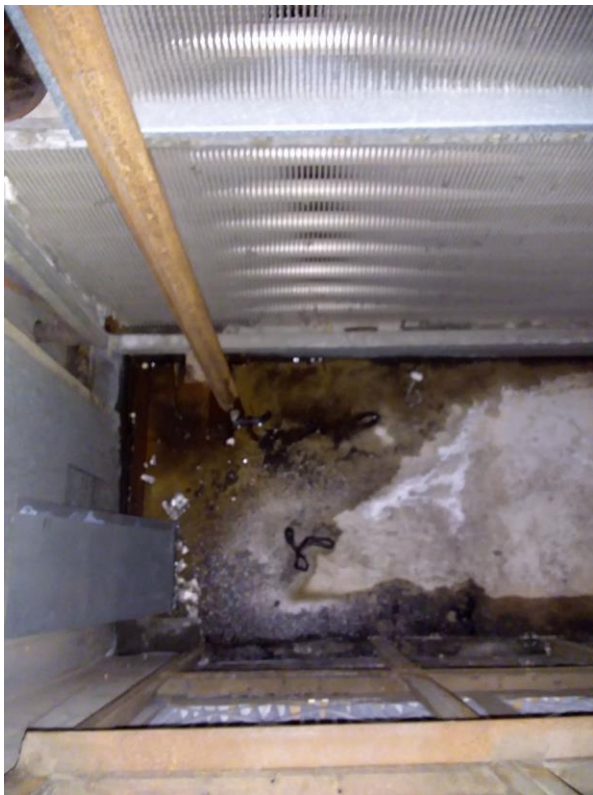
AHU\_03

Drain Pans

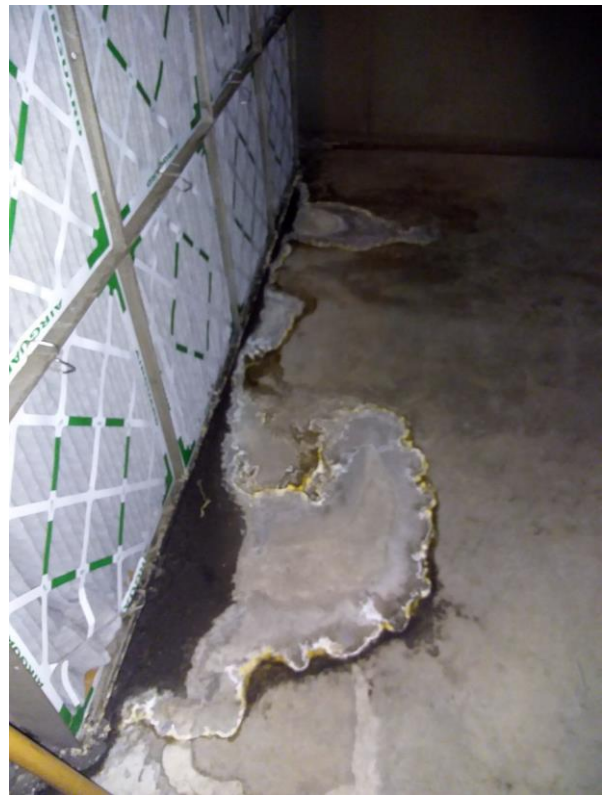
AHU\_03

General Condition

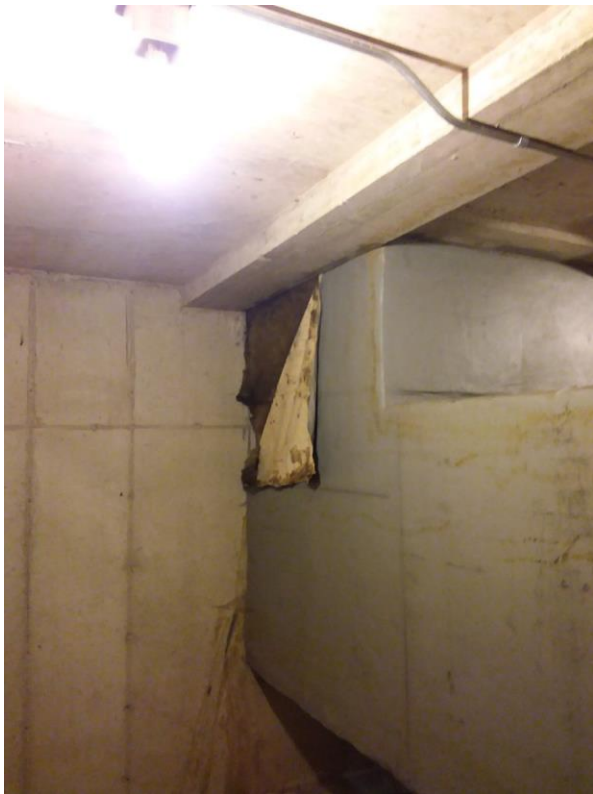
AHU\_03

General Condition

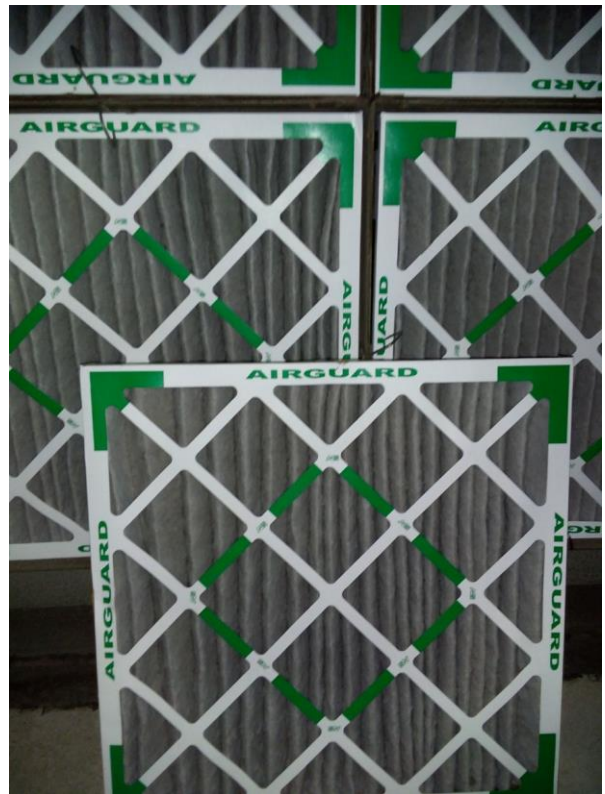
AHU\_04

Mixed Main Filter Cleanliness

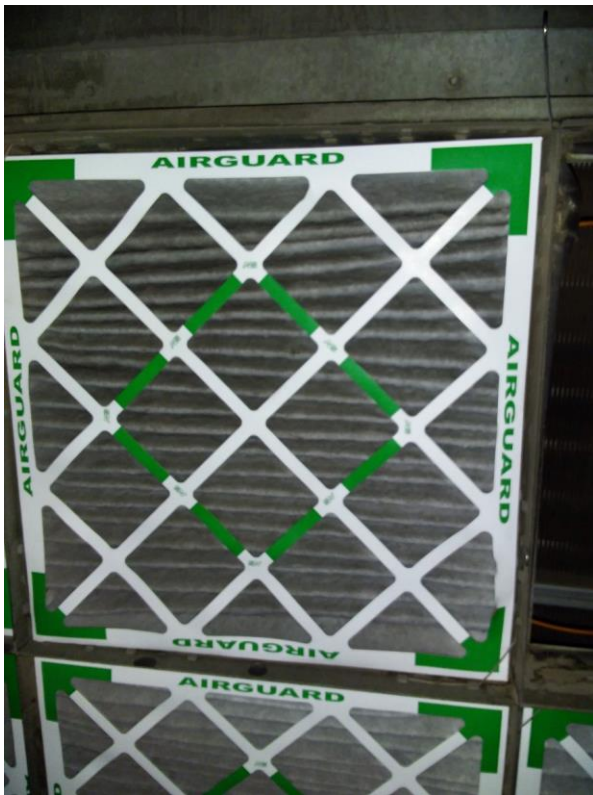
AHU\_05

Mixed Main Filter Cleanliness

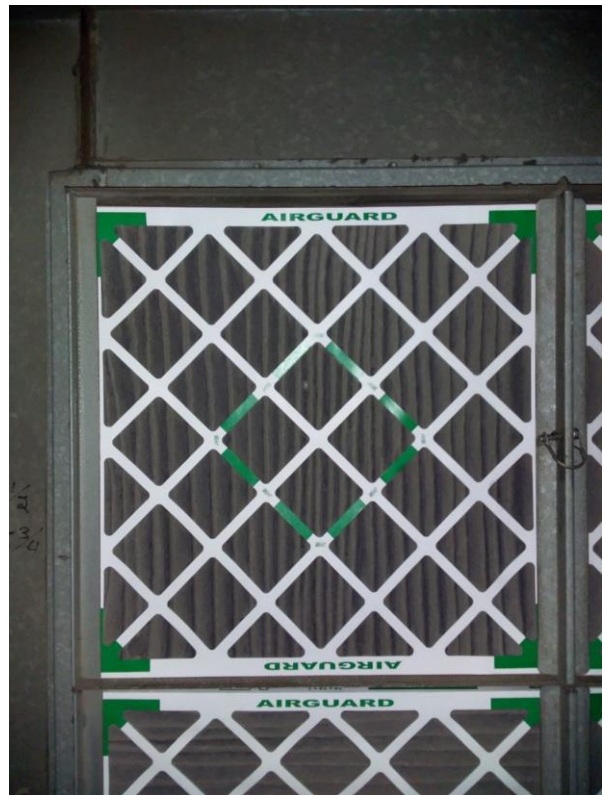
AHU\_06

Mixed Main Filter Cleanliness

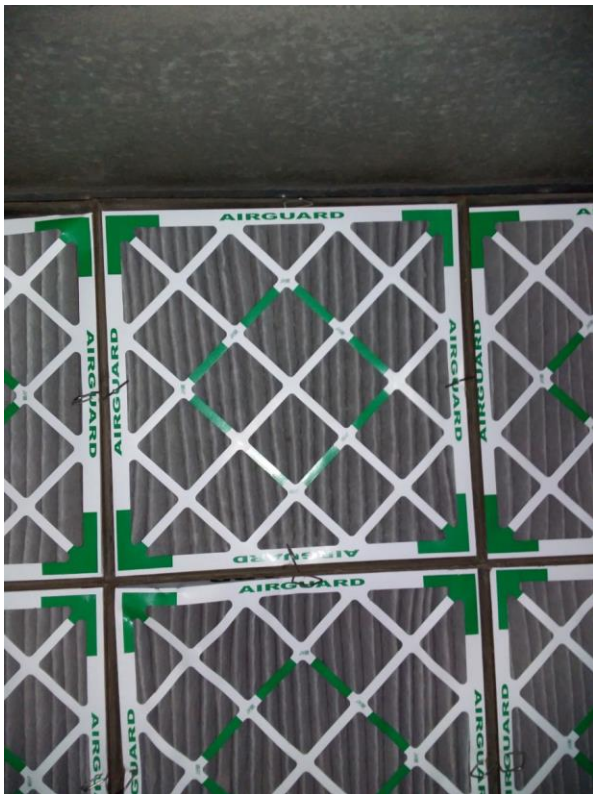
AHU\_07

Mixed Main Filter Cleanliness

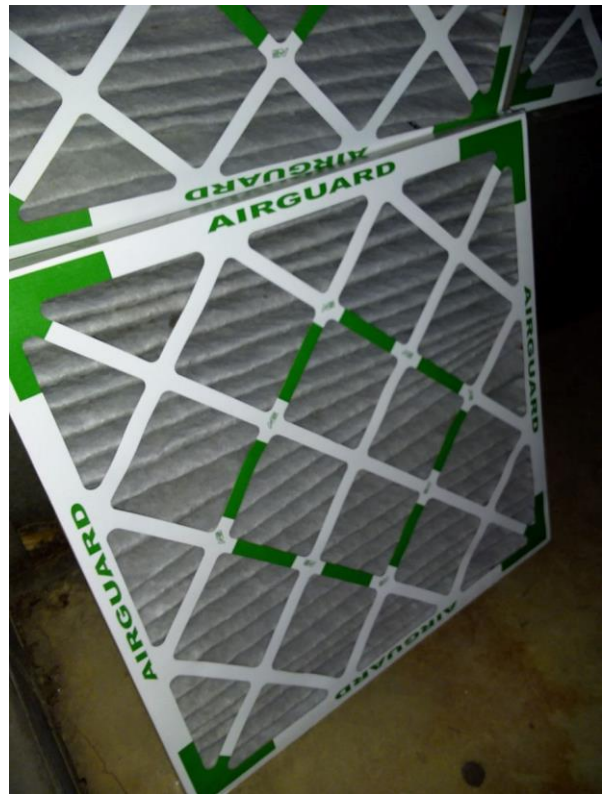
AHU\_08

Mixed Main Filter Cleanliness

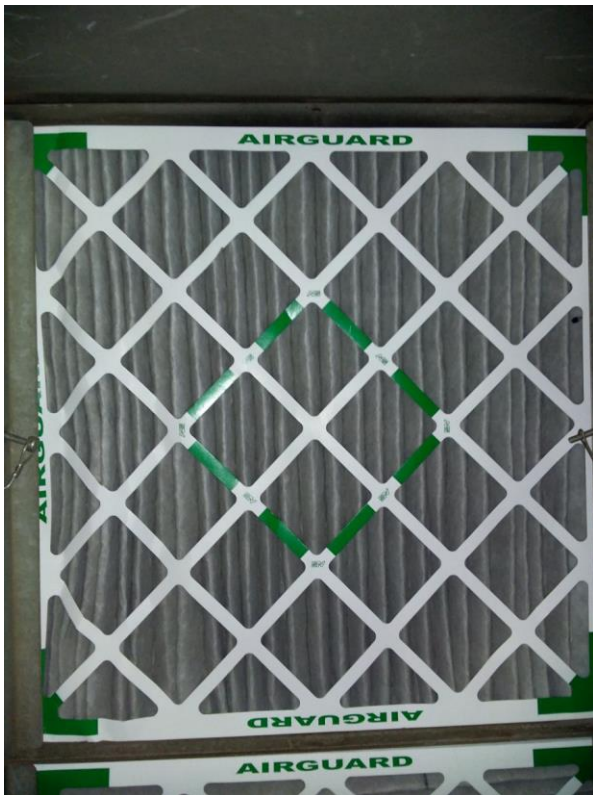
AHU\_09

Mixed Main Filter Cleanliness

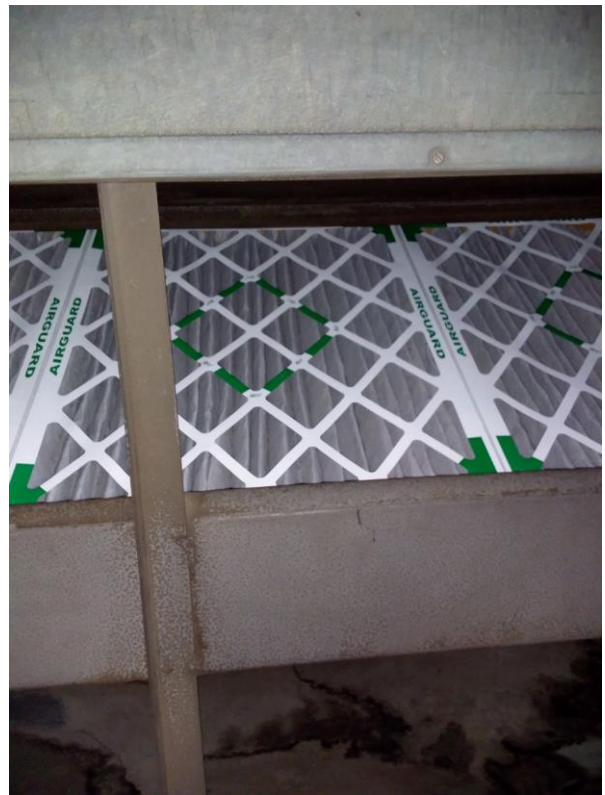
AHU\_10

Mixed Main Filter Cleanliness

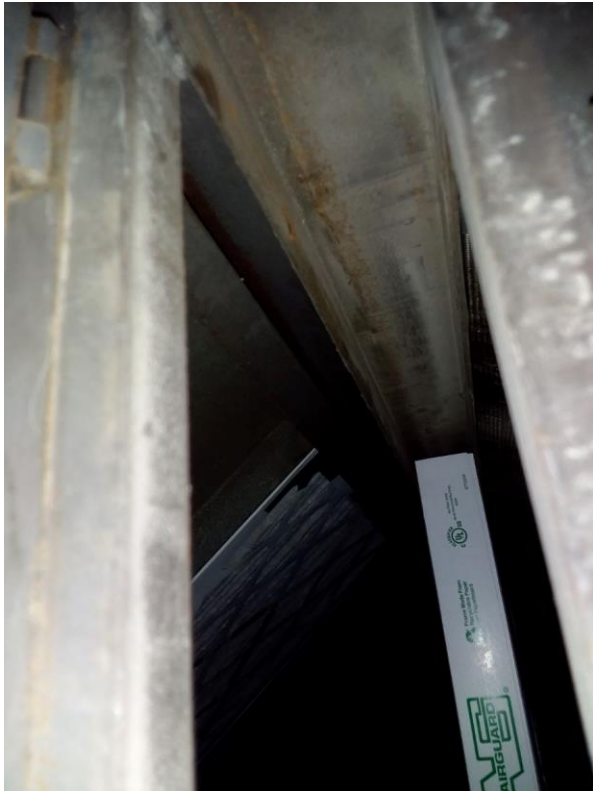
AHU\_11  
Heating Coils

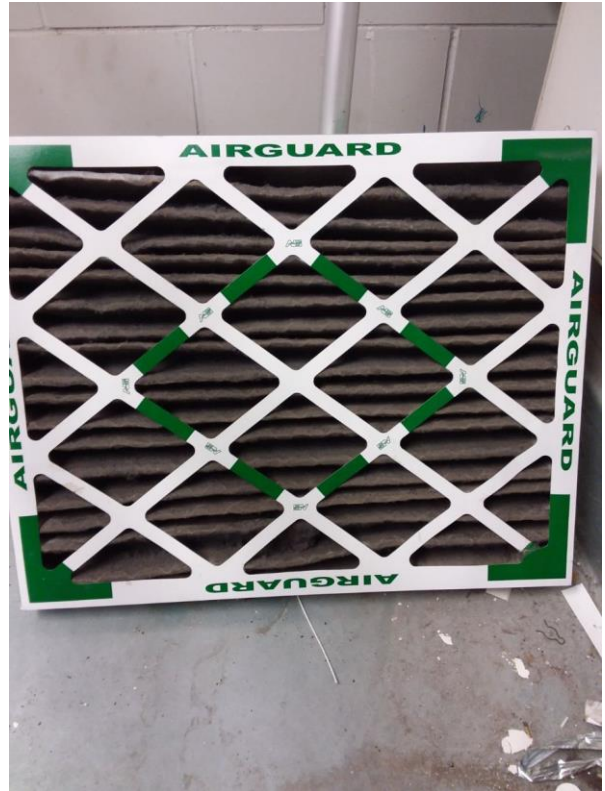
AHU\_16  
Mixed Pre-Filter Cleanliness

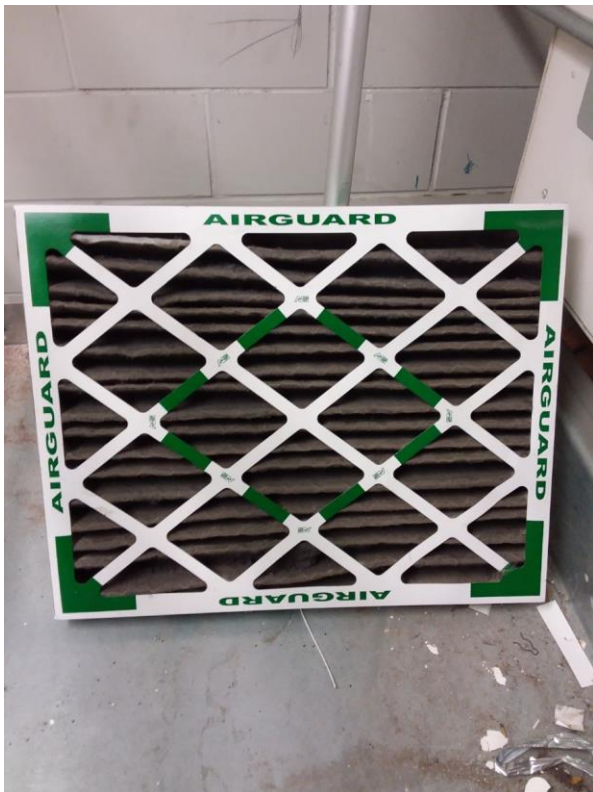
AHU\_16  
Mixed Main Filter Cleanliness

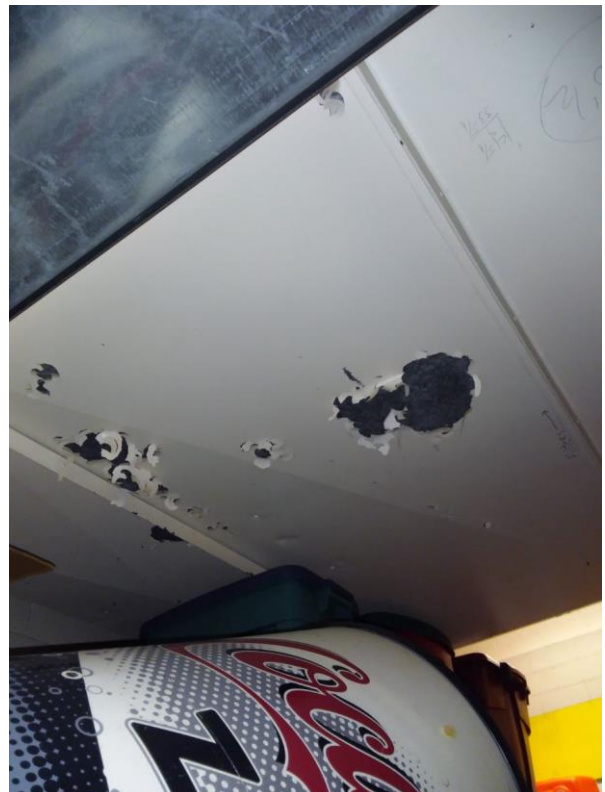
AHU\_16  
General Condition

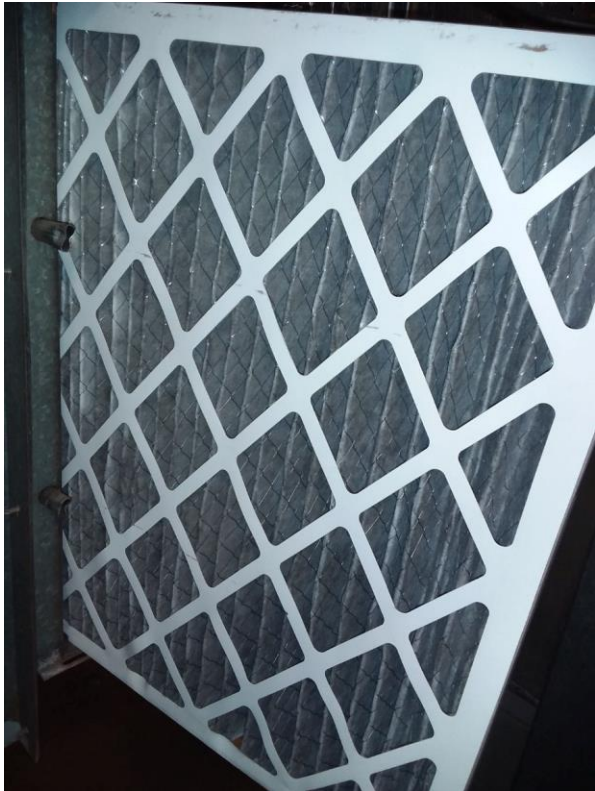
AHU\_17

Mixed Main Filter Cleanliness

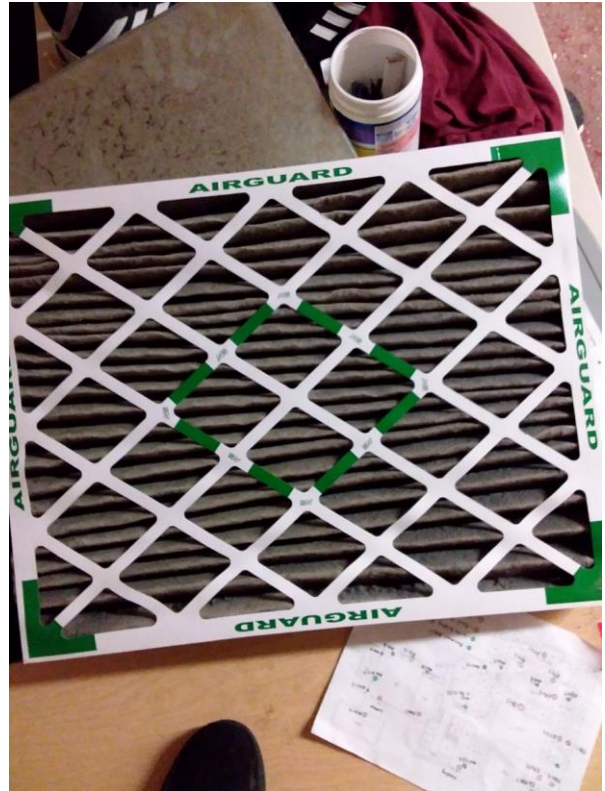
AHU\_18

Mixed Main Filter Cleanliness

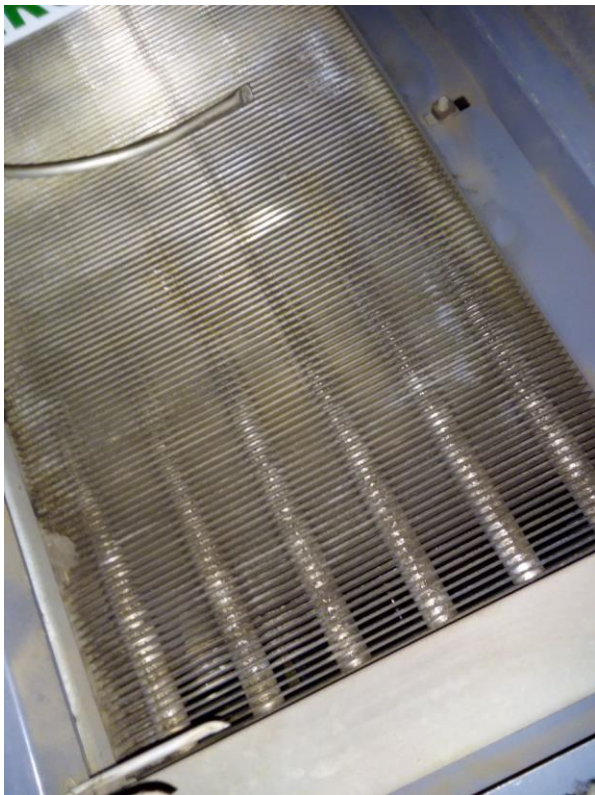
AHU\_18

Heating Coils

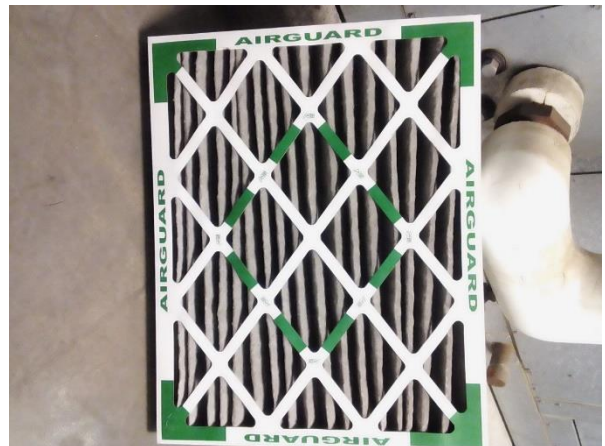
AHU\_19

Mixed Main Filter Cleanliness

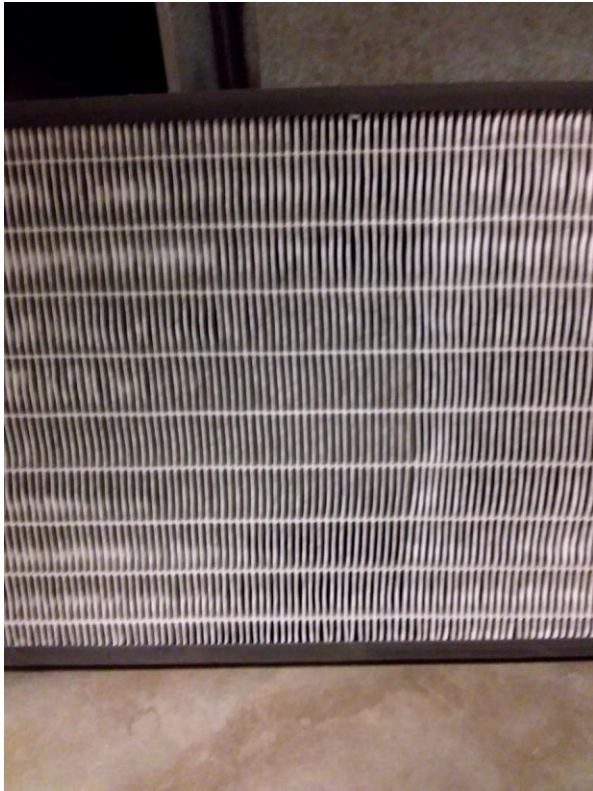
AHU\_20

Mixed Main Filter Cleanliness

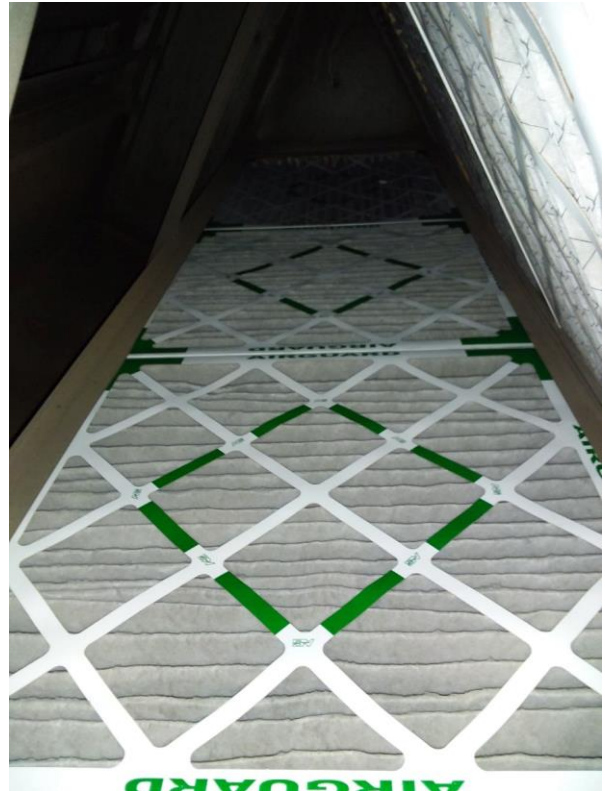
AHU\_21

Mixed Main Filter Cleanliness

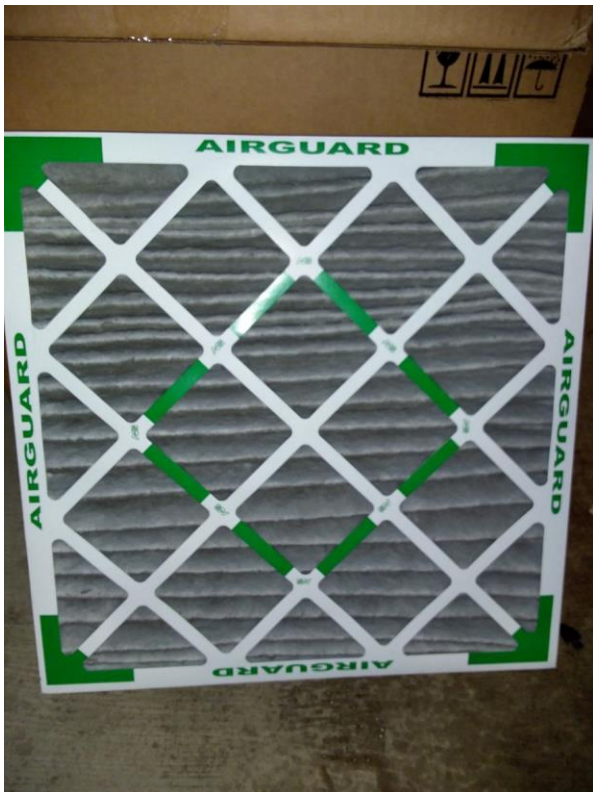
AHU\_22

Mixed Main Filter Cleanliness

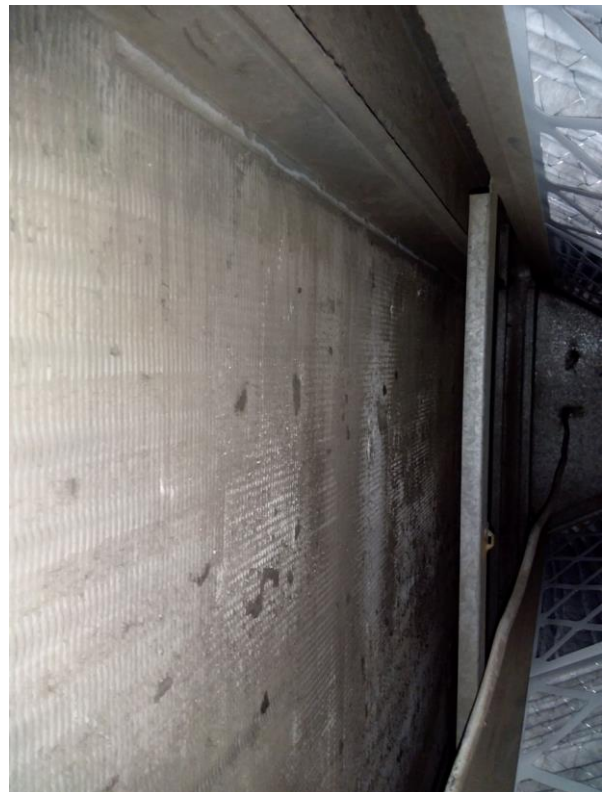
AHU\_22

Heating Coils

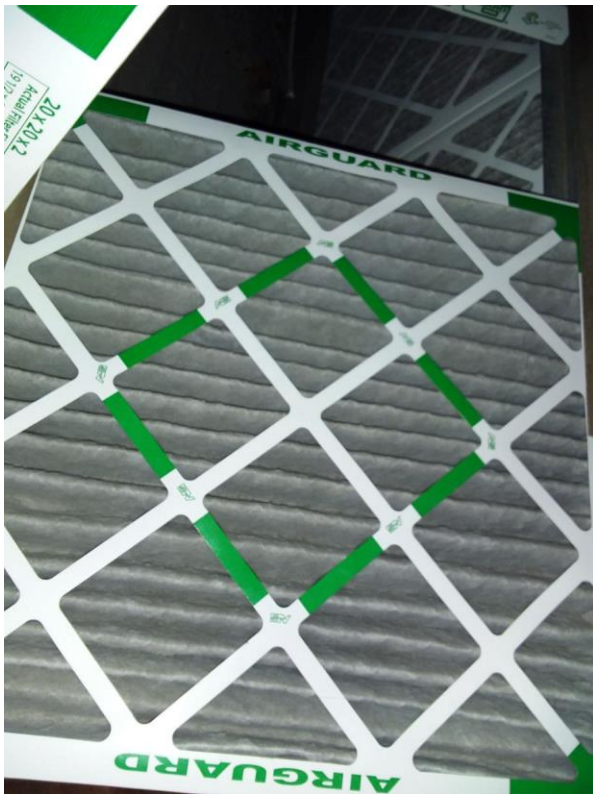
AHU\_23  
Mixed Main Filter Cleanliness

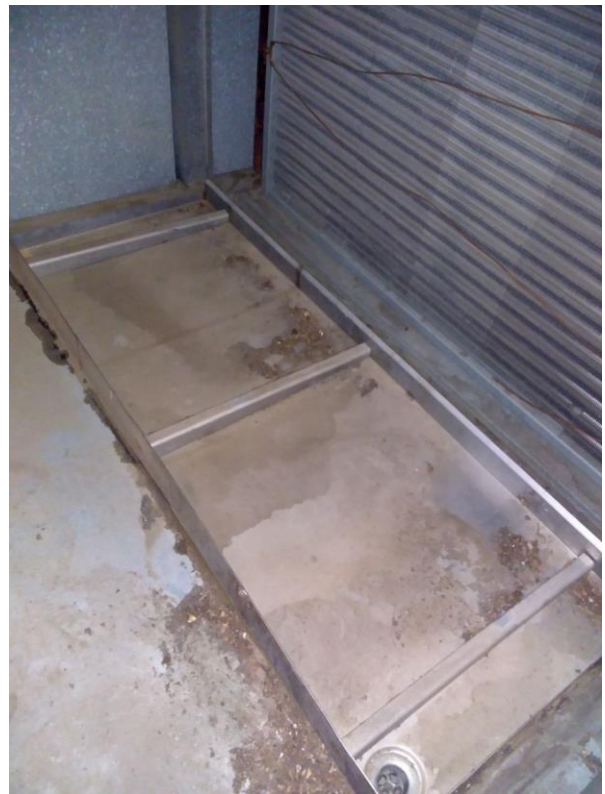
AHU\_23  
Drain Pans

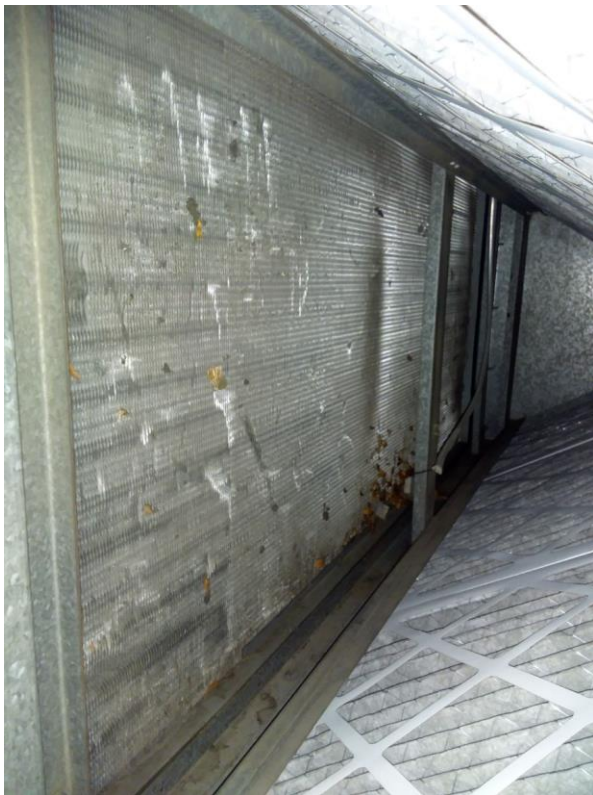
AHU\_23  
Heating Coils

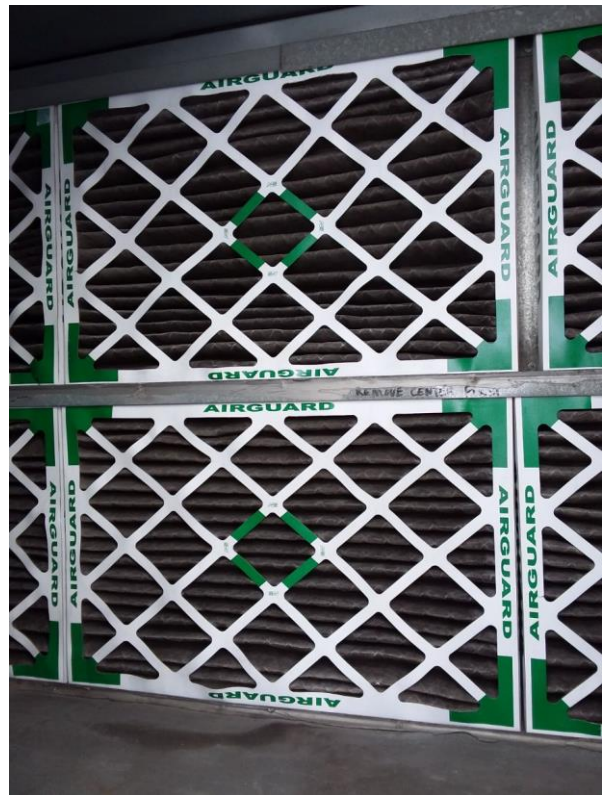
ERU\_02 (100% OA)  
Outdoor Pre-Filter Cleanliness

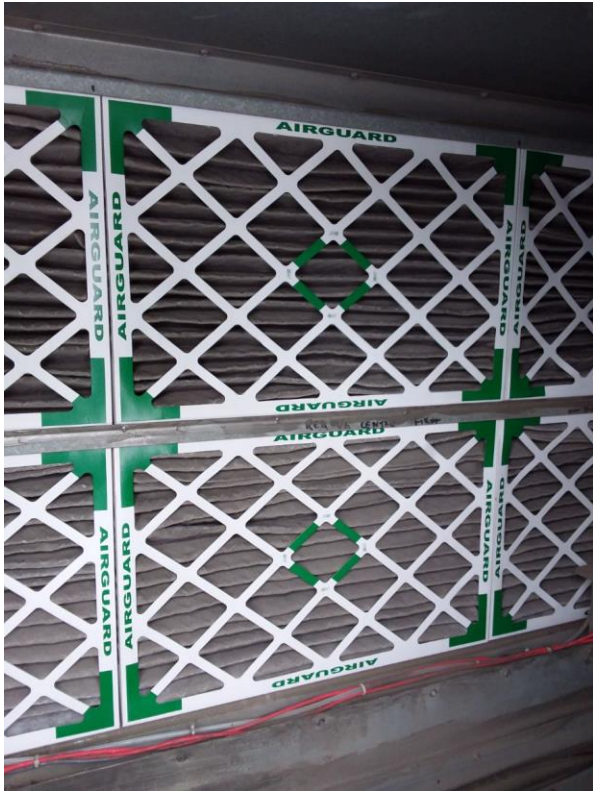
ERU\_02 (100% OA)  
Outdoor Main Filter Cleanliness

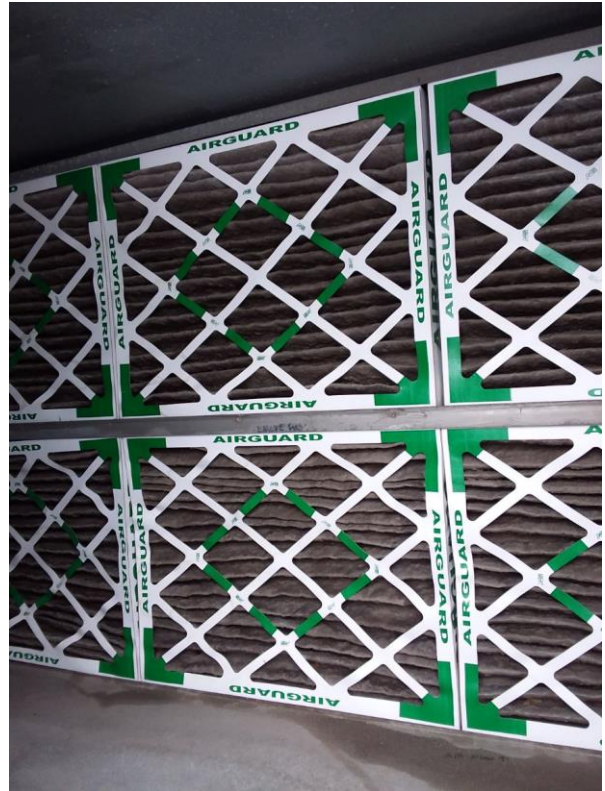
ERU\_03/1  
Outdoor Main Filter Cleanliness

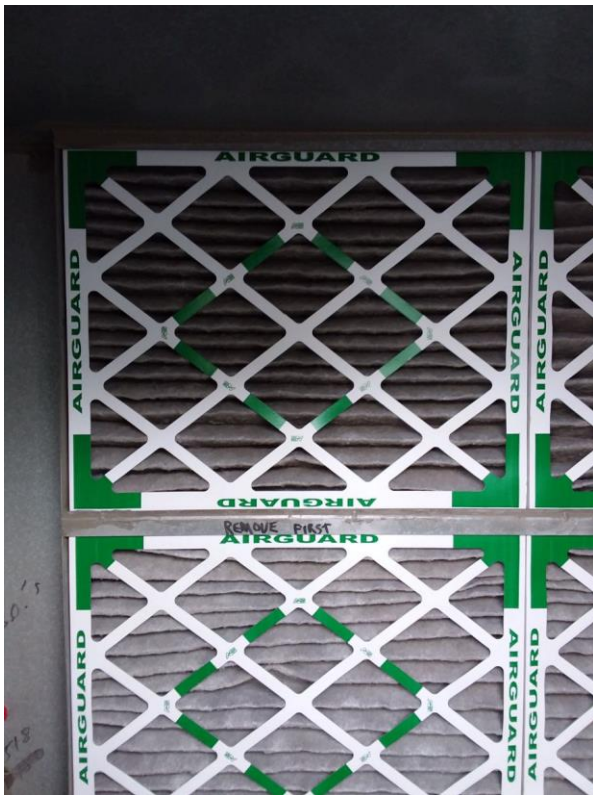
ERU\_03/1  
Return Main Filter Cleanliness

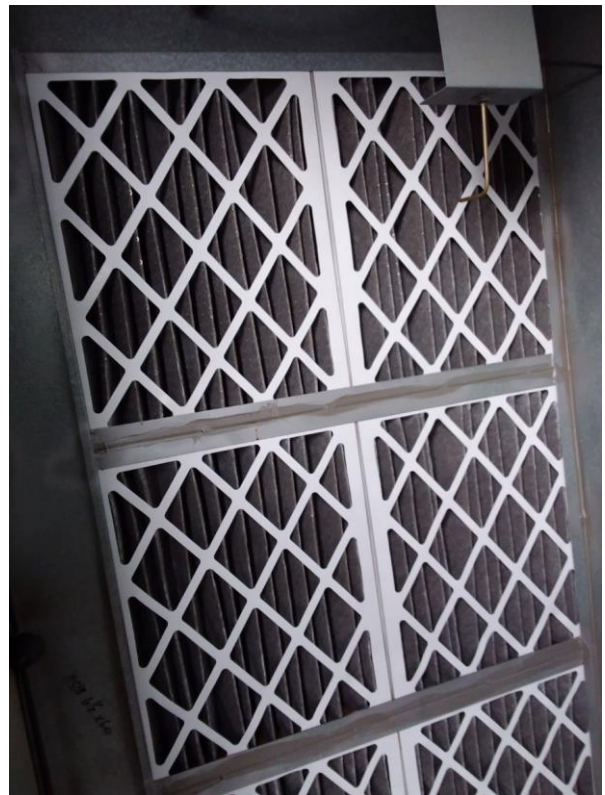
ERU\_03/1  
Mixed Main Filter Cleanliness

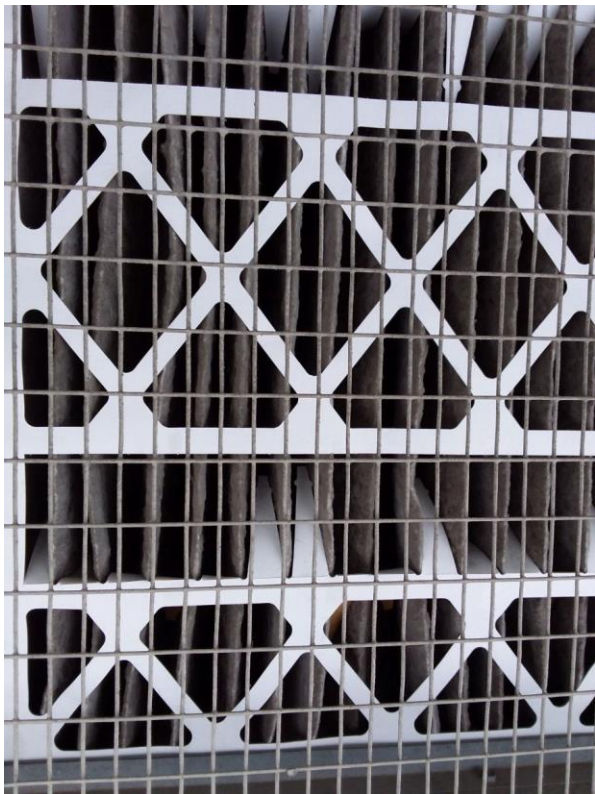
ERU 4 NEXT TO MAU 1  
Outdoor Pre-Filter Cleanliness

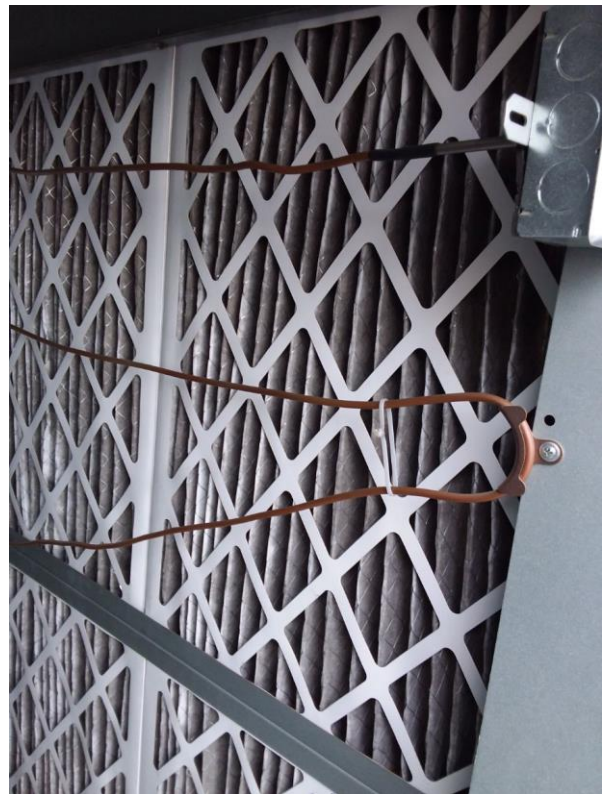
ERU 4 NEXT TO MAU 1  
Outdoor Main Filter Cleanliness

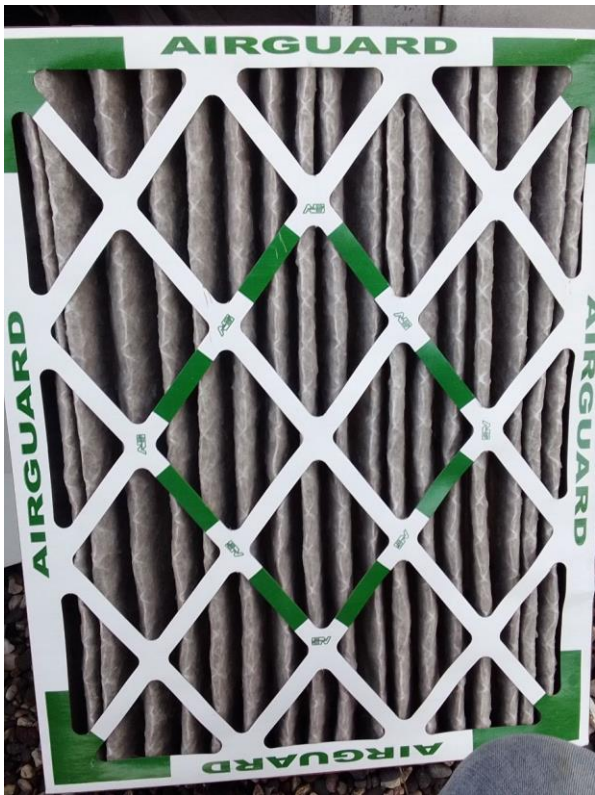
MAU\_03  
Mixed Main Filter Cleanliness

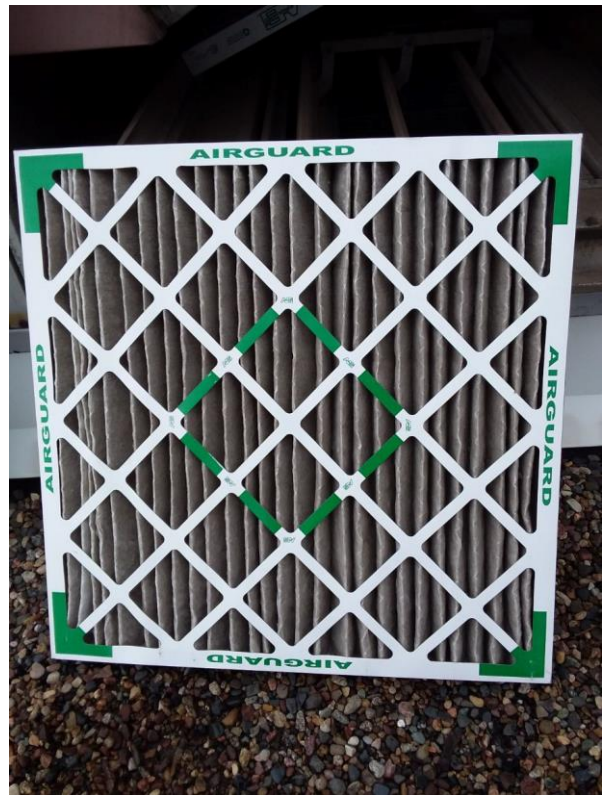
MAU 5  
Mixed Main Filter Cleanliness

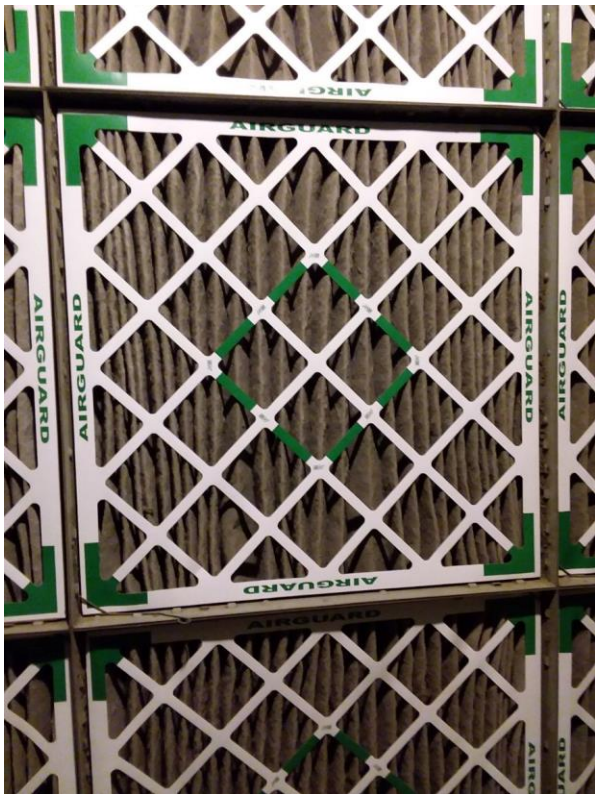
RTU\_01

Mixed Main Filter Cleanliness

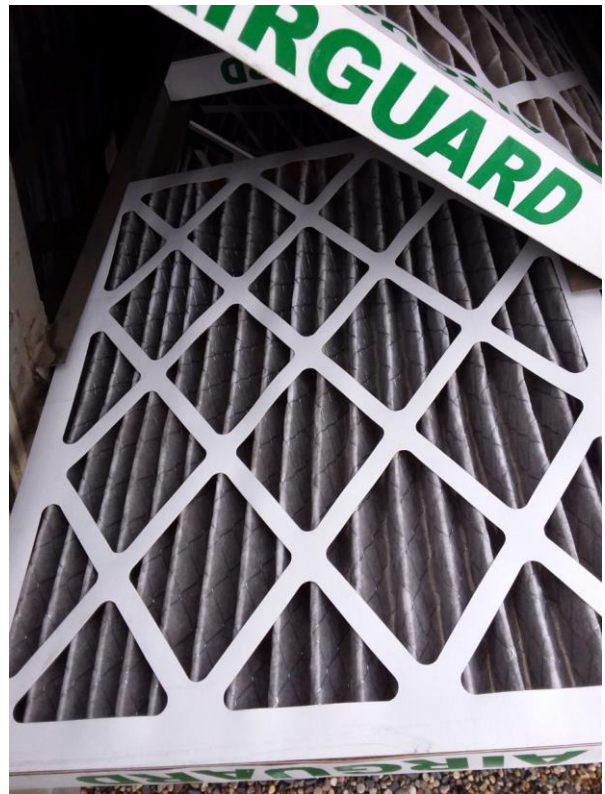
RTU\_02

Mixed Pre-Filter Cleanliness

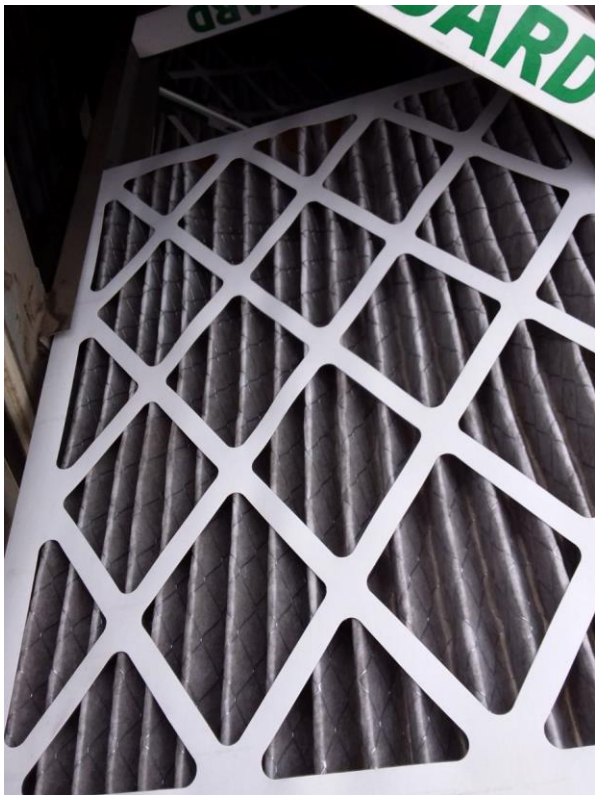
RTU\_02

Mixed Main Filter Cleanliness

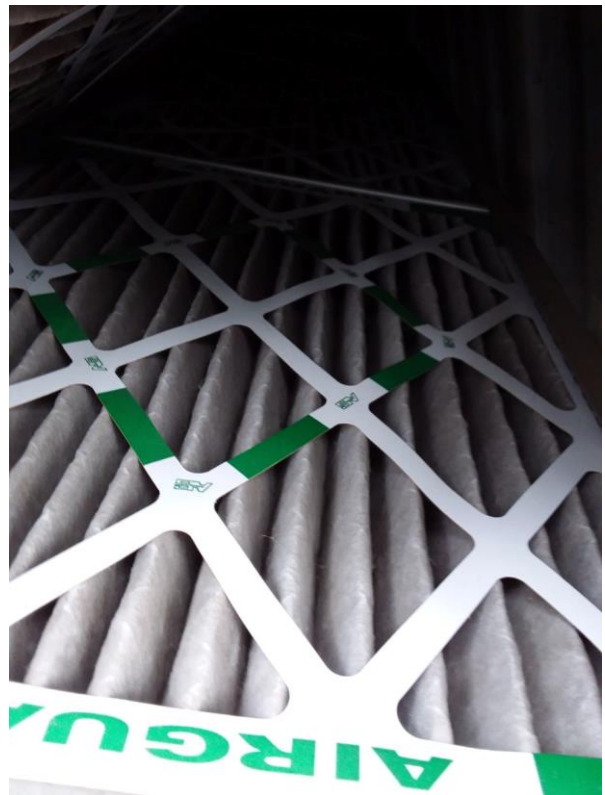
RTU\_03

Mixed Main Filter Cleanliness

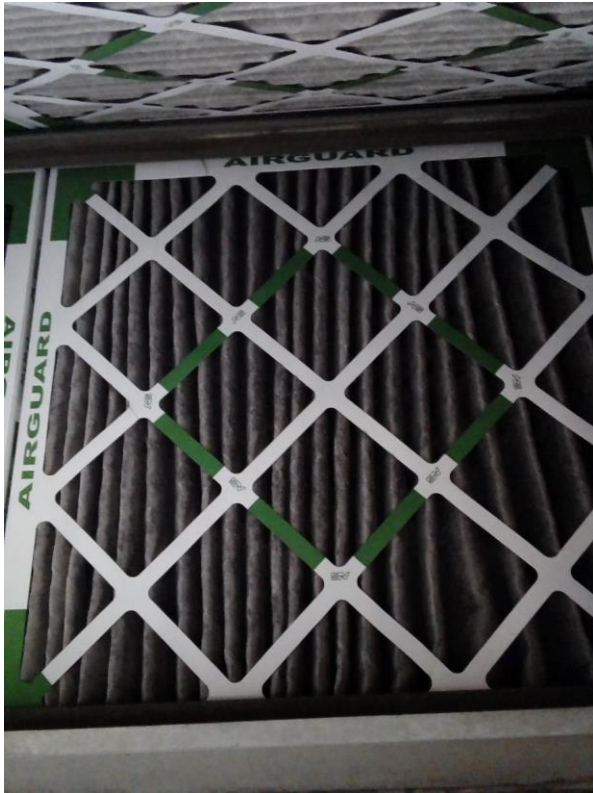
AHU\_14

Mixed Main Filter Cleanliness

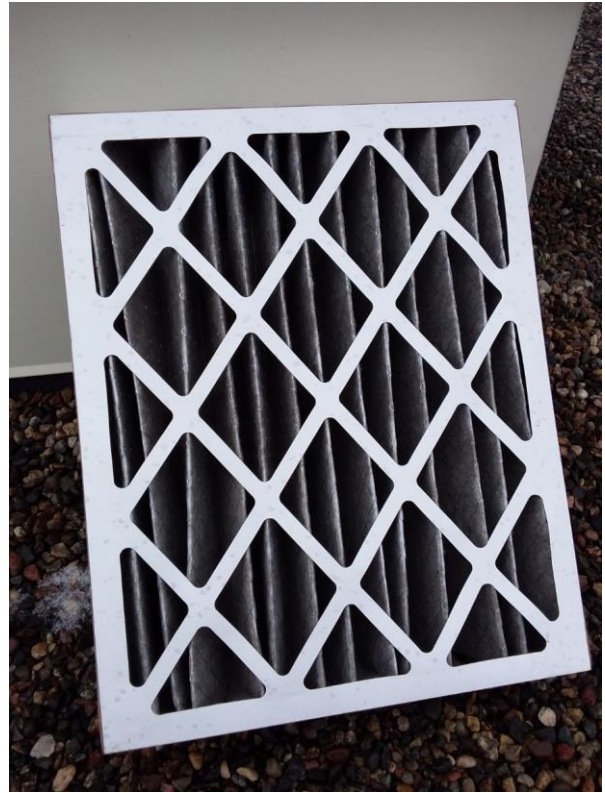
RTU\_10

Mixed Main Filter Cleanliness
