2022 - 2023 IAQ Walkthrough

Saint Paul Public Schools The Heights Community School

Walkthrough Date:
Friday, January 20, 2023

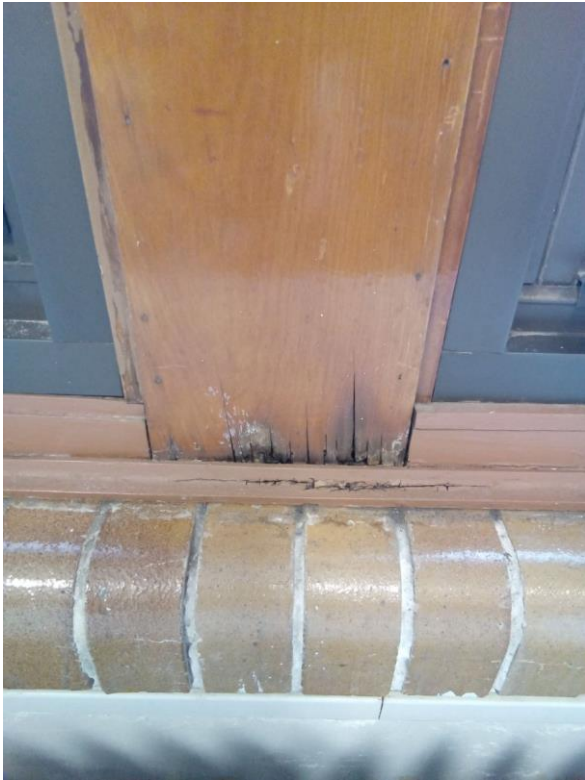
Moisture-impacted building materials should be repaired or replaced when discoloration or water staining is observed. Moisture-impacted building materials can be a source for microbial growth. The source for the moisture infiltration should be investigated and repaired if not easily identified.

- 1105
- 4259
- 2305 *Cracking cement wall*

Moisture-Impacted Materials

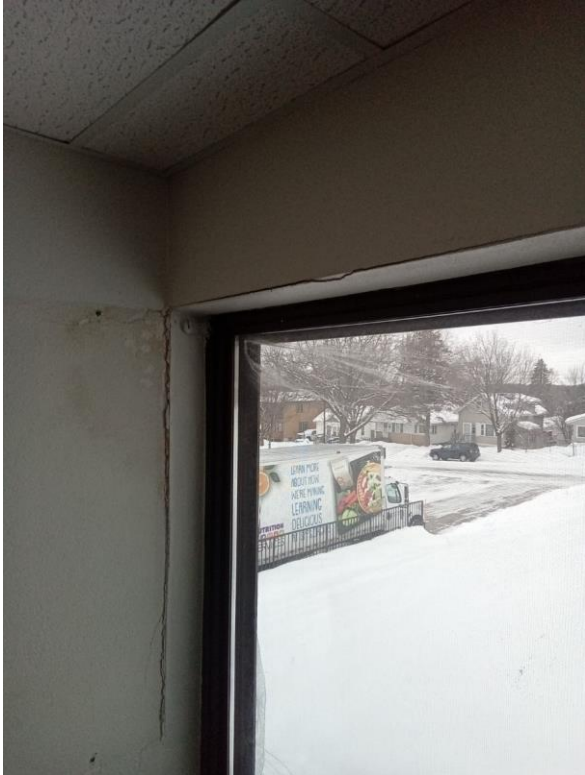
2305

Moisture-Impacted Materials

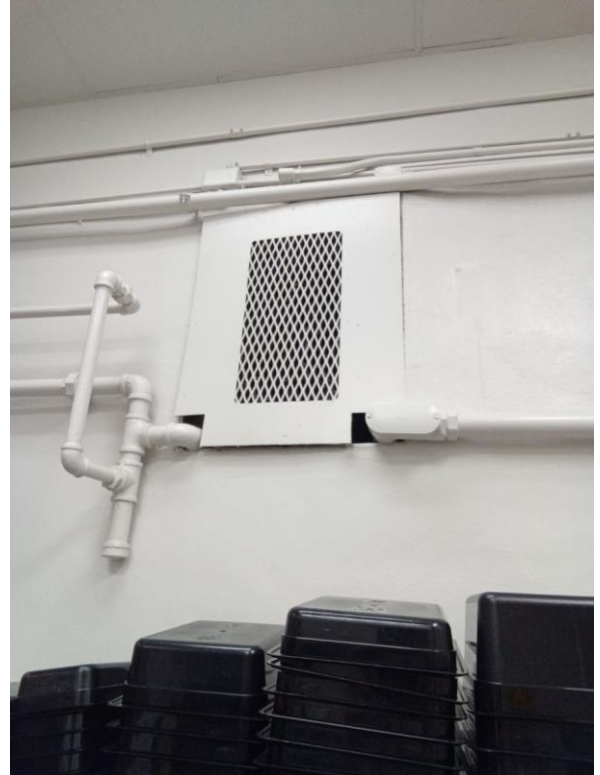
| • 1102 | <i>NE corner</i> | • 2111 <i>Air Return</i> |

Dust

IEA observed dust accumulation in the following room(s) and recommend that the specified area is wiped clean using a damp rag.

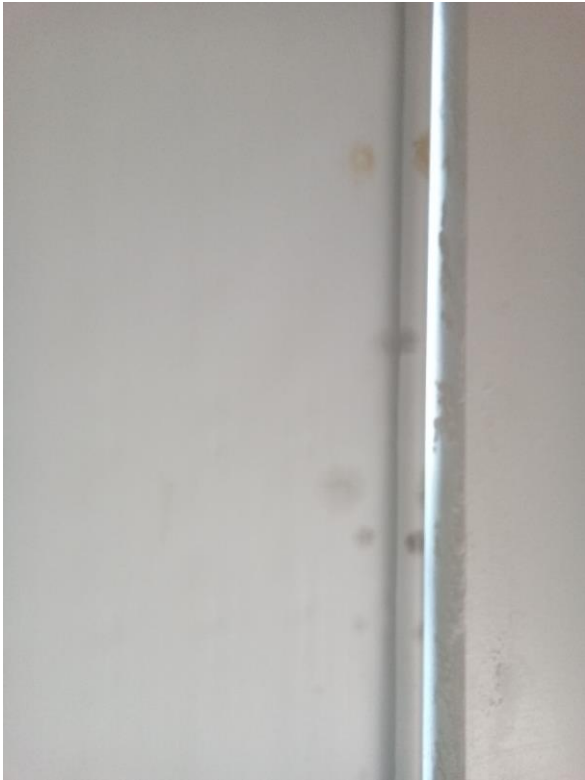
1105

Moisture-Impacted Materials

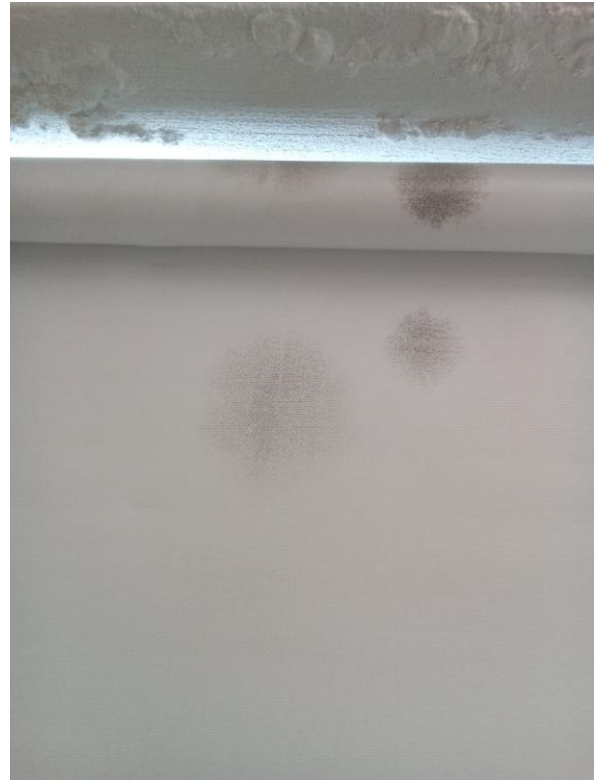
- 1105

Suspect Microbial Growth

IEA observed building materials with possible microbial growth that should be removed and/or cleaned under controlled conditions, per the Minnesota Department of Health *Recommended Best Practices for Mold Remediation in Minnesota Schools* guidelines (<https://www.health.state.mn.us/communities/environment/air/docs/schools/remediation.pdf>) or following the Institute of Inspection, Cleaning and Restoration (IICRC) S520 Standard and Guide for Professional Mold Remediation to prevent possible contamination of adjacent locations and impact to building occupants. Further assessment or fungal sampling may be necessary to identify a scope of work for a professional mold remediation contractor.
