2023 - 2024 Ventilation Assessment

Saint Paul Public Schools The Heights Community School

Assessment Date: Thursday, April 6, 2023

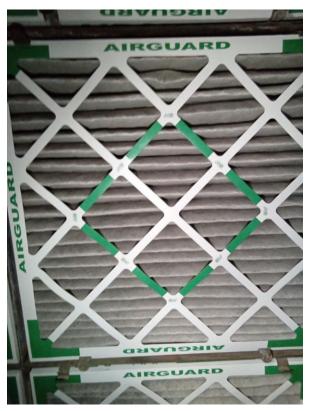
AHU 01 Mixed Main Filter Cleanliness

•	Water Cooling - None Energy	intake is located	somewhat dirty and on the border of needing replacement (scoring 3 out of 5) and fit well. Mixed air main filters are installed correctly.
Filter Ty	(ERU) - None ype - Mixed	pollution sources were found.	Drain pans are not applicable or not present. Drain pan condition is not known.

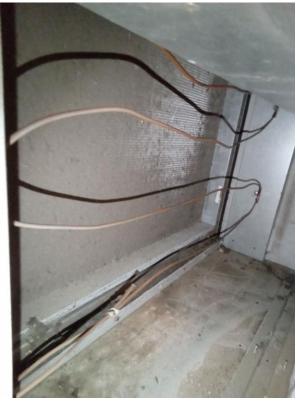
AHU 05 Heating Coils

Dirty Coils were observed on units AHU 05, UV 1111 and UV 2114 during the ventilation inspection.

Recommendation: Impacted/dirty coils can result in poor ventilation air supply as well as be a source for mold and bacterial growth on the coils. Coils should be cleaned annually, or as needed, as identified in the operations and maintenance program.

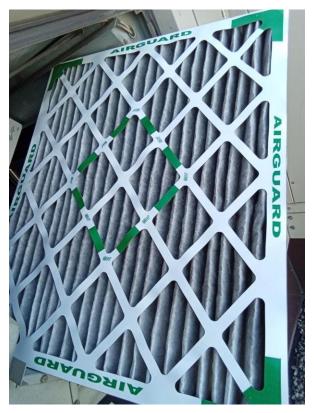
RTU 04 (100% OA) Outdoor Main Filter Cleanliness

•	Supply System	intake is	are somewhat dirty and on the border of needing replacement	
	- Constant	accessible	(scoring 4 out of 5) and fit well. Outdoor air main filters are	
	Volume	Outdoor air	installed correctly.

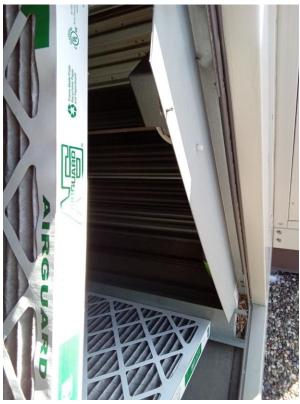
RTU 05 (100% OA) Outdoor Main Filter Fit

•	Supply System	intake is	are somewhat dirty and on the border of needing replacement
	- Constant	accessible	(scoring 3 out of 5) and fit poorly. Outdoor air main filters are
	Volume		installed correctly.

Dirty or poorly fitting filters were observed in unit RTU 05 (100% OA) during the ventilation inspection.

Recommendation: The operations and maintenance program for filter changes should be reviewed and revised to ensure proper filter changes to optimize filtration capacity.

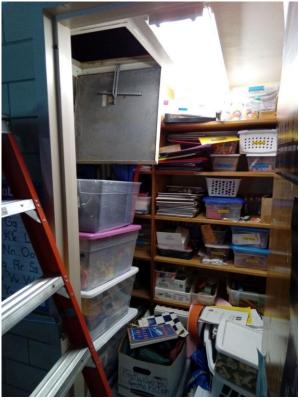
FCU 01 Air Handling Room

Excessive storage and/or chemical storage were observed in the mechanical equipment room(s) during the site inspection.

Recommendation: Excessive storage can block access to the ventilation equipment and prevent proper maintenance, filter changes and inspections. Stored items can potentially impact the operation of the systems and limit their ability to properly ventilate.

Chemicals stored in the mechanical room can result in odors or chemicals introduced into the ventilation air and impact the IAQ of building occupants.
