2022 - 2023 IAQ Walkthrough

Saint Paul Public Schools Hidden River Middle School

Walkthrough Date:
Wednesday, December 14, 2022

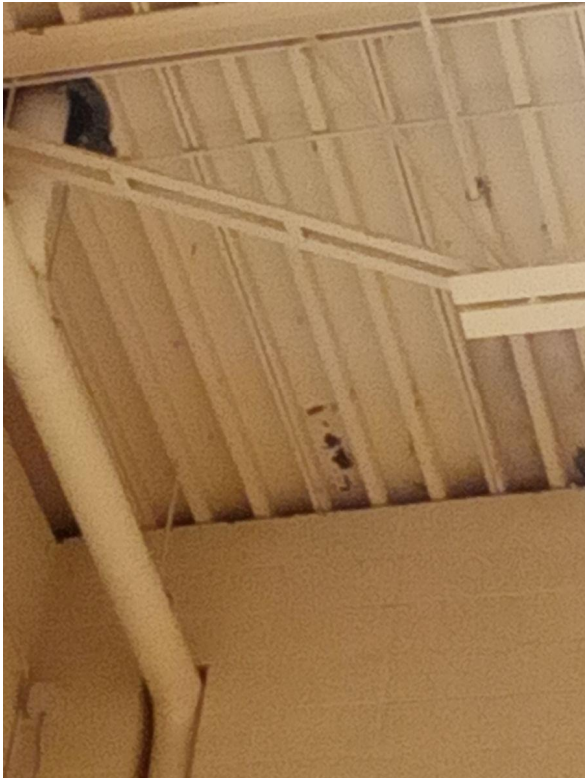
1305

IEA observed bubbling/peeling paint in area(s) within the room(s) listed below. Bubbling/peeling paint can be caused by moisture issues. IEA recommends investigating the cause and repairing the paint. IEA recommends ensuring that the paint is not lead-based prior to disturbance.

Bubbling/Peeling Paint
