2023 - 2024 Ventilation Assessment

Saint Paul Public Schools Highland Park Elementary School

Assessment Date:
Monday, April 10, 2023

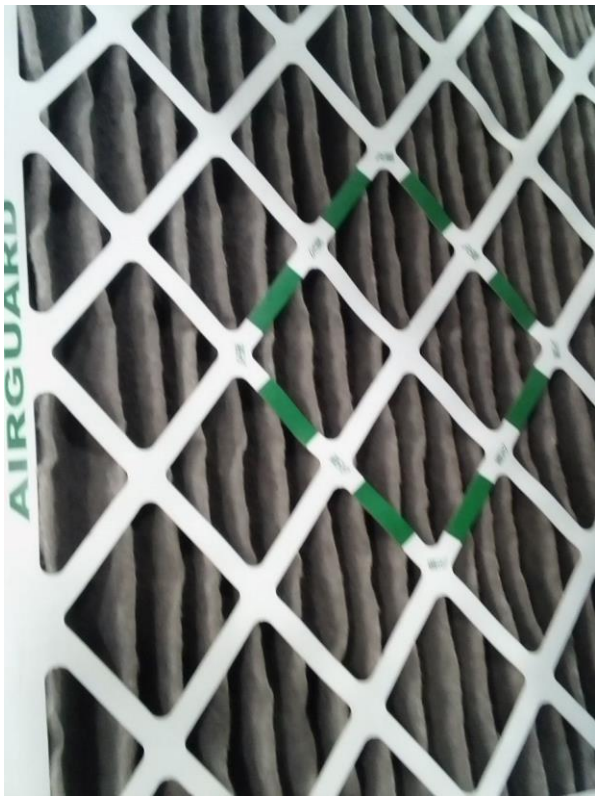
Unit Designation:	AHU-A1	
Location of Unit:	Mechanical room 1120b	
Areas Served:	See attached map Gymnasium	
System Enhancements:	None	
Supply System	Outdoor Air	Cleanliness and Observations
Type <ul style="list-style-type: none"> Supply System - Constant Volume Heating - Hot Water Cooling - None Energy Recovery Unit (ERU) - None 	Outdoor air intake is accessible Outdoor air intake is located on an exterior wall. No nearby pollution sources were found.	Outdoor air filters are not present. Return air filters are not present. Mixed air pre-filters are not present. Mixed air main filters are somewhat dirty and on the border of needing replacement (scoring 4 out of 5) and fit well. Mixed air main filters are installed correctly. Drain pans are not applicable or not present. Drain pan condition is not known.
Filter Type - Mixed <ul style="list-style-type: none"> Pre-filter: None Main filter: Pleated, MERV 13 	Outdoor air intake is in good condition.	Heating coils are clean. Heat wheels are not present. Exterior ducting is visible. Exterior ducting insulation is in good condition. Interior ducting is visible. Interior ducting insulation is not present. Interior ducting is clean. Air handling room is free of trash/chemicals. Outside damper is open, and its condition is good. Return damper is closed, and its condition is good. The general condition of the unit is good.

Mixed Main Filter Cleanliness

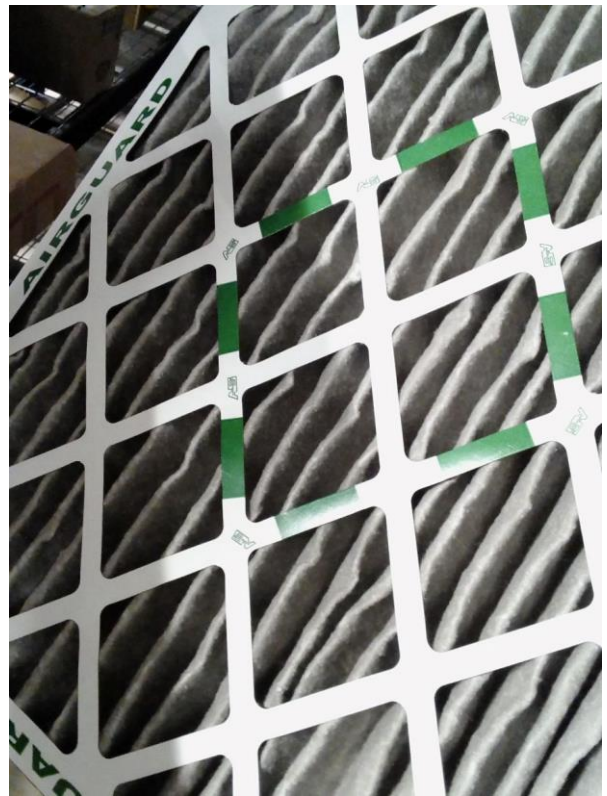
DOAS-B1

Filter Type - Outdoor <ul style="list-style-type: none"> Pre-filter: None Main filter: Pleated, MERV 13 	<p>Outdoor air intake is in good condition.</p>	<p>Drain pans are not plugged. Drain pan condition is good.</p> <p>Heating coils are clean and cooling coils are clean.</p> <p>Heat wheels are clean.</p> <p>Exterior ducting is visible. Exterior ducting insulation is in good condition.</p> <p>Interior ducting is visible. Interior ducting insulation is not present. Interior ducting is clean.</p> <p>Air handling room is free of trash/chemicals.</p> <p>Outside damper is open, and its condition is good.</p> <p>Return damper is open, and its condition is good.</p> <p>The general condition of the unit is good.</p>
Filter Type - Return <ul style="list-style-type: none"> Pre-filter: None Main filter: Pleated, MERV 13

Outdoor Main Filter Cleanliness

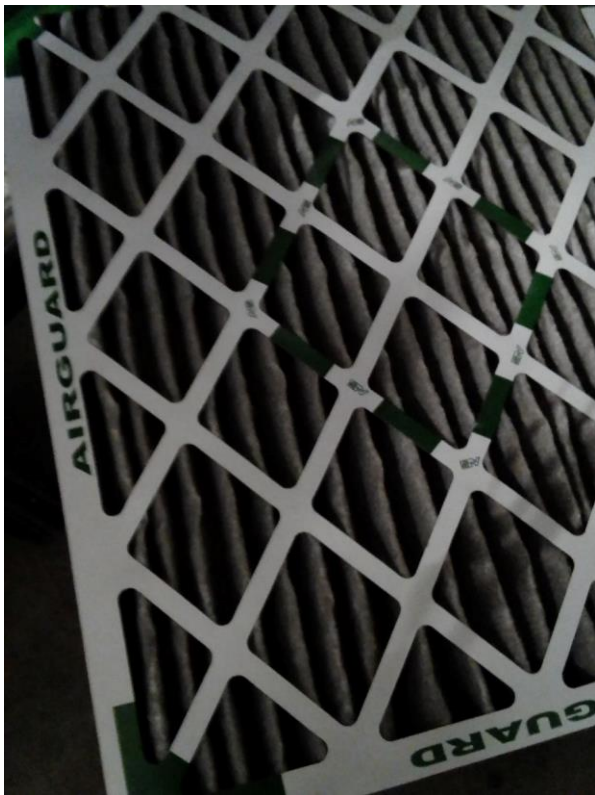
Unit Designation:	DOAS-B1	
Location of Unit:	Mechanical room 256	
Areas Served:	See attached map Area B, 1st Floor VAVs	
System Enhancements:	None	
Supply System	Outdoor Air	Cleanliness and Observations
Type <ul style="list-style-type: none"> Supply System - VAV Heating - Hot Water Cooling - Dx Energy Recovery Unit (ERU) - Wheel 	<p>Outdoor air intake is inaccessible</p> <p>Outdoor air intake is located in an unknown location.</p> <p>It is not known if there are nearby pollution sources.</p>	<p>Outdoor air pre-filters are not present. Outdoor air main filters are somewhat dirty and on the border of needing replacement (scoring 3 out of 5) and fit well. Outdoor air main filters are installed correctly.</p> <p>Return air pre-filters are not present. Return air main filters are somewhat dirty and on the border of needing replacement (scoring 3 out of 5) and fit well. Return air main filters are installed correctly.</p>

Return Main Filter Cleanliness

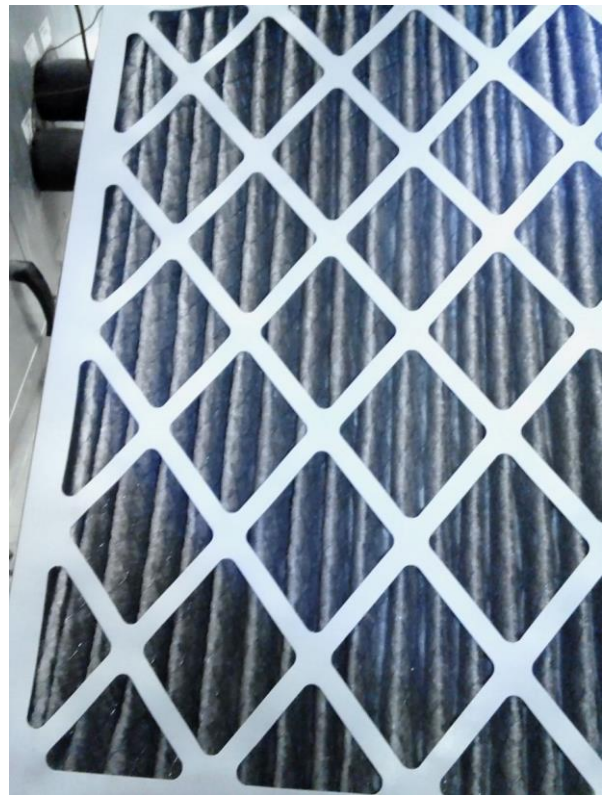
DOAS-B1

Mixed Main Filter Cleanliness

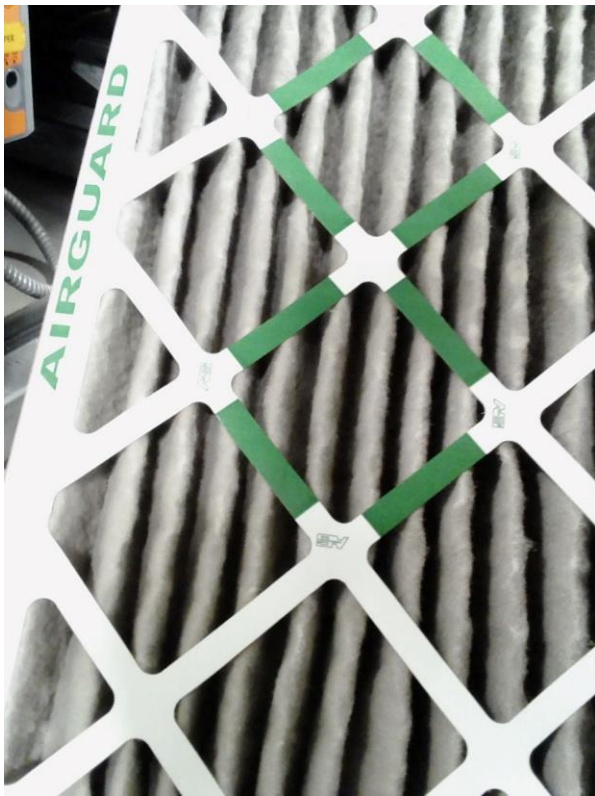
Unit Designation:	AHU-B2	
Location of Unit:	Mechanical room 257	
Areas Served:	See attached map Multi Use Room Lower Level	
System Enhancements:	None	
Supply System	Outdoor Air	Cleanliness and Observations
Type <ul style="list-style-type: none"> Supply System - Constant Volume Heating - Hot Water Cooling - None Energy Recovery Unit (ERU) - None 	Outdoor air intake is inaccessible Outdoor air intake is located in an unknown location. It is not known if there are nearby pollution sources.	Outdoor air filters are not present. Return air filters are not present. Mixed air pre-filters are not present. Mixed air main filters are somewhat dirty and on the border of needing replacement (scoring 3 out of 5) and fit well. Mixed air main filters are installed correctly. Drain pans are not applicable or not present. Drain pan condition is not known.
Filter Type - Mixed <ul style="list-style-type: none"> Pre-filter: None Main filter: Pleated, MERV 13 	Outdoor air intake is in good condition.	Heating coils are clean. Heat wheels are not present. Exterior ducting is visible. Exterior ducting insulation is in good condition. Interior ducting is visible. Interior ducting insulation is not present. Interior ducting is clean. Air handling room is free of trash/chemicals. Outside damper is open, and its condition is good. Return damper is open, and its condition is good. The general condition of the unit is good.

Mixed Main Filter Cleanliness

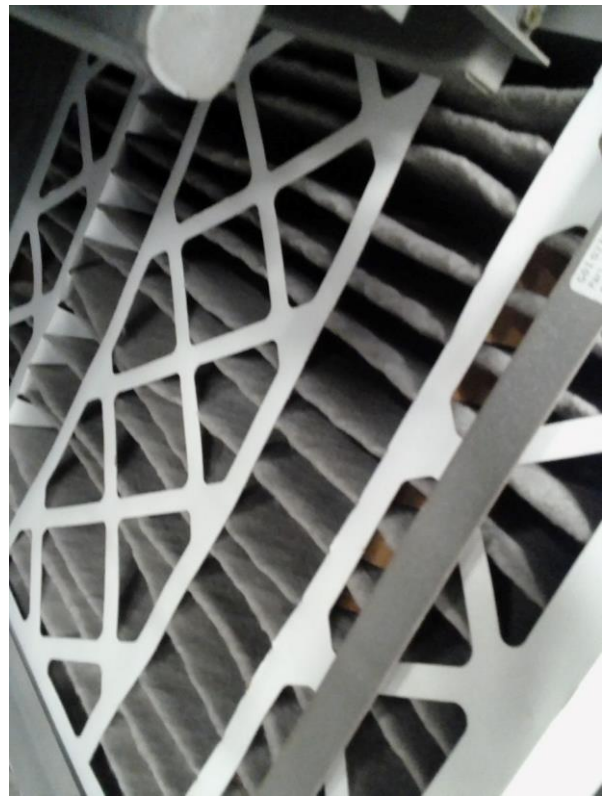
Unit Designation:	AHU-B3	
Location of Unit:	Mechanical room 2114	
Areas Served:	See attached map Area B, 2nd Floor VAVs	
System Enhancements:	None	
Supply System	Outdoor Air	Cleanliness and Observations
Type <ul style="list-style-type: none"> • Supply System - VAV • Heating - Hot Water • Cooling - Dx • Energy Recovery Unit (ERU) - None 	<p>Outdoor air intake is accessible</p> <p>Outdoor air intake is located in an unknown location.</p> <p>It is not known if there are nearby pollution sources.</p>	<p>Outdoor air filters are not present.</p> <p>Return air filters are not present.</p> <p>Mixed air pre-filters are not present. Mixed air main filters are somewhat dirty and on the border of needing replacement (scoring 3 out of 5) and fit well. Mixed air main filters are installed correctly.</p> <p>Drain pans are not plugged. Drain pan condition is good.</p>
Filter Type - Mixed <ul style="list-style-type: none"> • Pre-filter: None • Main filter: Pleated, MERV 13 	<p>Outdoor air intake is in good condition.</p>	<p>Heating coils are clean and cooling coils are clean.</p> <p>Heat wheels are not present.</p> <p>Exterior ducting is visible. Exterior ducting insulation is in good condition.</p> <p>Interior ducting is visible. Interior ducting insulation is not present. Interior ducting is clean.</p> <p>Air handling room is free of trash/chemicals.</p> <p>Outside damper is open, and its condition is good.</p> <p>Return damper is closed, and its condition is good.</p> <p>The general condition of the unit is good.</p>

Mixed Main Filter Cleanliness

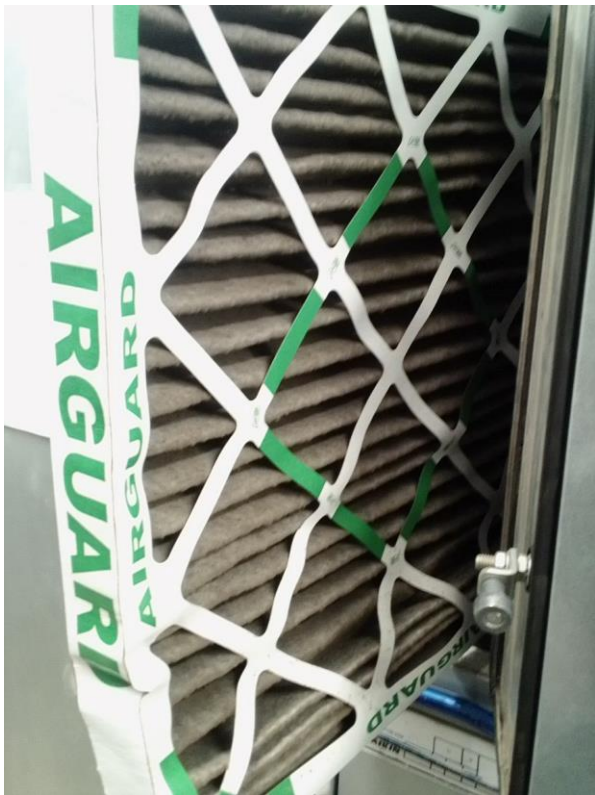
DOAS-A1

Outdoor Main Filter Cleanliness

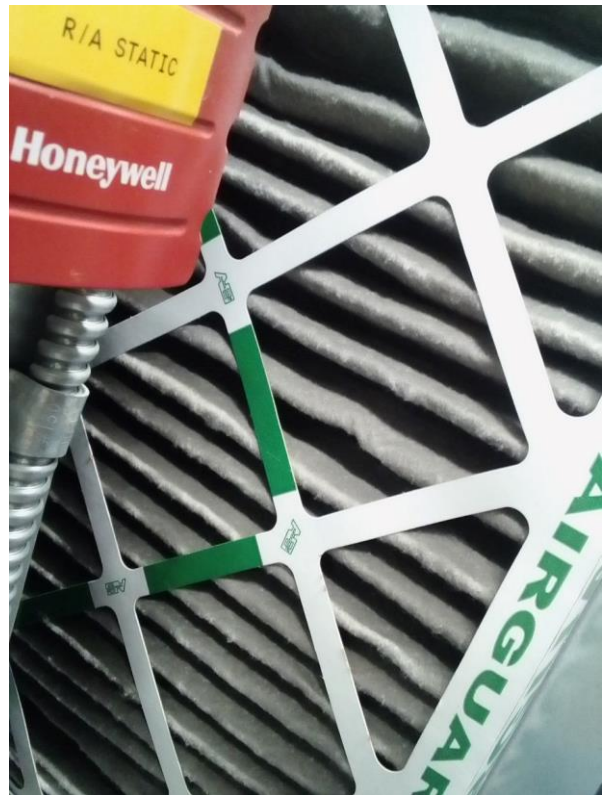
DOAS-A1

Return Main Filter Cleanliness

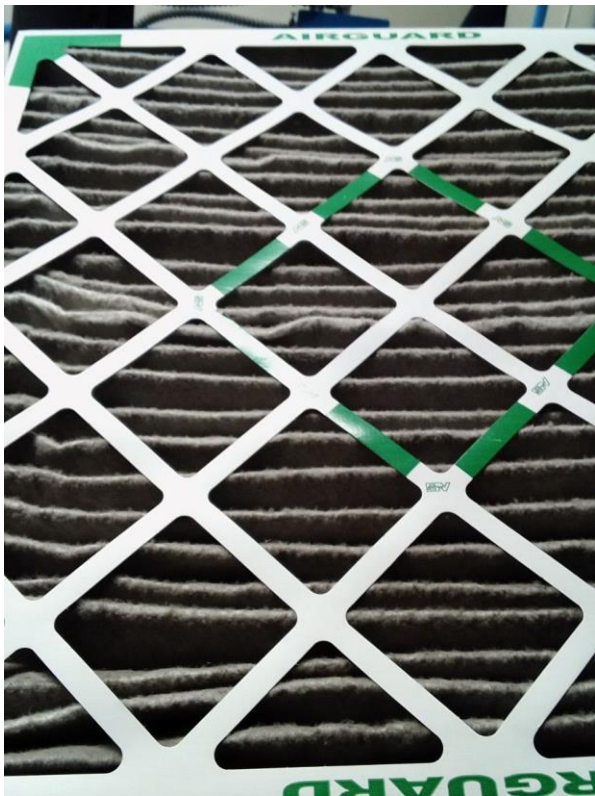
AHU-B1

Mixed Pre-Filter Cleanliness

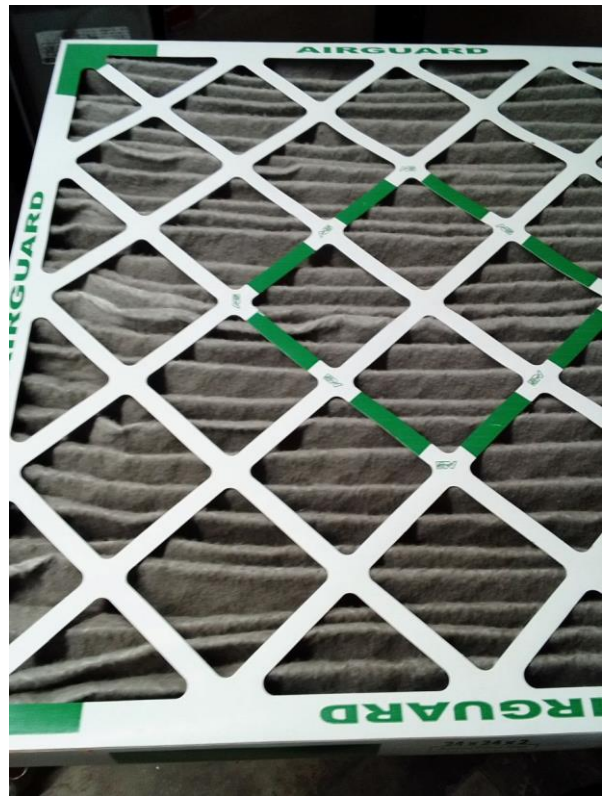
Unit Designation:	AHU-B1	
Location of Unit:	Mechanical room 255	
Areas Served:	See attached map 1st Floor East Classrooms	
System Enhancements:	None	
Supply System	Outdoor Air	Cleanliness and Observations
Type <ul style="list-style-type: none"> Supply System - Constant Volume Heating - Hot Water Cooling - Dx Energy Recovery Unit (ERU) - None 	<p>Outdoor air intake is accessible</p> <p>Outdoor air intake is located in an unknown location.</p> <p>It is not known if there are nearby pollution sources.</p>	<p>Outdoor air filters are not present.</p> <p>Return air filters are not present.</p> <p>Mixed air pre-filters are not present. Mixed air main filters are somewhat dirty and on the border of needing replacement (scoring 3 out of 5) and fit well. Mixed air main filters are installed correctly.</p> <p>Drain pans are not plugged. Drain pan condition is good.</p>
Filter Type - Mixed <ul style="list-style-type: none"> Pre-filter: None Main filter: Pleated, MERV 13 	<p>Outdoor air intake is in good condition.</p>	<p>Heating coils are clean and cooling coils are clean.</p> <p>Heat wheels are not present.</p> <p>Exterior ducting is visible. Exterior ducting insulation is in good condition.</p> <p>Interior ducting is visible. Interior ducting insulation is not present. Interior ducting is clean.</p> <p>Air handling room is free of trash/chemicals.</p> <p>Outside damper is open, and its condition is good.</p> <p>Return damper is closed, and its condition is good.</p> <p>The general condition of the unit is good.</p>

Mixed Main Filter Cleanliness

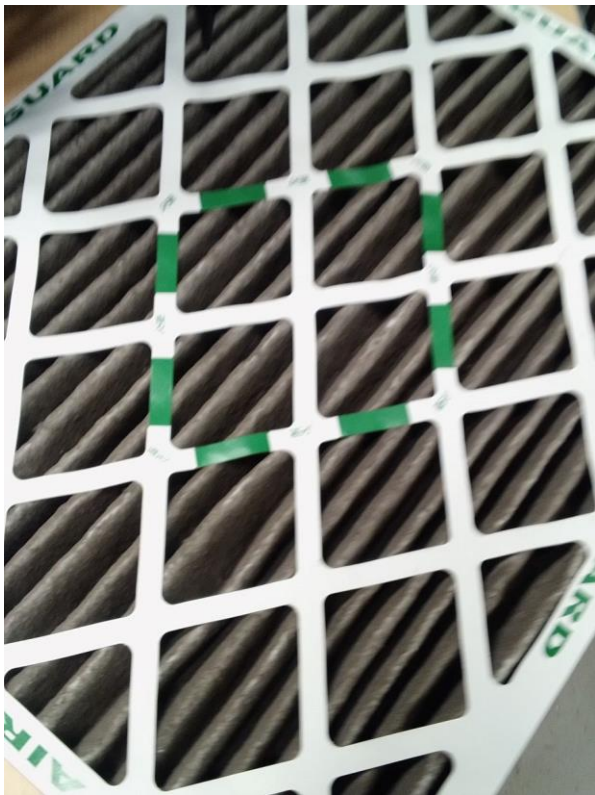
DOAS-B2

Outdoor Main Filter Cleanliness

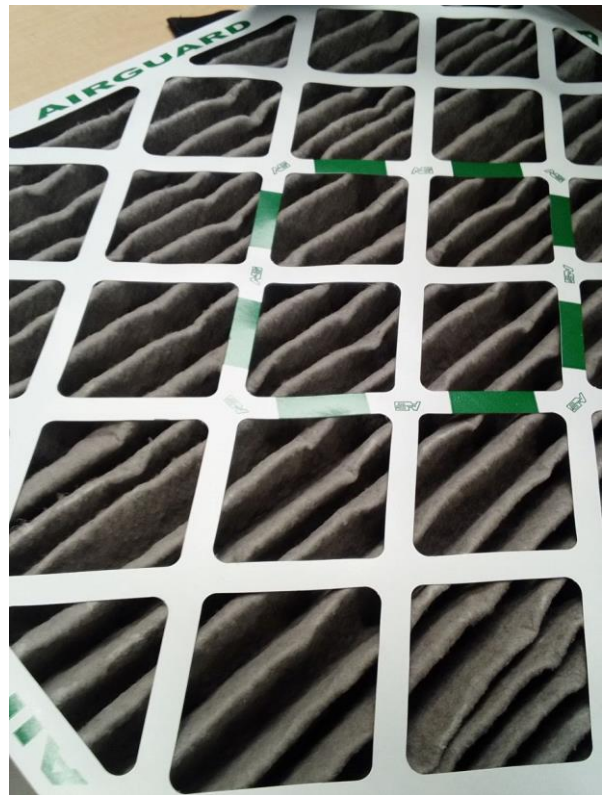
DOAS-B2

Return Main Filter Cleanliness

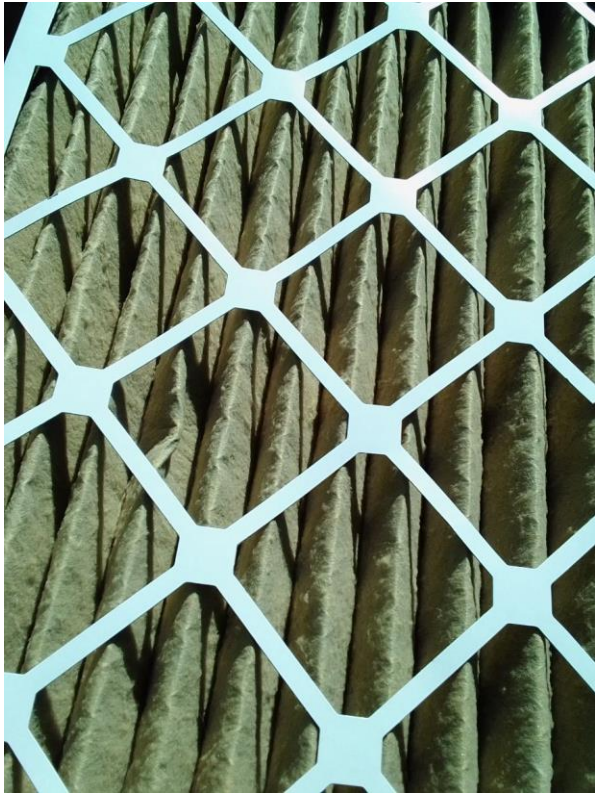
Unit Designation:	RTU-01	
Location of Unit:	Roof over library	
Areas Served:	See attached map Area C Main Level West	
System Enhancements:	None	
Supply System	Outdoor Air	Cleanliness and Observations
Type <ul style="list-style-type: none"> • Supply System - Constant Volume • Heating - Hot Water • Cooling - None • Energy Recovery Unit (ERU) - None 	<p>Outdoor air intake is accessible</p> <p>Outdoor air intake is located on the roof.</p> <p>No nearby pollution sources were found.</p>	<p>Outdoor air filters are not present.</p> <p>Return air filters are not present.</p> <p>Mixed air pre-filters are not present. Mixed air main filters are somewhat dirty and on the border of needing replacement (scoring 3 out of 5) and fit well. Mixed air main filters are installed correctly.</p> <p>Drain pans are not applicable or not present. Drain pan condition is not known.</p>
Filter Type - Mixed <ul style="list-style-type: none"> • Pre-filter: None • Main filter: Pleated, MERV 11 	<p>Outdoor air intake is in good condition.</p>	<p>Heating coils are clean.</p> <p>Heat wheels are not present.</p> <p>Exterior ducting is visible. Exterior ducting insulation is not present.</p> <p>Interior ducting is not visible. Interior ducting insulation is in an unknown condition. Interior ducting is of unknown cleanliness.</p> <p>Air handling room is free of trash/chemicals.</p> <p>Outside damper is open, and its condition is good.</p> <p>Return damper is closed, and its condition is good.</p> <p>The general condition of the unit is good.</p>

Mixed Main Filter Cleanliness

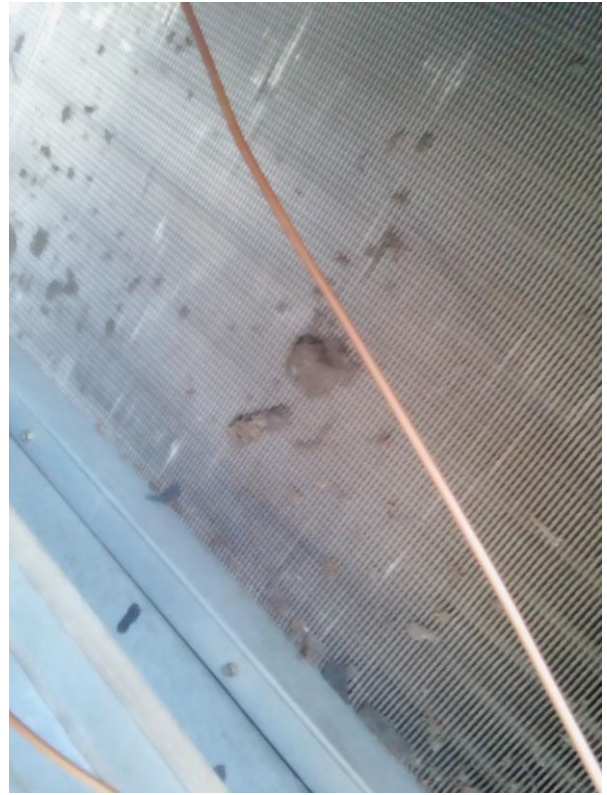
Dirty Coils were observed on unit RTU-02 during the ventilation inspection.

Heating Coils

Recommendation: Impacted/dirty coils can result in poor ventilation air supply as well as be a source for mold and bacterial growth on the coils. Coils should be cleaned annually, or as needed, as identified in the operations and maintenance program.
