2022 - 2023 IAQ Walkthrough

Saint Paul Public Schools Highland Park Middle School

Walkthrough Date:
Friday, January 6, 2023

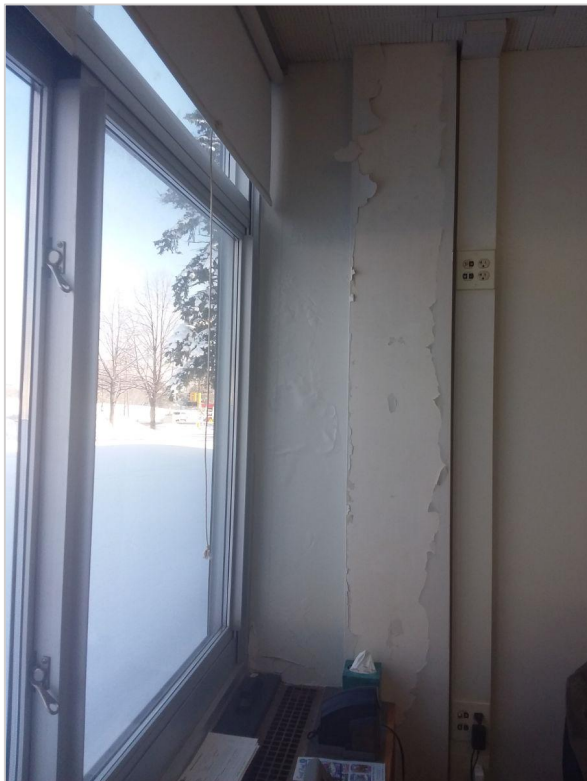
1405

Bubbling/Peeling Paint

IEA observed bubbling/peeling paint in area(s) within the room(s) listed below. Bubbling/peeling paint can be caused by moisture issues. IEA recommends investigating the cause and repairing the paint. IEA recommends ensuring that the paint is not lead-based prior to disturbance.

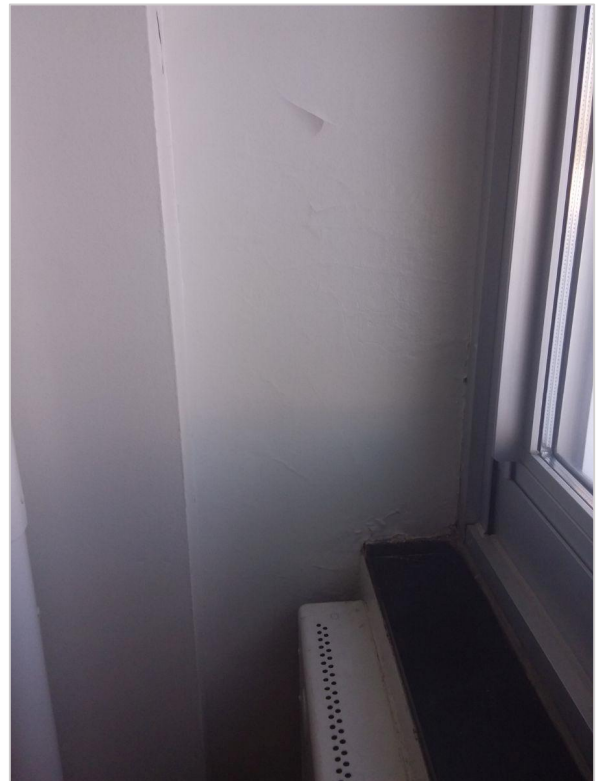
1403

Bubbling/Peeling Paint

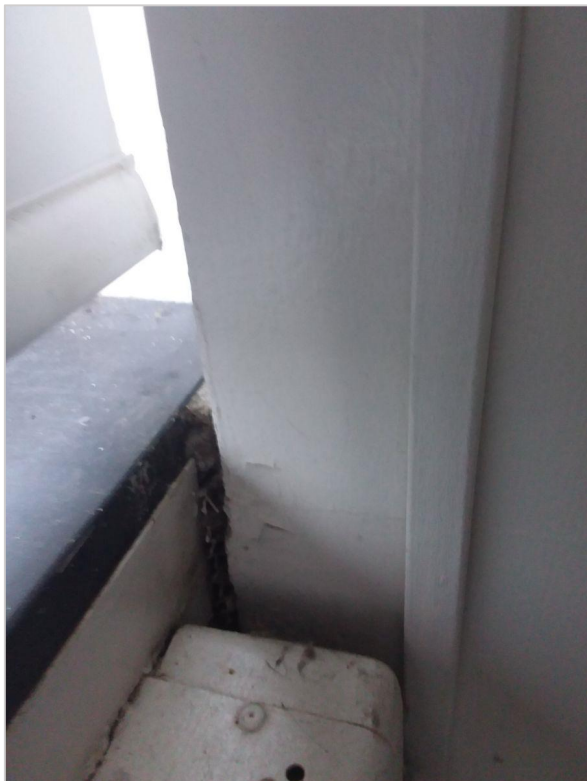
1409

Bubbling/Peeling Paint

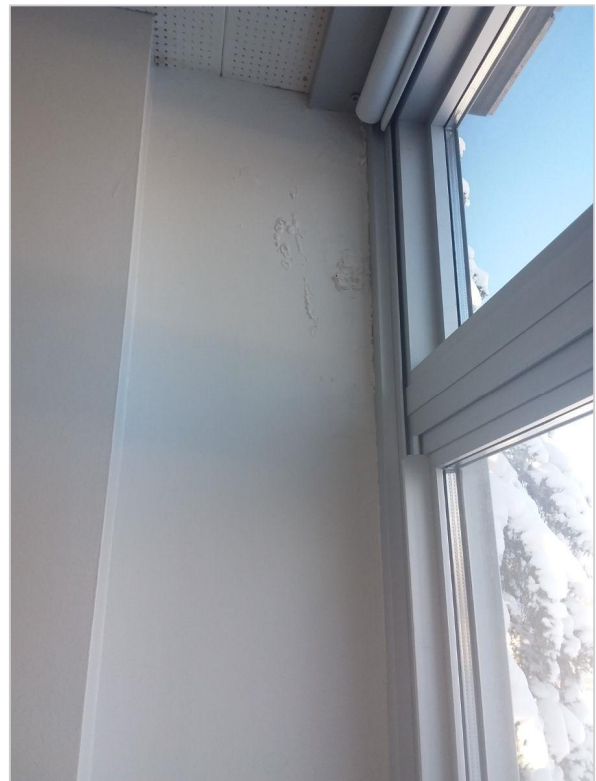
2417

Bubbling/Peeling Paint

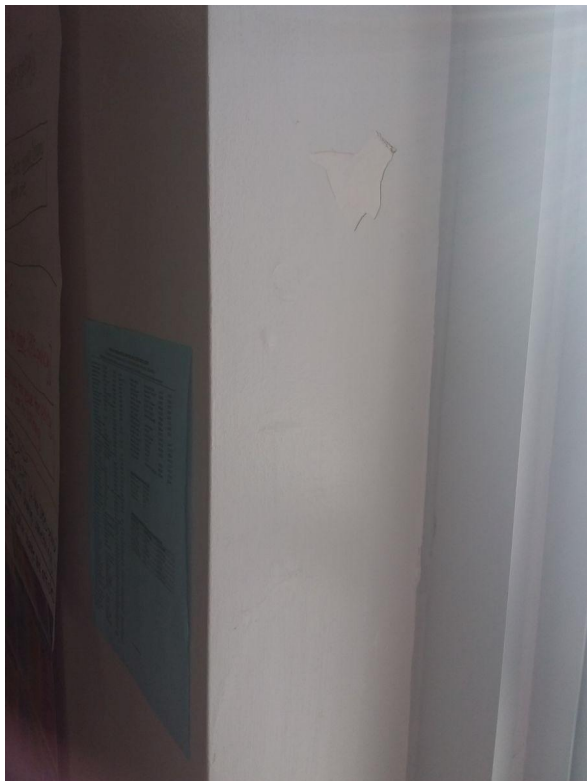
2410

Bubbling/Peeling Paint

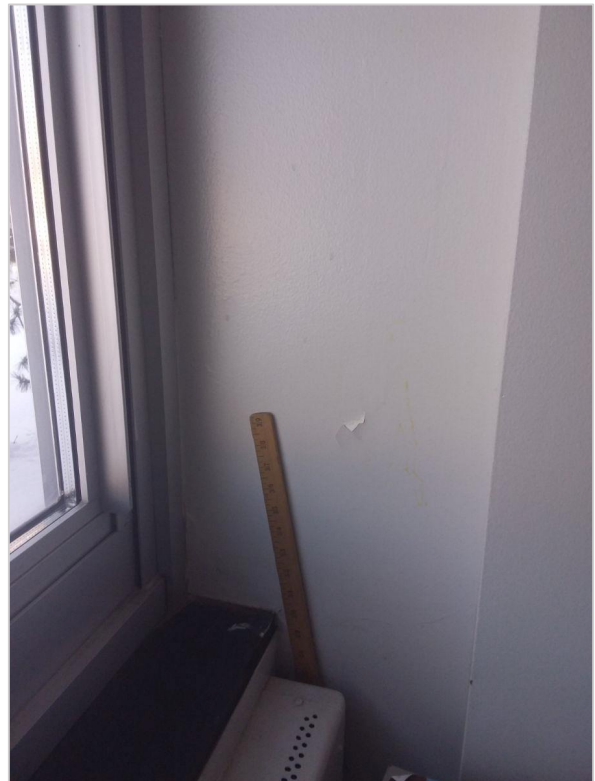
2413

Bubbling/Peeling Paint

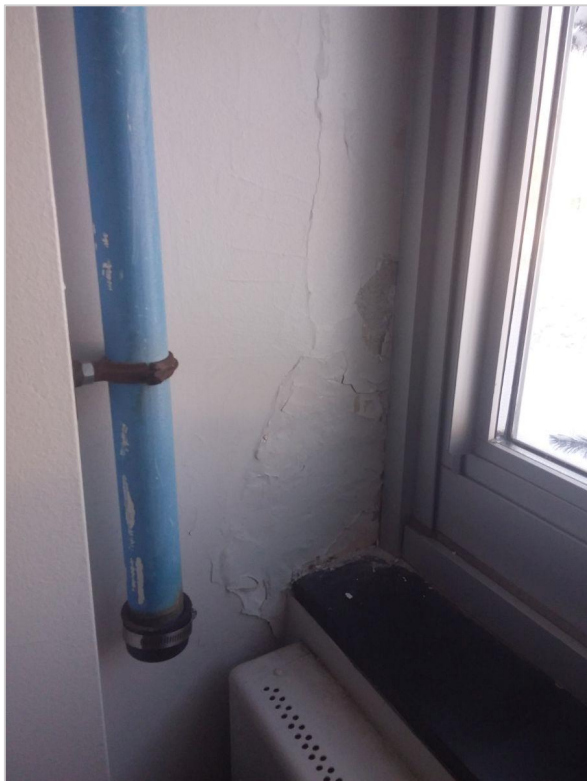
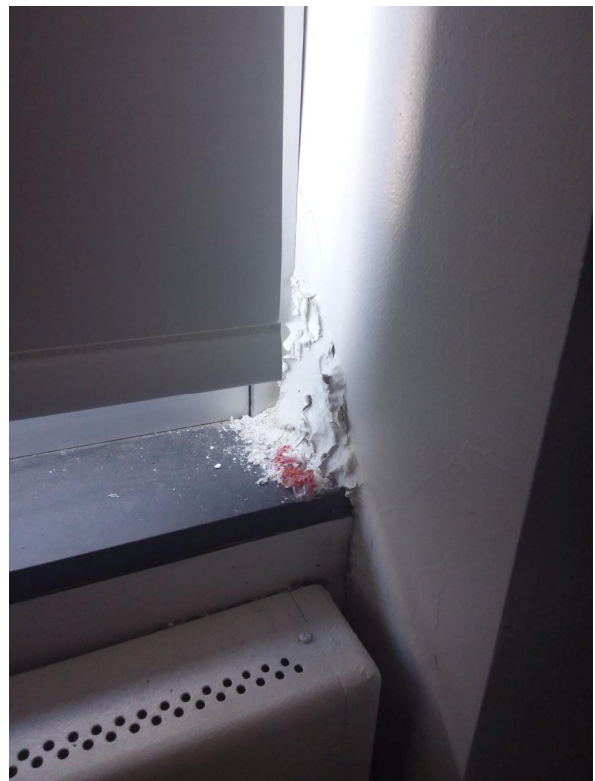
2411

Bubbling/Peeling Paint

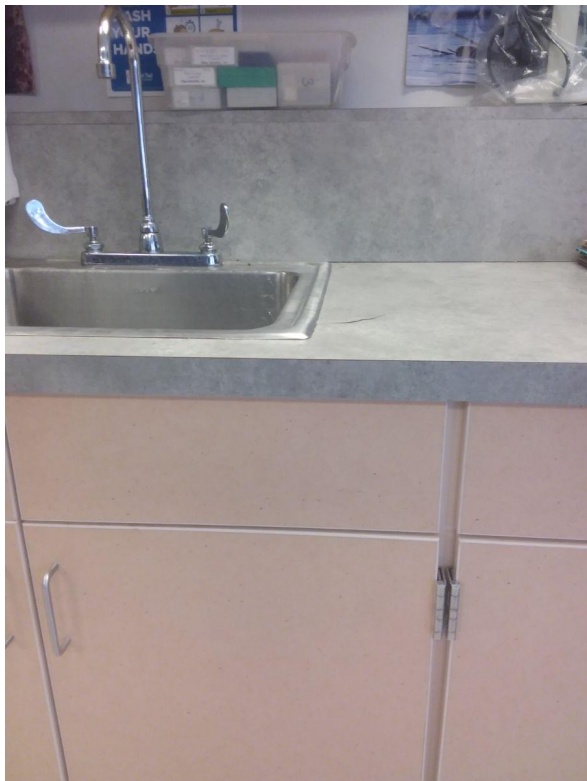
2411

Moisture Impacted Materials

Moisture-impacted building materials should be repaired or replaced when discoloration or water staining is observed. Moisture-impacted building materials can be a source for microbial growth. The source for the moisture infiltration should be investigated and repaired if not easily identified.

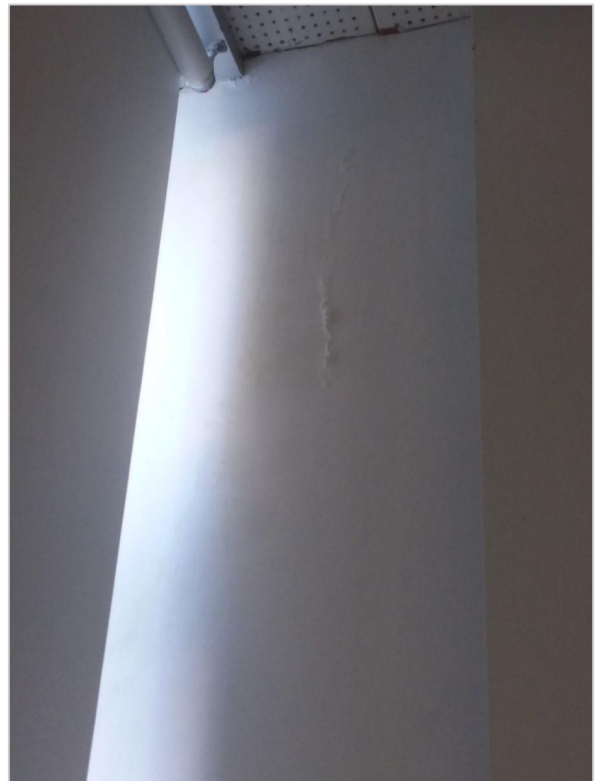
2403

Bubbling/Peeling Paint

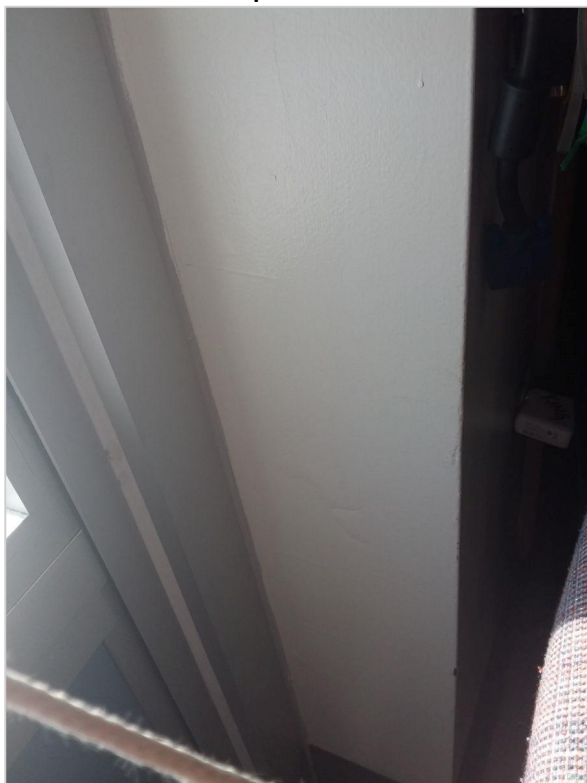
2406

Bubbling/Peeling Paint

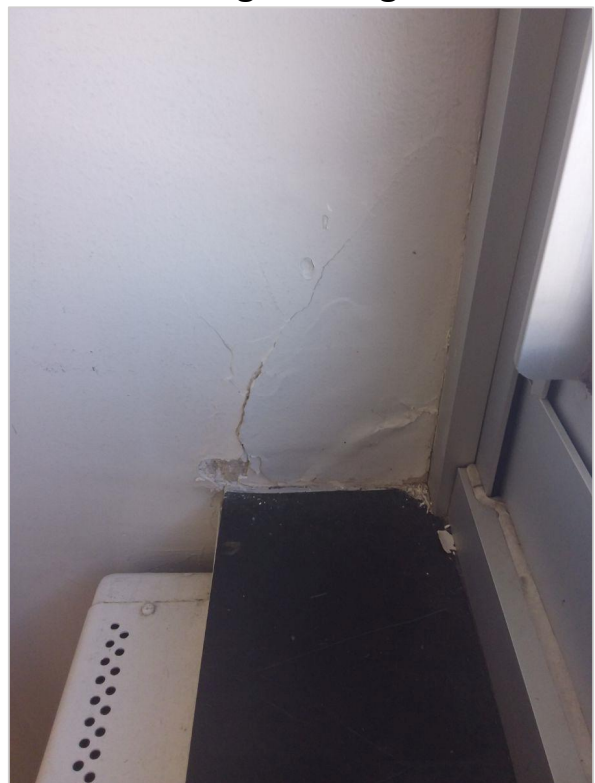
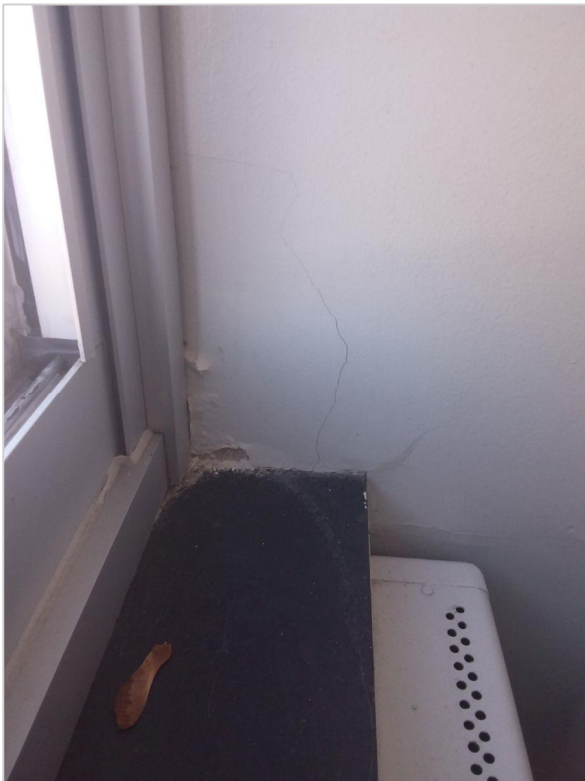
3403

Moisture Impacted Materials

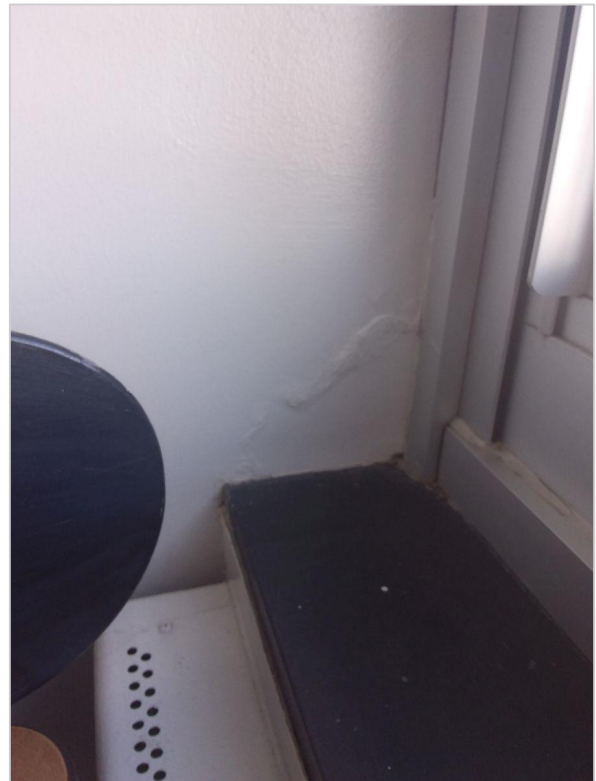
3405

Bubbling/Peeling Paint

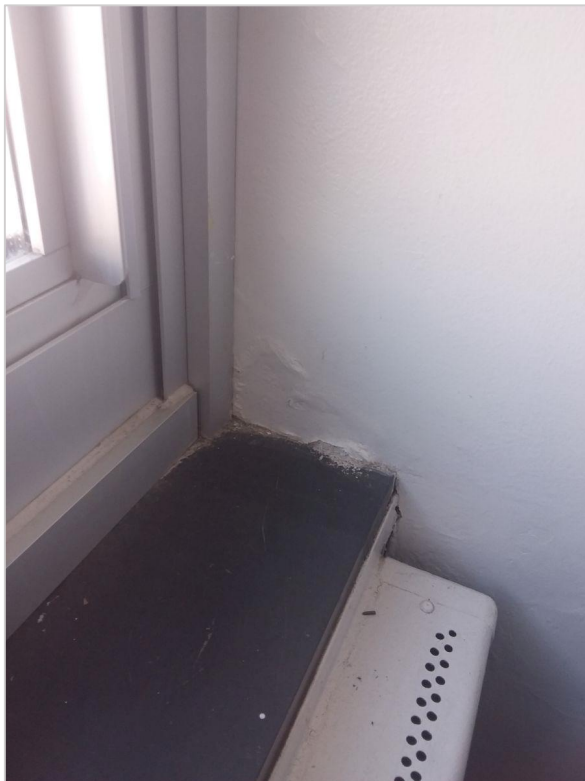
3407

Bubbling/Peeling Paint

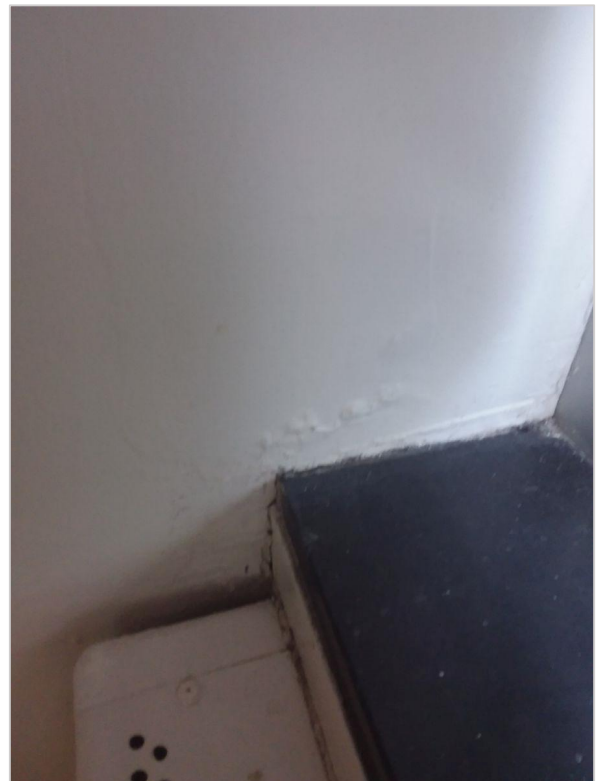
3411

Bubbling/Peeling Paint

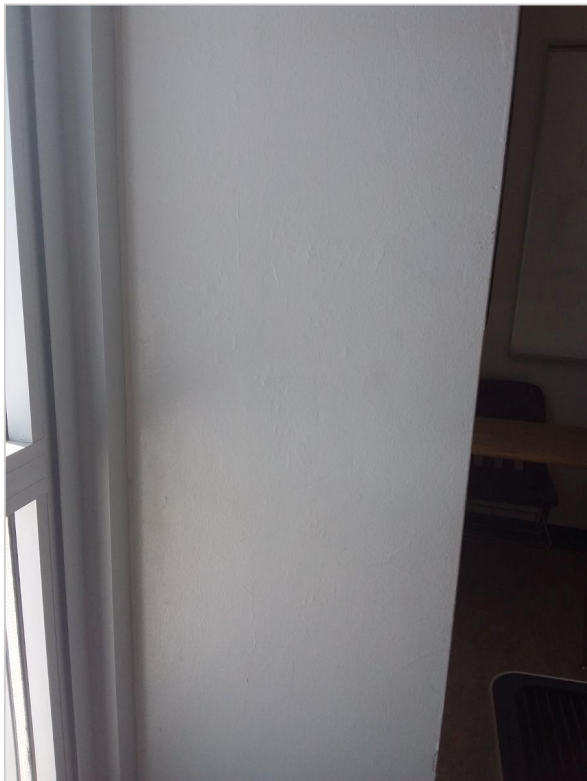
3410
Bubbling/Peeling Paint

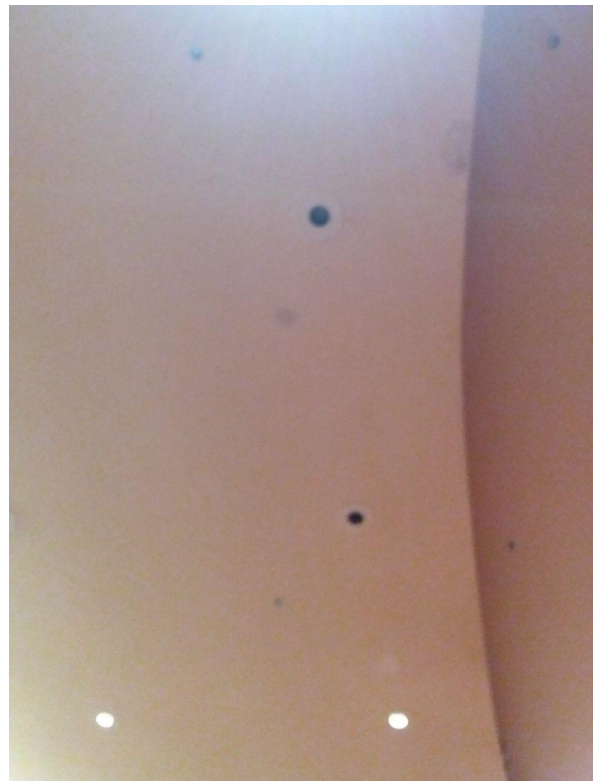
AUDITORIUM
Moisture Impacted Materials

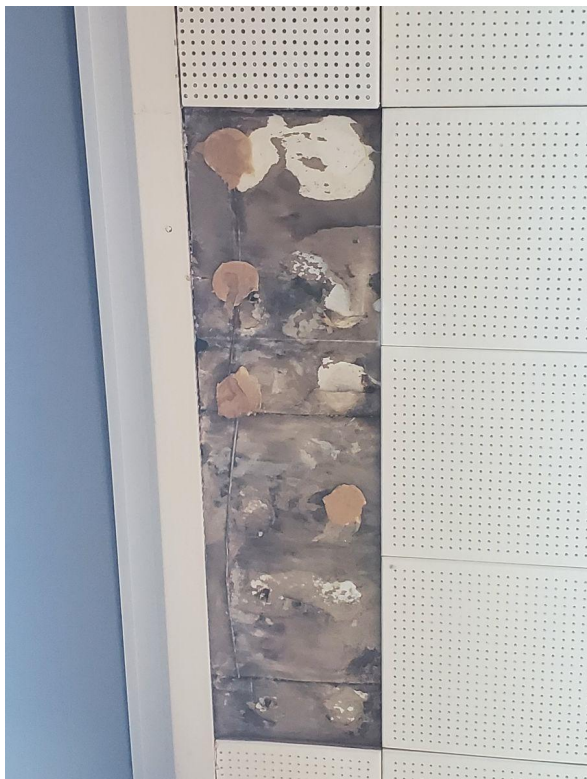
- 1112 *Suspect growth where missing tiles*
- CAFETERIA *were.*
- CAFETERIA *Along the east wall of the cafeteria*

1112 CAFETERIA
Suspect Microbial Growth

IEA observed building materials with possible microbial growth that should be removed and/or cleaned under controlled conditions, per the Minnesota Department of Health *Recommended Best Practices for Mold Remediation in Minnesota Schools* guidelines (<https://www.health.state.mn.us/communities/environment/air/docs/schools/remediation.pdf>) or following the Institute of Inspection, Cleaning and Restoration (IICRC) S520 Standard and Guide for Professional Mold Remediation to prevent possible contamination of adjacent locations and impact to building occupants. Further assessment or fungal sampling may be necessary to identify a scope of work for a professional mold remediation contractor.
