## 2023 - 2024 Ventilation Assessment

## Saint Paul Public Schools Highland Park Middle School

Assessment Date:  
Tuesday, April 25, 2023

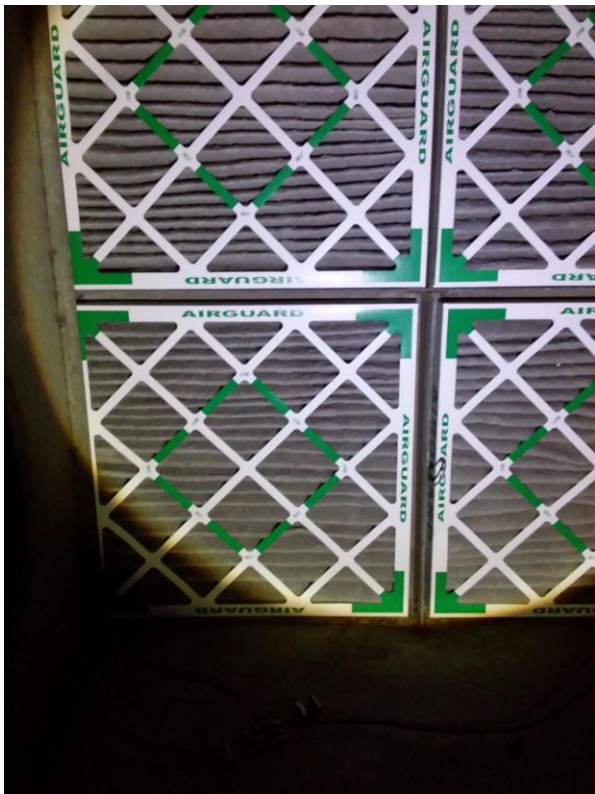
<b>Unit Designation:</b>	AHU 01	
<b>Location of Unit:</b>	Mechanical room WEST TUNNEL	
<b>Areas Served:</b>	131,313,151,319 See attached map	
<b>System Enhancements:</b>	None	
<b>Supply System</b>	<b>Outdoor Air</b>	<b>Cleanliness and Observations</b>
<b>Type</b> <ul style="list-style-type: none"> <li>Supply System - Constant Volume</li> <li>Heating - Hot Water</li> <li>Cooling - None</li> <li>Energy Recovery Unit (ERU) - None</li> </ul>	Outdoor air intake is inaccessible  Outdoor air intake is located in an unknown location.  It is not known if there are nearby pollution sources.	Outdoor air filters are not present.  Return air filters are not present.  Mixed air pre-filters are not present. Mixed air main filters are somewhat dirty and on the border of needing replacement (scoring 3 out of 5) and fit well. Mixed air main filters are installed correctly.  Drain pans are not applicable or not present. Drain pan condition is not known.

<b>Filter Type - Mixed</b> <ul style="list-style-type: none"> <li>Pre-filter: None</li> <li>Main filter: Pleated, MERV 11</li> </ul>	Outdoor air intake is in good condition.	Heating coils are clean.  Heat wheels are not present.  Exterior ducting is visible. Exterior ducting insulation is not present.  Interior ducting is not visible. Interior ducting insulation is in an unknown condition. Interior ducting is of unknown cleanliness.  Air handling room is free of trash/chemicals.  Outside damper is inaccessible, and its condition is not known.  Return damper is inaccessible, and its condition is not known.  The general condition of the unit is good.

Mixed Main Filter Cleanliness

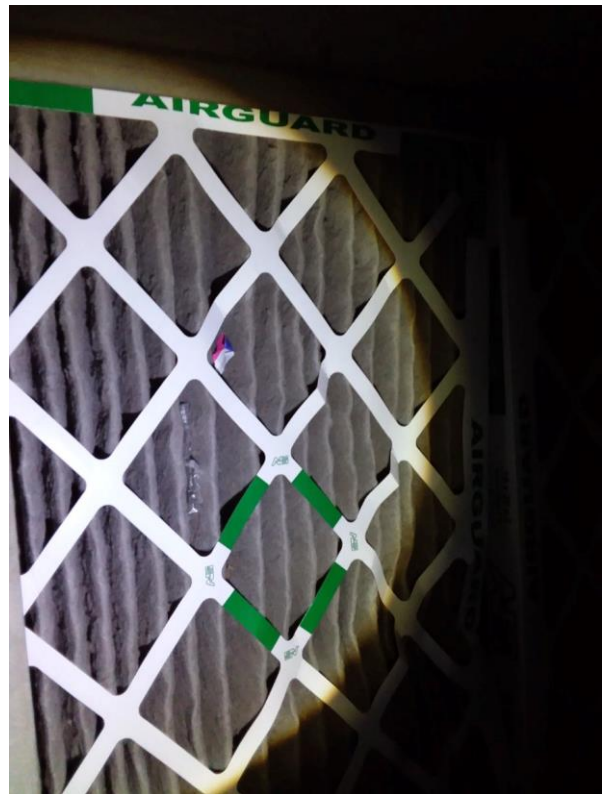
<b>Unit Designation:</b>	AHU 02	
<b>Location of Unit:</b>	Mechanical room WEST TUNNEL	
<b>Areas Served:</b>	1311,1317,1309,1307,1305,1505B See attached map	
<b>System Enhancements:</b>	None	
<b>Supply System</b>	<b>Outdoor Air</b>	<b>Cleanliness and Observations</b>
<b>Type</b> <ul style="list-style-type: none"> <li>Supply System - Constant Volume</li> <li>Heating - Hot Water</li> <li>Cooling - None</li> <li>Energy Recovery Unit (ERU) - None</li> </ul>	<p>Outdoor air intake is inaccessible</p> <p>Outdoor air intake is located in an unknown location.</p> <p>It is not known if there are nearby pollution sources.</p>	<p>Outdoor air filters are not present.</p> <p>Return air filters are not present.</p> <p>Mixed air pre-filters are not present. Mixed air main filters are somewhat dirty and on the border of needing replacement (scoring 4 out of 5) and fit well. Mixed air main filters are installed correctly.</p> <p>Drain pans are not applicable or not present. Drain pan condition is not known.</p>

<b>Filter Type - Mixed</b> <ul style="list-style-type: none"> <li>Pre-filter: None</li> <li>Main filter: Pleated, MERV 11</li> </ul>	<p>Outdoor air intake is in good condition.</p>	<p>Heating coils are clean.</p> <p>Heat wheels are not present.</p> <p>Exterior ducting is visible. Exterior ducting insulation is not present.</p> <p>Interior ducting is visible. Interior ducting insulation is in good condition. Interior ducting is clean.</p> <p>Air handling room is free of trash/chemicals.</p> <p>Outside damper is inaccessible, and its condition is not known.</p> <p>Return damper is inaccessible, and its condition is not known.</p> <p>The general condition of the unit is good.</p>

Mixed Main Filter Cleanliness

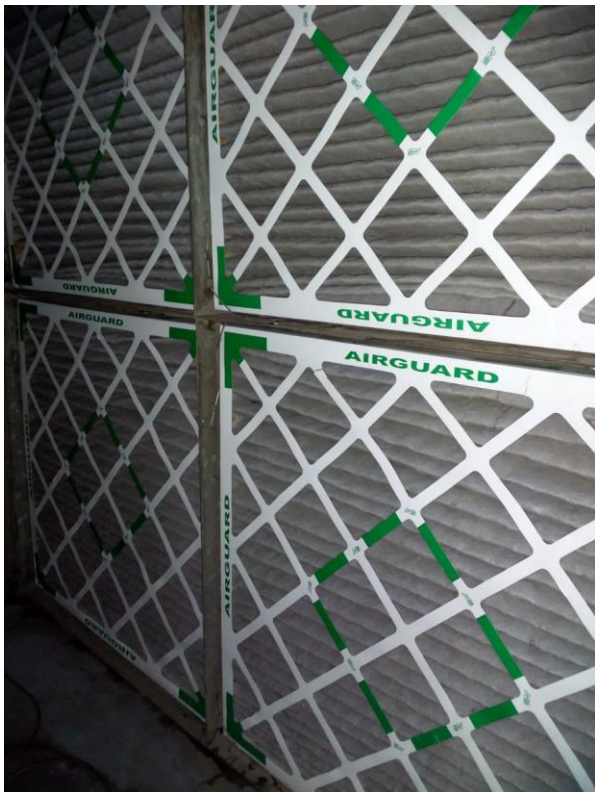
<b>Unit Designation:</b>	AHU 04	
<b>Location of Unit:</b>	Mechanical room N. PENTHOUSE	
<b>Areas Served:</b>	1,302,130,413,061,300 See attached map	
<b>System Enhancements:</b>	None	
<b>Supply System</b>	<b>Outdoor Air</b>	<b>Cleanliness and Observations</b>
<b>Type</b> <ul style="list-style-type: none"> <li>Supply System - Constant Volume</li> <li>Heating - Hot Water</li> <li>Cooling - None</li> <li>Energy Recovery Unit (ERU) - None</li> </ul>	Outdoor air intake is accessible  Outdoor air intake is located on an exterior wall.  No nearby pollution sources were found.	Outdoor air filters are not present.  Return air filters are not present.  Mixed air pre-filters are not present. Mixed air main filters are somewhat dirty and on the border of needing replacement (scoring 4 out of 5) and fit well. Mixed air main filters are installed correctly.  Drain pans are not applicable or not present. Drain pan condition is not known.

<b>Filter Type - Mixed</b> <ul style="list-style-type: none"> <li>Pre-filter: None</li> <li>Main filter: Pleated, MERV 11</li> </ul>	Outdoor air intake is in good condition.	Heating coils are clean.  Heat wheels are not present.  Exterior ducting is visible. Exterior ducting insulation is not present.  Interior ducting is not visible. Interior ducting insulation is in an unknown condition. Interior ducting is of unknown cleanliness.  Air handling room is free of trash/chemicals.  Outside damper is open, and its condition is good.  Return damper is open, and its condition is good.  The general condition of the unit is good.

Mixed Main Filter Cleanliness

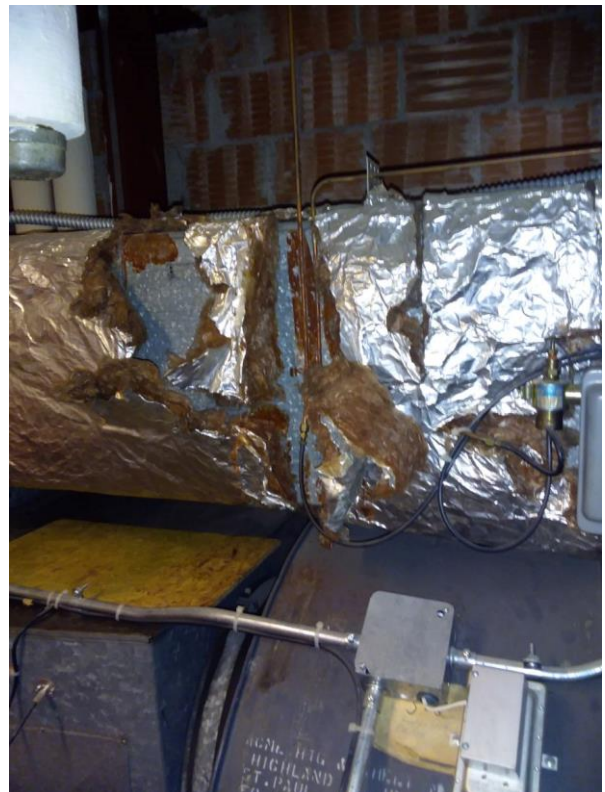
<b>Filter Type - Outdoor</b> <ul style="list-style-type: none"> <li>Pre-filter: None</li> <li>Main filter: Pleated, MERV 11</li> </ul>	<p>Outdoor air intake is in good condition.</p>	<p>Heat wheels are not present.</p> <p>Exterior ducting is not visible. Exterior ducting insulation is in an unknown condition.</p> <p>Interior ducting is not visible. Interior ducting insulation is in an unknown condition. Interior ducting is of unknown cleanliness.</p> <p>Air handling room is free of trash/chemicals.</p> <p>Outside damper is inaccessible, and its condition is not known.</p> <p>Return damper is not present.</p> <p>The general condition of the unit is poor.</p>

The general condition of units AHU 05 100% OA and AHU 11 was poor.

General Condition

**Recommendation:** The units should be repaired or cleaned as needed.

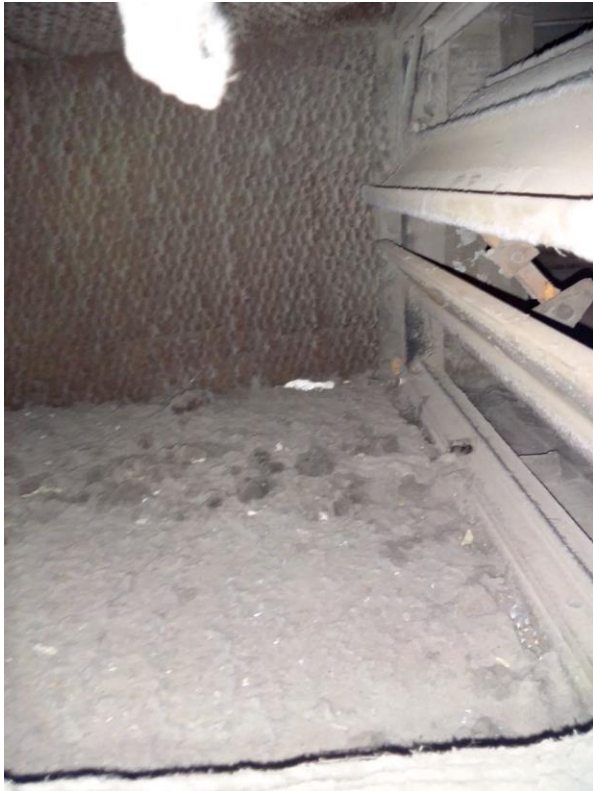
The accessible ductwork for unit AHU 06 was visibly dirty, damaged, or had evidence of moisture at the time of the site inspection.

AHU 06  
Interior Ducting

**Recommendation:** IEA recommends further inspection into the overall condition of the interior ductwork and level of dirt/debris quantified. If deemed a concern, it is recommended that the interior ducting be cleaned by a professional contractor to improve the impact on the IAQ for the supply spaces.

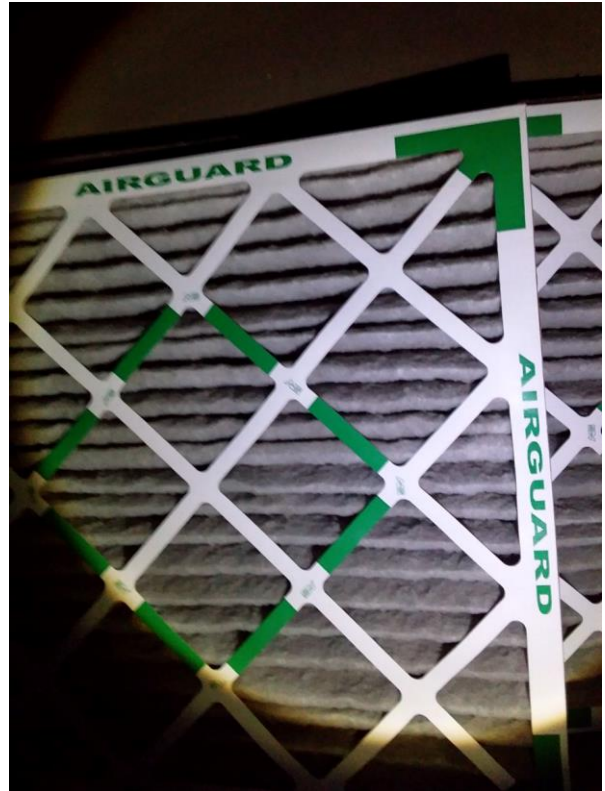
<b>Unit Designation:</b>	AHU 07	
<b>Location of Unit:</b>	Mechanical room N. PENTHOUSE	
<b>Areas Served:</b>	1209, 1210, 1211, 1212, 1213 See attached map	
<b>System Enhancements:</b>	None	
<b>Supply System</b>	<b>Outdoor Air</b>	<b>Cleanliness and Observations</b>
<b>Type</b> <ul style="list-style-type: none"> <li>Supply System - Constant Volume</li> <li>Heating - Hot Water</li> <li>Cooling - None</li> <li>Energy Recovery Unit (ERU) - None</li> </ul>	Outdoor air intake is accessible  Outdoor air intake is located on an exterior wall.  No nearby pollution sources were found.	Outdoor air filters are not present.  Return air filters are not present.  Mixed air pre-filters are not present. Mixed air main filters are somewhat dirty and on the border of needing replacement (scoring 3 out of 5) and fit well. Mixed air main filters are installed correctly.  Drain pans are not applicable or not present. Drain pan condition is not known.

<b>Filter Type - Mixed</b> <ul style="list-style-type: none"> <li>Pre-filter: None</li> <li>Main filter: Pleated, MERV 11</li> </ul>	Outdoor air intake is in good condition.	Heating coils are clean.  Heat wheels are not present.  Exterior ducting is visible. Exterior ducting insulation is not present.  Interior ducting is not visible. Interior ducting insulation is in an unknown condition. Interior ducting is of unknown cleanliness.  Air handling room is free of trash/chemicals.  Outside damper is inaccessible, and its condition is not known.  Return damper is inaccessible, and its condition is not known.  The general condition of the unit is good.

AHU 07  
Mixed Main Filter Cleanliness

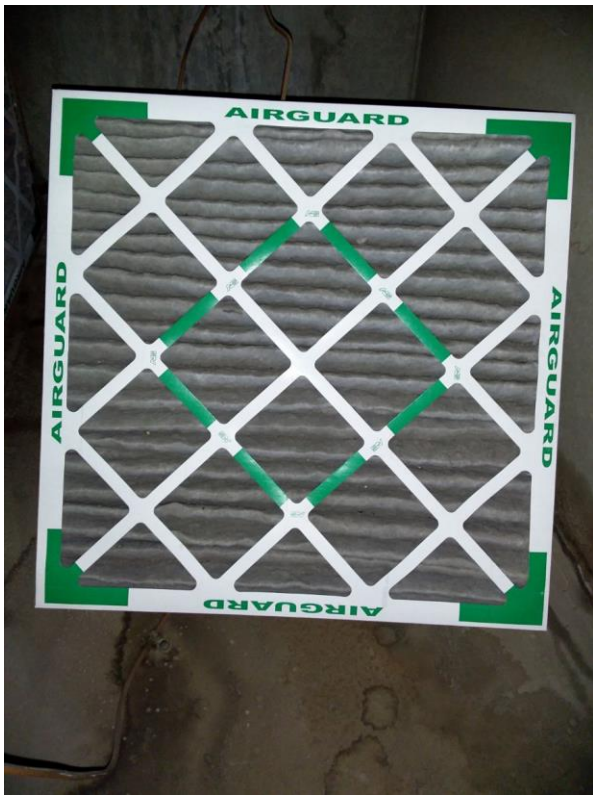
<b>Unit Designation:</b>	AHU 08	
<b>Location of Unit:</b>	Mechanical room N. PENTHOUSE	
<b>Areas Served:</b>	1208 See attached map	
<b>System Enhancements:</b>	None	
<b>Supply System</b>	<b>Outdoor Air</b>	<b>Cleanliness and Observations</b>
<b>Type</b> <ul style="list-style-type: none"> <li>Supply System - Constant Volume</li> <li>Heating - Hot Water</li> <li>Cooling - None</li> <li>Energy Recovery Unit (ERU) - None</li> </ul>	Outdoor air intake is accessible  Outdoor air intake is located on an exterior wall.  No nearby pollution sources were found.	Outdoor air filters are not present.  Return air filters are not present.  Mixed air pre-filters are not present. Mixed air main filters are somewhat dirty and on the border of needing replacement (scoring 3 out of 5) and fit well. Mixed air main filters are installed correctly.  Drain pans are not applicable or not present. Drain pan condition is not known.

<b>Filter Type - Mixed</b> <ul style="list-style-type: none"> <li>Pre-filter: None</li> <li>Main filter: Pleated, MERV 11</li> </ul>	Outdoor air intake is in good condition.	Heating coils are clean.  Heat wheels are not present.  Exterior ducting is not visible. Exterior ducting insulation is in an unknown condition.  Interior ducting is not visible. Interior ducting insulation is in an unknown condition. Interior ducting is of unknown cleanliness.  Air handling room is free of trash/chemicals.  Outside damper is open, and its condition is good.  Return damper is inaccessible, and its condition is not known.  The general condition of the unit is good.

AHU 08  
Mixed Main Filter Cleanliness

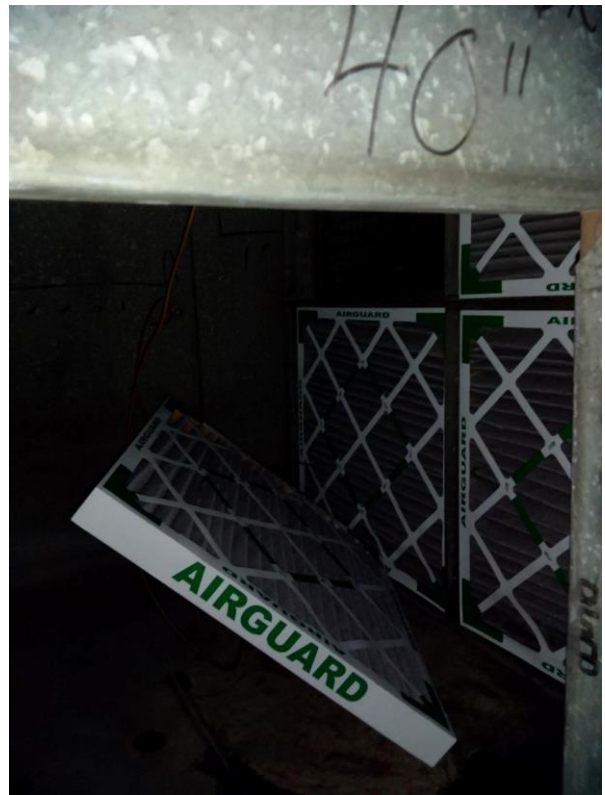
Dirty or poorly fitting filters were observed in unit AHU 10 during the ventilation inspection.

AHU 10  
Mixed Main Filter Installation

**Recommendation:** The operations and maintenance program for filter changes should be reviewed and revised to ensure proper filter changes to optimize filtration capacity.

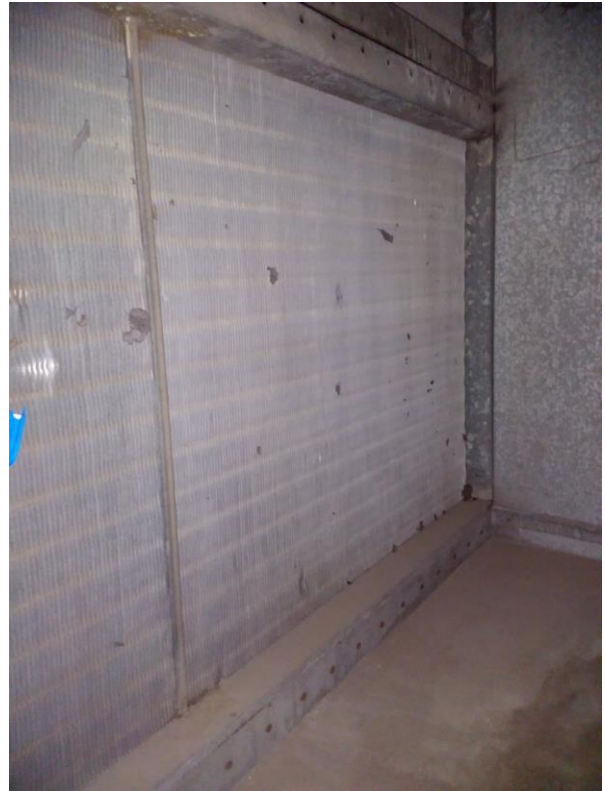
Dirty Coils were observed on units AHU 12, RTU 03 and RTU 04 during the ventilation inspection.

AHU 12  
Heating Coils

**Recommendation:** Impacted/dirty coils can result in poor ventilation air supply as well as be a source for mold and bacterial growth on the coils. Coils should be cleaned annually, or as needed, as identified in the operations and maintenance program.

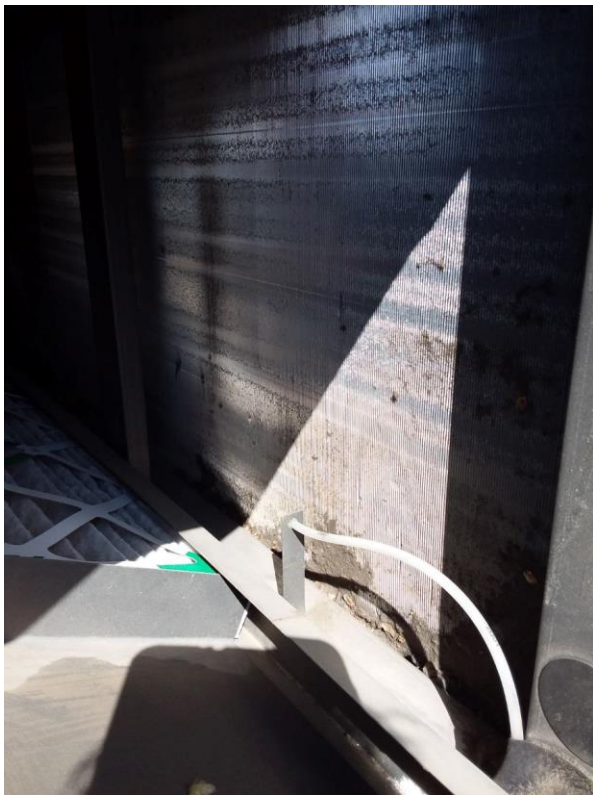
RTU 03  
Heating Coils

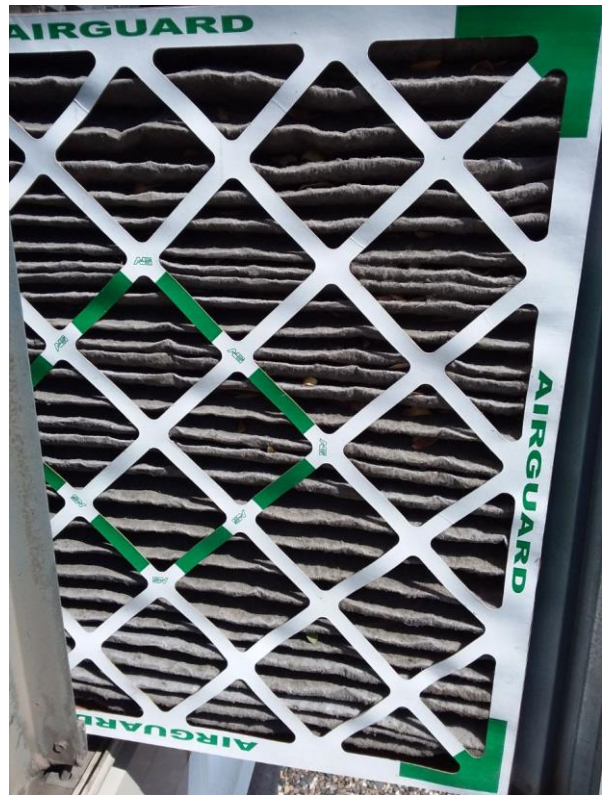
<b>Filter Type - Mixed</b> <ul style="list-style-type: none"> <li>Pre-filter: Pleated, MERV 11</li> <li>Main filter: Metal Mesh, N/A</li> </ul>	Outdoor air intake is in good condition.

RTU 04  
Mixed Pre-Filter Cleanliness

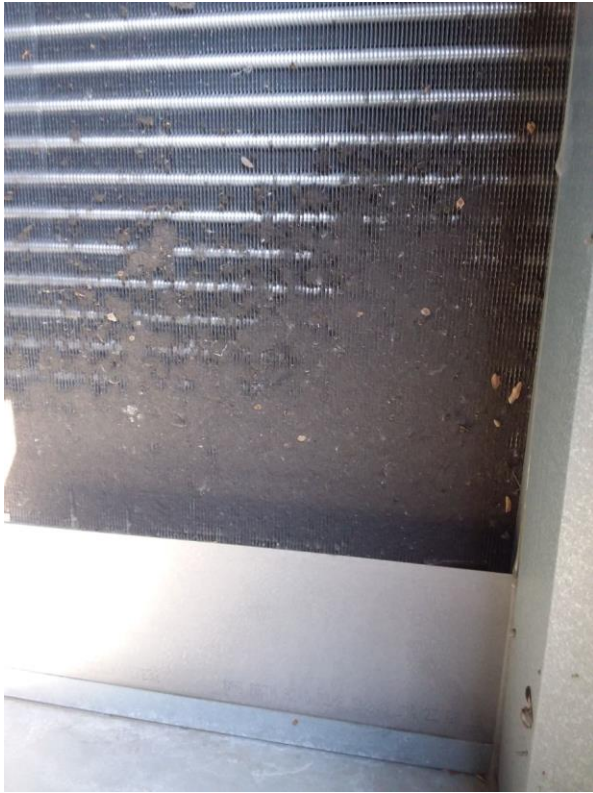
RTU 04  
Heating Coils
