# 2022 - 2023 IAQ Walkthrough

## Saint Paul Public Schools Highwood Hills Elementary School

Walkthrough Date:  
Friday, February 17, 2023

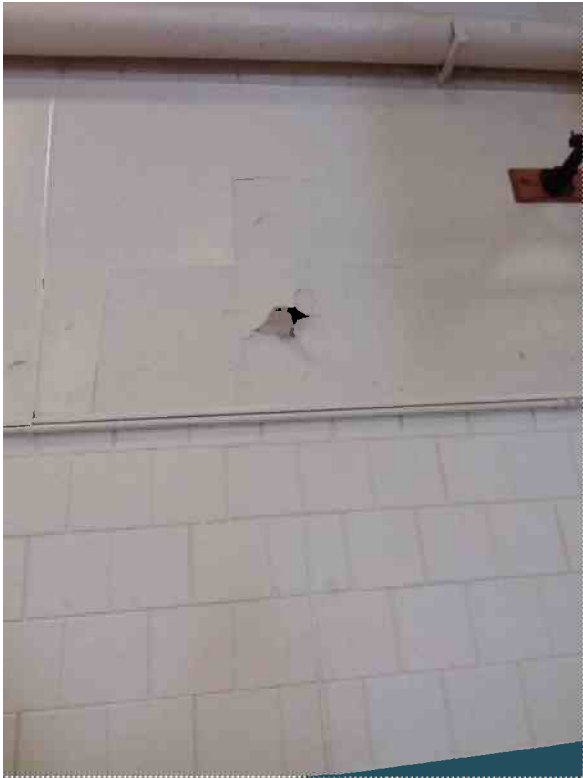
- 2104                      *Peeling paint and wall damage in multiple locations*  
GYMNASIUM

2104 GYMNASIUM  
Bubbling/Peeling Paint

Bubbling/peeling paint can be caused by moisture issues. IEA recommends investigating the cause and repairing the paint. IEA recommends ensuring that the paint is not lead-based prior to disturbance.
