## 2022 - 2023 IAQ Walkthrough

## Saint Paul Public Schools Hmong Language & Culture Middle School

Walkthrough Date:  
Wednesday, January 18, 2023

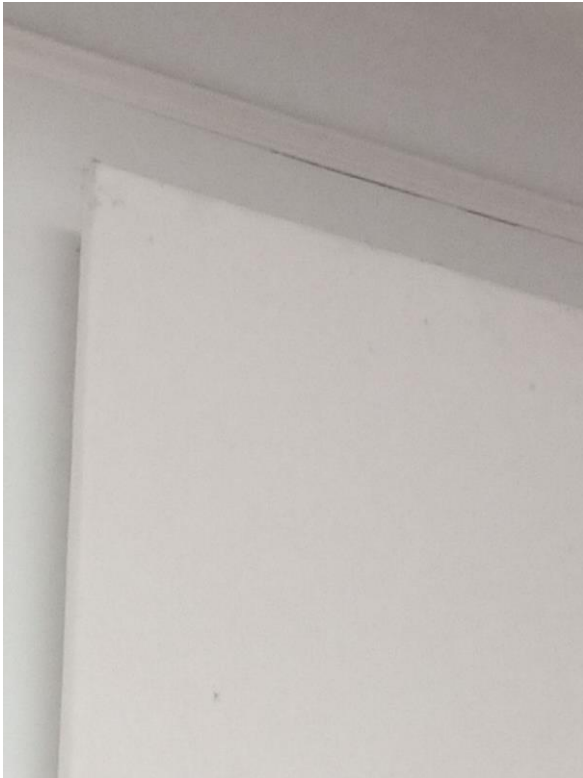
| Room / Location | Number of Occupants | Odor Present | Observations | Dust Accumulation | CO <sub>2</sub> (ppm) | CO (ppm) | RH (%) | Temp (°F) |
|---|---|---|---|---|---|---|---|---|
| 1304 | 1 | No | | Yes<br>Fabric sound panels | 453 | 0.4 | 25.0 | 72.7 |

| • 1304 | <i>Fabric sound panels</i> | | |

1304  
Dust

IEA observed dust accumulation in the following room(s) and recommend that the specified area is wiped clean using a damp rag.

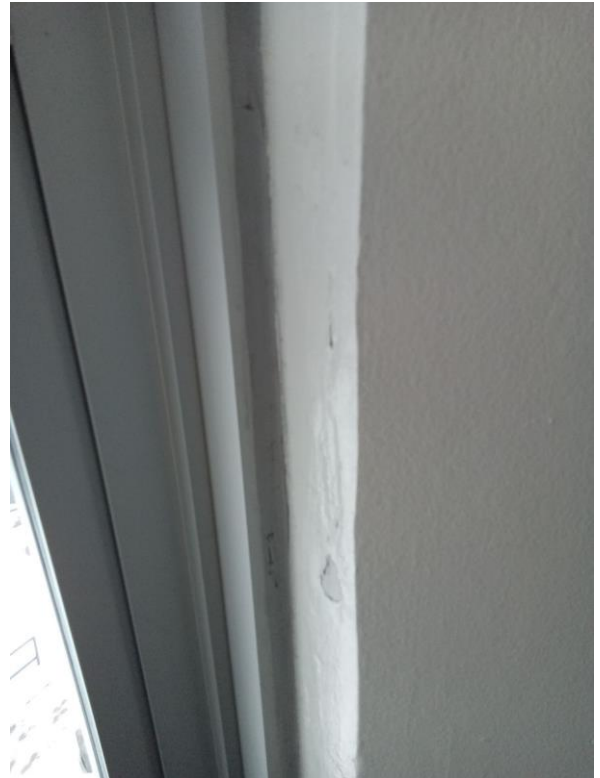
| Room / Location | Number of Occupants | Odor Present | Observations | Dust Accumulation | CO <sub>2</sub> (ppm) | CO (ppm) | RH (%) | Temp (°F) |
|---|---|---|---|---|---|---|---|---|
| 2111 | 0 | No | <ul style="list-style-type: none"> <li>Bubbling/Peeling Paint: See Appendix A</li> </ul> | No | 412 | 0.4 | 23.9 | 68.4 |

2111  
Bubbling/Peeling Paint

IEA observed bubbling/peeling paint in area(s) within the room(s) listed below. Bubbling/peeling paint can be caused by moisture issues. IEA recommends investigating the cause and repairing the paint. IEA recommends ensuring that the paint is not lead-based prior to disturbance.

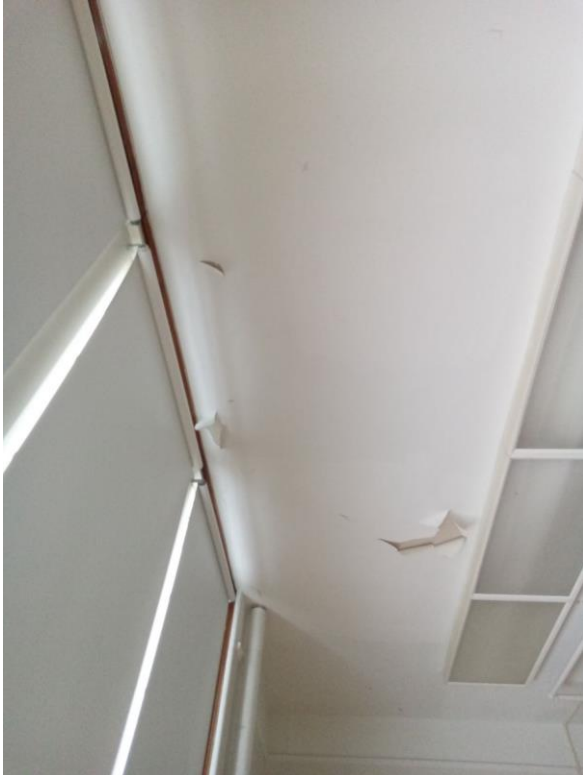
| Room / Location | Number of Occupants | Odor Present | Observations | Dust Accumulation | CO <sub>2</sub> (ppm) | CO (ppm) | RH (%) | Temp (°F) |
|---|---|---|---|---|---|---|---|---|
| 2303 | 0 | No | <ul style="list-style-type: none"> <li>Bubbling/Peeling Paint: See Appendix A</li> </ul> | No | 452 | 0.4 | 25.5 | 70.3 |

2303  
Bubbling/Peeling Paint

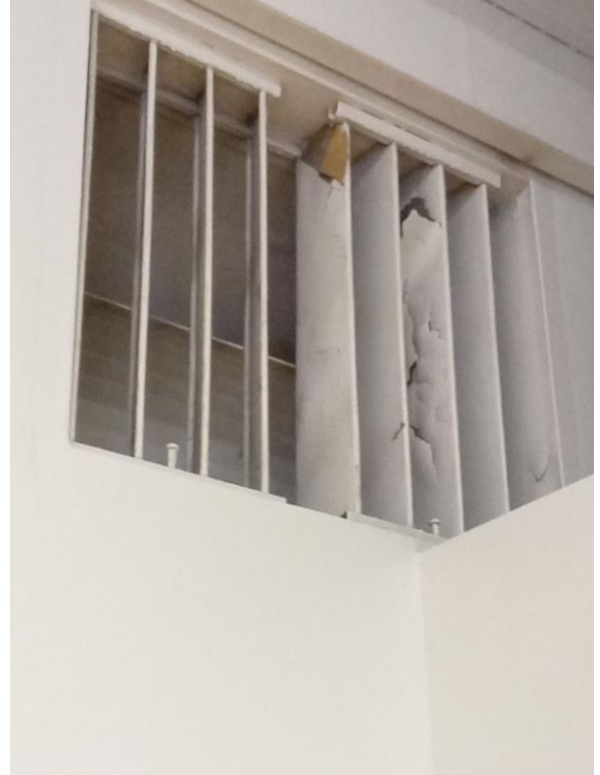
| Room / Location | Number of Occupants | Odor Present | Observations | Dust Accumulation | CO <sub>2</sub> (ppm) | CO (ppm) | RH (%) | Temp (°F) |
|---|---|---|---|---|---|---|---|---|
| 2301 | 0 | No | <ul style="list-style-type: none"> <li>Bubbling/Peeling Paint: See Appendix A</li> </ul> | No | 463 | 0.4 | 24.3 | 71.8 |

2301  
Bubbling/Peeling Paint
